MONITORING YEAR 6 ANNUAL REPORT

AGONY ACRES MITIGATION SITE

Guilford County, NC

DMS Project Number 95716

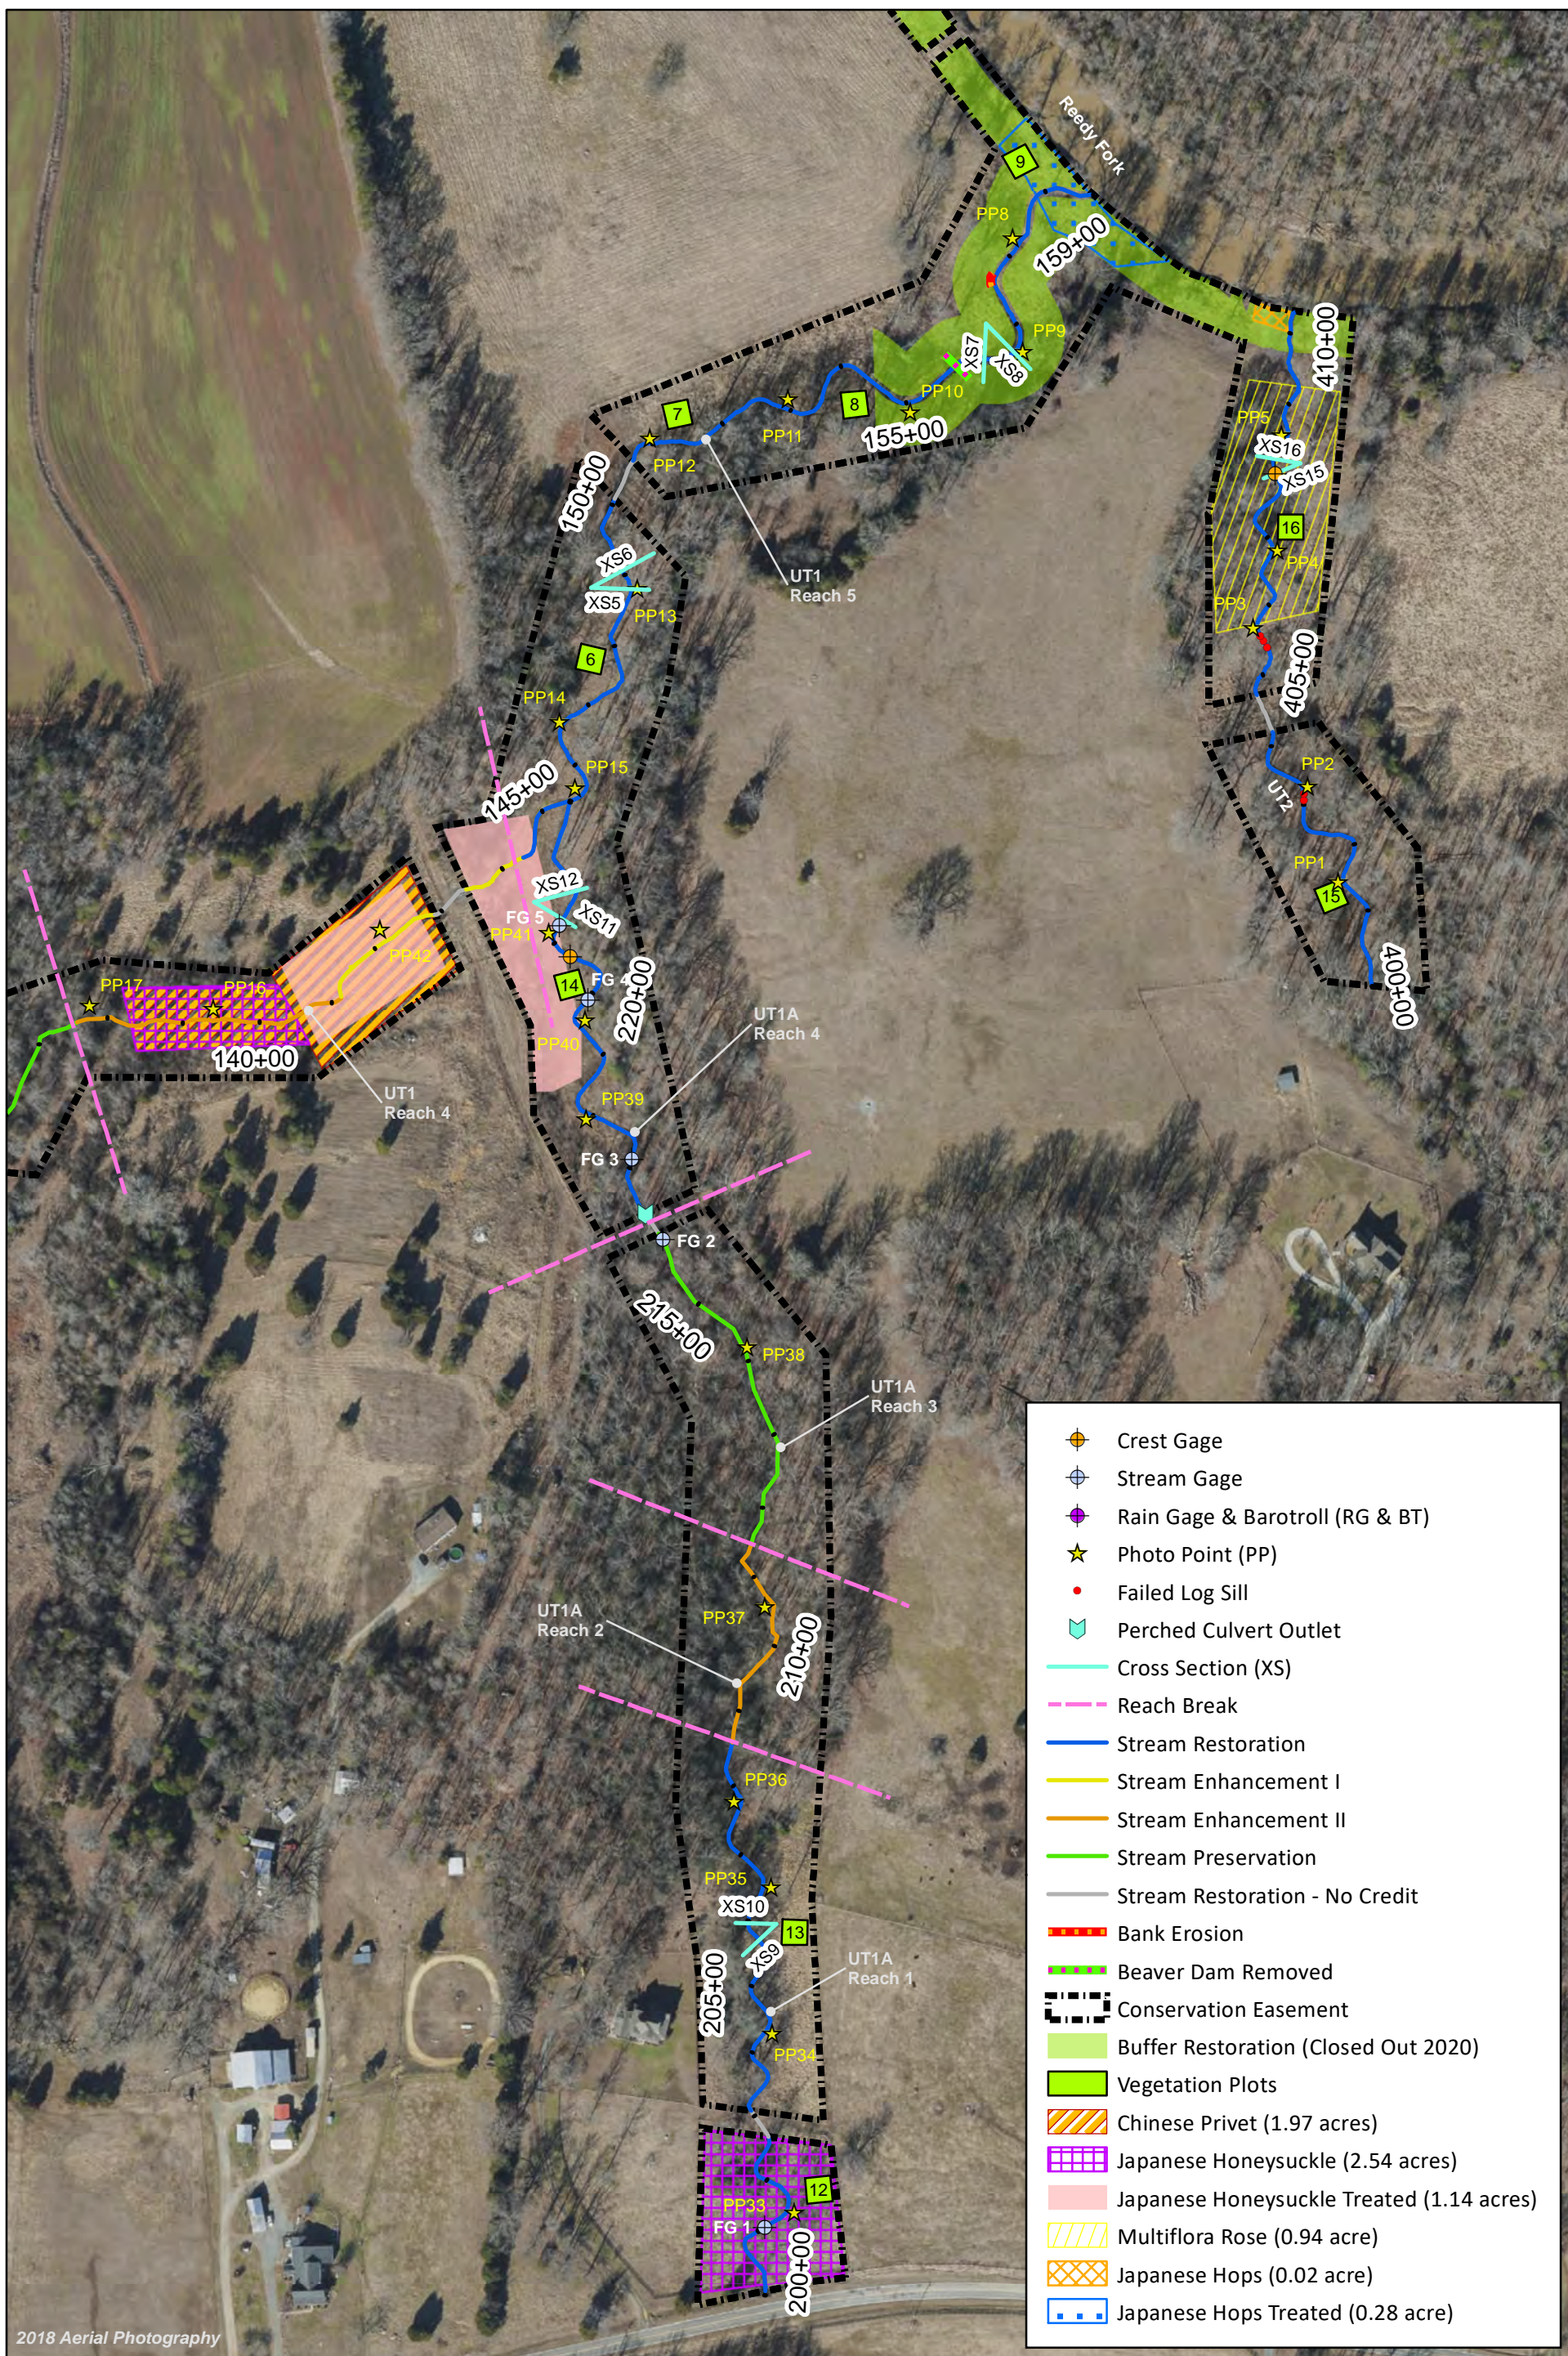
Figure 3.2. Integrated Current Condition Plan View
 (Sheet 2 of 2)
 Agony Acres Mitigation Site
 DMS Project No. 95716
 Monitoring Year 6 - 2020
 Guilford County, NC

Four Beavers and a dam were removed from lower UT1 in August 2020 (Figure 3.2). The stream channel and vegetation did not appear to sustain permanent damage as a result of the beaver activity. The vegetation community in the impacted area was observed re-sprouting vigorously and the primary species affected was black willow (*Salix nigra*). The culvert at the crossing between UT1A reaches three and four is perched and needs repair. Five log sills within two constructed riffles on UT2 are showing minor signs of piping, but do not present risk of imminent failure, bank erosion, or channel instability (Figure 3.2). There is one local occurrence of bank erosion on the outside of a meander bend in lower UT1 (Figure 3.2).

All areas of invasive vegetation are scheduled for treatment and removal in the spring of 2021. Repair of the perched culvert and piping log sills is expected during the winter of 2020. The localized area of bank erosion in lower UT1 reach 5 will be seeded and planted with live stakes during spring of 2021. This stabilization approach is intended to minimize impacts to existing vegetation.

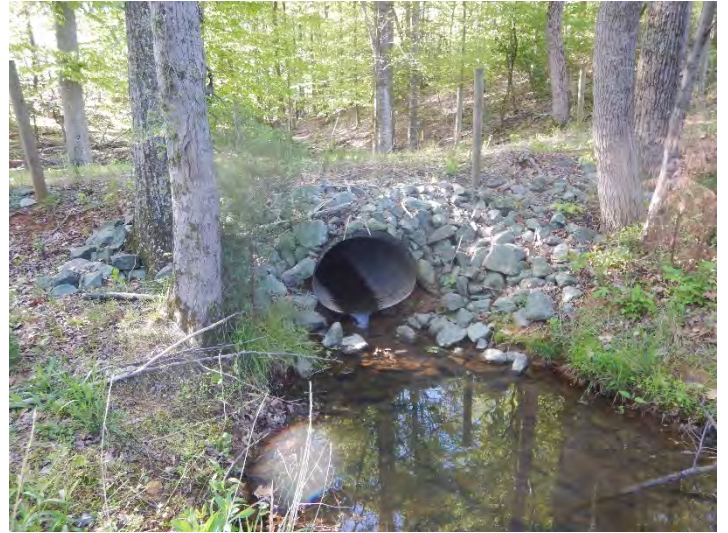
- What caused the culvert to become perched? **Most likely the rock used at the culvert outlet was too small for large storm events, such as hurricanes. We will seek larger stone when repairing this.**

UT1A Perched Culvert – (04/17/2020)

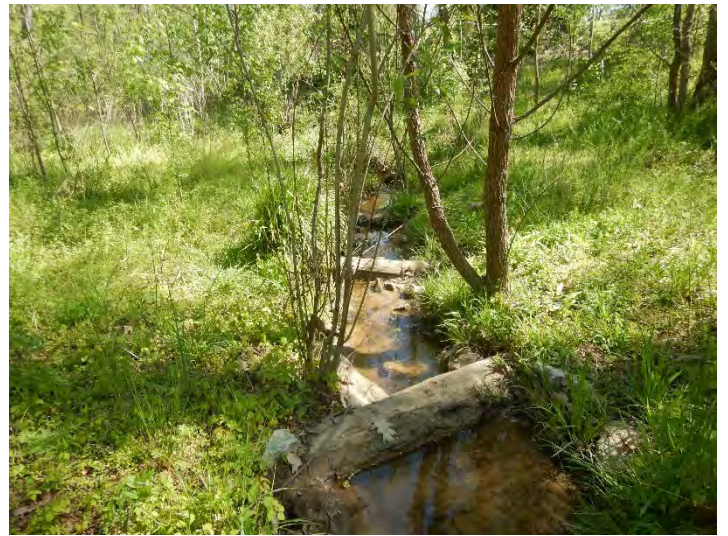
- UT2 has 5 log sill showing minor piping, but Table 5d states that 3 of 5 structures are not exhibiting piping. Could the other 3 log sills not accounted for here fit into another category somehow, or does Wildlands believe the piping isn't severe enough to include in the Table? **Our intent is to convey there are 2 constructed riffles that each have 3 logs in them, some of which are piping. During as-built reporting, in Table 5d these were not counted as stand-alone log sill structures, but part of the constructed riffle. In one riffle all three of the logs are piping, and in the other riffle two of the three logs are piping. We were not sure which category to list this under but decided on the piping category since the entire constructed riffle has not failed. We reported it as 2 of the 5 structures are piping in Table 5d since it is only 2 constructed riffles. The IRT saw this area on the site walk last year so they are aware that a few logs are piping in UT2. If you feel we should report this in a different category on Table 5d let me know and we can update it.**

UT2 Piping Log Sills – (04/17/2020)
