# MONITORING YEAR 1 ANNUAL REPORT

## ALEXANDER FARM MITIGATION SITE

Alexander County, NC  
DEQ Contract No. 7416  
DMS Project No. 100048  
USACE Action ID No. SAW-2018-00451  
NCDEQ DWR Certification No. 18-0665  
RFP #: 16-007277

Data Collection Period: October 2020 – December 2020  
Draft Submission Date: February 15, 2021

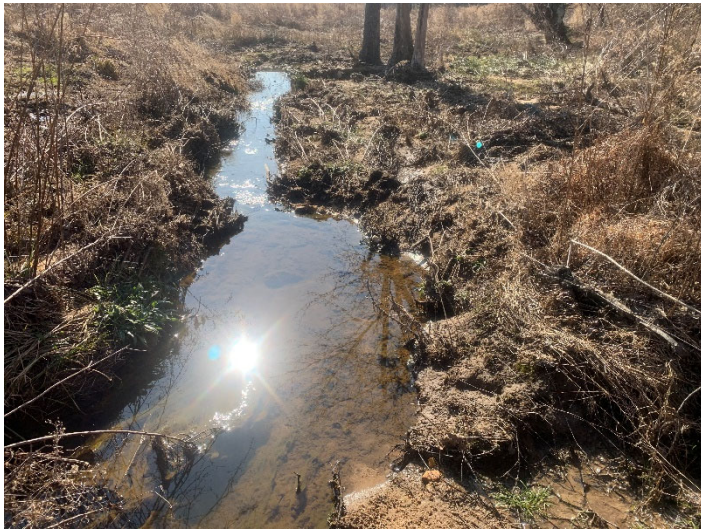
*Wildlands' response: As requested, photos of erosional areas for UT1 Reach 2 have been included in the "Area of Concerns" photolog located in Appendix 2.*

**UT1 R2 Right Bank Erosion (STA 120+00-120+20) – view downstream (2/9/2021)**

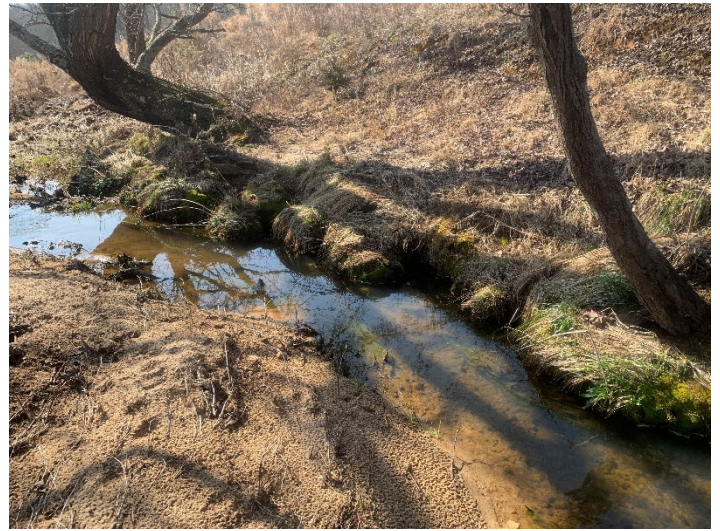
**UT1 R2 Right Bank Erosion (STA 121+00-121+15) – view downstream (2/9/2021)**

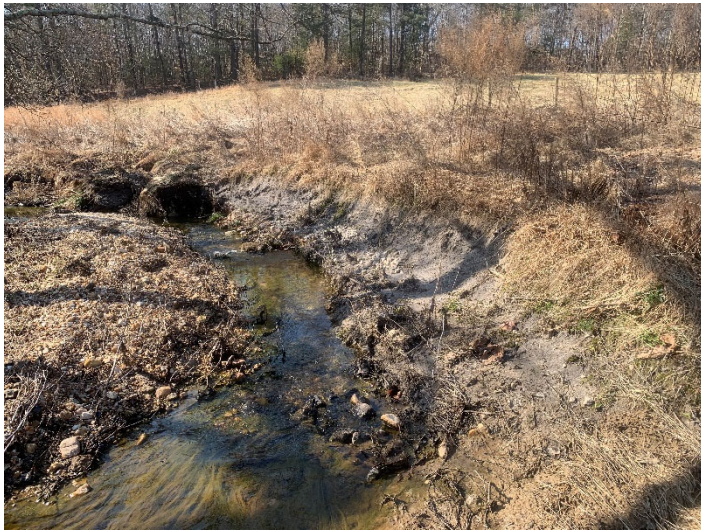
**UT1 R2 Right Bank Erosion (STA 126+00-126+20) – view downstream (2/9/2021)**

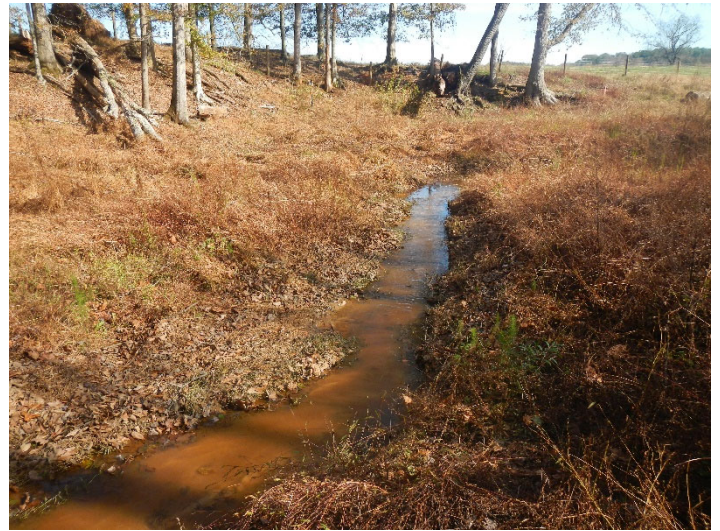
1. Bed	1. Vertical Stability (Riffle and Run units)	Aggradation			2	110	95%			
		Degradation			0	0	100%			
	2. Riffle Condition	Texture/Substrate	17	17			100%

**UT1 R4A Aggradation (STA 139+00-139+75) – view downstream (11/05/2020)**
