MONITORING YEAR 3 ANNUAL REPORT

ALEXANDER FARM MITIGATION SITE

DMS Project No. 100048

Data Collection Period: January 2022 – November 2022

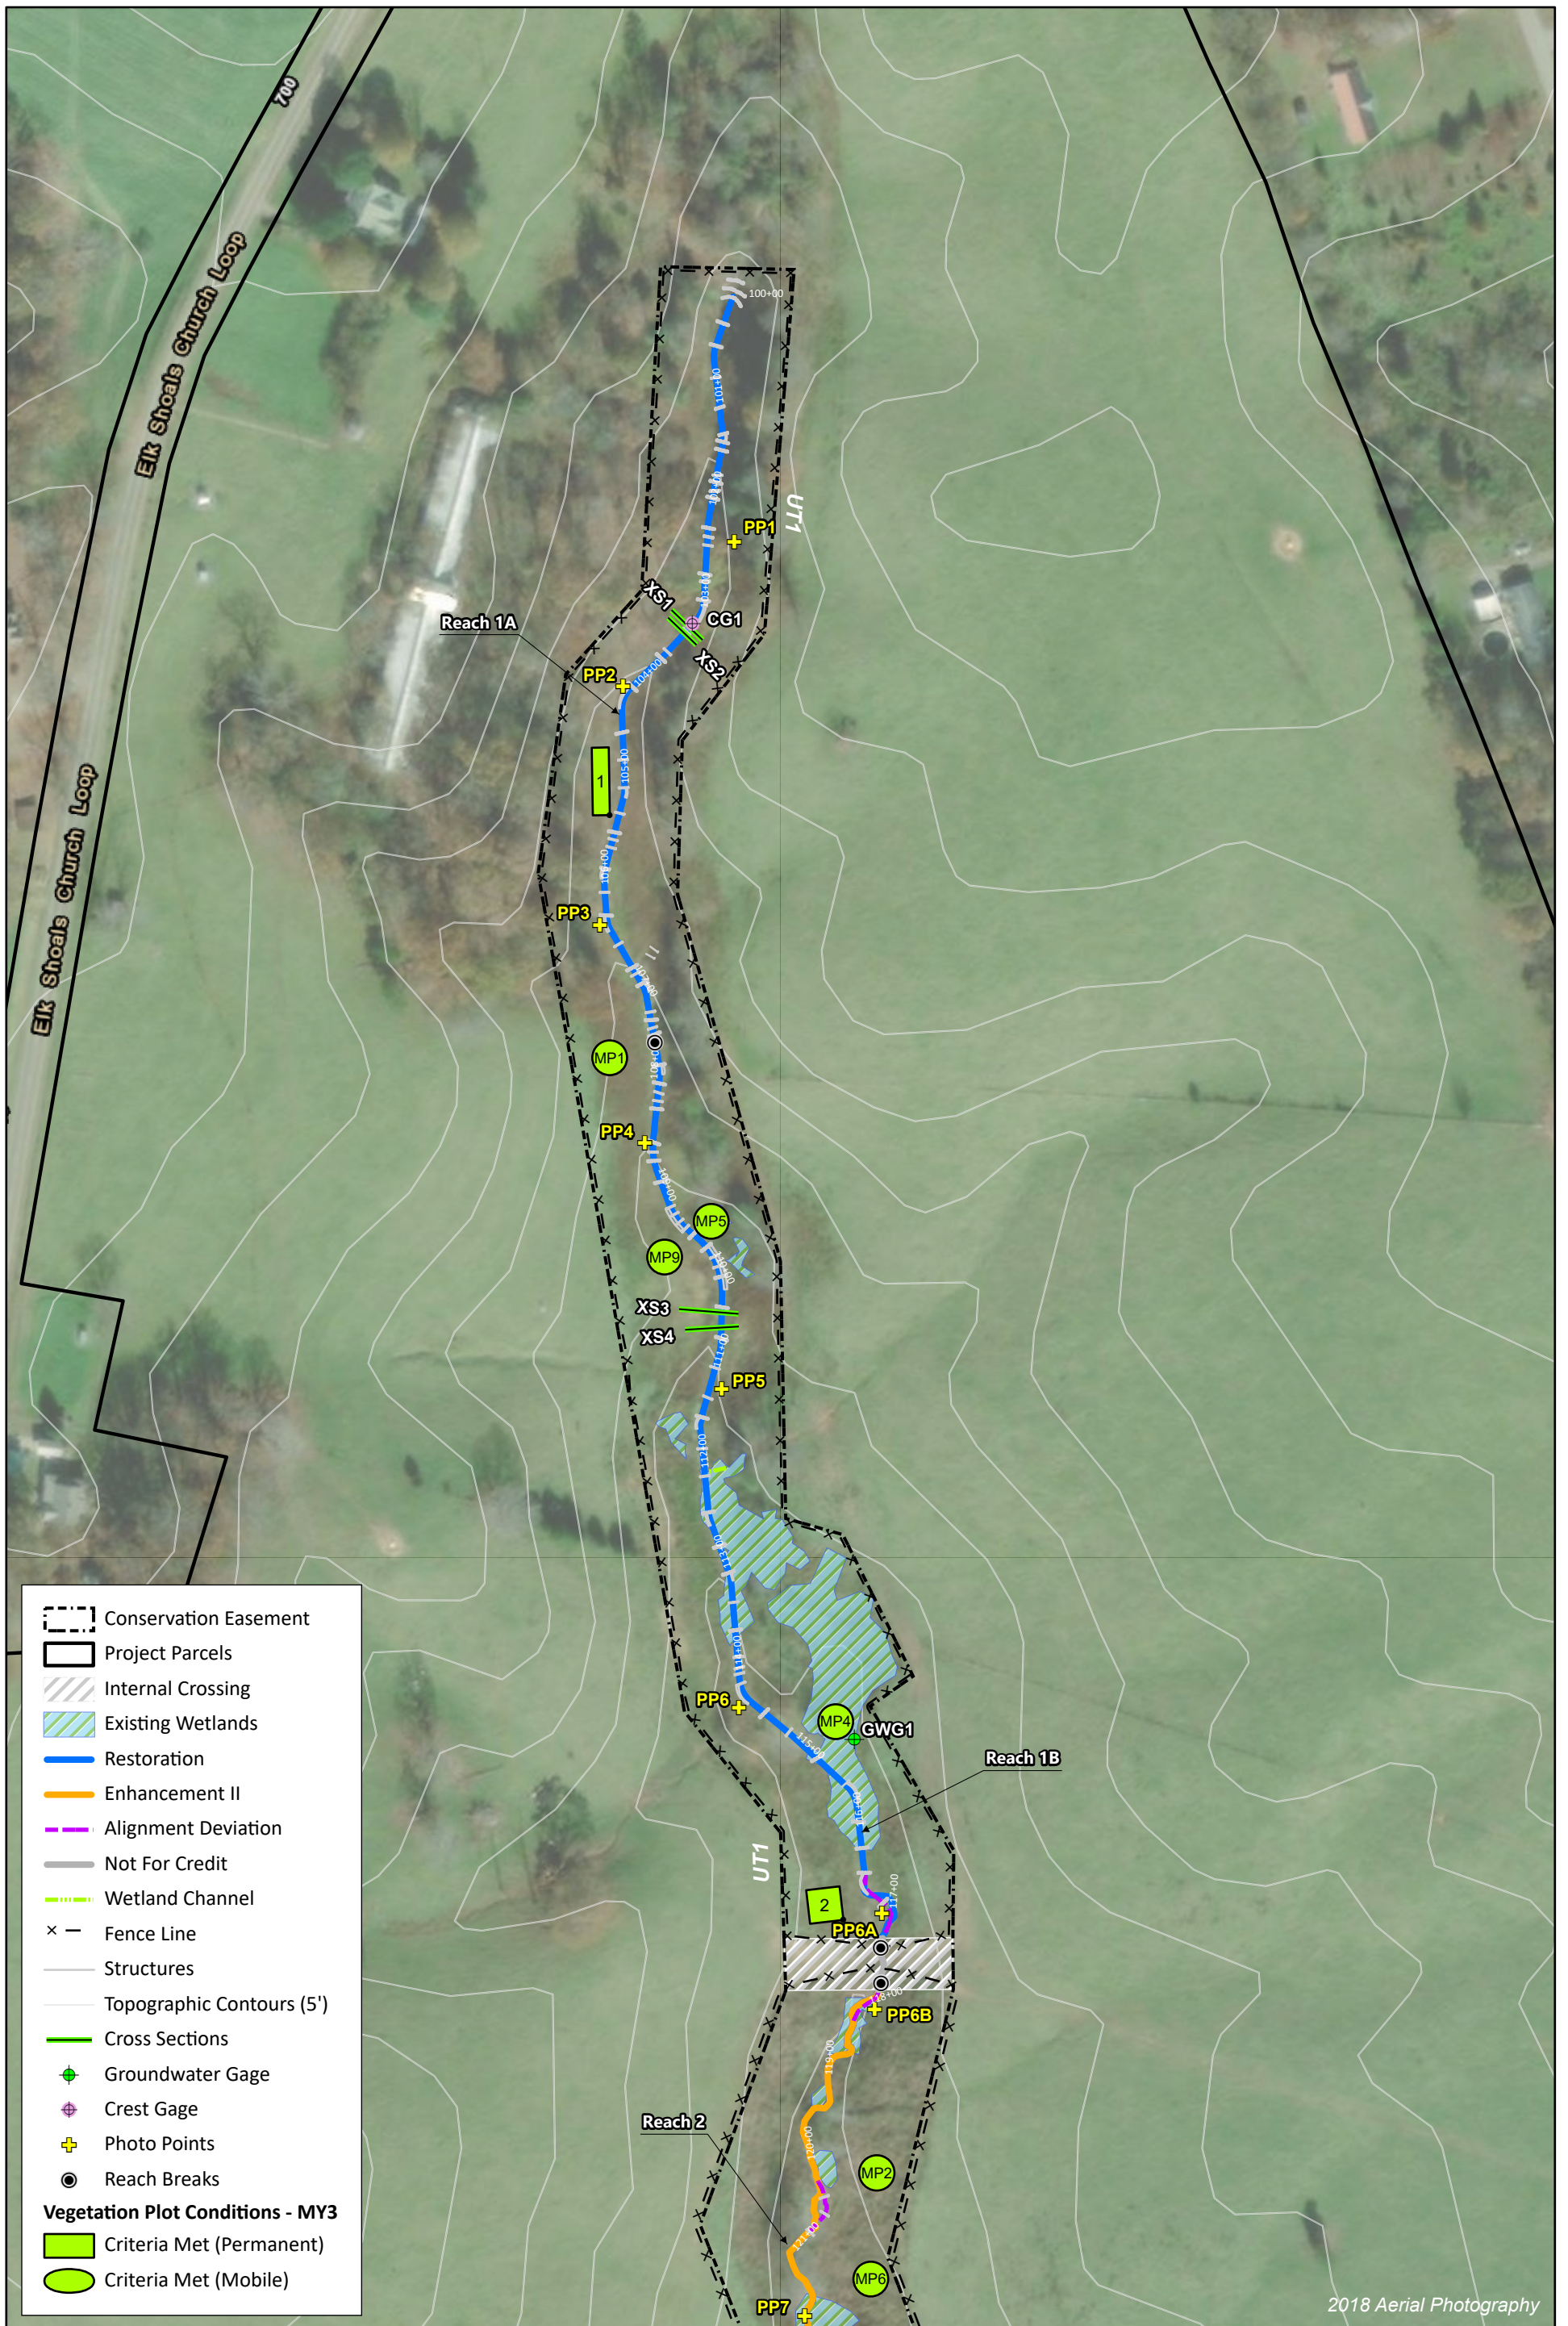
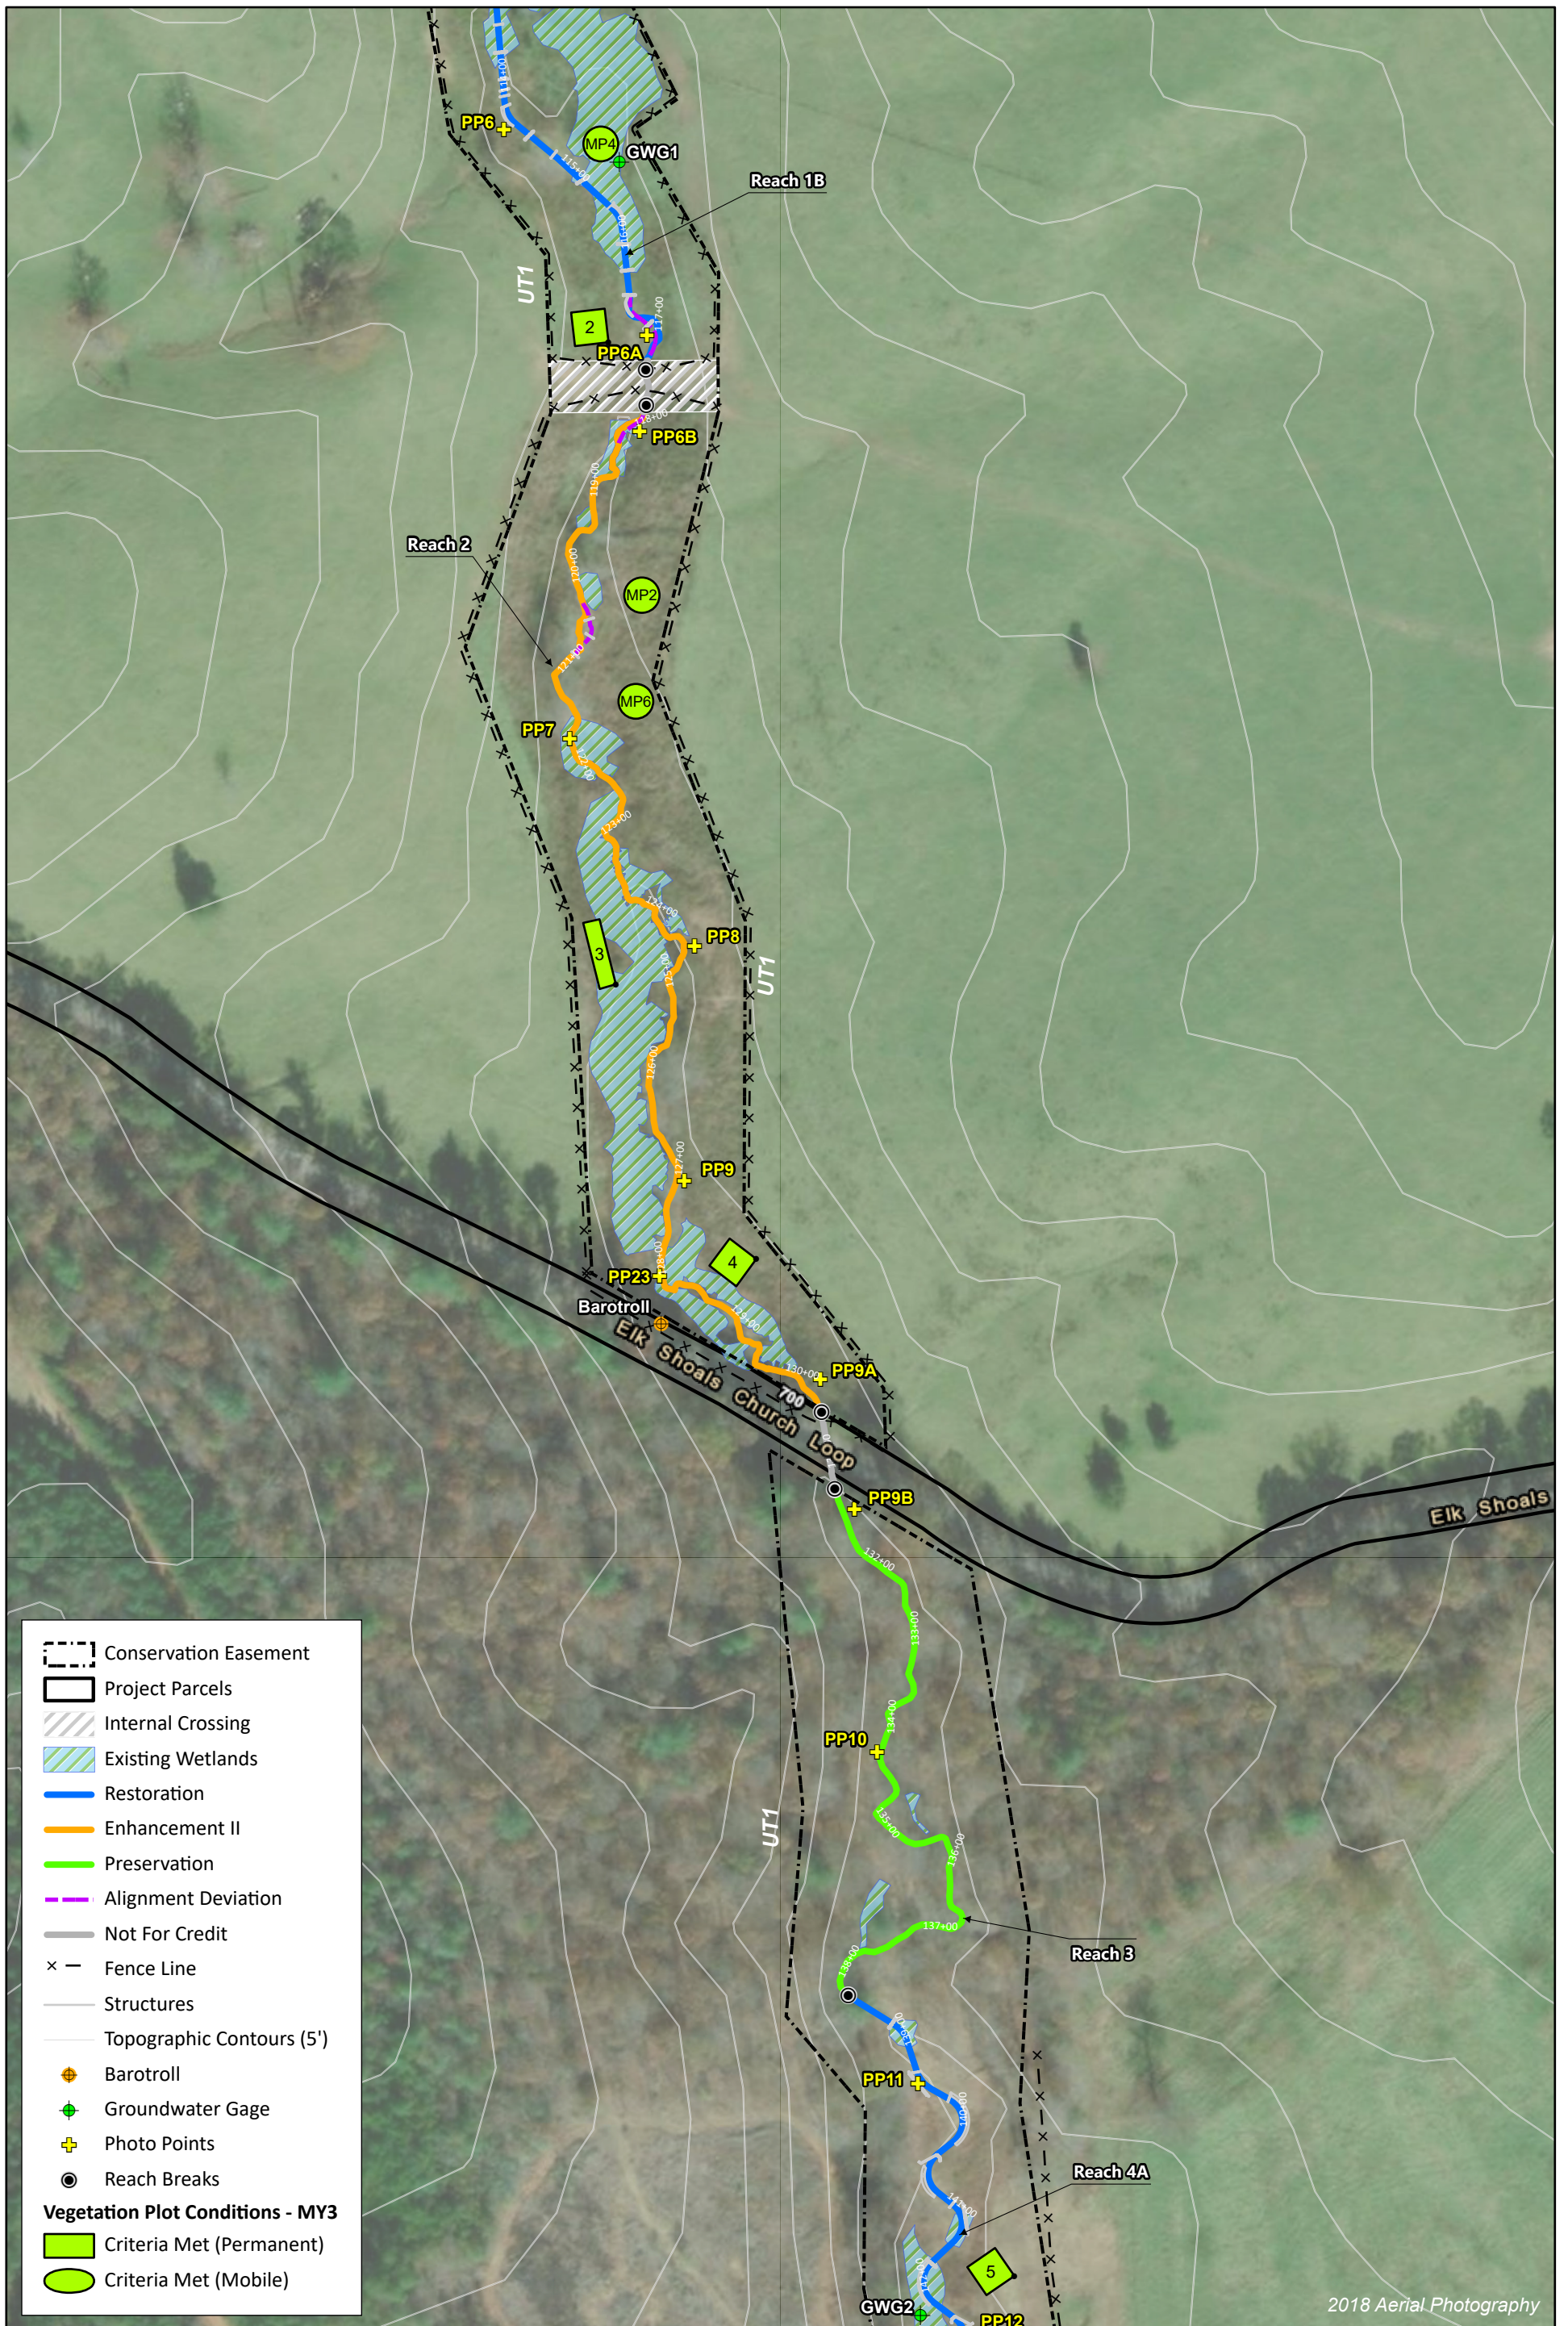
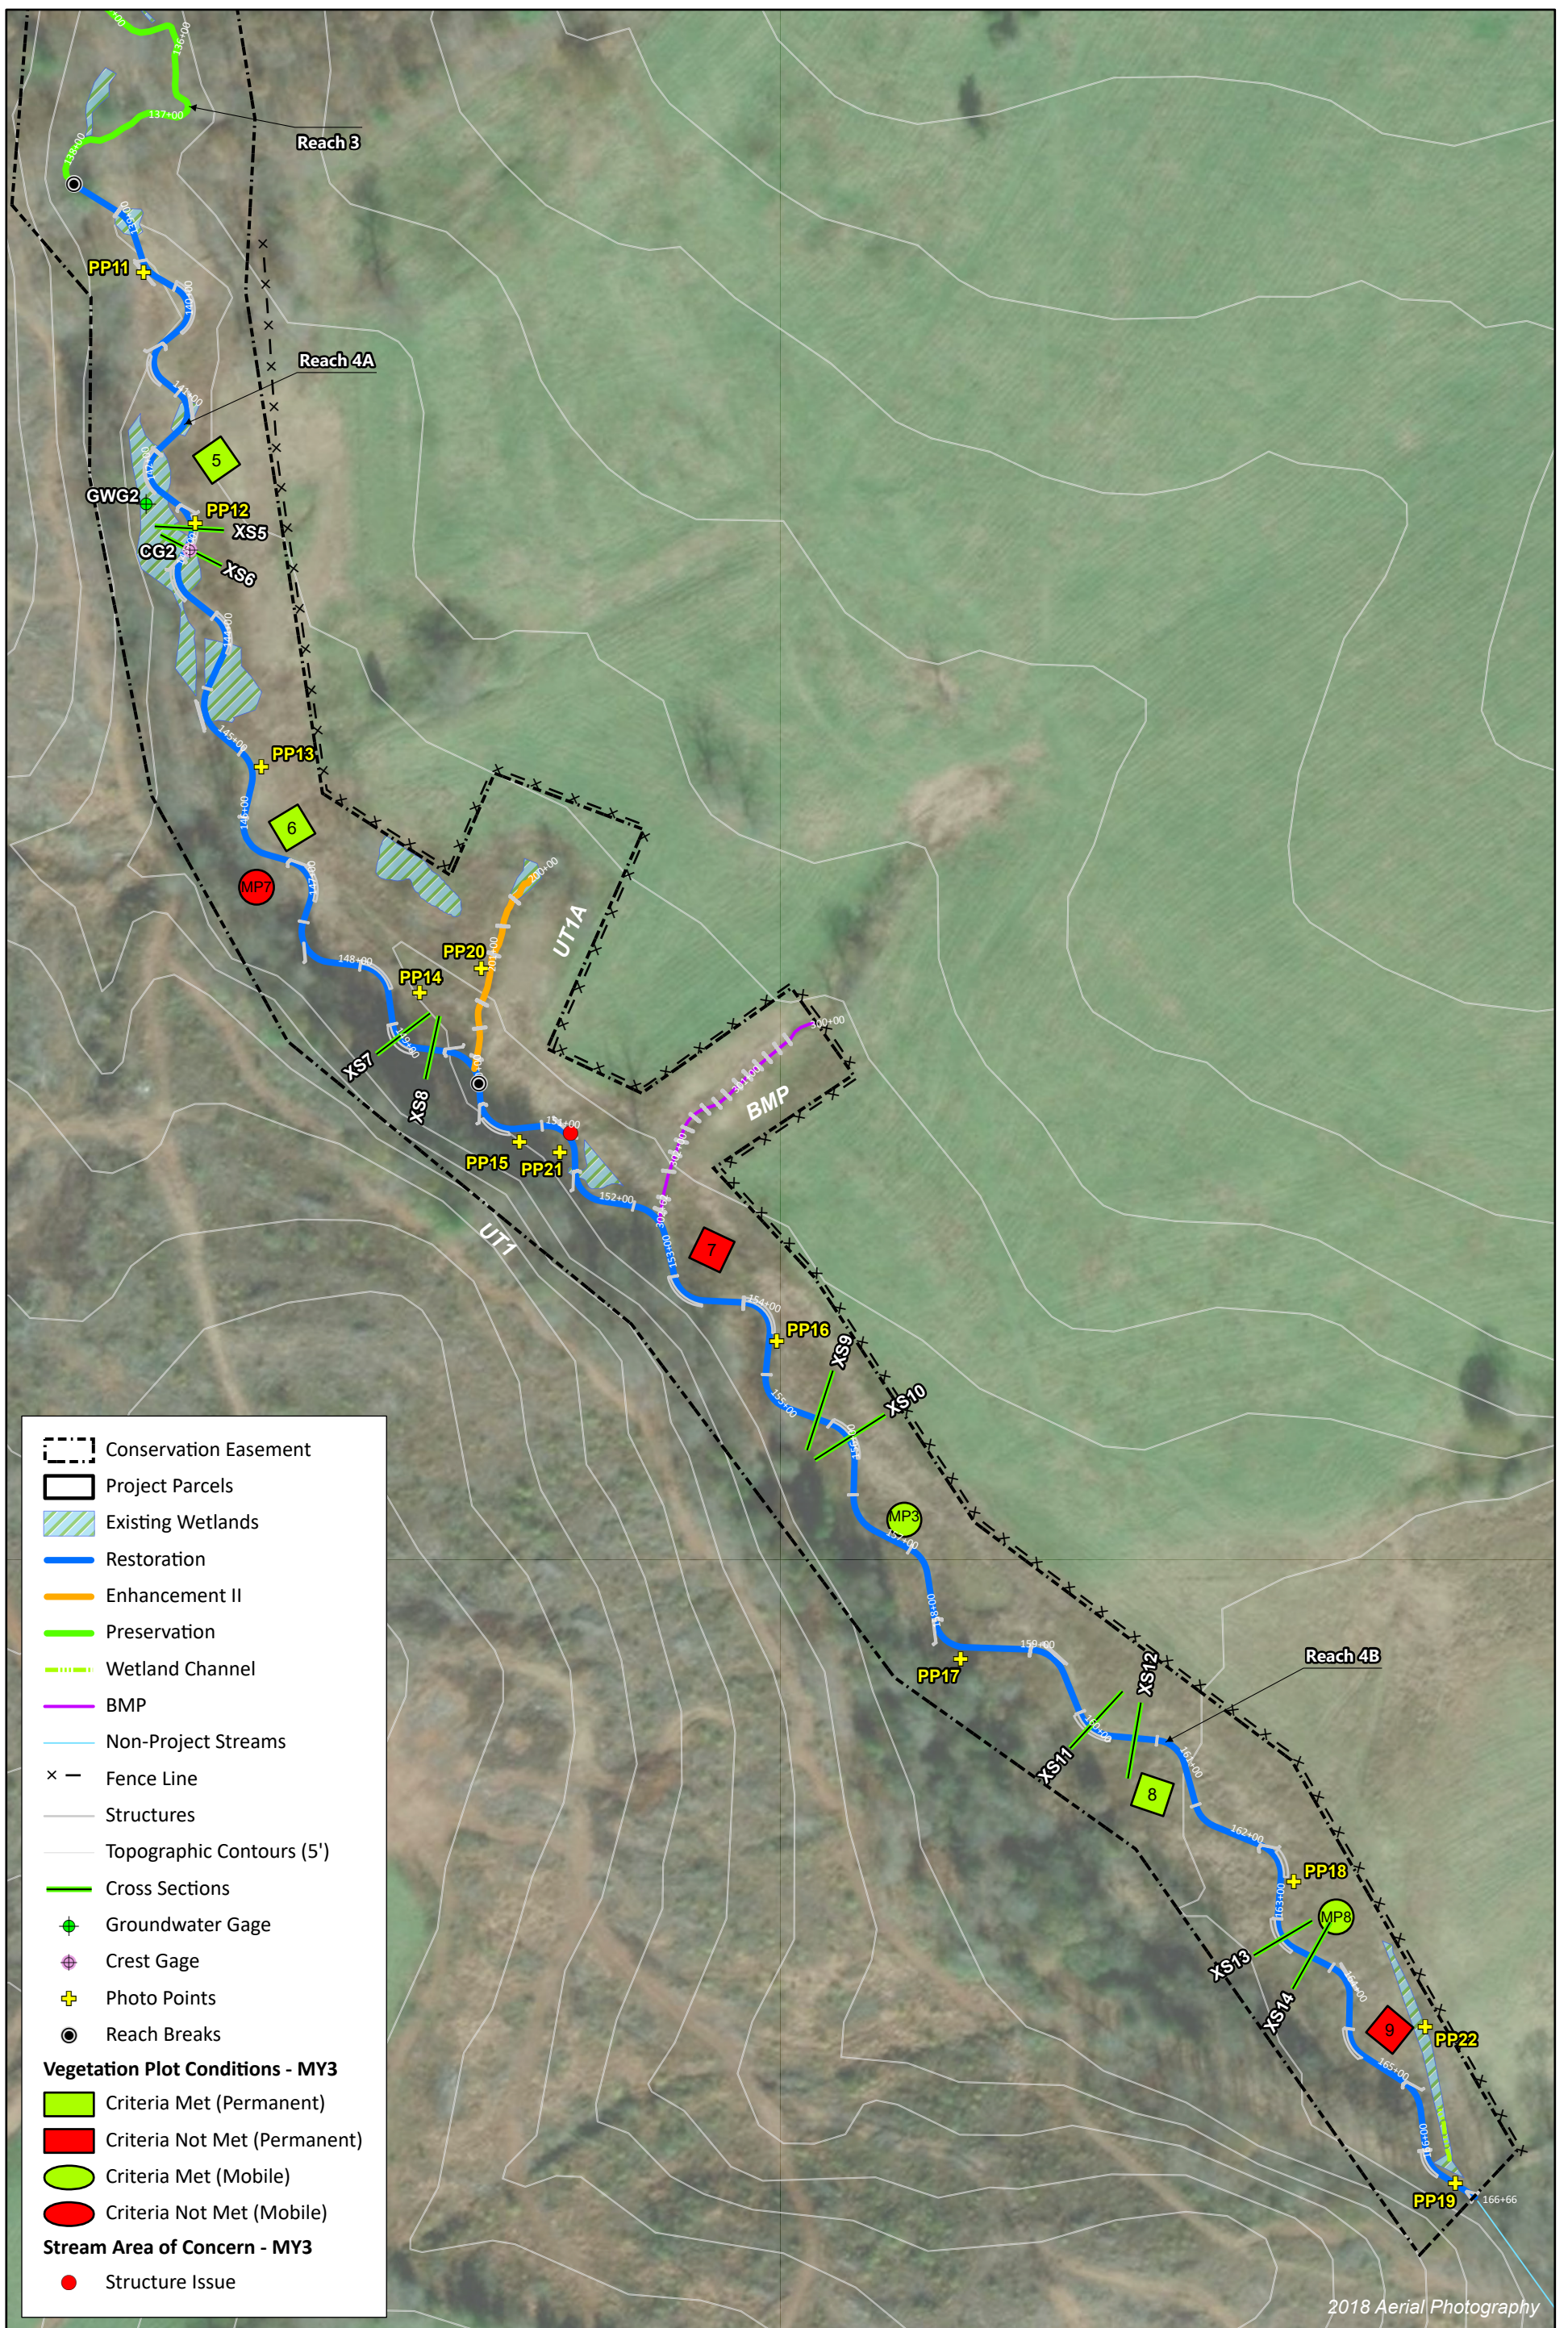
Please refer to CCPV Figures 1 – 1c and Appendix A for stream stability tables, added photo points, and photographs of repaired MY2 areas of concern, and Appendix F for the meeting minutes from the Alexander Farm IRT Credit Release Site Walk. Wildlands will continue to monitor these areas and remedial actions will be implemented if these areas threaten the stability of the project.

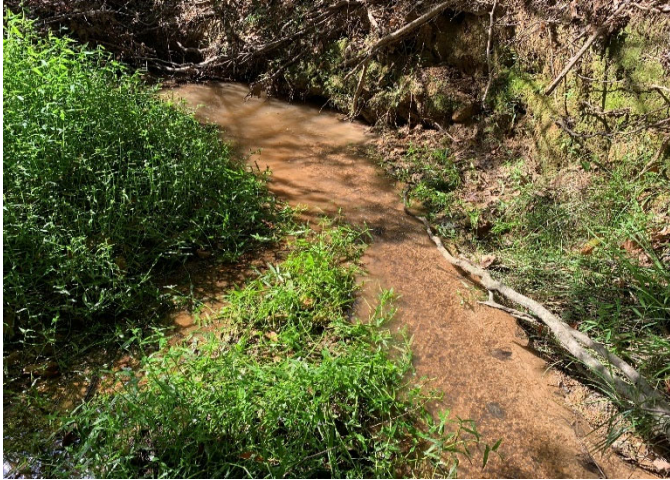
All streams on the Site, including the three areas of concern that were recorded in MY1, are remaining stable. Streambank vegetation has become established, and these areas are no longer an issue. During the MY2 visual stream assessment approximately 110 LF of aggradation from station 138+75 to 139+85 was noted on UT1 Reach 4A. In MY3 on June 17, 2022, a large tree that was impeding flow in this section of the stream was cut down, allowing for normal stream flows to return; thereby, flushing the sediment through the system. This area is no longer of concern.

UT1 R4A (STA 139+00-139+75) – view downstream of aggradation area reported in MY2 (09/20/2022)

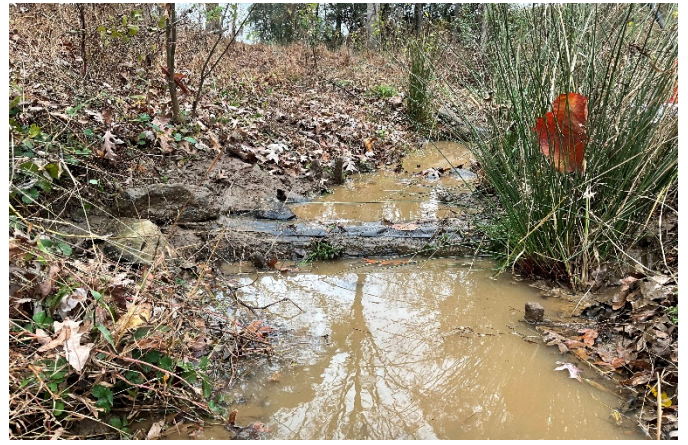
200 LF of stream on UT1 Reach 1A was noted as lacking sufficient streamflow from May - October 2022. Within this section of the reach, three piping log sills were repaired, and filter fabric was added in late 2022. Sufficient streamflow returned to the area in the fall of 2022 and continues to flow throughout the entire reach. All areas, throughout the project, are doing well and trending towards success. No easement violations and only one area of fence damage were noted during MY3. The fence was repaired in November 2022. Wildlands will continue to monitor these areas throughout the seven-year monitoring period to benefit the ecological health of the Site.

UT1 R1A Structure Repaired (STA 104+00) – view upstream (11/10/2022)

Wildlands' response: Visual monitoring was to be conducted until repairs were finished to a few piping log sills without enough filter fabric. Now that repairs are completed and functioning appropriately, Wildlands plans to install a game camera in early 2023 to continue monitoring the area for issues resulting in insufficient baseflow. Additional text has been added to Section 1.4.5 for clarity.

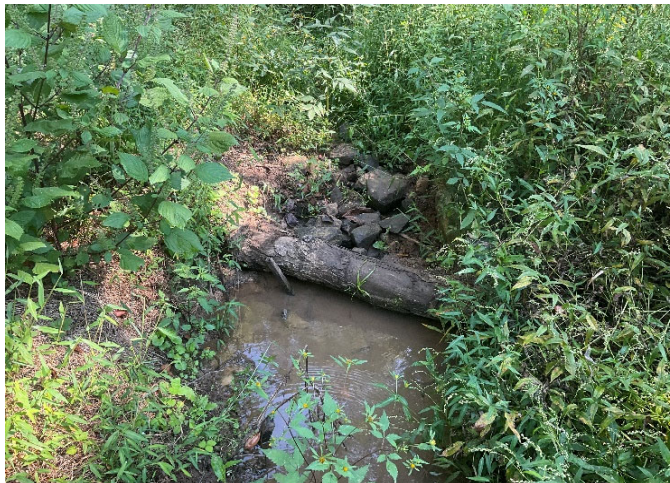
In early May 2022, prior to the IRT Credit Release Site Walk, Wildlands documented the lack of sufficient baseflow on approximately 200 linear feet (LF) of UT1 Reach 1A. Because this area, nor any other area of the project had experienced baseflow issues in the past, Wildlands discussed the anomaly with the IRT during the on-site meeting. In the short term, Wildlands decided to visually monitor the section of stream, the baseflow upstream and downstream of the area, the functionality of bounding grade control, and the hydrologic conditions within the immediate floodplain and contributing drainage area. Based on this approach and shallow baseflow returning to the riffles and pools within this area of the reach, in early September of 2022, Wildlands believed that structure piping, noted in MY2, was allowing stream flow to move subsurface. Therefore, between October 10th and December 16th before any other additional monitoring measures were implemented, Wildlands repaired three piping log sills within the area and replaced the filter fabric. Since these measures were implemented surface flow has increased to sufficient levels throughout the reach. Previously piping structures along UT1 Reach 1A are no longer of concern. Wildlands plans to install a game camera to monitor the area moving forward.

UT1 R1A Structure Piping (STA 104+05) – view upstream (09/20/2022)

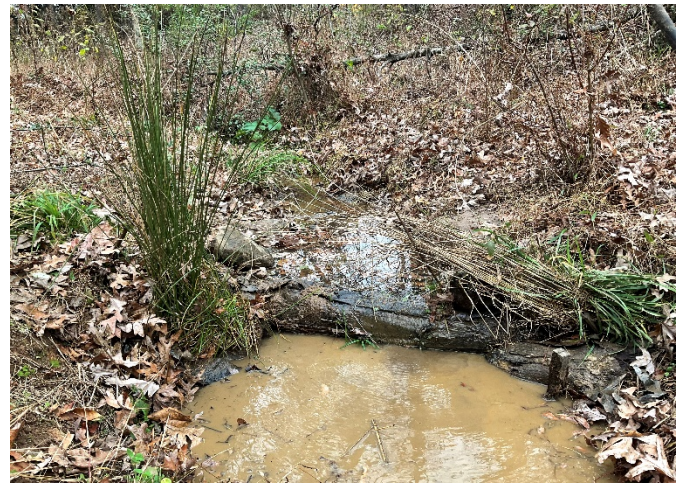
UT1 R1A Structure Repaired (STA 104+05) – view upstream (11/10/2022)
