MONITORING YEAR 4 ANNUAL REPORT

ALEXANDER FARM MITIGATION SITE

Alexander County, NC

DMS Project No. 100048

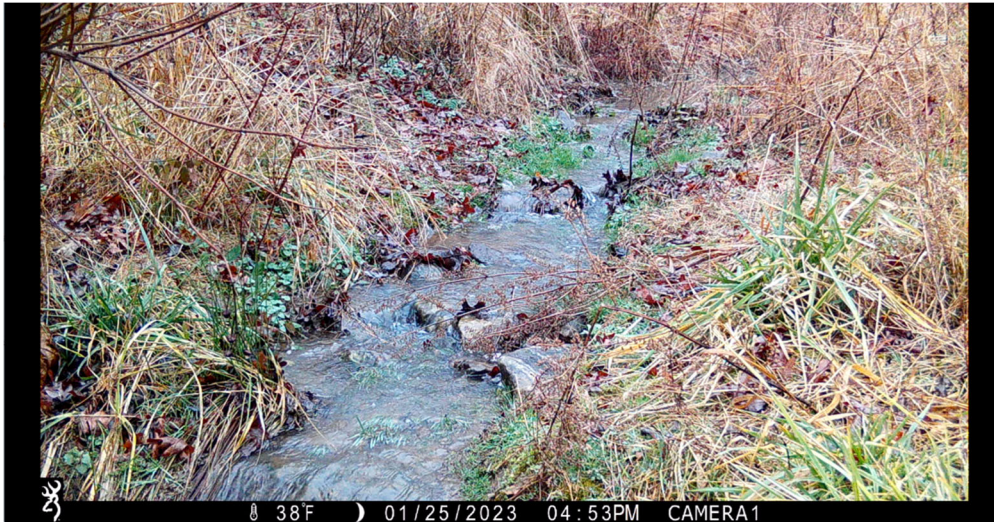
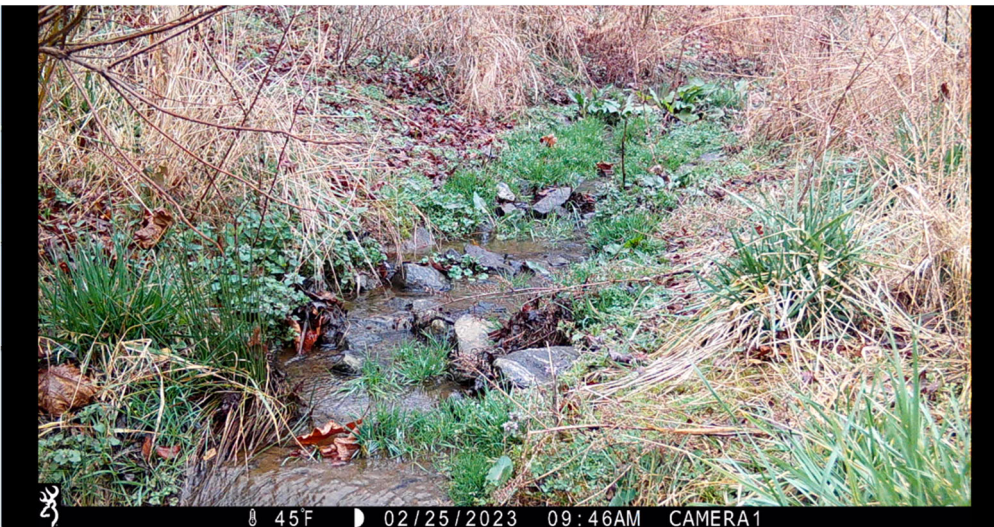
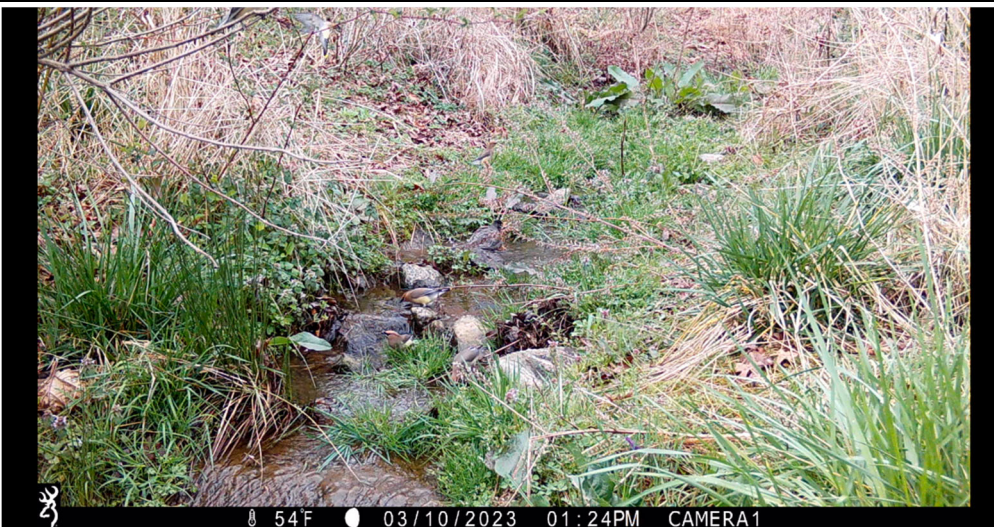
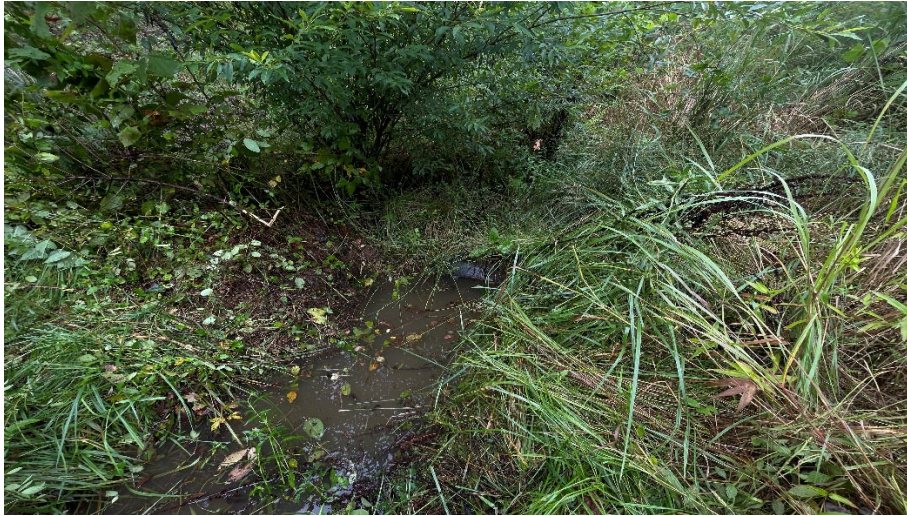
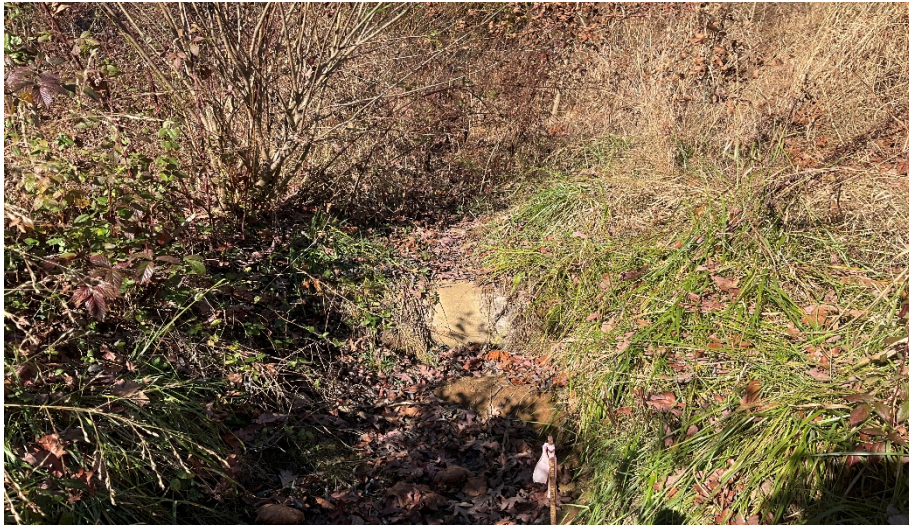
UT1 Reach 1A Subsurface Flow Photographs
Monitoring Year 4

In early May 2022 approximately 200 LF of stream along UT1 Reach 1A was lacking baseflow. Within this section of the reach, two piping log sills were repaired, and filter fabric was added. A game camera was installed in MY4 and it, as well as visual assessments, documented that sufficient streamflow returned in the fall of 2022 and continued to flow throughout the entire reach until November 2023 when drought conditions returned after months of below normal rainfall. As of the MY4 visual assessment, all of the repaired structures are functioning as designed. Wildlands will continue to monitor the Site, and additional adaptive maintenance will be implemented, as necessary, throughout the seven-year monitoring period to benefit the ecological health of the Site.

UT1 Reach 1A – Lack of Water in Channel (11/28/2023)

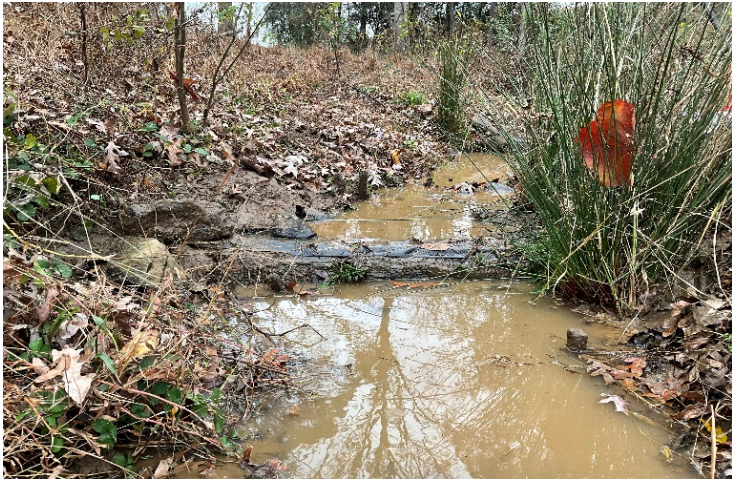
UT1 R1A Structure Repaired (STA 104+00) – view upstream
(11/10/2022)

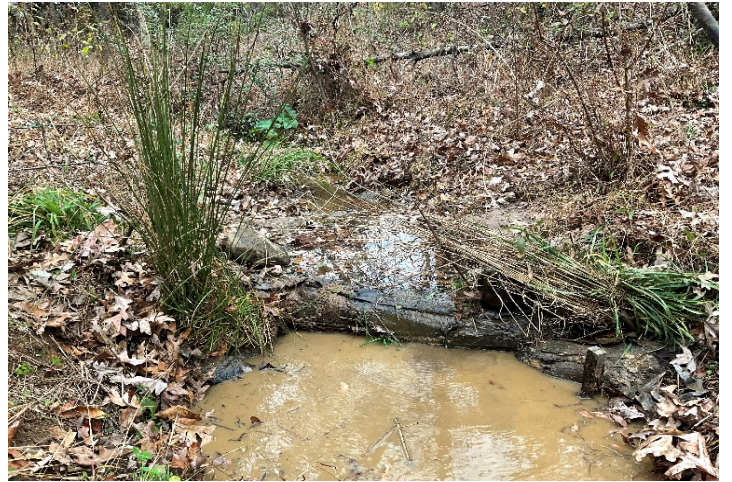
UT1 R1A Structure Repaired (STA 104+05) – view upstream
(11/10/2022)

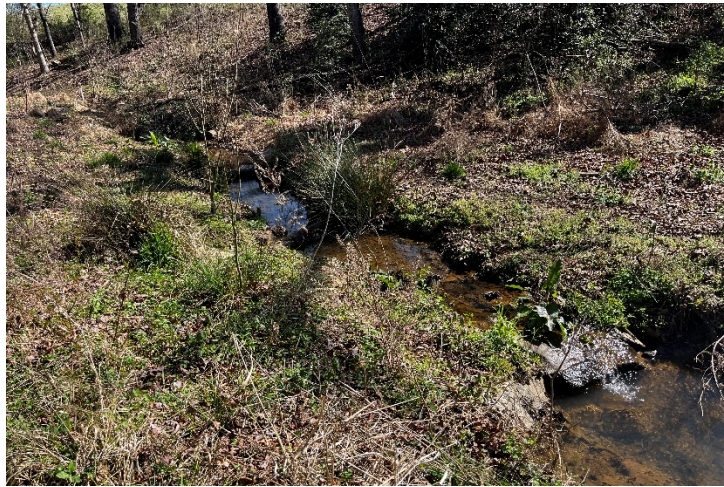
UT1 R1A Structure Repaired (STA 104+00 – 104+05) – view upstream (03/09/2023)

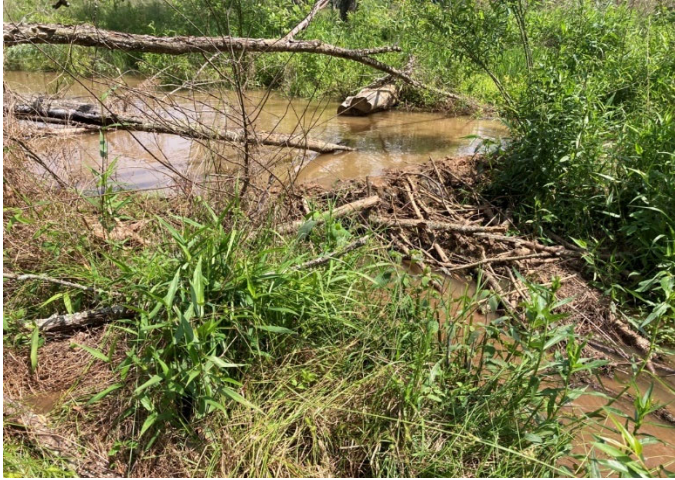
In May of 2023, one beaver dam was noted towards the bottom of UT1 Reach 4B at station 165+58. Wildlands contacted USDA APHIS to remove the beavers. The beavers were trapped in June 2023, and the dam was released by Wildlands in August 2023. Damage caused by the beaver dam and inundation was minimal and likely temporary. It consisted of only minor vegetation damage and sediment deposition along the banks. As of October 2023, no other beaver activity has been noted on the Site.

Beaver Dam – view upstream – UT1 R4B at STA 165+58
(05/10/2023)
