FINAL
MONITORING REPORT (MY1)

ALLIANCE HEADWATERS MITIGATION SITE

Johnston County, North Carolina

Data Collection: January-November 2020
Submission: January 2021

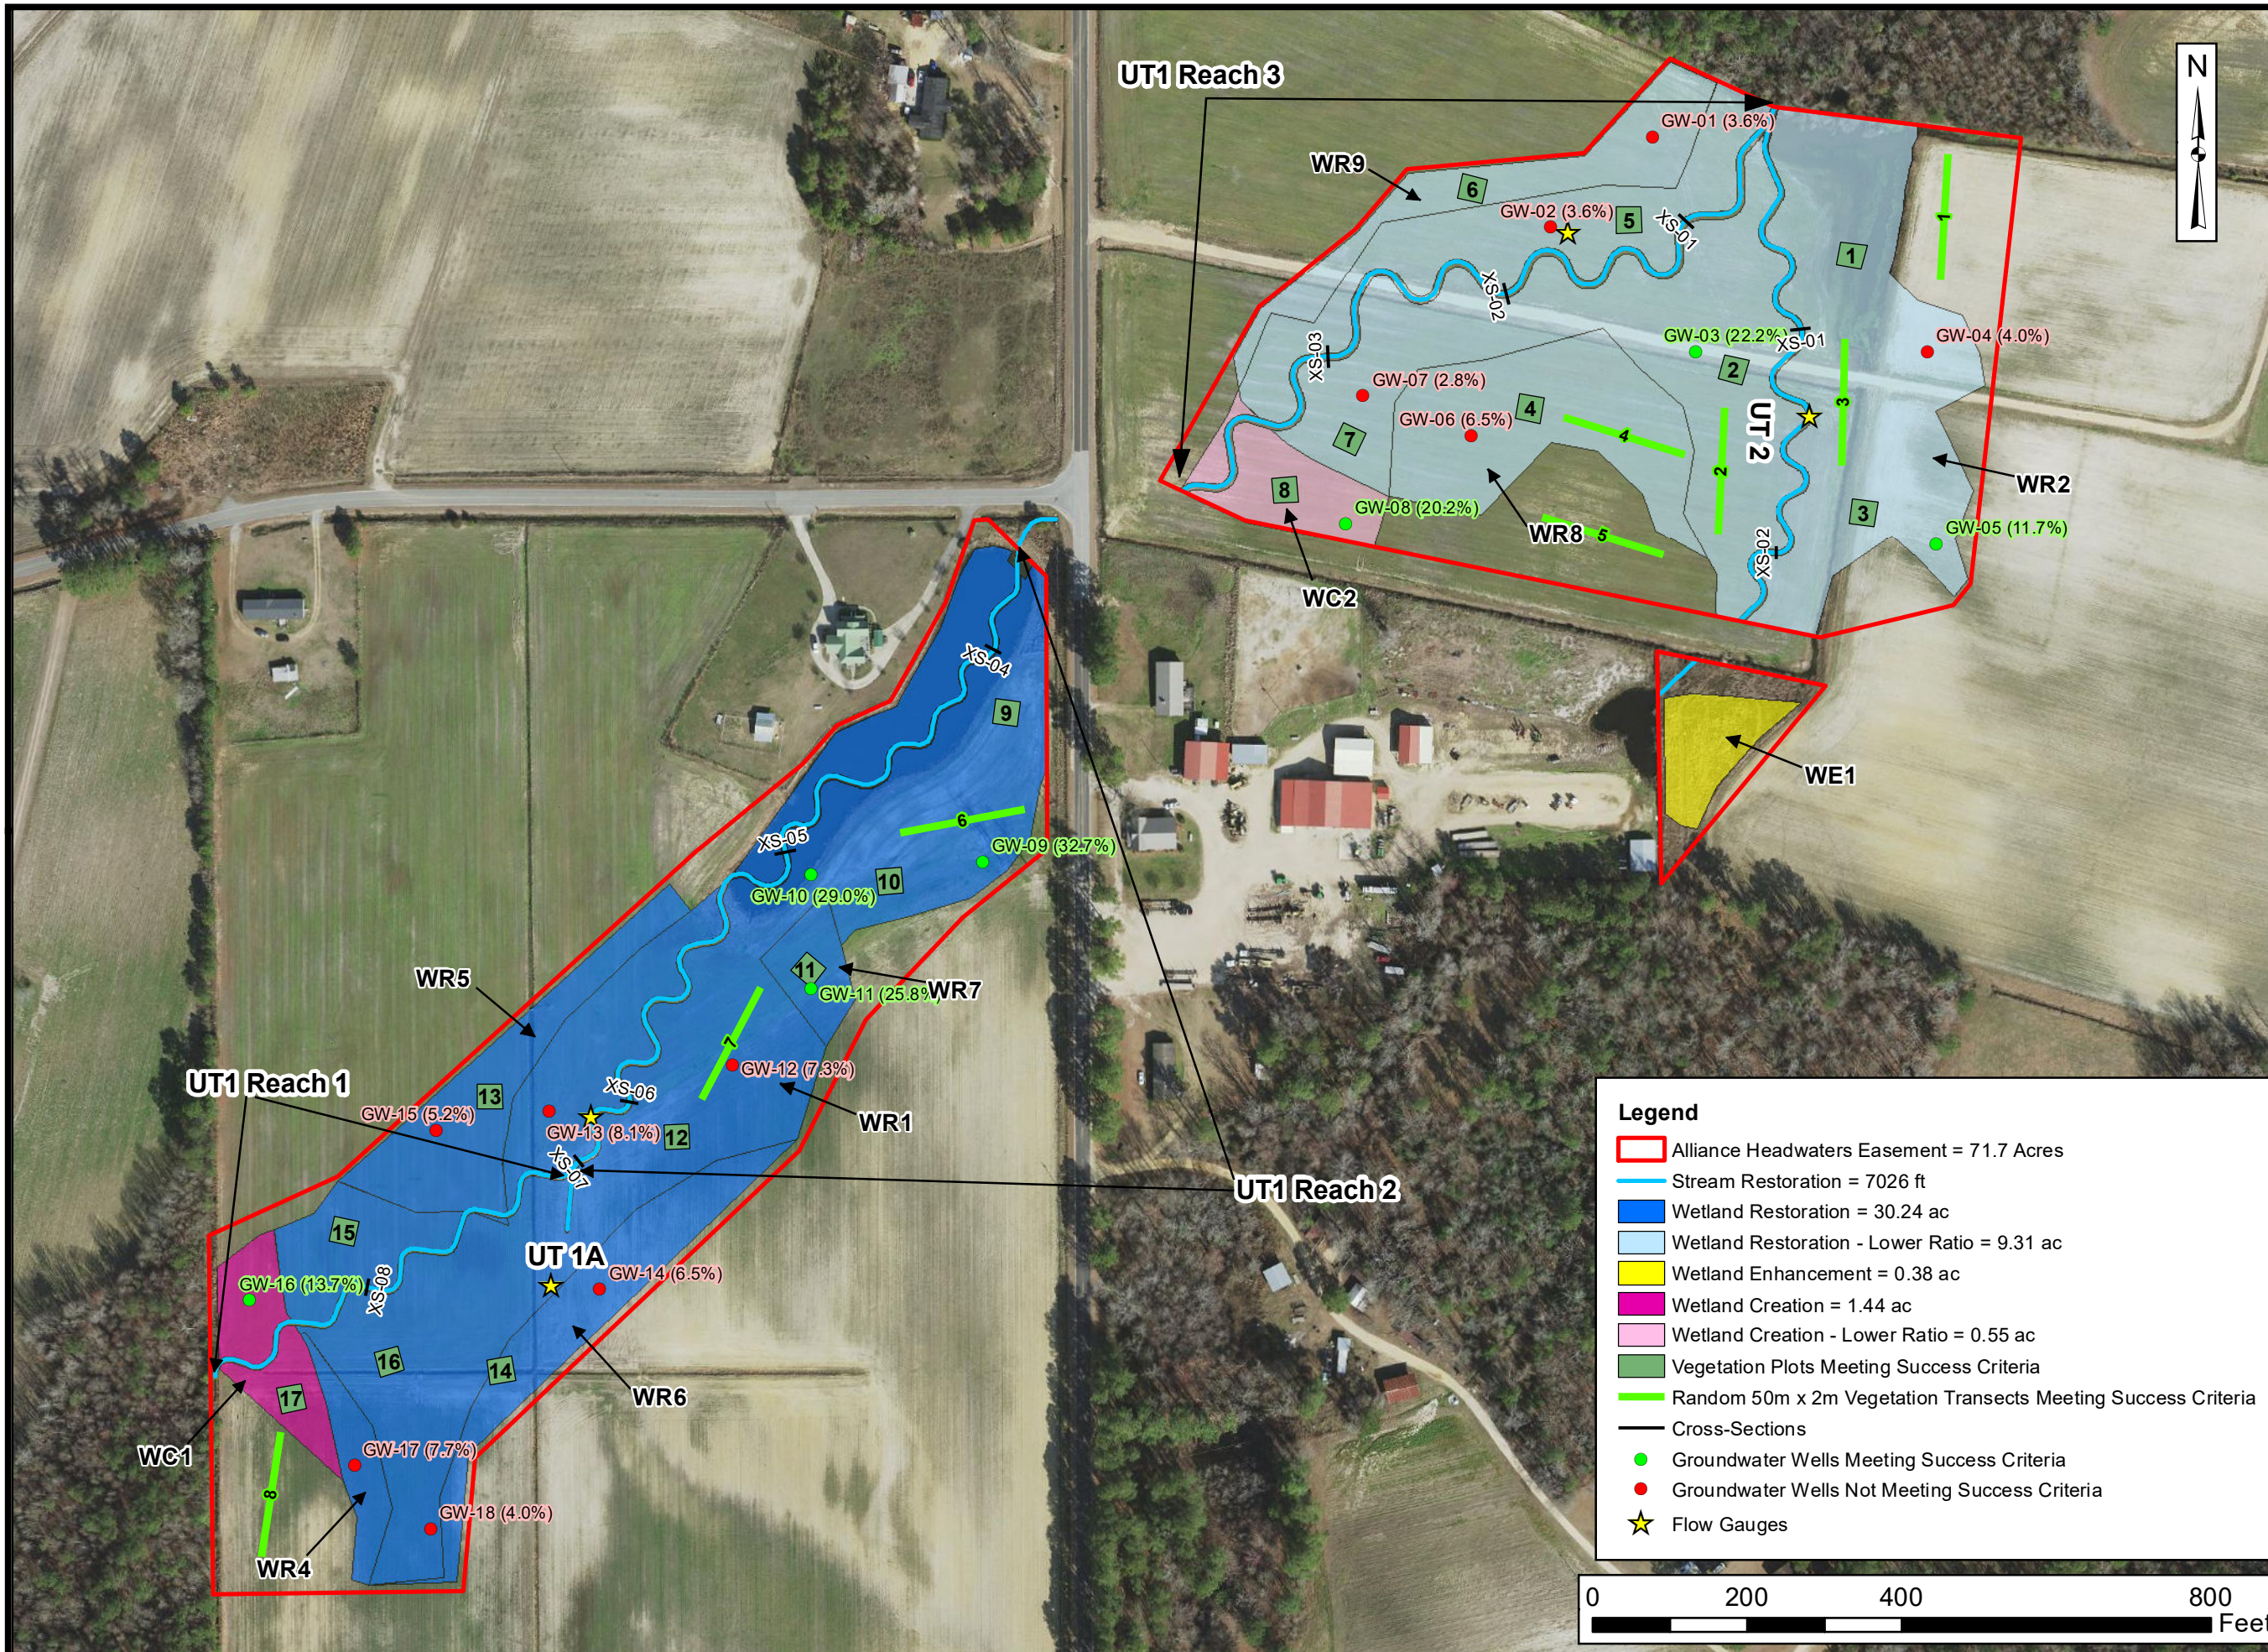
Title:
CURRENT CONDITIONS PLAN VIEW

- CCPV. Please provide location of soil temp probe on legend and map per IRT request. It may also be beneficial to label hydroperiods on the gauges (add to attribute table and label) to show overall trends that may help in IRT discussions of gauge performance.
The soil temperature probe/rain gauge location was added to Figure 2. Additionally, hydroperiods for the groundwater gauges (in percent of growing season) were added to the labels on Figure 2.

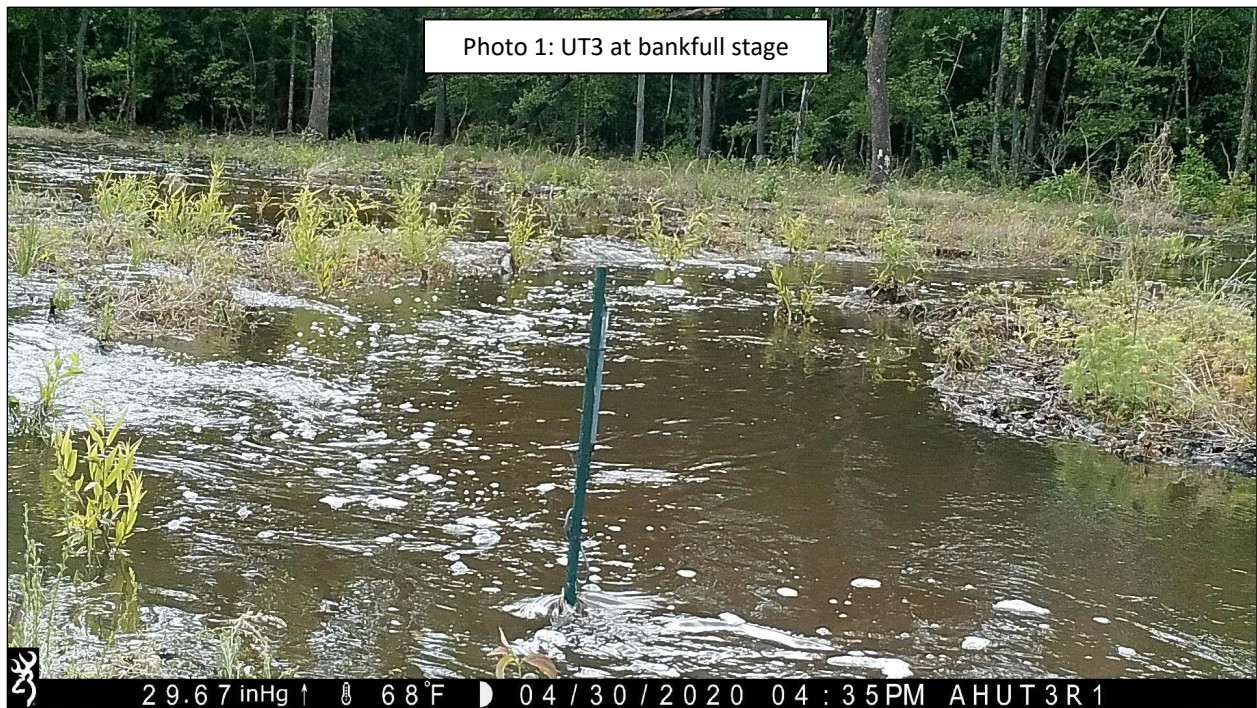
Date of Data Collection	Date of Occurrence	Method	Photo (if available)
April 30, 2020	April 30, 2020	Stream gauges and trail cameras captured a bankfull event at UT3 after 1.17 inches of rain was documented between April 30 and May 1, 2020 at an onsite rain gauge	1
November 19, 2020	November 12, 2020	Wrack and laid-back vegetation were observed outside the TOB of UT1 after 3.61 inches of rain was documented between November 12 and 13, 2020 at a nearby weather station.	2

Photo 2: Wrack and laid-back vegetation outside the TOB of UT1 after a bankfull event.
