FINAL
MONITORING REPORT (MY3)

ALLIANCE HEADWATERS MITIGATION SITE

Johnston County, North Carolina

DMS ID No. 97086

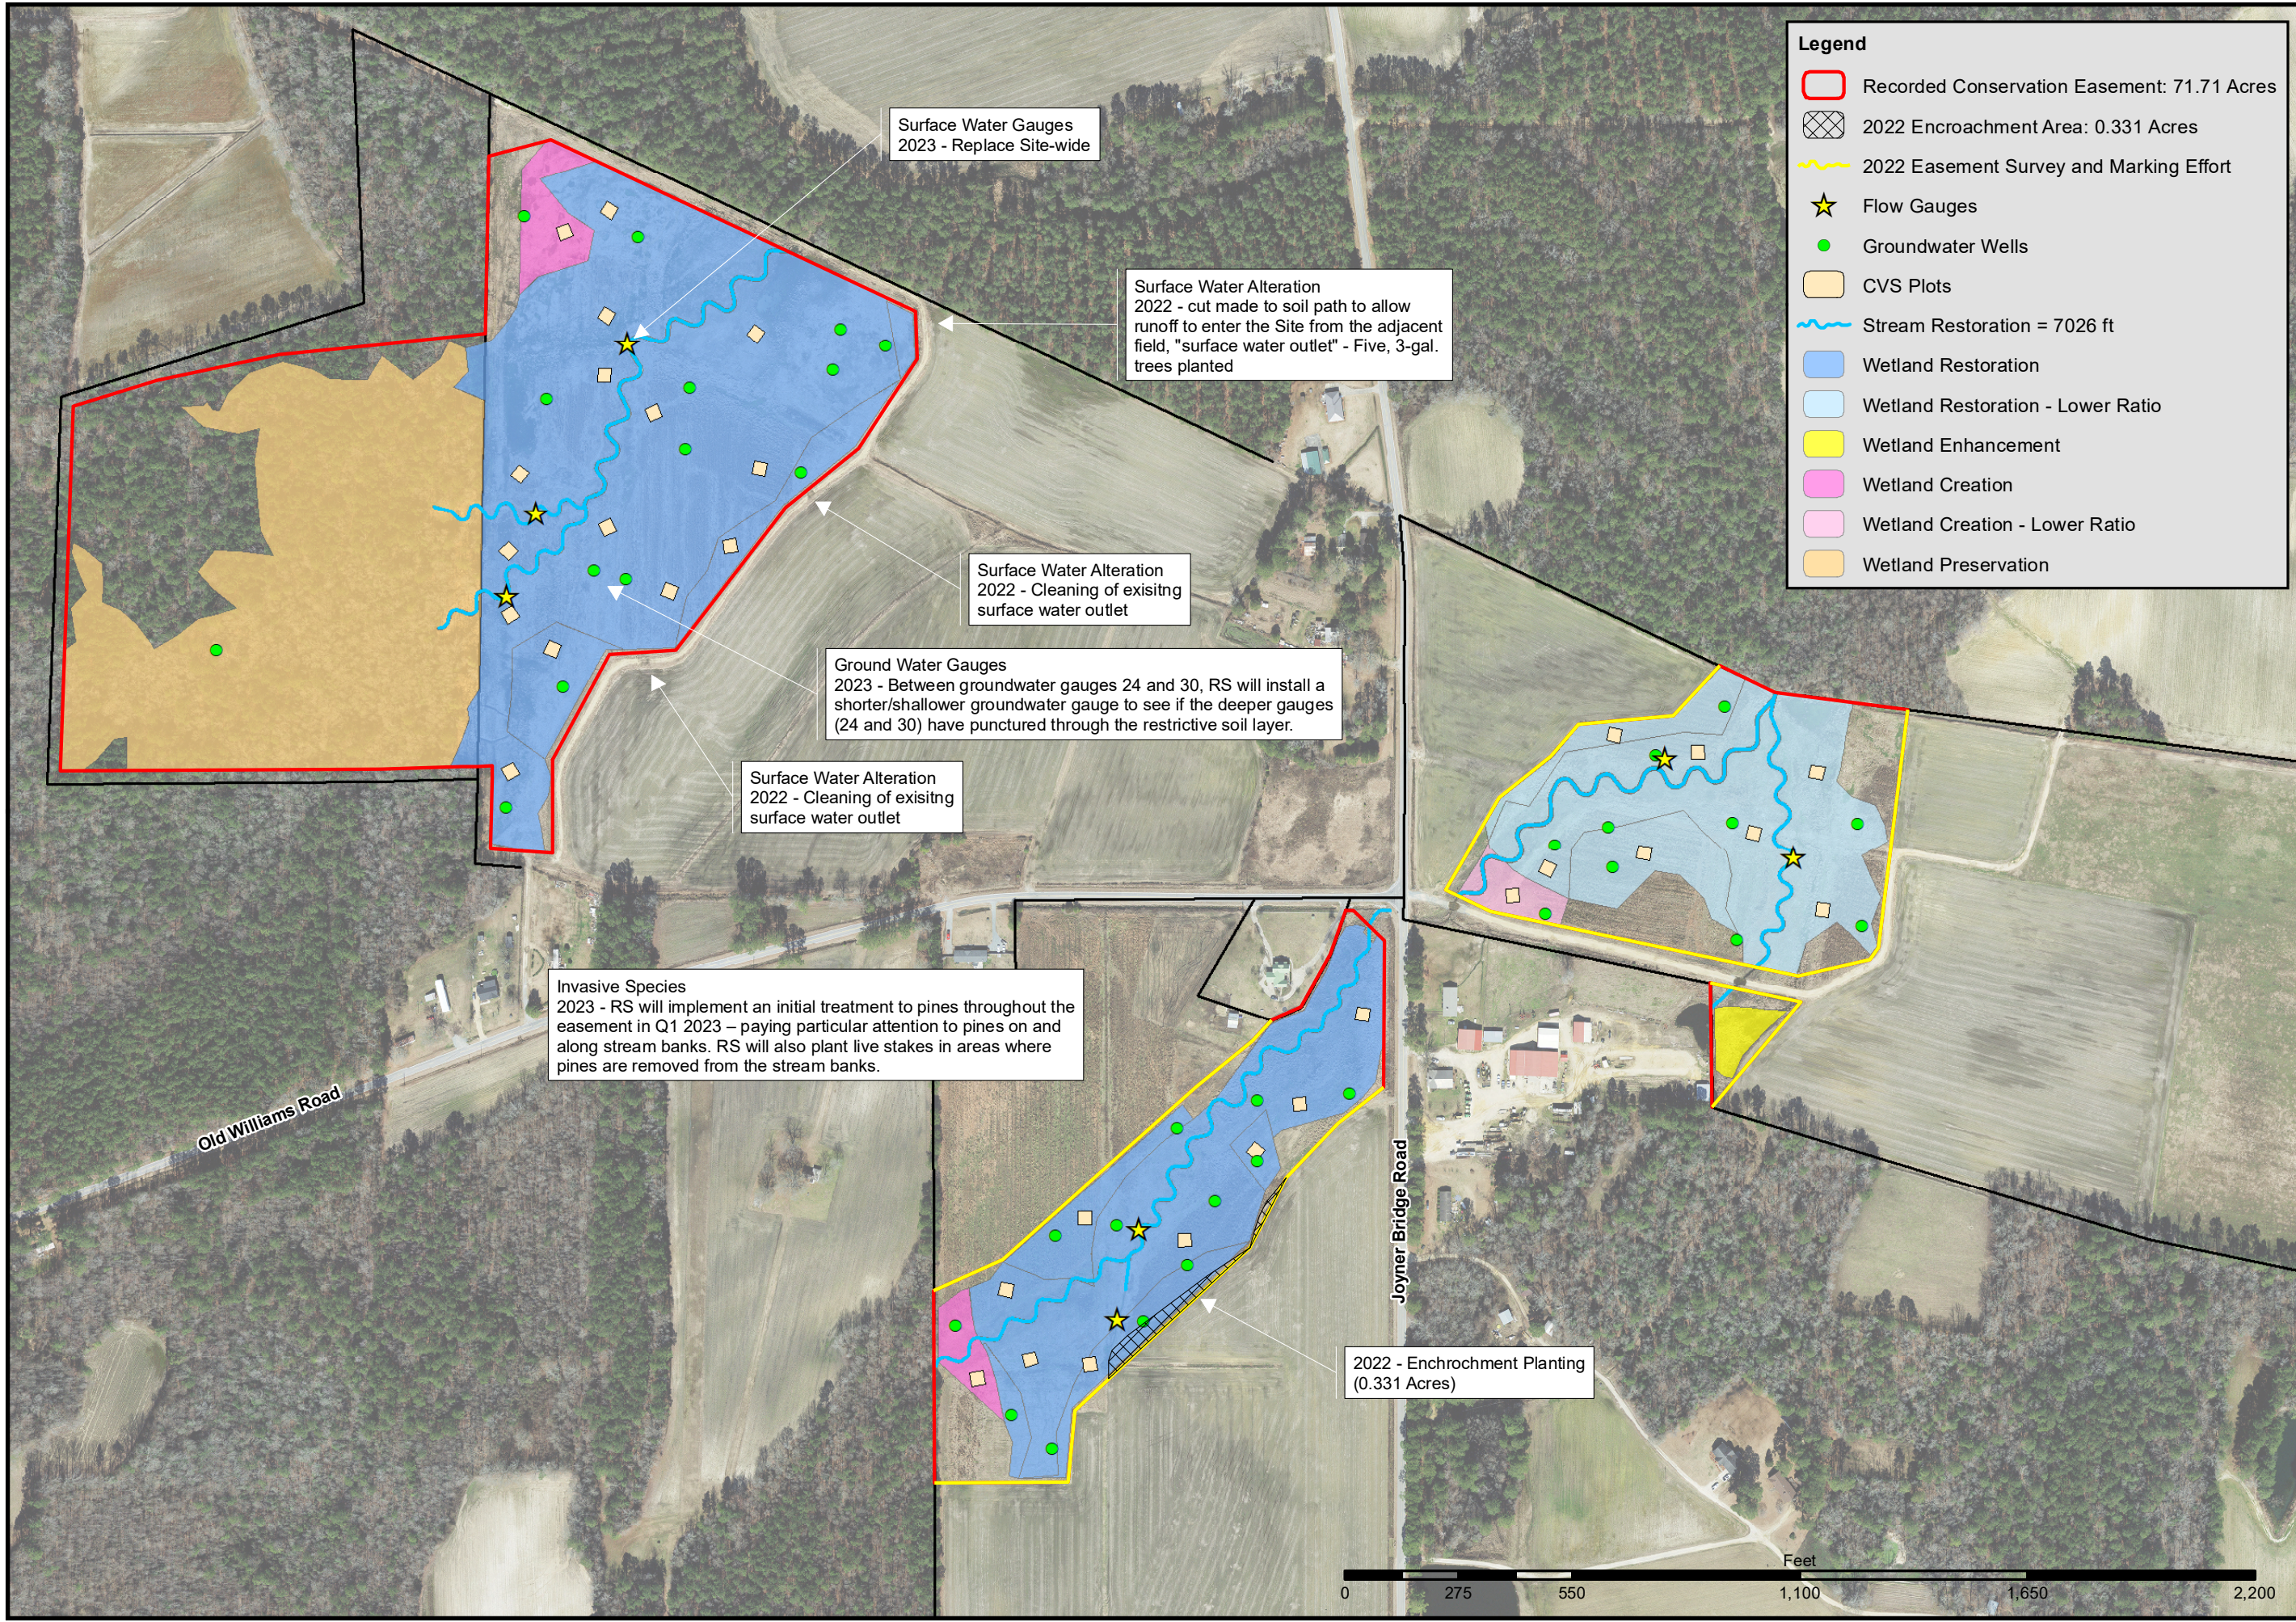
FIGURE
2B

Easement encroachment was observed during visual assessment site visits along the northwest parcel boundary of UT1-Reach 3 (all very minor and under 500 sq. ft.), WE1's southeastern easement boundary (under 0.10 acres), and the southeastern easement boundary along UT1-Reach 1 (0.331 acres).

RS had k2 Design (project surveyor) re-survey the easement boundaries of UT1, Reaches 1-3, and WE1 in early November 2022. Following the survey effort, RS replaced several of the easement corner markers with 6-inch treated fence posts and new conservation easement signage. In addition, RS added 6-inch treated fence posts and new conservation easement signage to areas where long straight stretches of easement would benefit from additional marking; specifically areas of previous encroachment and the agricultural road along the southern easement boundary of UT1 Reach 3 and UT2 - (Appendix F. Site Photos).

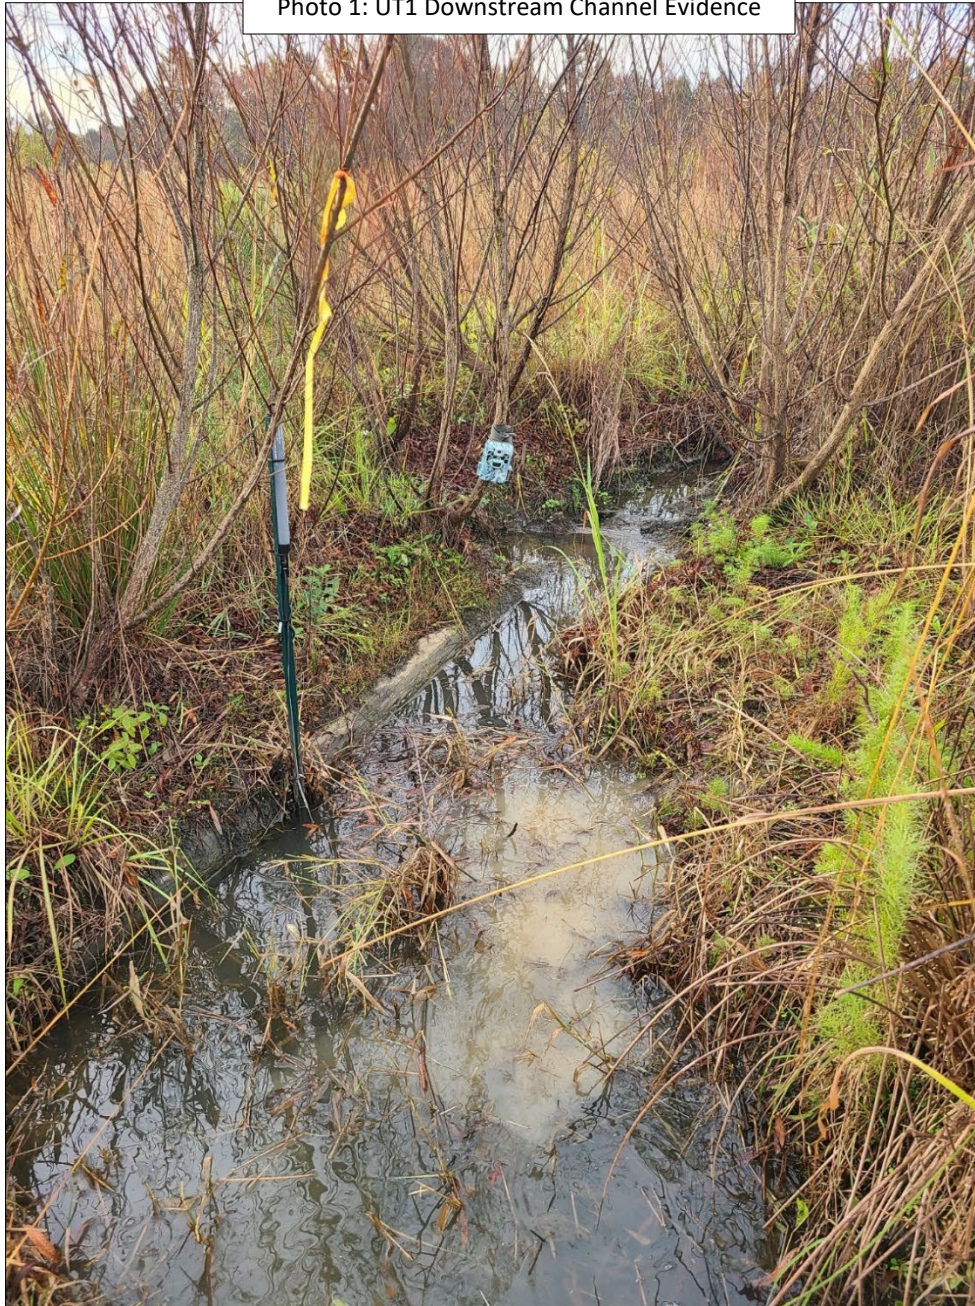
Photo 1: UT1 Downstream Channel Evidence

UT1 Downstream Channel Evidence	Year 1 (2020)	Year 2 (2021)	Year 3 (2022)	Year 4 (2023)	Year 5 (2024)	Year 6 (2025)	Year 7 (2026)
Max consecutive days channel flow	201	119	116				
Presence of litter and debris (wracking)	Yes	Yes	Yes				
Leaf litter disturbed or washed away	Yes	Yes	Yes				
Matted, bent, or absence of vegetation (herbaceous or otherwise)	Yes	Yes	Yes				
Sediment deposition and/or scour indicating sediment transport	Yes	Yes	Yes				
Water staining due to continual presence of water	Yes	Yes	Yes				
Formation of channel bed and banks	Yes	Yes	Yes				
Sediment sorting within the primary path of flow	Yes	Yes	Yes				
Sediment shelving or a natural line impressed on the banks	Yes	Yes	Yes				
Change in plant community (absence or destruction of terrestrial vegetation and/or transition to species adapted for flow or inundation for a long duration, including hydrophytes)	Yes	Yes	Yes				
Development of channel pattern (meander bends and/or channel braiding) at natural topographic breaks, woody debris piles, or plant root systems	Yes	Yes	Yes

Exposure of woody plant roots within the primary path of flow	No	No	No				
Other:

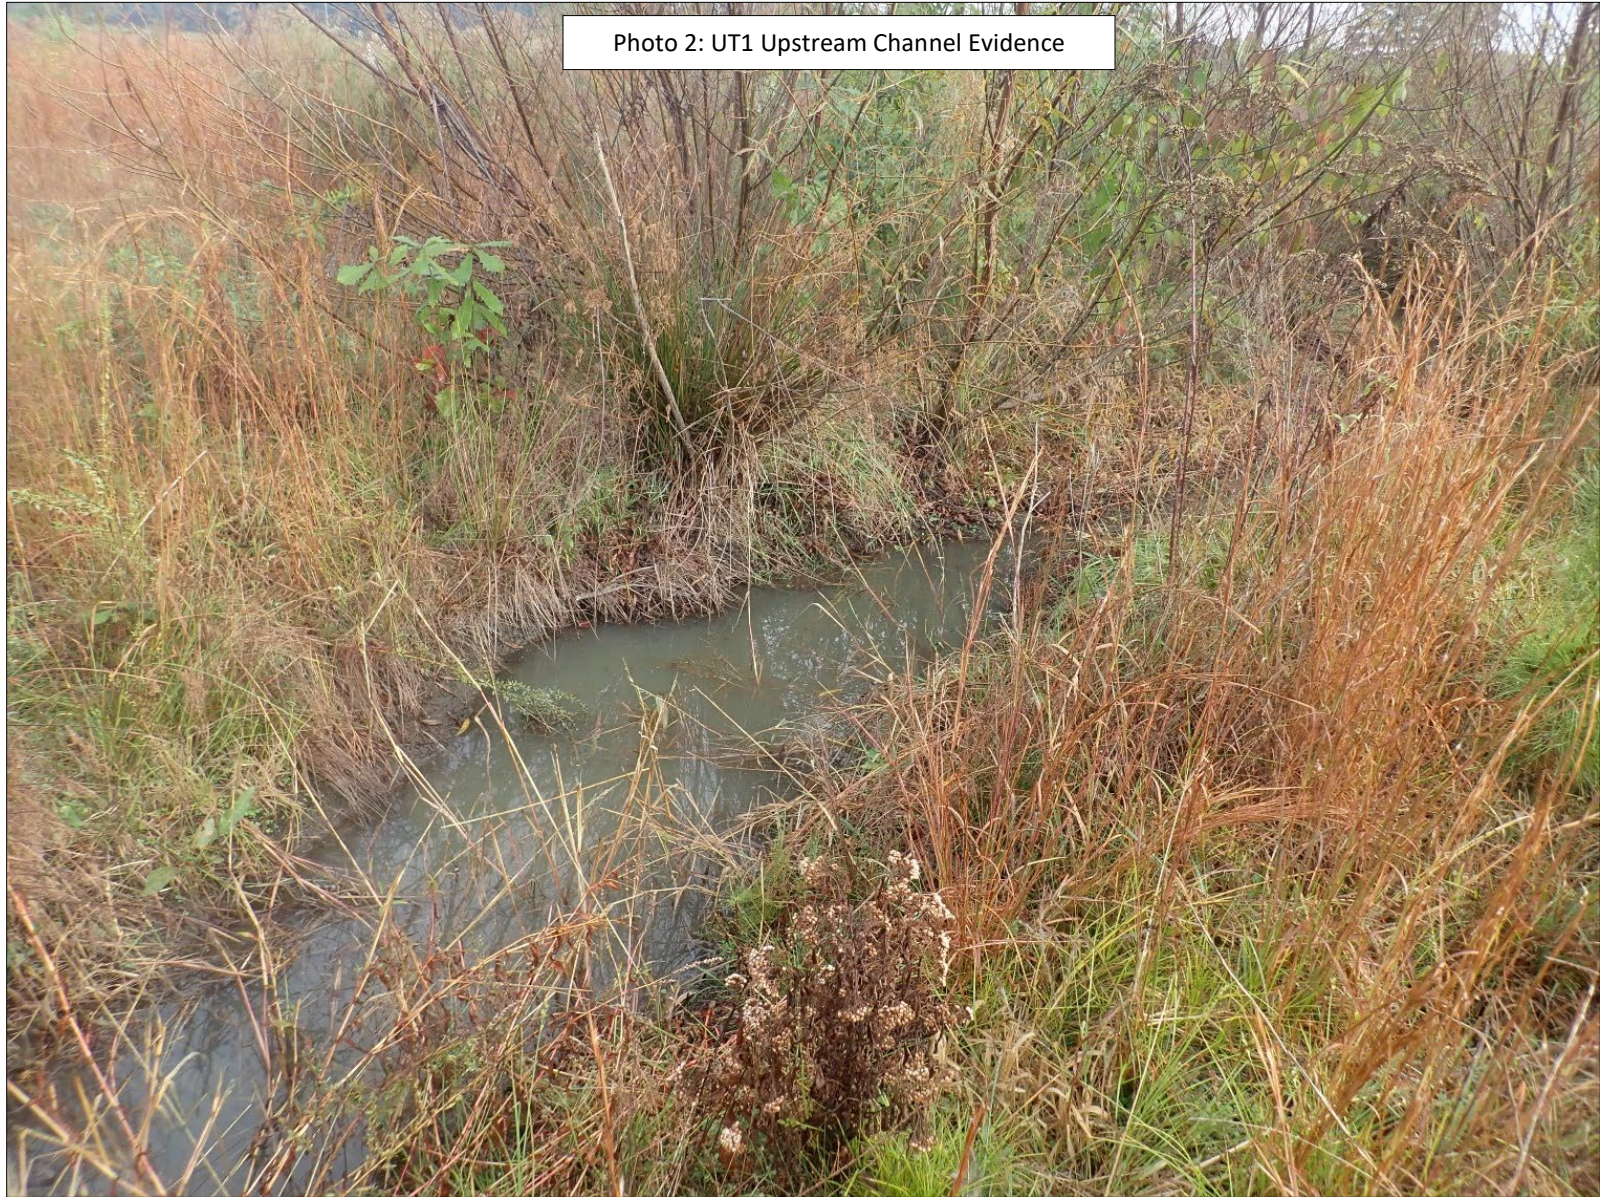
Photo 2: UT1 Upstream Channel Evidence

UT1 Upstream Channel Evidence	Year 1 (2020)	Year 2 (2021)	Year 3 (2022)	Year 4 (2023)	Year 5 (2024)	Year 6 (2025)	Year 7 (2026)
Max consecutive days channel flow	190	160	186				
Presence of litter and debris (wracking)	Yes	Yes	Yes				
Leaf litter disturbed or washed away	Yes	Yes	Yes				
Matted, bent, or absence of vegetation (herbaceous or otherwise)	Yes	Yes	Yes				
Sediment deposition and/or scour indicating sediment transport	Yes	Yes	Yes				
Water staining due to continual presence of water	Yes	Yes	Yes				
Formation of channel bed and banks	Yes	Yes	Yes				
Sediment sorting within the primary path of flow	Yes	Yes	Yes				
Sediment shelving or a natural line impressed on the banks	Yes	Yes	Yes				
Change in plant community (absence or destruction of terrestrial vegetation and/or transition to species adapted for flow or inundation for a long duration, including hydrophytes)	Yes	Yes	Yes				
Development of channel pattern (meander bends and/or channel braiding) at natural topographic breaks, woody debris piles, or plant root systems	Yes	Yes	Yes

Exposure of woody plant roots within the primary path of flow	No	No	No				
Other:

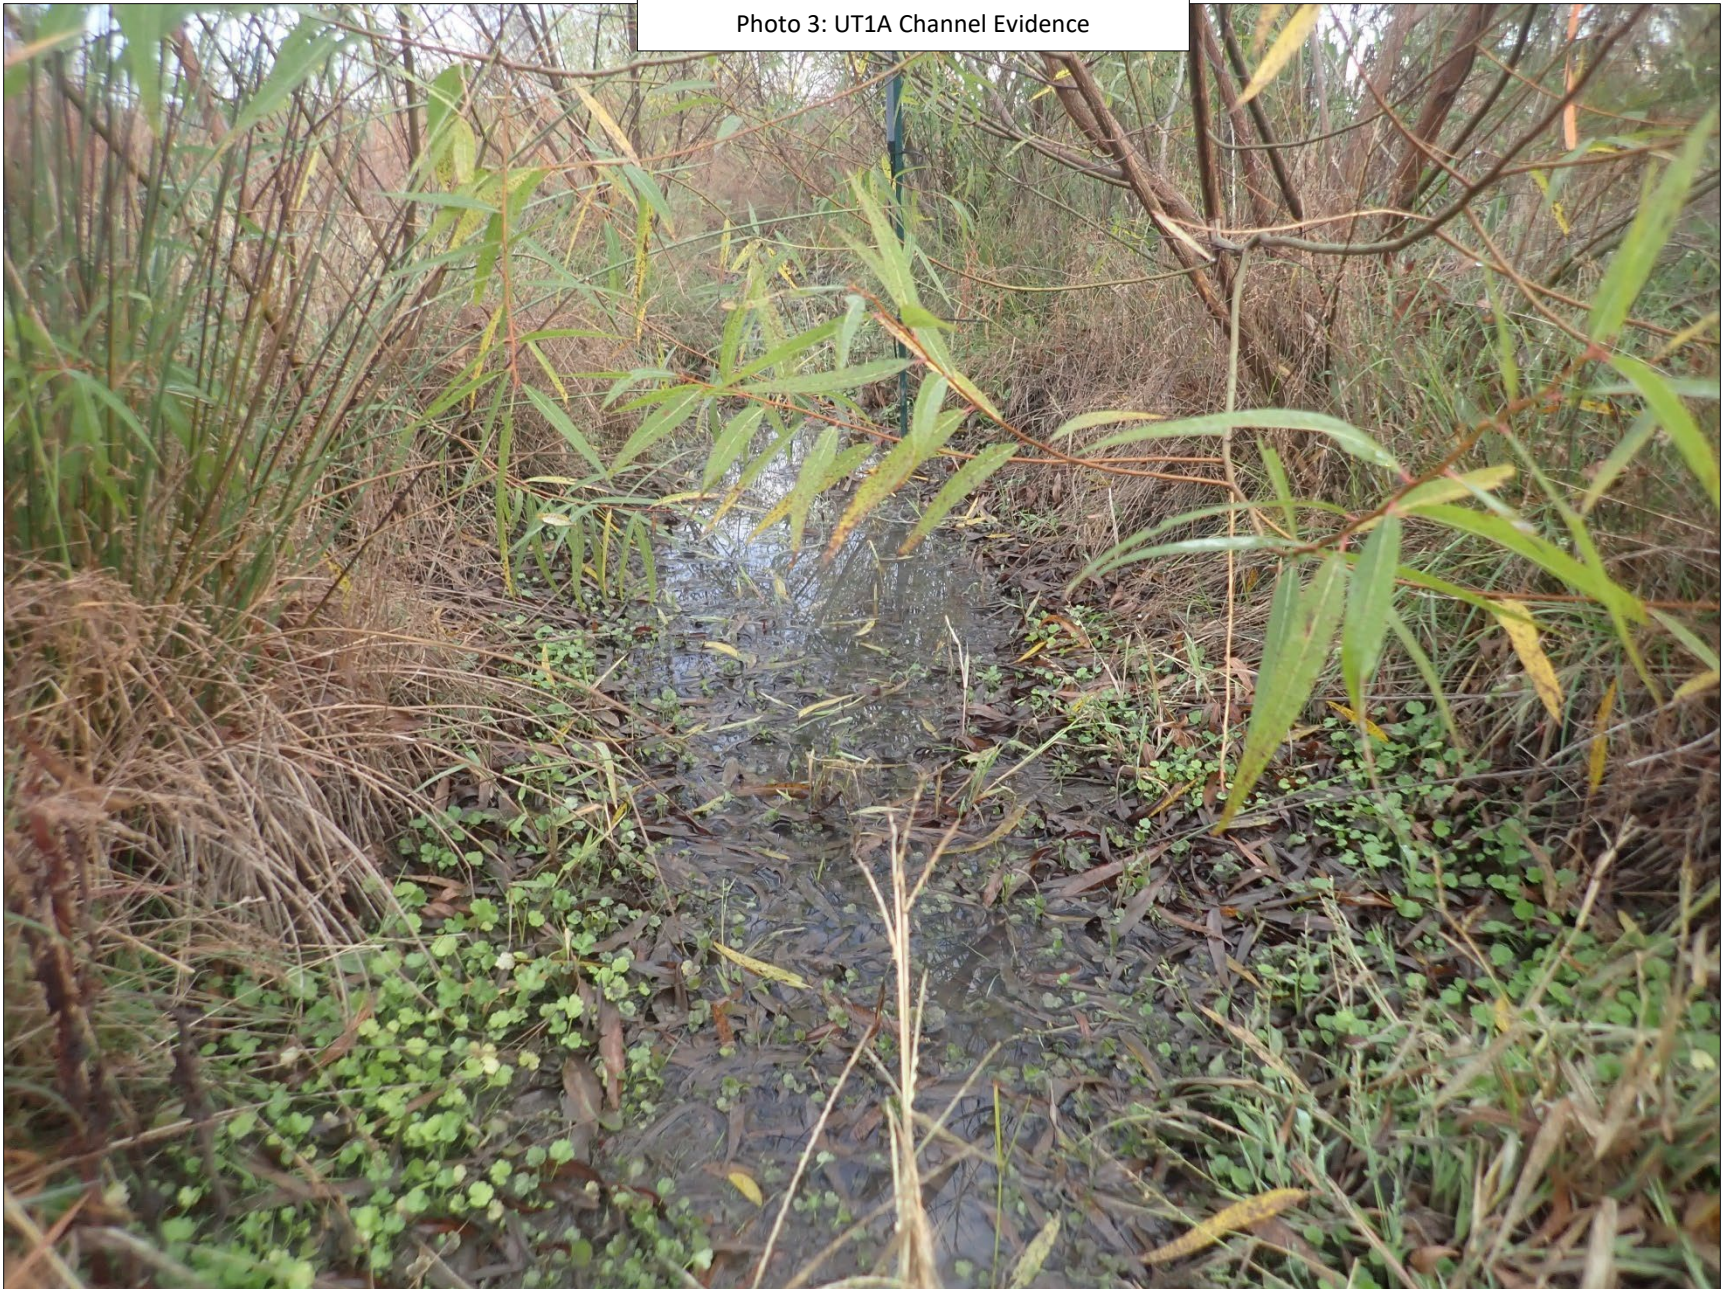
Photo 3: UT1A Channel Evidence

UT1A Channel Evidence	Year 1 (2020)	Year 2 (2021)	Year 3 (2022)	Year 4 (2023)	Year 5 (2024)	Year 6 (2025)	Year 7 (2026)
Max consecutive days channel flow	97	73	90				
Presence of litter and debris (wracking)	Yes	Yes	Yes				
Leaf litter disturbed or washed away	Yes	Yes	Yes				
Matted, bent, or absence of vegetation (herbaceous or otherwise)	Yes	Yes	Yes				
Sediment deposition and/or scour indicating sediment transport	Yes	Yes	Yes				
Water staining due to continual presence of water	Yes	Yes	Yes				
Formation of channel bed and banks	Yes	Yes	Yes				
Sediment sorting within the primary path of flow	Yes	Yes	Yes				
Sediment shelving or a natural line impressed on the banks	Yes	Yes	Yes				
Change in plant community (absence or destruction of terrestrial vegetation and/or transition to species adapted for flow or inundation for a long duration, including hydrophytes)	Yes	Yes	Yes				
Development of channel pattern (meander bends and/or channel braiding) at natural topographic breaks, woody debris piles, or plant root systems	Yes	Yes	Yes

Exposure of woody plant roots within the primary path of flow	No	No	No				
Other:

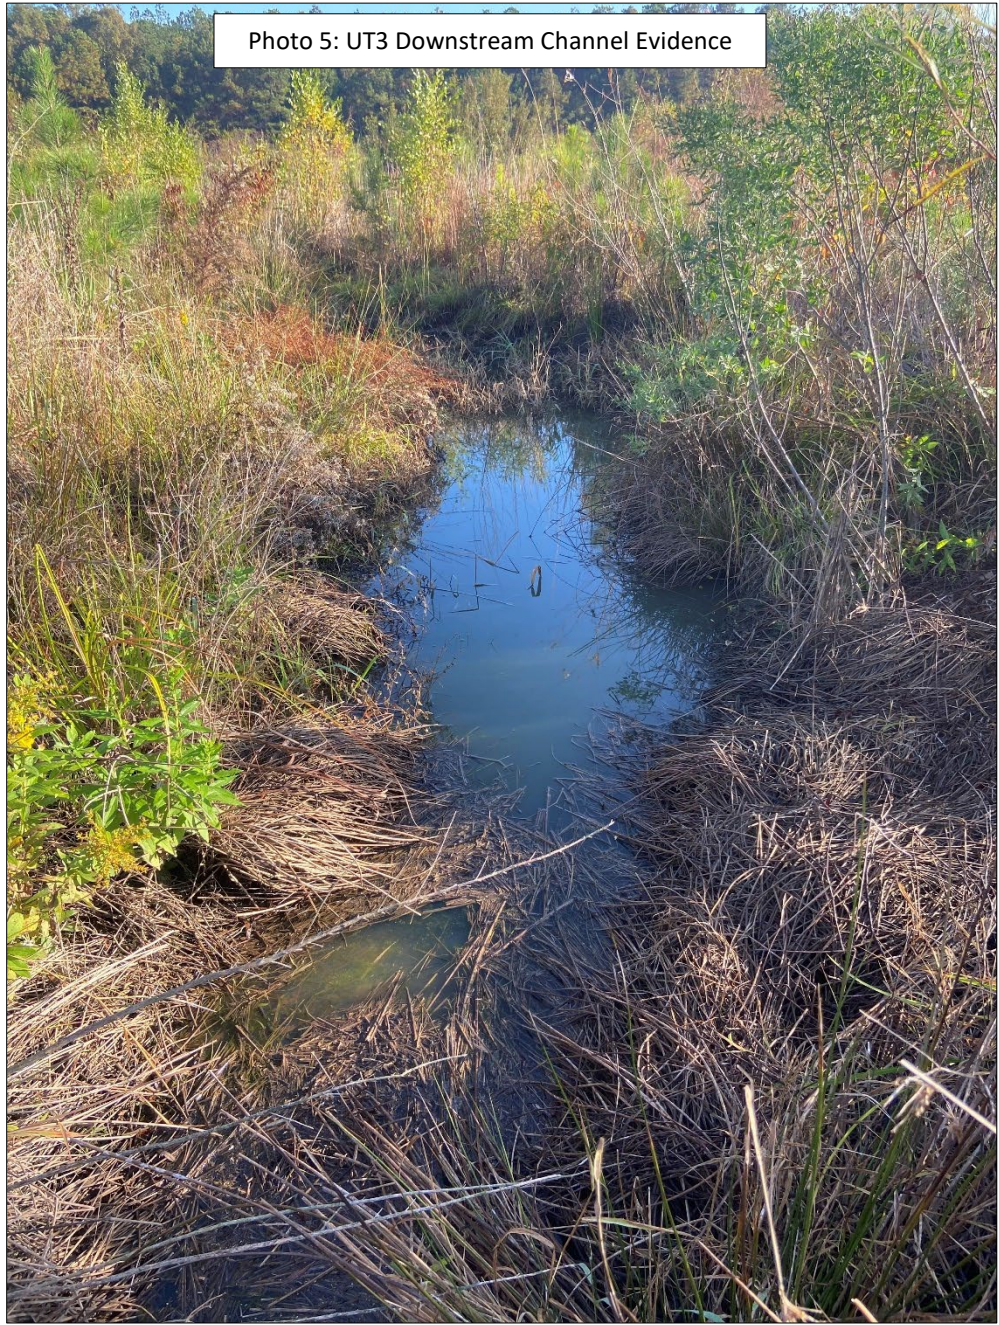
Photo 5: UT3 Downstream Channel Evidence

UT3 Downstream Channel Evidence	Year 1 (2020)	Year 2 (2021)	Year 3 (2022)	Year 4 (2023)	Year 5 (2024)	Year 6 (2025)	Year 7 (2026)
Max consecutive days channel flow	119	234	67				
Presence of litter and debris (wracking)	Yes	Yes	Yes				
Leaf litter disturbed or washed away	Yes	Yes	Yes				
Matted, bent, or absence of vegetation (herbaceous or otherwise)	Yes	Yes	Yes				
Sediment deposition and/or scour indicating sediment transport	Yes	Yes	Yes				
Water staining due to continual presence of water	Yes	Yes	Yes				
Formation of channel bed and banks	Yes	Yes	Yes				
Sediment sorting within the primary path of flow	Yes	Yes	Yes				
Sediment shelving or a natural line impressed on the banks	Yes	Yes	Yes				
Change in plant community (absence or destruction of terrestrial vegetation and/or transition to species adapted for flow or inundation for a long duration, including hydrophytes)	Yes	Yes	Yes				
Development of channel pattern (meander bends and/or channel braiding) at natural topographic breaks, woody debris piles, or plant root systems	Yes	Yes	Yes

Exposure of woody plant roots within the primary path of flow	No	No	No				
Other:

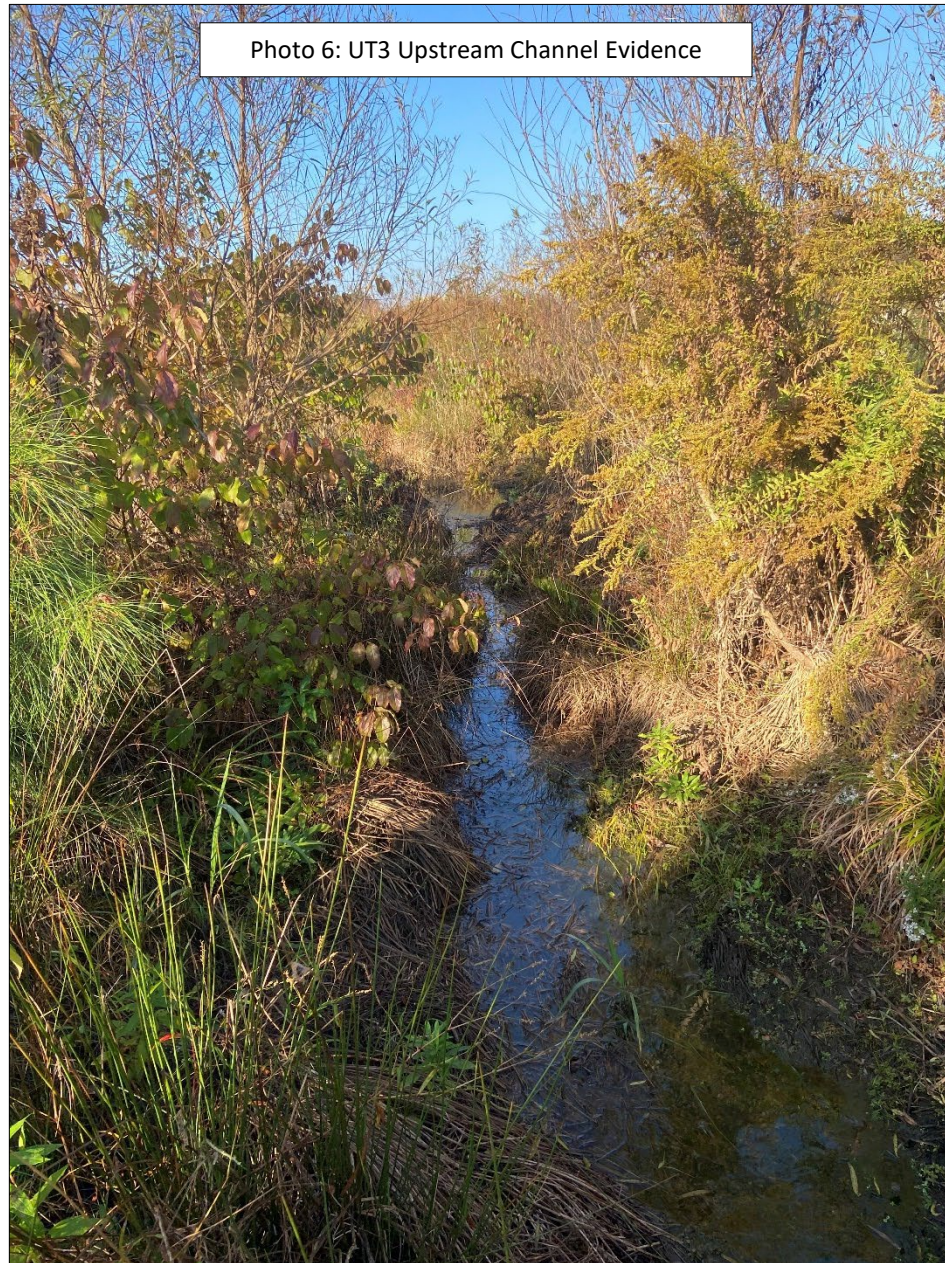
Photo 6: UT3 Upstream Channel Evidence

UT3 Upstream Channel Evidence	Year 1 (2020)	Year 2 (2021)	Year 3 (2022)	Year 4 (2023)	Year 5 (2024)	Year 6 (2025)	Year 7 (2026)
Max consecutive days channel flow	136	127	96				
Presence of litter and debris (wracking)	Yes	Yes	Yes				
Leaf litter disturbed or washed away	Yes	Yes	Yes				
Matted, bent, or absence of vegetation (herbaceous or otherwise)	Yes	Yes	Yes				
Sediment deposition and/or scour indicating sediment transport	Yes	Yes	Yes				
Water staining due to continual presence of water	Yes	Yes	Yes				
Formation of channel bed and banks	Yes	Yes	Yes				
Sediment sorting within the primary path of flow	Yes	Yes	Yes				
Sediment shelving or a natural line impressed on the banks	Yes	Yes	Yes				
Change in plant community (absence or destruction of terrestrial vegetation and/or transition to species adapted for flow or inundation for a long duration, including hydrophytes)	Yes	Yes	Yes				
Development of channel pattern (meander bends and/or channel braiding) at natural topographic breaks, woody debris piles, or plant root systems	Yes	Yes	Yes

Exposure of woody plant roots within the primary path of flow	No	No	No				
Other:

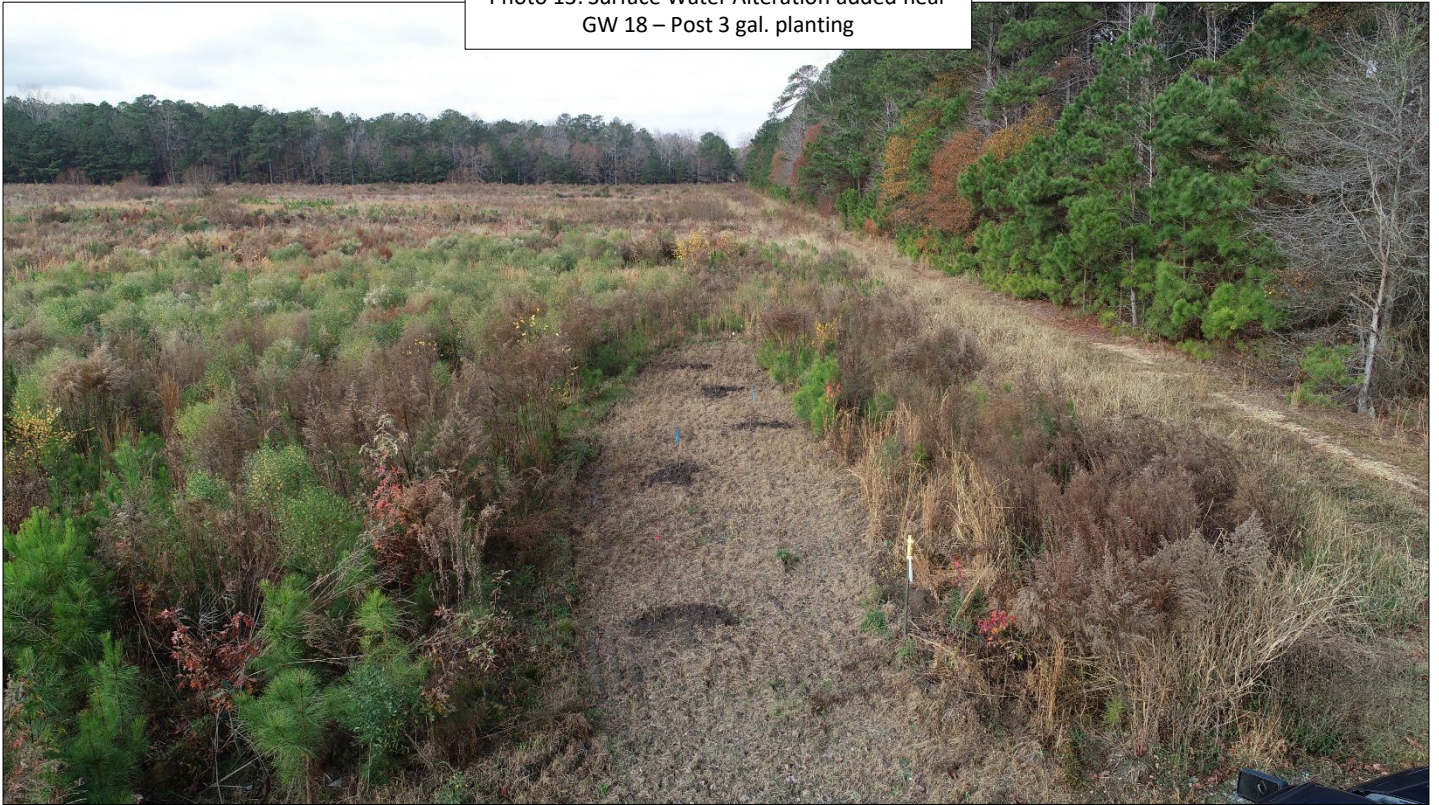
Photo 13: Surface Water Alteration added near
GW 18 – Post 3 gal. planting

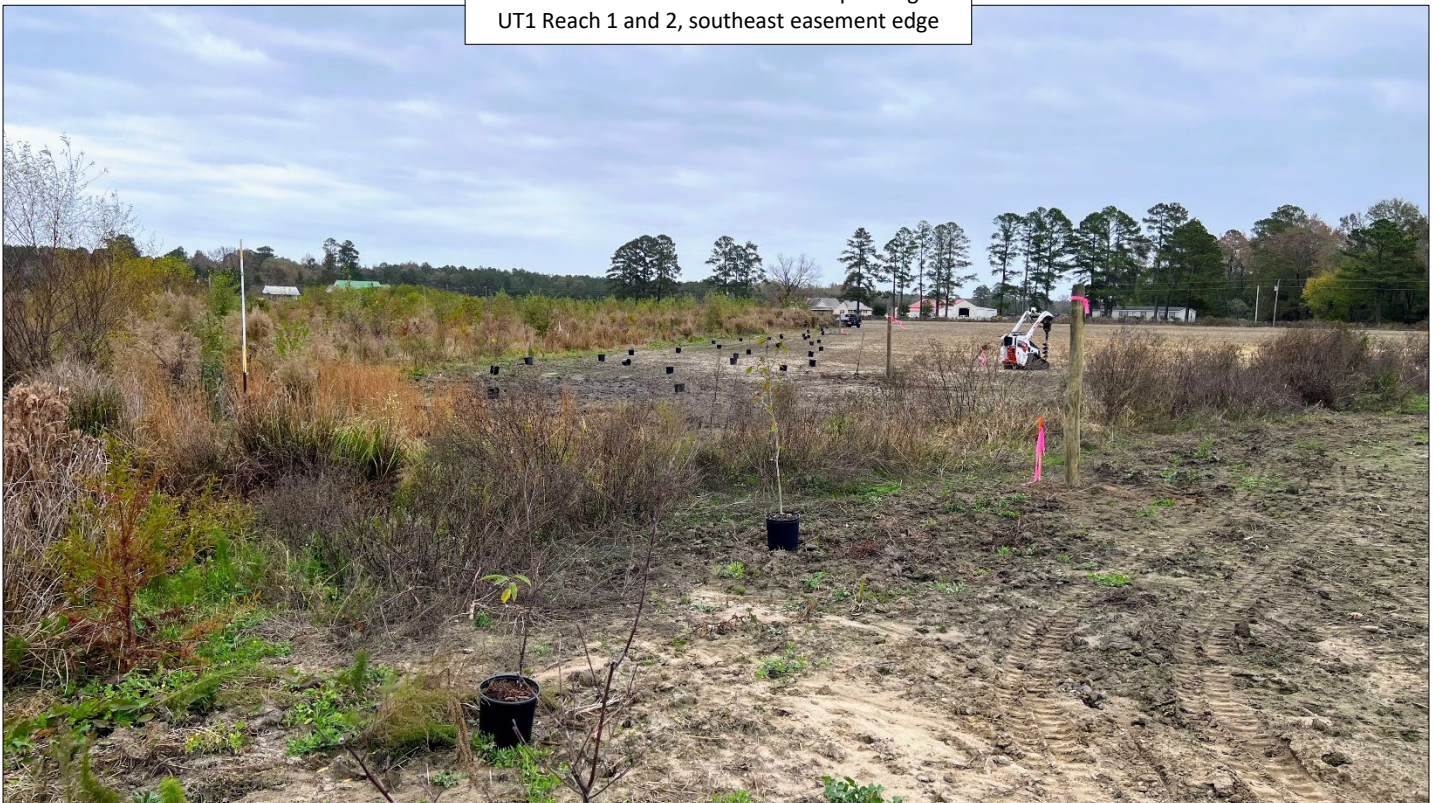
Photo 14: Encroachment Area Replanting
UT1 Reach 1 and 2, southeast easement edge

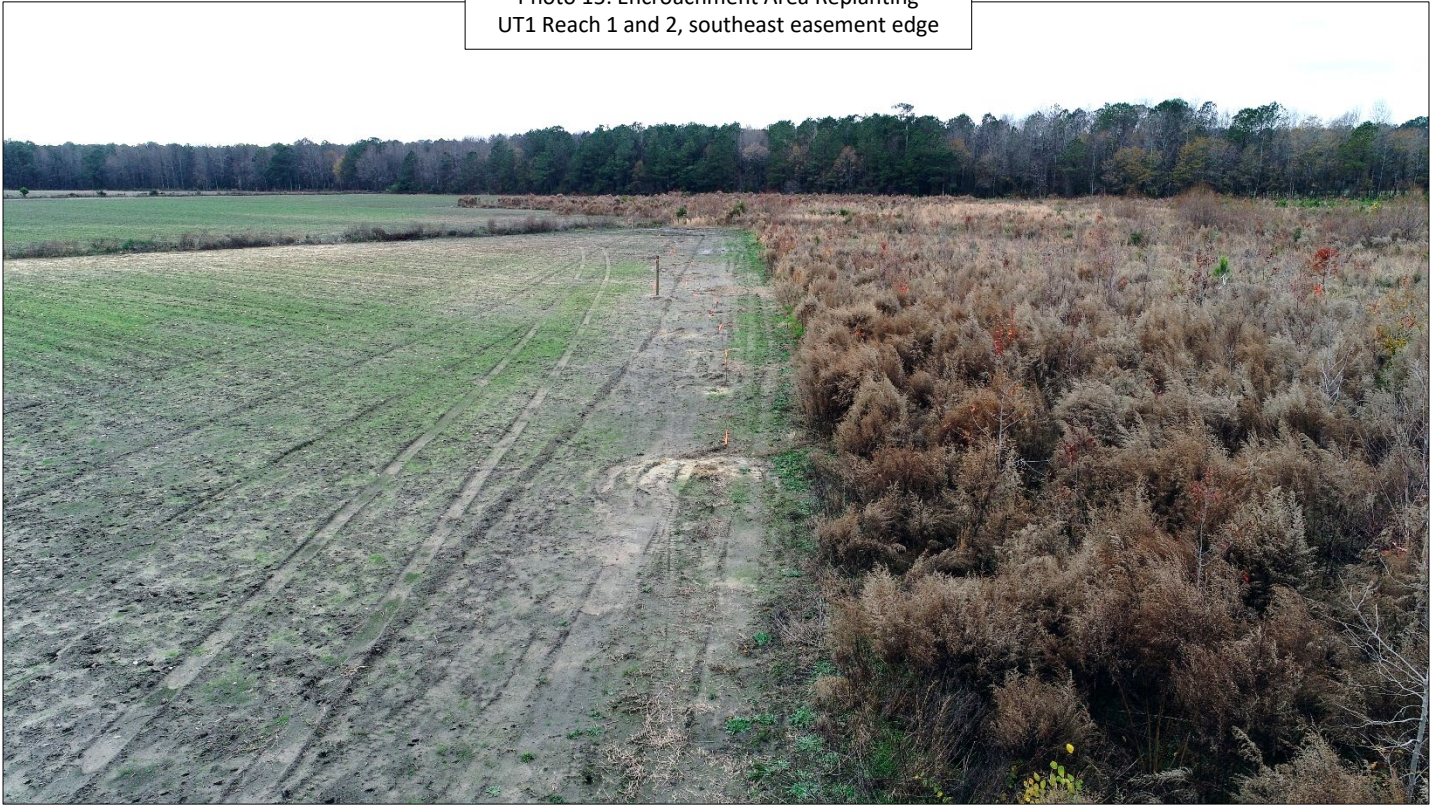
Photo 15: Encroachment Area Replanting
UT1 Reach 1 and 2, southeast easement edge

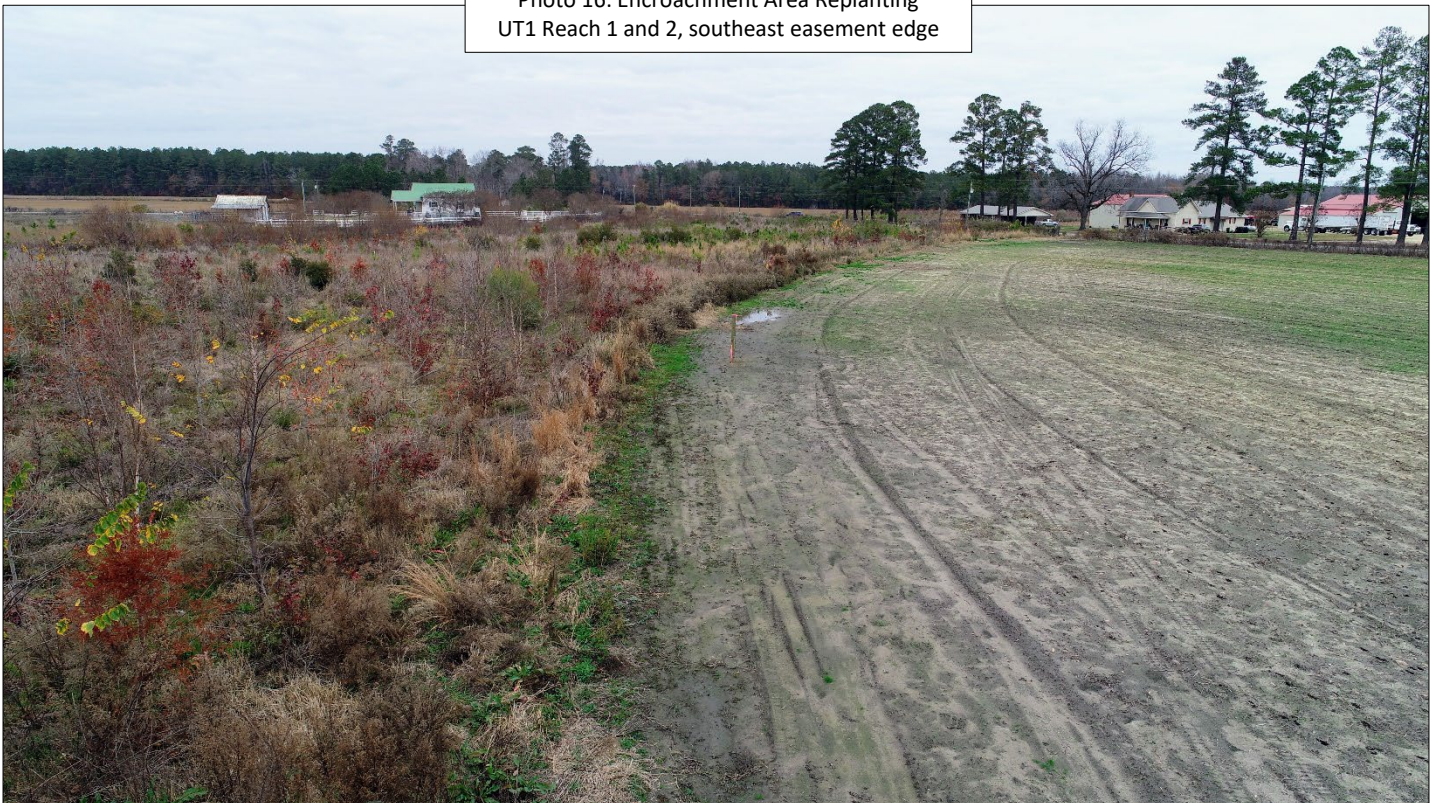
Photo 16: Encroachment Area Replanting
UT1 Reach 1 and 2, southeast easement edge

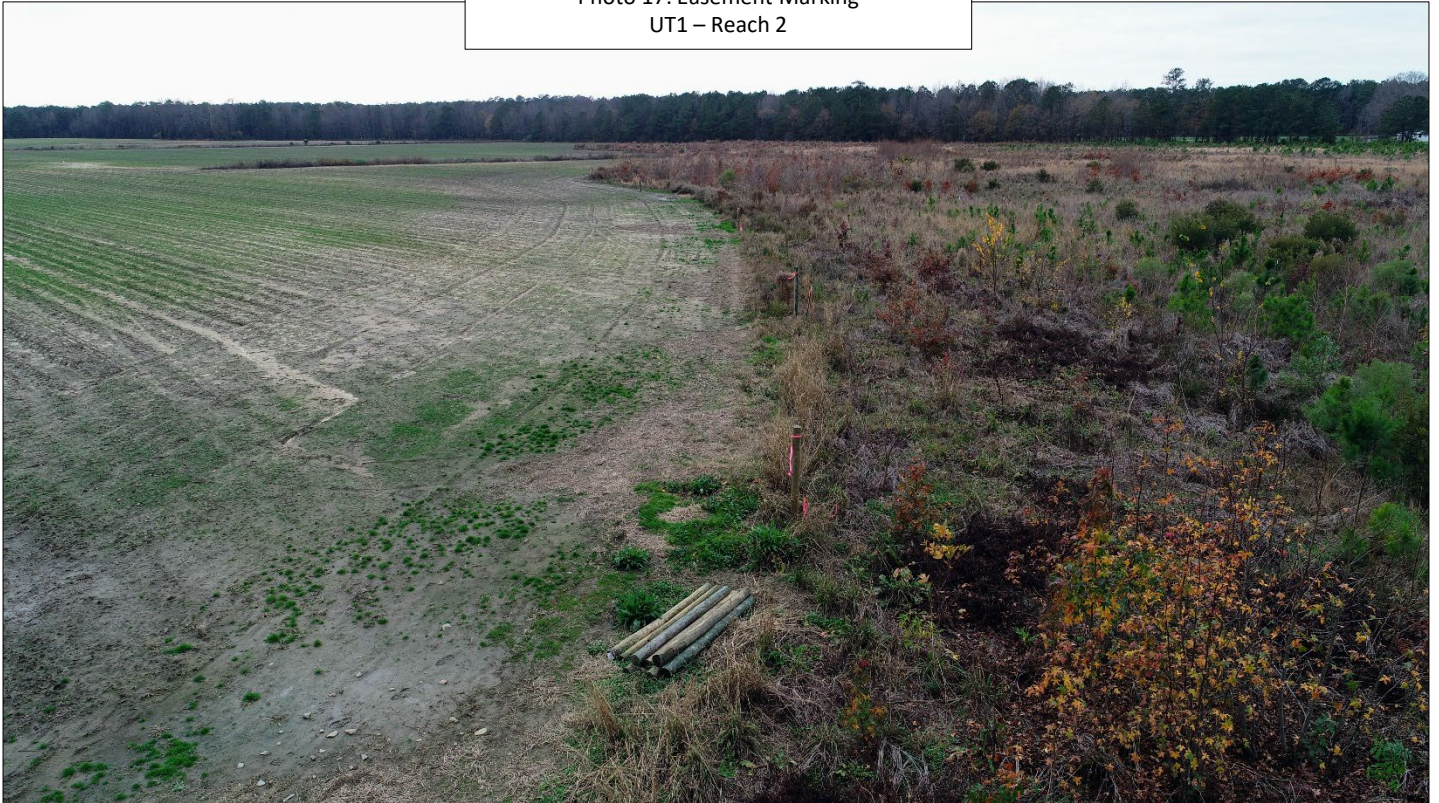
Photo 17: Easement Marking
UT1 – Reach 2

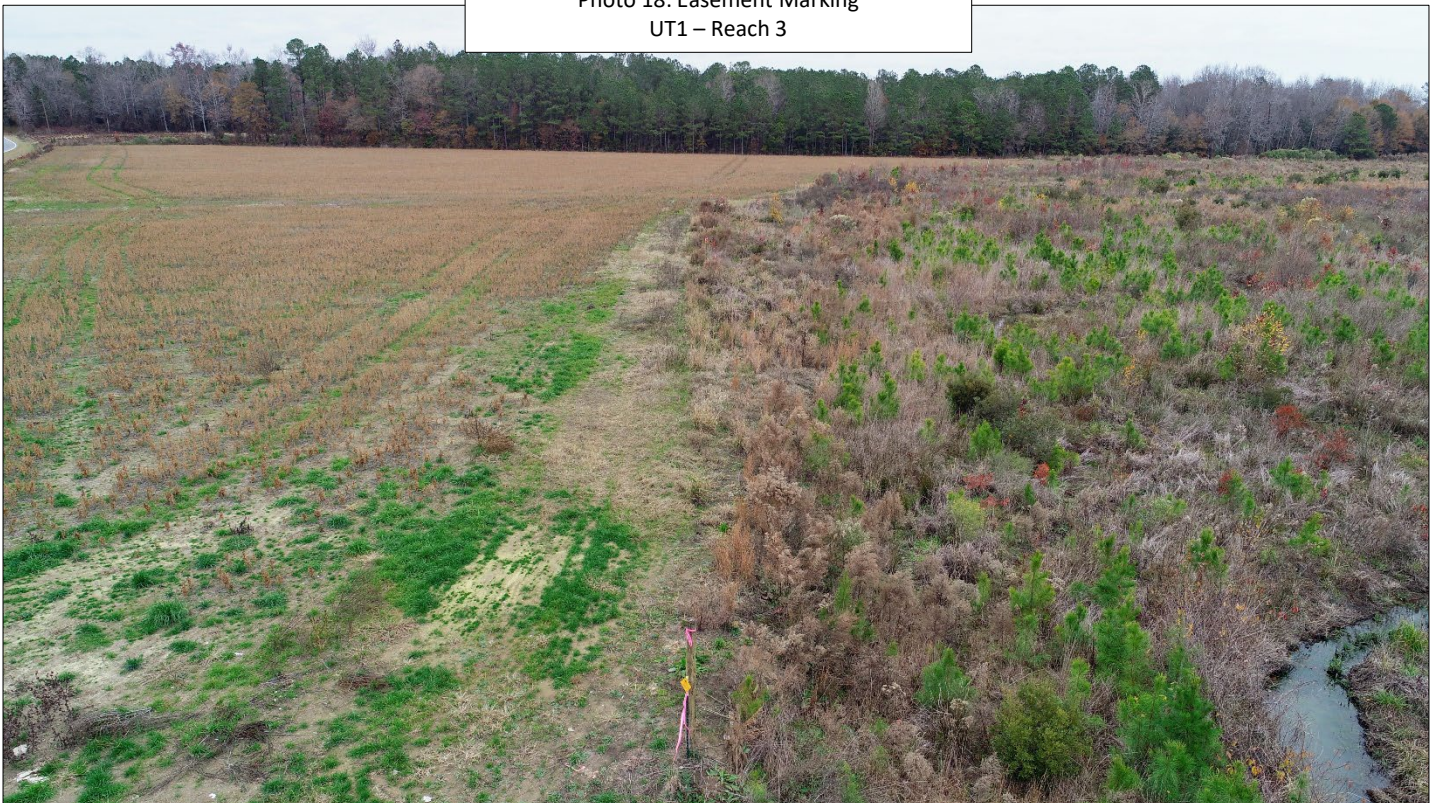
Photo 18: Easement Marking
UT1 – Reach 3

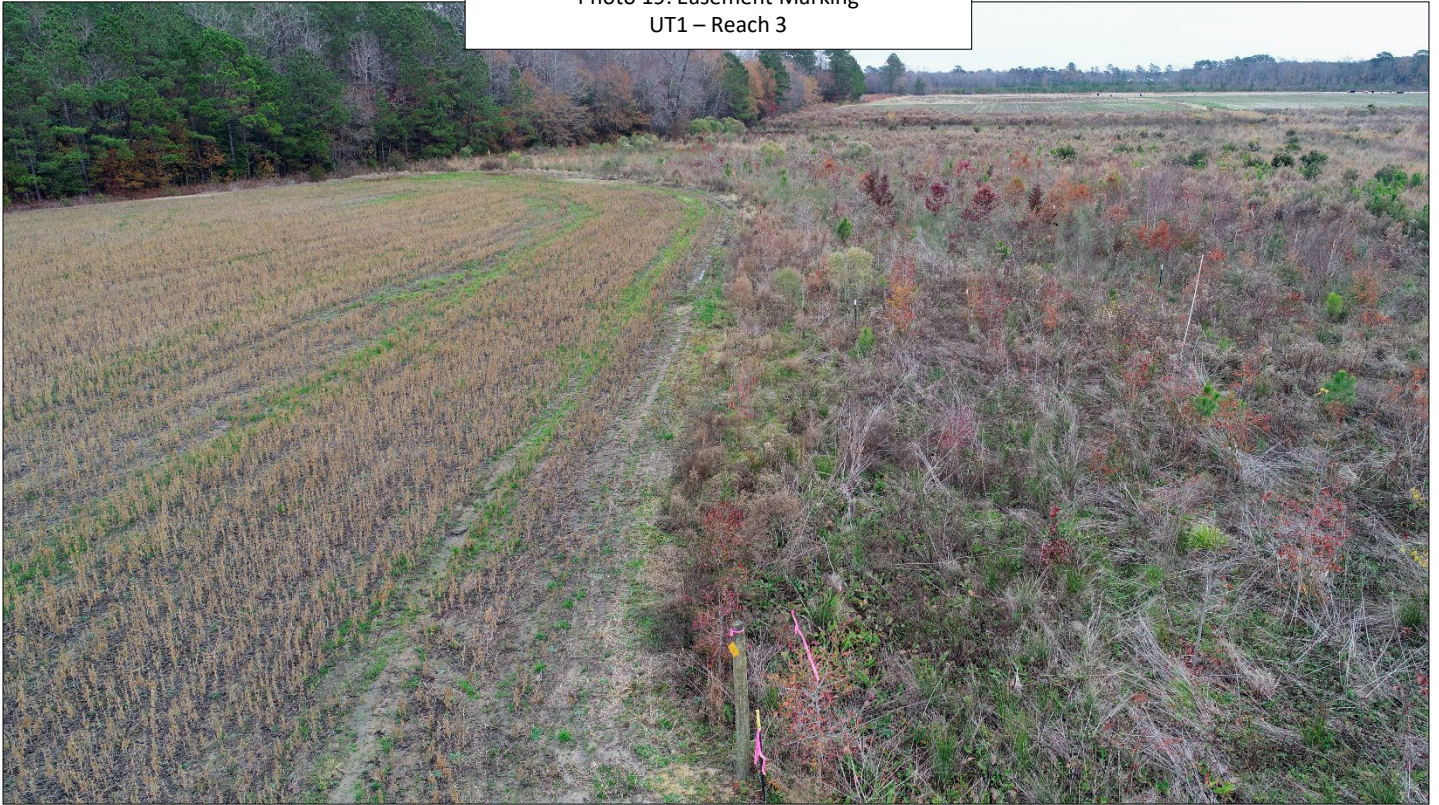
Photo 19: Easement Marking
UT1 – Reach 3

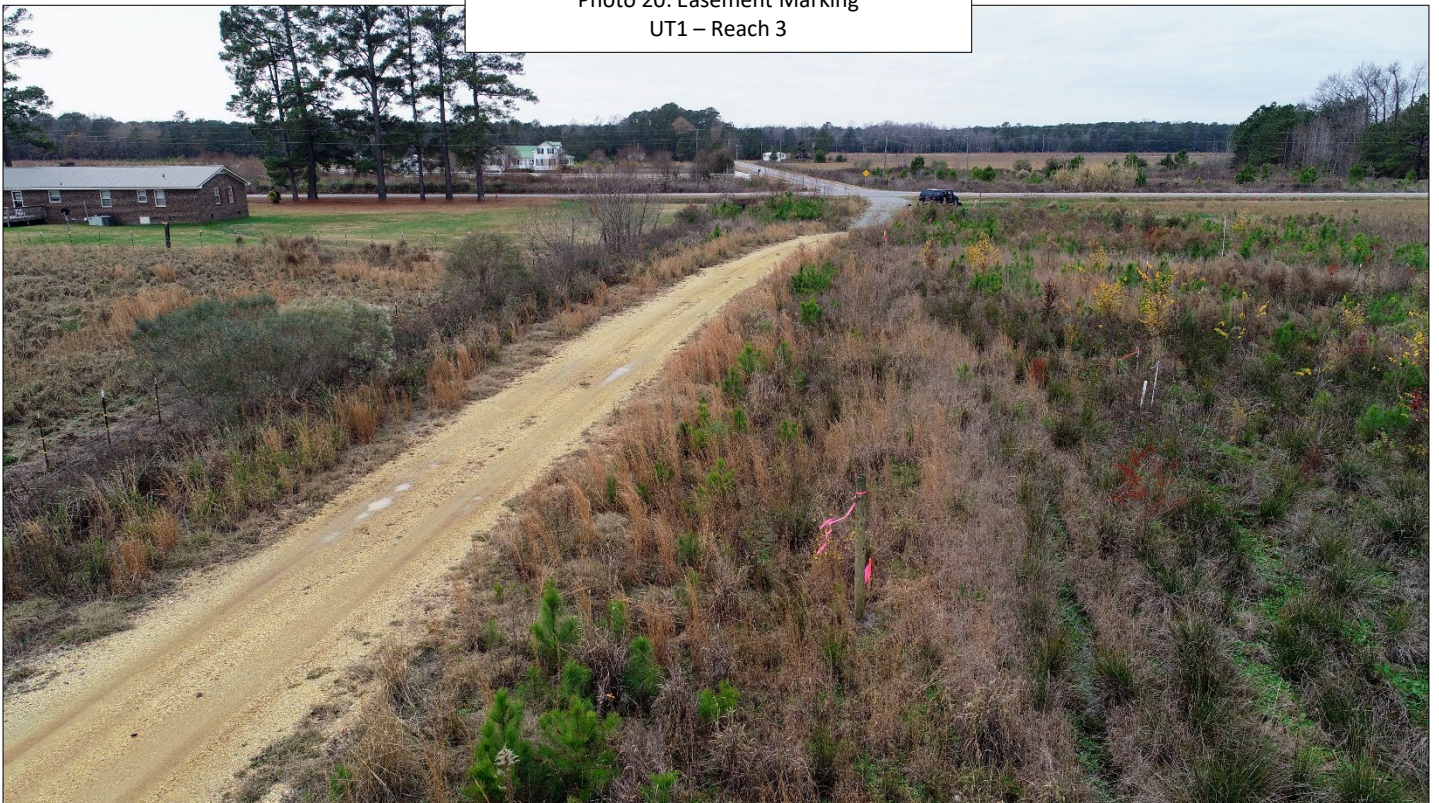
Photo 20: Easement Marking
UT1 – Reach 3
