FINAL
MONITORING REPORT (MY3)

ALLIANCE HEADWATERS MITIGATION SITE

Johnston County, North Carolina

DMS ID No. 97086

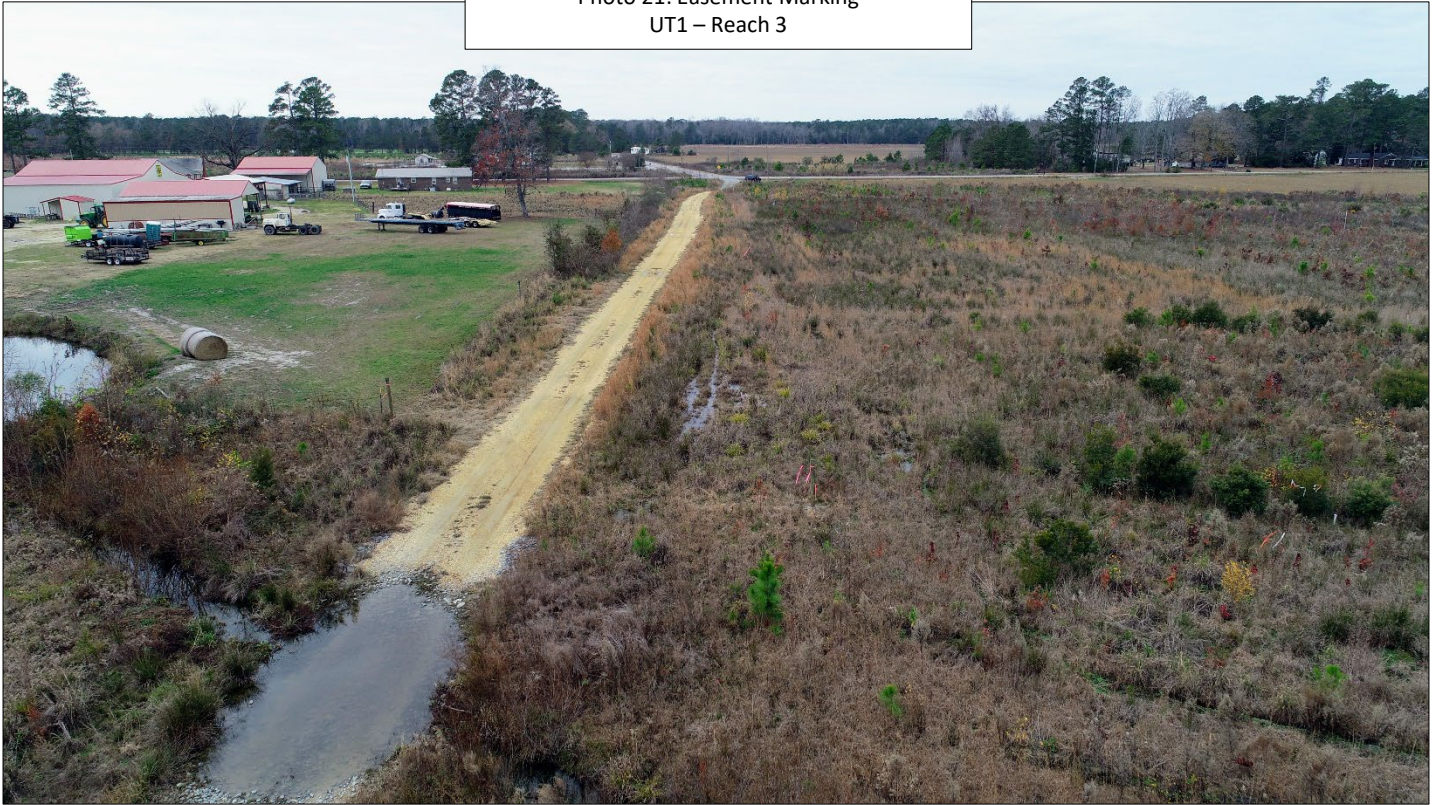
Photo 21: Easement Marking
UT1 – Reach 3

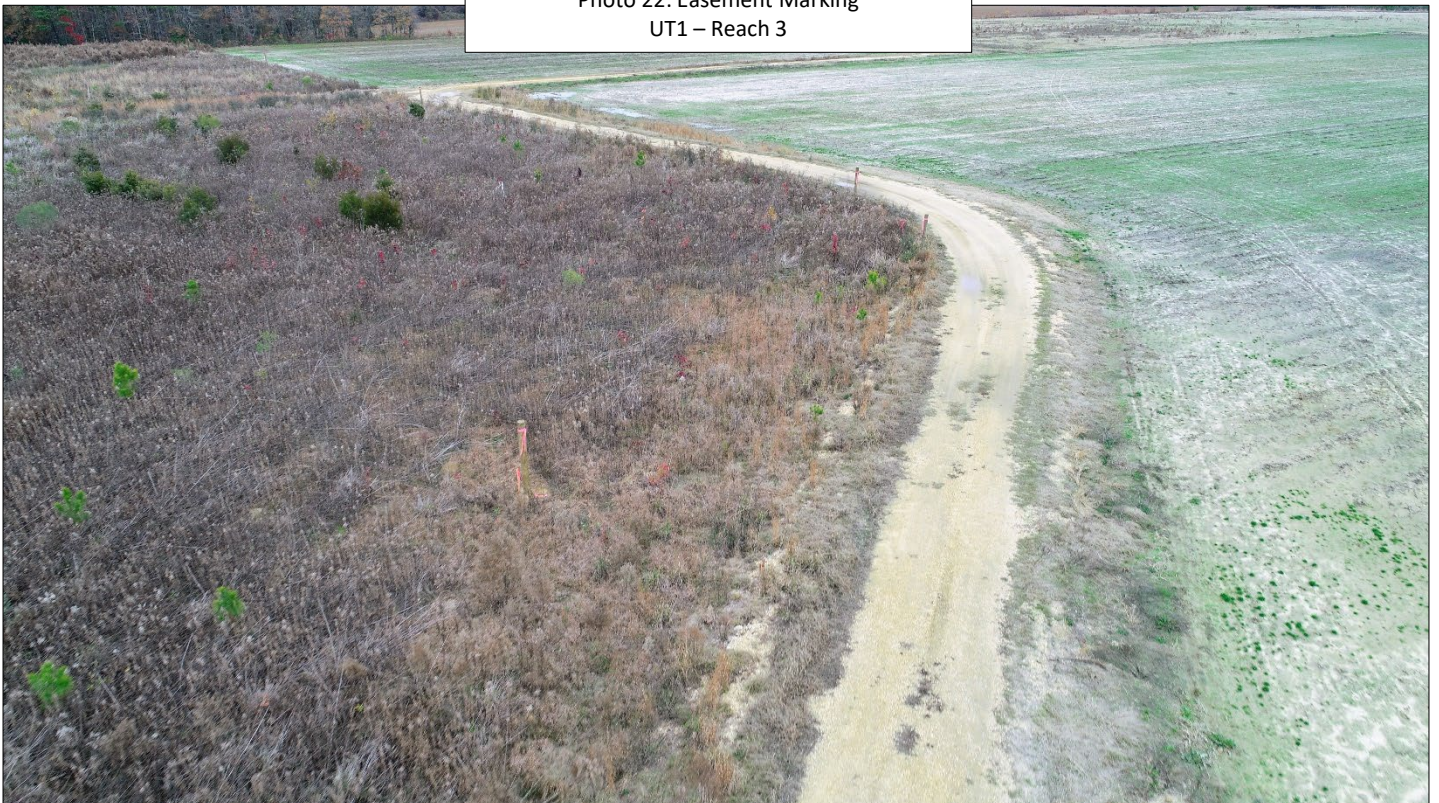
Photo 22: Easement Marking
UT1 – Reach 3

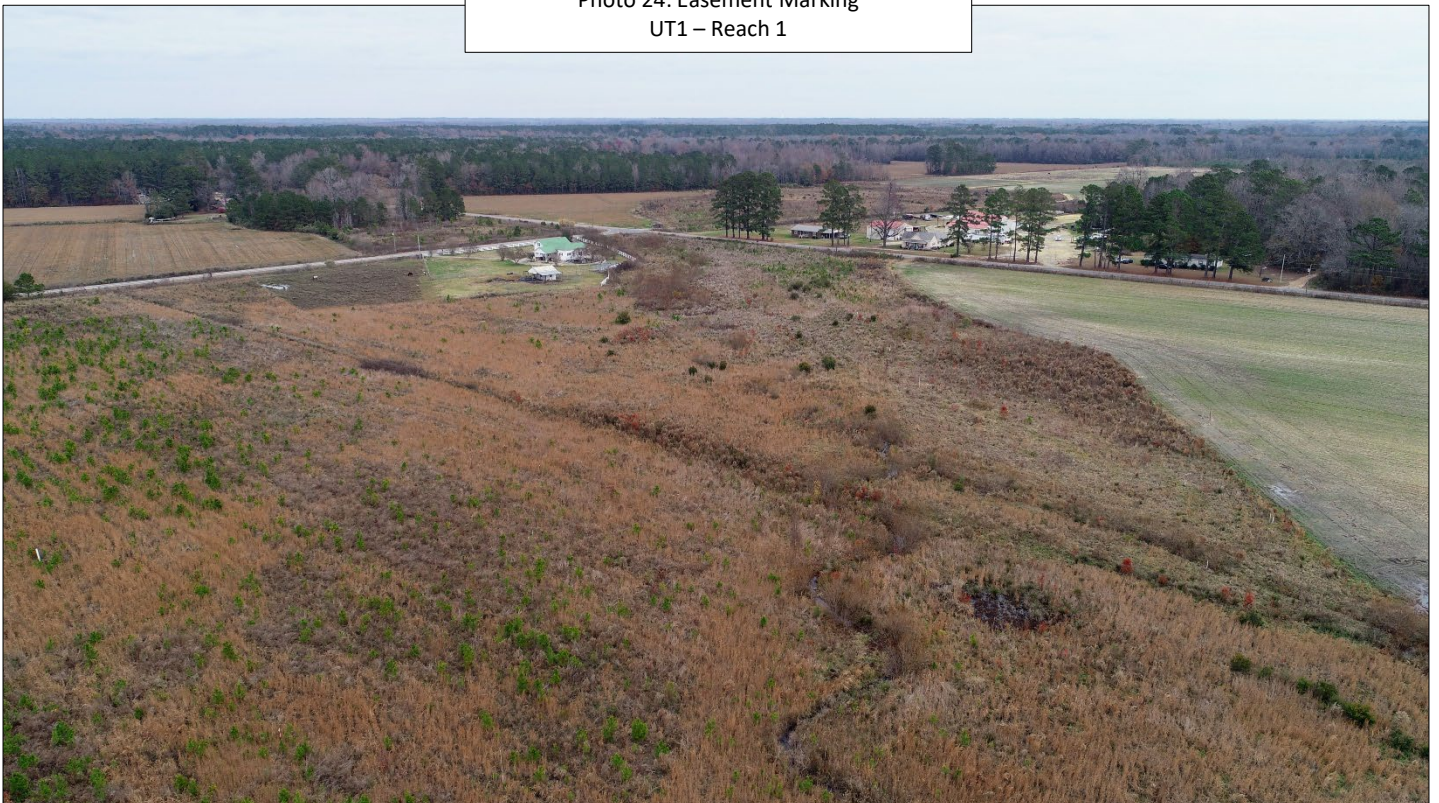
Photo 24: Easement Marking
UT1 – Reach 1
