MONITORING REPORT (MY4)

ALLIANCE HEADWATERS MITIGATION SITE

Johnston County, North Carolina

DMS ID No. 97086

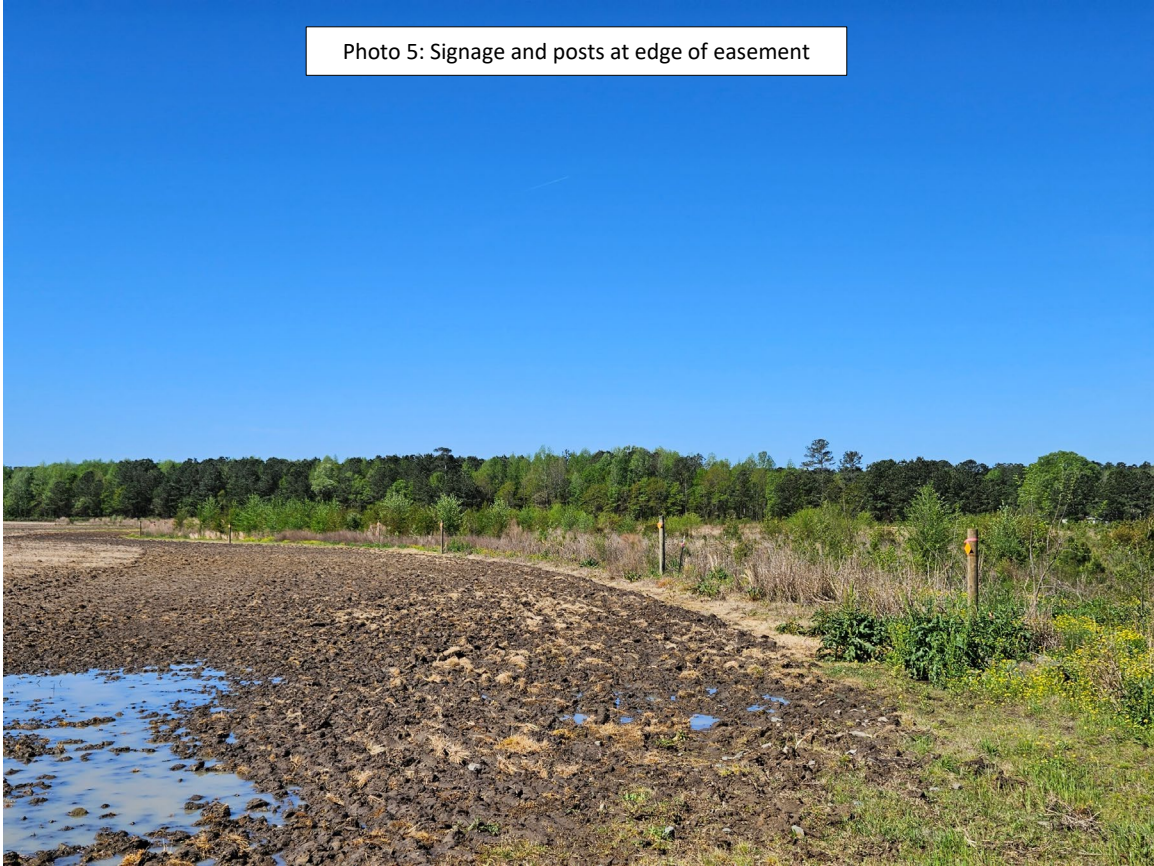
Photo 5: Signage and posts at edge of easement

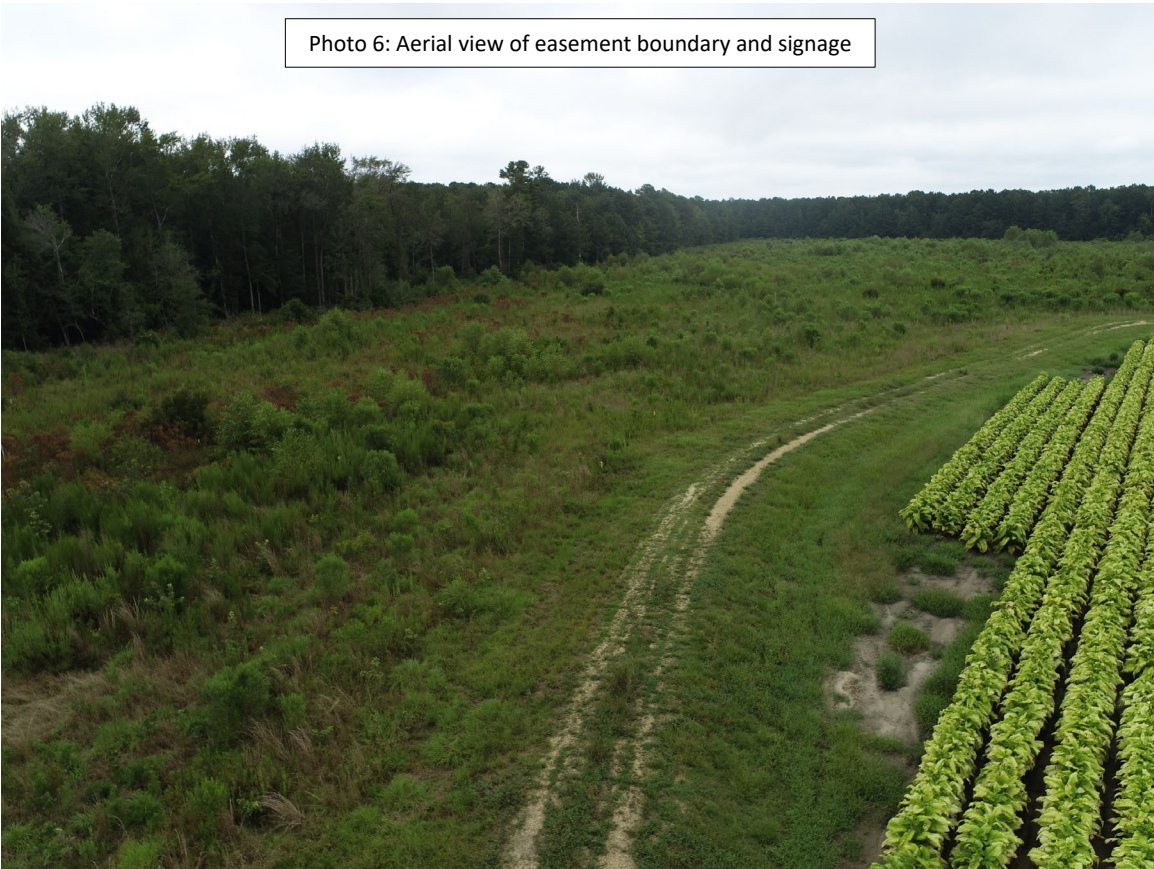
Photo 6: Aerial view of easement boundary and signage

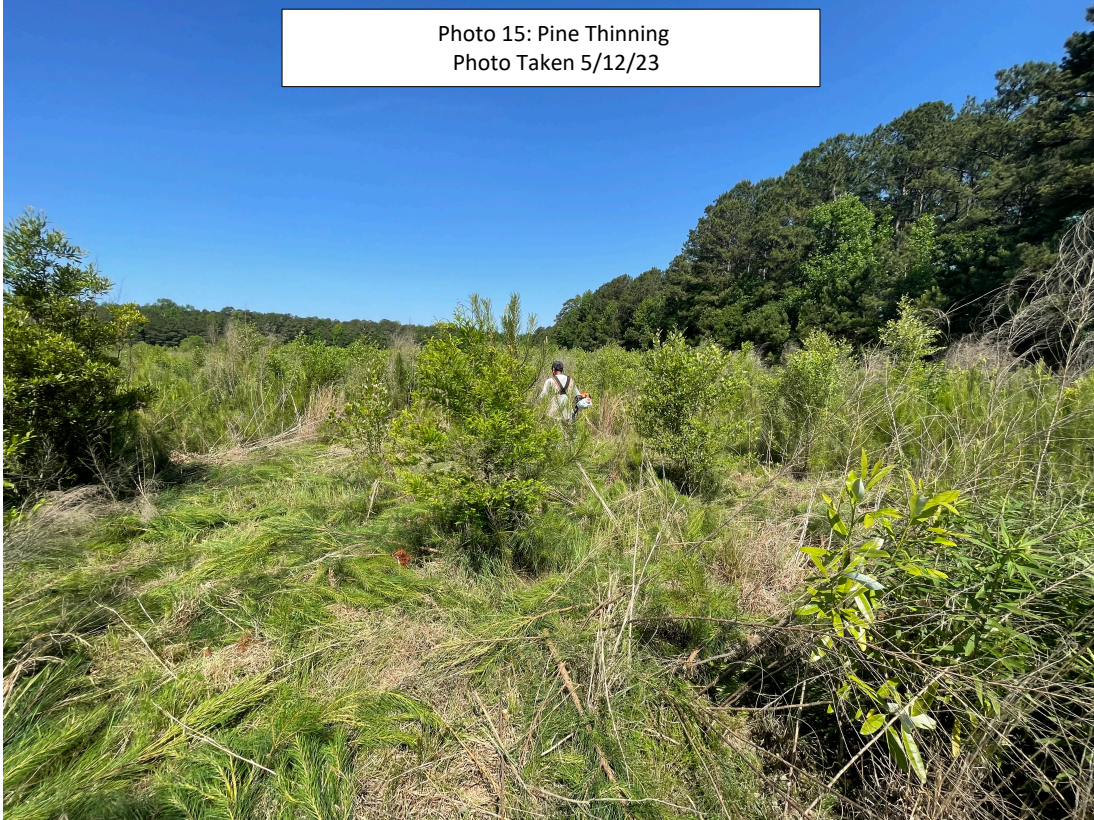
Photo 15: Pine Thinning
Photo Taken 5/12/23

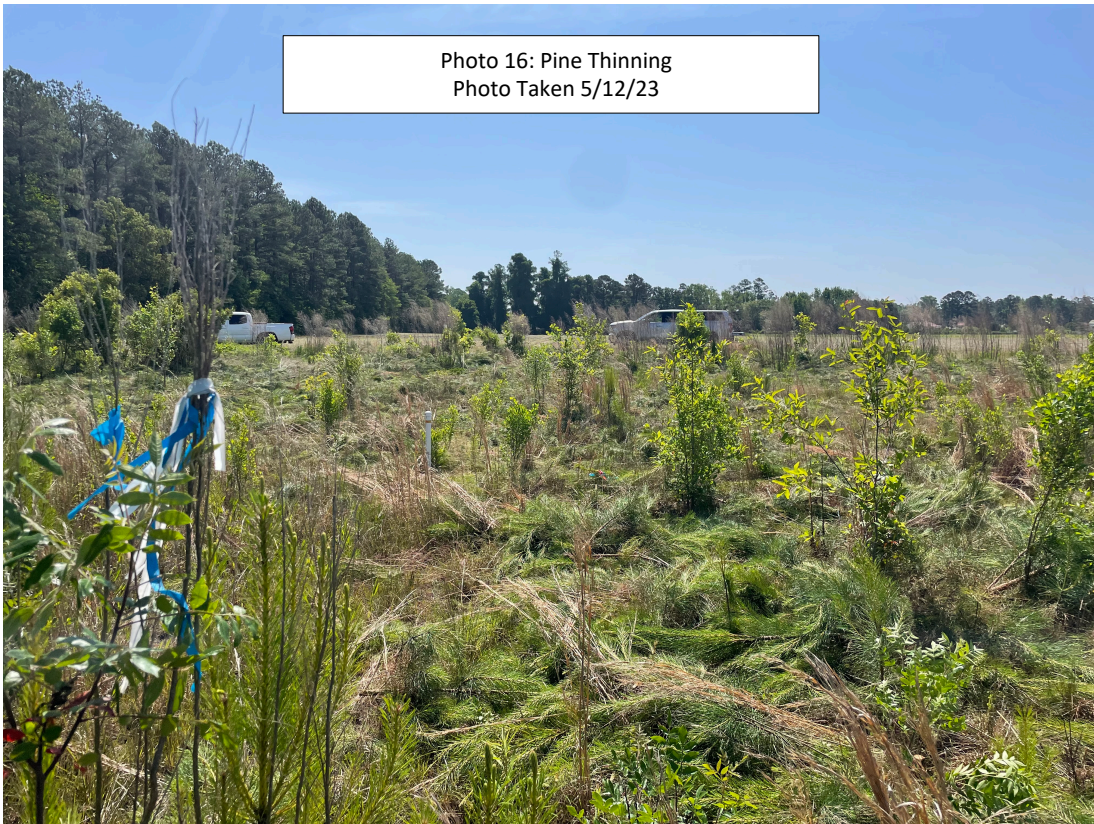
Photo 16: Pine Thinning
Photo Taken 5/12/23
