As-Built Baseline Monitoring Report

APPLE VALLEY PROJECT

NCDMS Project #100063 (Contract #7531)

March 2021

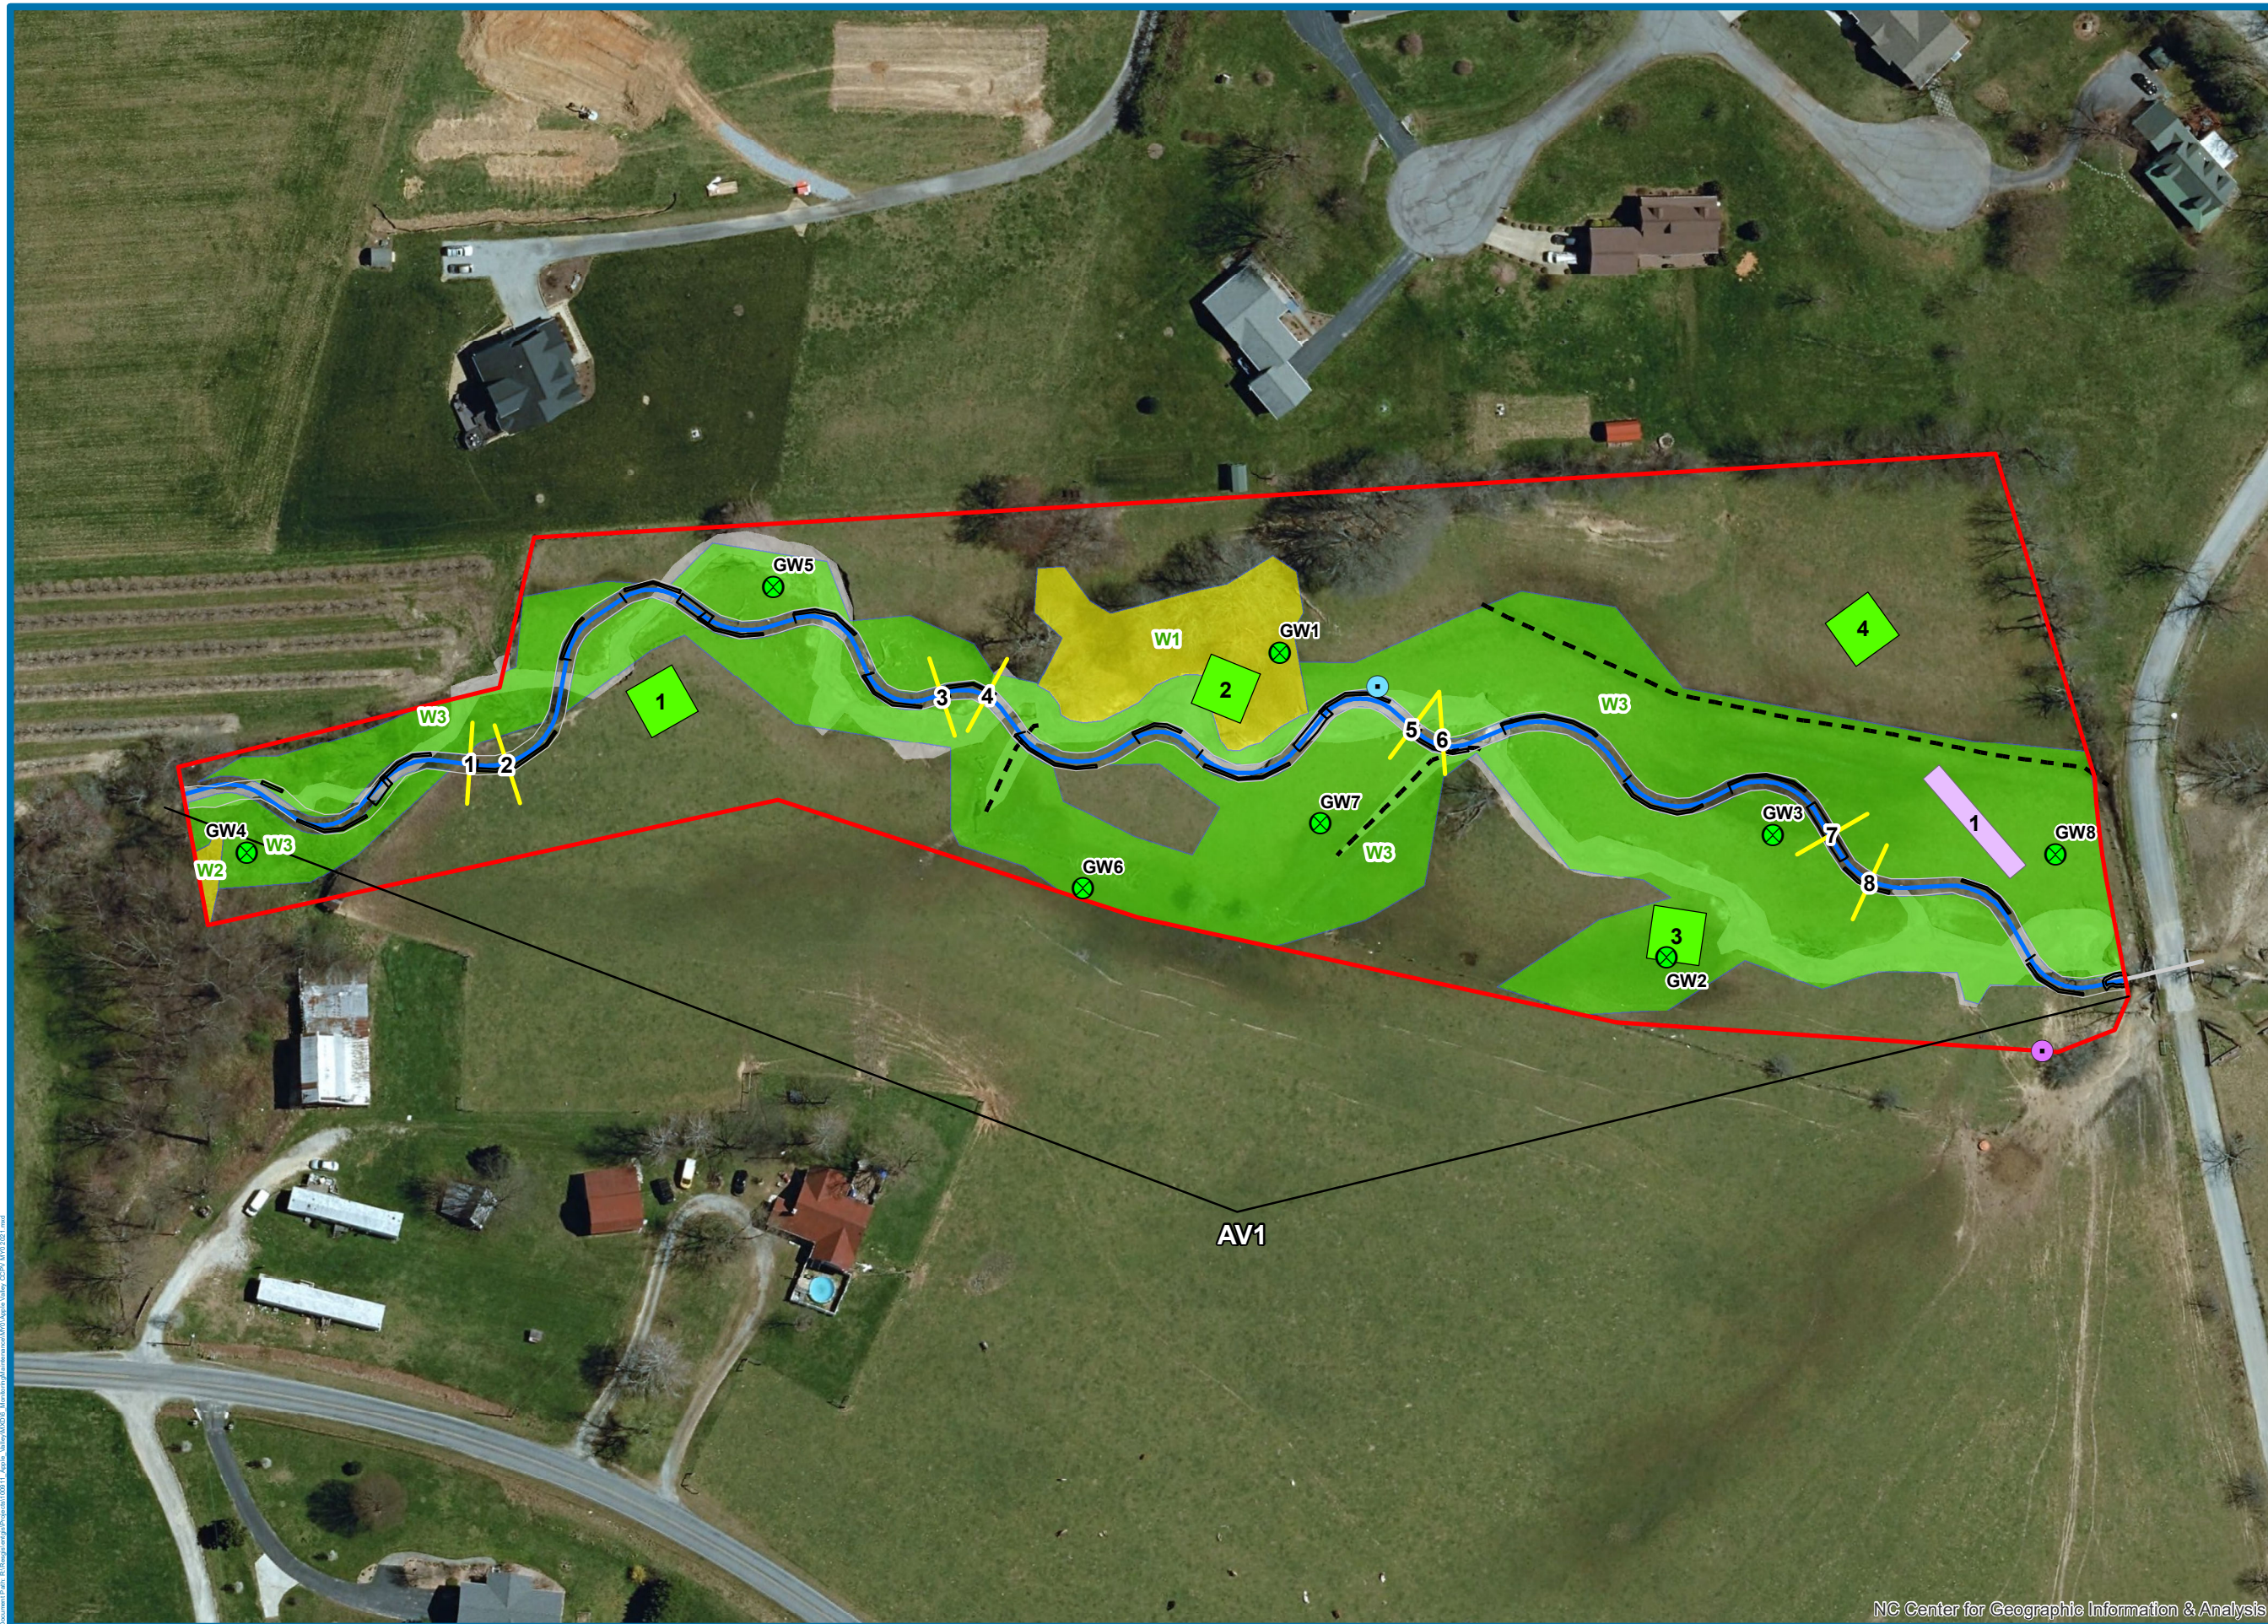
Visual Stream Stability Assessment

Major Channel Category		Metric	Number Stable, Performing as Intended	Total Number in As-built	Amount of Unstable Footage	% Stable, Performing as Intended
Bank	Surface Scour/Bare Bank	Bank lacking vegetative cover resulting simply from poor growth and/or surface scour			0	100%
	Toe Erosion	Bank toe eroding to the extent that bank failure appears likely. Does <u>NOT</u> include undercuts that are modest, appear sustainable and are providing habitat.			0	100%
	Bank Failure	Fluvial and geotechnical - rotational, slumping, calving, or collapse			0	100%
Totals					0	100%
Structure	Grade Control	Grade control structures exhibiting maintenance of grade across the sill.	18	18		100%
	Bank Protection	Bank erosion within the structures extent of influence does <u>not</u> exceed 15%. (See guidance for this table in DMS monitoring guidance document)	20	20		100%

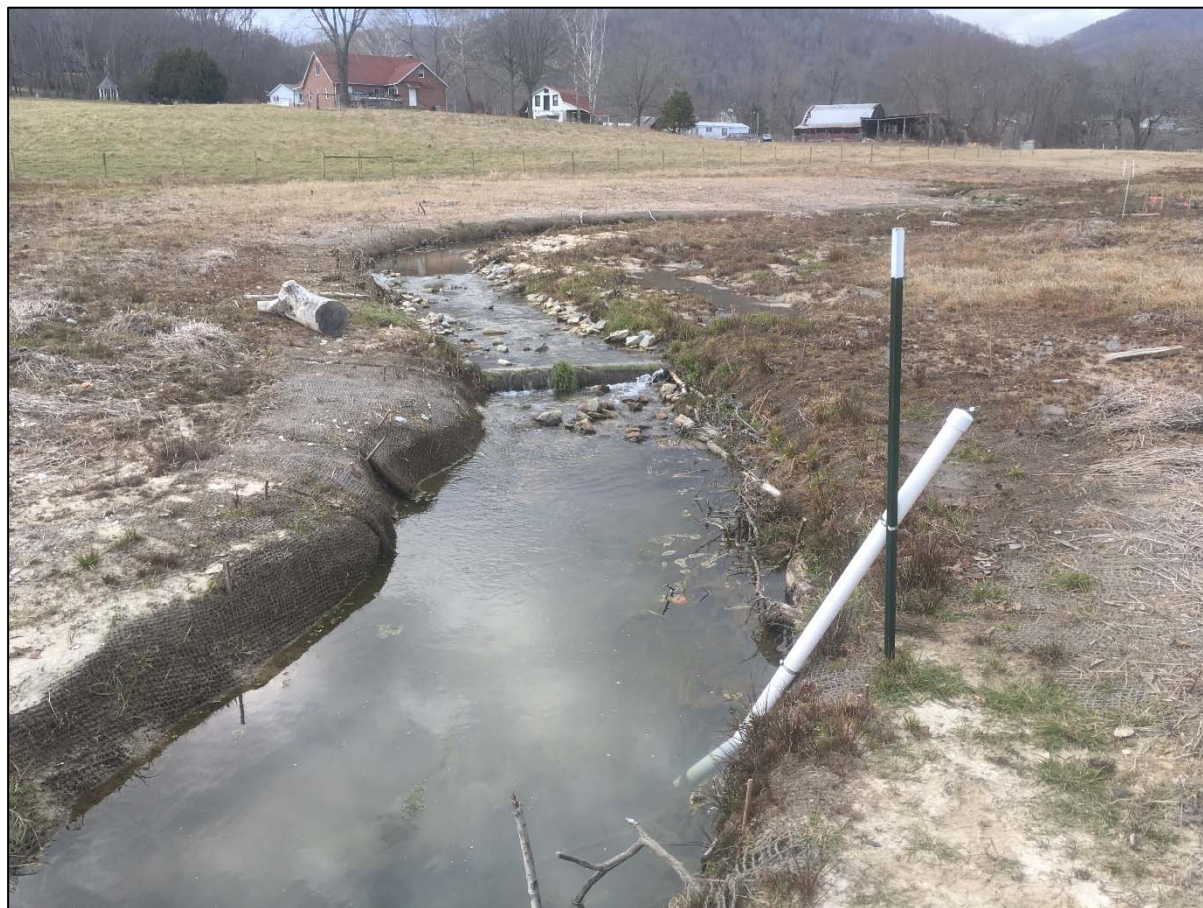
Stage Recorder AV1

One stage recorder was installed on January 20, 2021 and will document bankfull events. Stream hydrology data will be included in the Monitoring Year 1 Report in this section and in the appendices. The gauge location can be found on **Figure 2** and photos are in **Appendix B**.
