Year 2 Monitoring Report

APPLE VALLEY PROJECT

NCDMS Project #100063 (Contract #7531)
USACE Action ID: SAW-2018-01150
DWR Project #20181028

Henderson County, North Carolina
French Broad River Basin
HUC 06010105

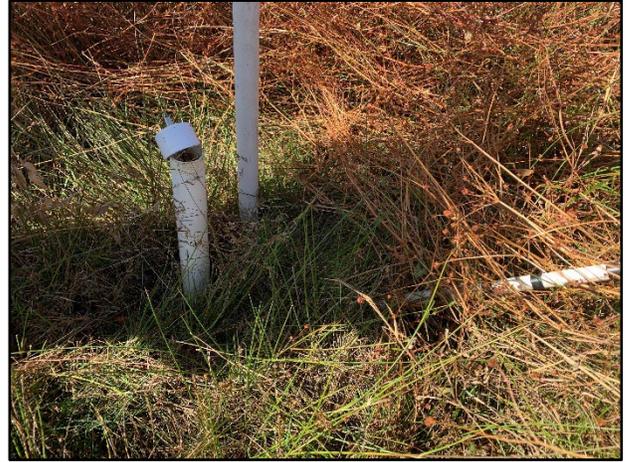
GWG 8 has not met success criteria for the first two years of the monitoring period. It is noted that a nearby ditch may be affecting the performance. This gauge is the lone gauge for the reestablishment area on the east side of the creek (south section). Does RES expect the hydrology to improve in future years, given the proximity to the ditch? Does the area to the immediate north of GWG 8 (away from the ditch) appear to have better hydrology? In general, how does RES plan to monitor and /or potentially adaptively manage the wetlands in this area in the future?

Groundwater Well 8 – surrounded with *Persicaria saggitata* and *Juncus* sp. (10/20/2022)

[RES plans to create a minimally invasive ditch plug, using coir logs and wooden stakes, in order to decrease the amount of water diversion through this section of wetland and ultimately work to improve hydrology for GW8. A plug was originally proposed in the design plans; however, the wetland along the south side of the project was exceedingly wet during construction, therefore the ditch plug installation was left as lower priority maintenance, as necessary. If hydrology does not improve for GW8, RES will install an additional](#)

groundwater gauge further north from the existing gauge. As stated in the report, there are several vegetative wetland indicators surrounding GW8.

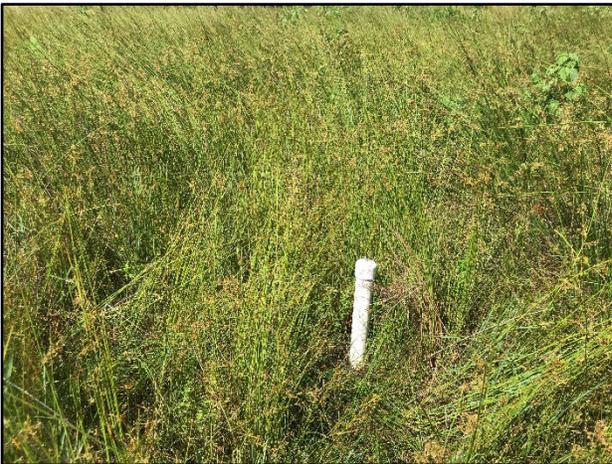
Groundwater Well 8 – surrounded with *Juncus* sp. and *Ludwigia alternifolia* (6/15/2022)

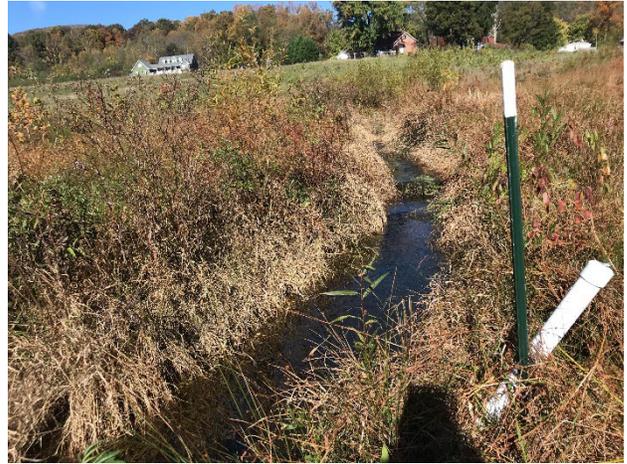
Stage Recorder AV-1 (10/20/2022)

This was a typo and has been revised to say, "The stage recorder malfunctioned in 2021, and was replaced in May 2022." Upon gauge download in 2021, it was discovered that the stage recorder on AV1 had only reading twice per day, instead of reading once per hour, 24 hours per day.

One stage recorder was installed on January 20, 2021, along AV1; however, the automatic recording pressure transducers (HOBO device) was originally programmed to collect readings twice a day, as opposed to once every hour—the correct interval. The original HOBO was replaced with a new one, reading at the proper intervals, on May 11, 2022. It is in place to document bankfull events throughout each monitoring year. The stage recorder on AV1 recorded six bankfull events during MY2, with the highest reading on September 5, 2022, reading a maximum bankfull height of 1.061 feet above the top of bank. The gauge location can be found on **Figure 2** and photos are in **Appendix B**.

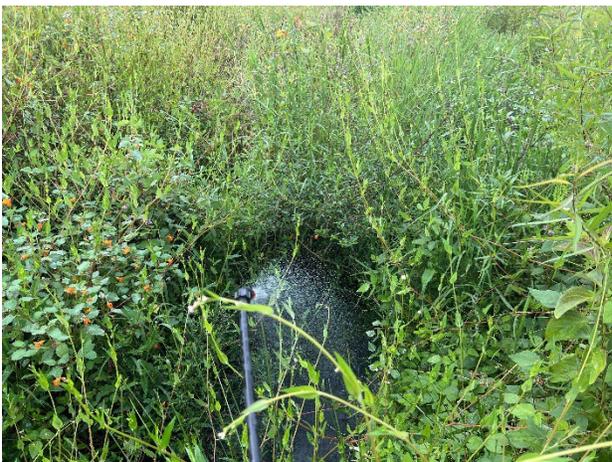
In-channel vegetation was treated in response to a comment from DMS during MY1. The exact species was not confirmed, but potential species were provided in the MY1 comment response memo (*Iris virginica*, *Panicum virgatum*). The species could have been introduced via the adjacent landscapes surrounding the easement, or seed could have established in the channel, flowing in from the 277-acre drainage area. While it did not pose an immediate threat, as a preventative, early-stage measure, the in-channel vegetation was treated. As time goes on, it is expected that surrounding trees, both livestakes and bareroots, will continue to grow along the banks, shading out further in-channel vegetation establishment.

In-Stream Vegetation treated via foliar spray
(8/25/2022)
