Year 3 Monitoring Report

APPLE VALLEY PROJECT

NCDMS Project #100063 (Contract #7531)
USACE Action ID: SAW-2018-01150
DWR Project #20181028

Henderson County, North Carolina
French Broad River Basin
HUC 06010105

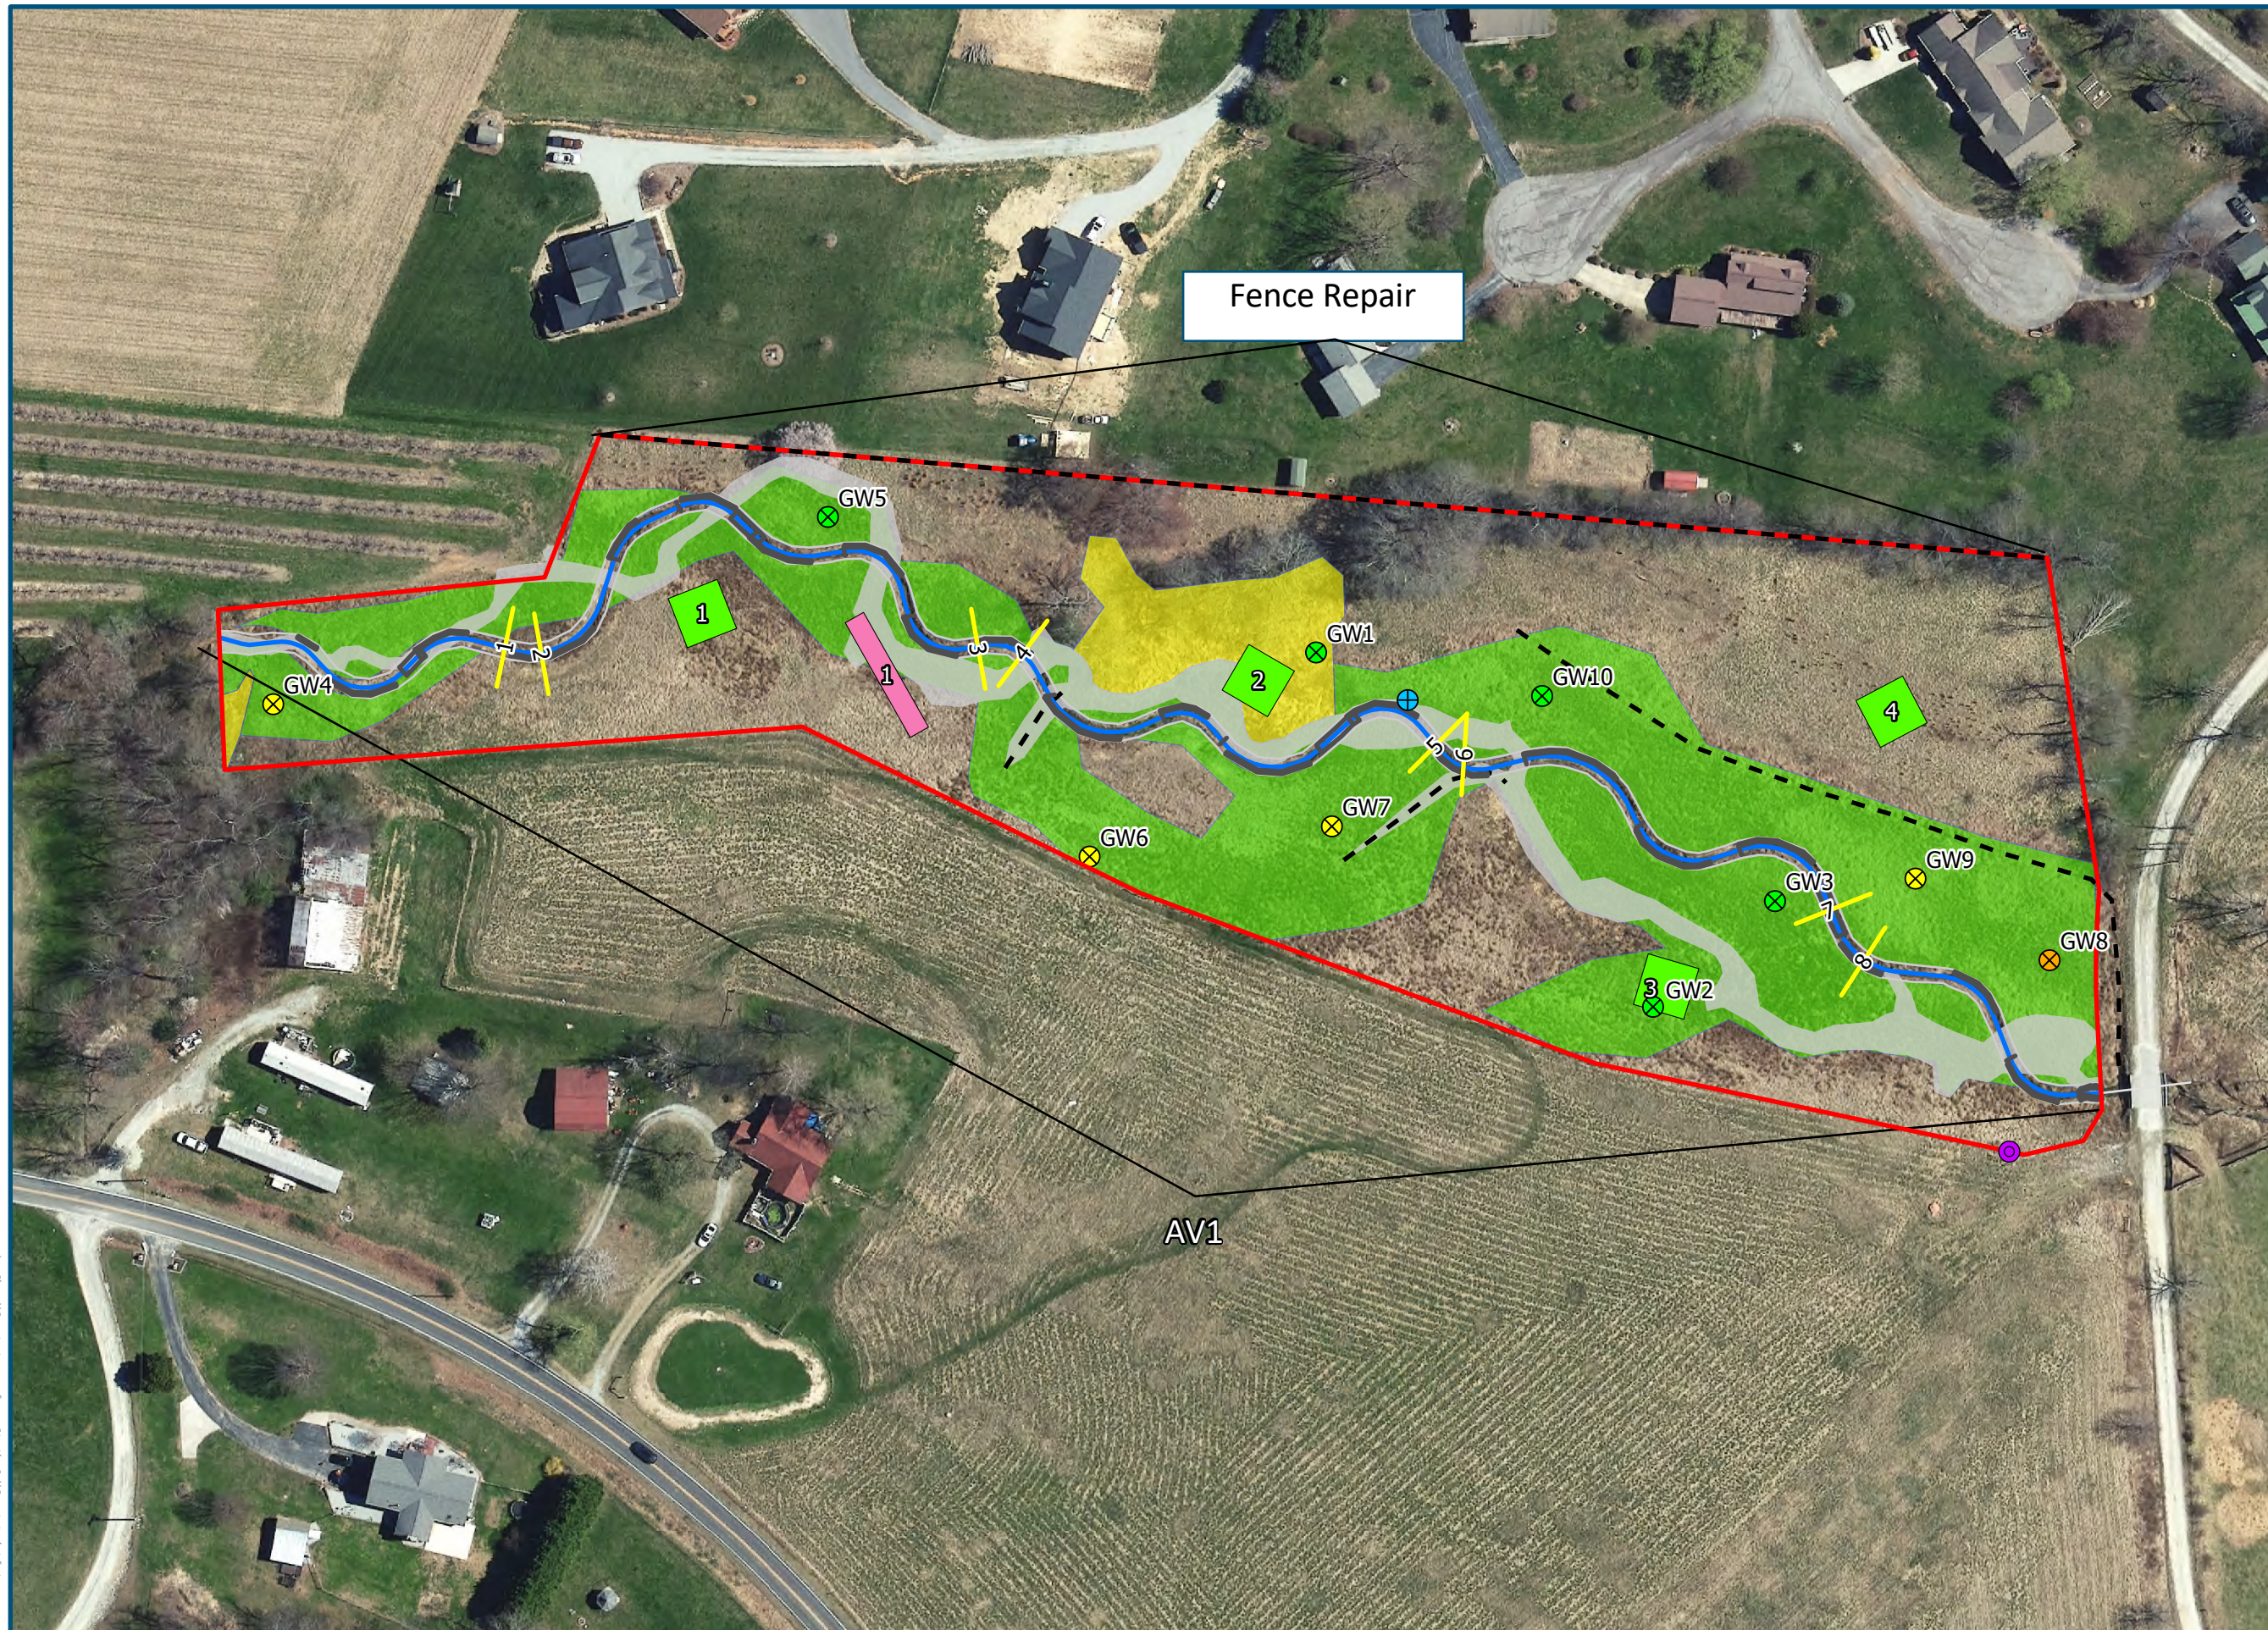
Boundary encroachments (tree cutting and related fence damages) and fencing deficiencies (falling down/loose fencing along much of the eastern boundary along the subdivision back yards) were noted during DMS's site visit on 12/19/2023; and email follow up details and map sent to RES. Please indicate what RES' corrective plan is to address these issues, discuss briefly in the report, and include locations on the CCPV.

Visual assessment of vegetation outside of the monitoring plots indicates that the herbaceous vegetation is becoming well established throughout the project. A fair amount of wetland vegetation was present throughout all wetland areas, including *Juncus* sp., *Ludwigia alternifolia*, *Vernonia noveboracensis*, *Eupatorium perfoliatum*, *Impatiens capensis*, *Ludwigia alternifolia*, and *Persicaria sagittata* suggesting that wetlands are becoming well established throughout the site. Photos of the vegetation surrounding the groundwater wells can be found in **Appendix B**. Treatment of noxious and invasive species in 2022 was successful and no new areas of noxious or invasive species were noted during year three monitoring. The easement boundary was examined during year three monitoring; signs and fencing along the eastern boundary were found to be in poor condition and will be replaced during MY4. Additionally, any trees that are in danger of falling and damaging the repaired fence will be cut down and the debris will be dispersed within the easement.

RES will send out a crew to re-mark the boundary and install new signage along this portion of the easement. A tree cutting is expected to prevent a tree from the easement falling into the neighbor's yard. Debris from tree cutting will be dispersed within the easement. The easement portion of focus has been marked on the CCPV.

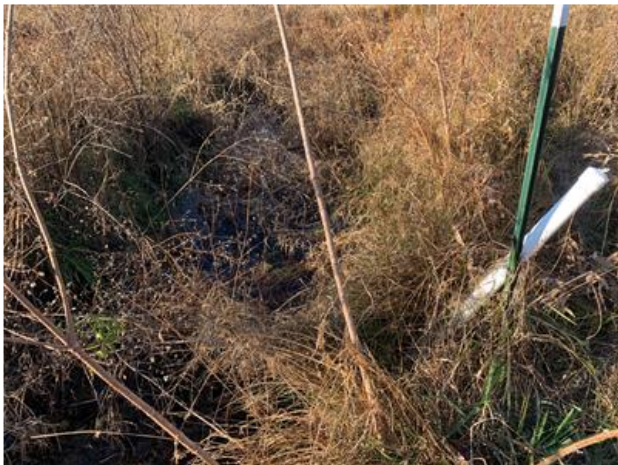
Stage Recorder AV-1 (11/28/2023)

One stage recorder was installed on January 20, 2021, along AV1; however, the automatic recording pressure transducers (HOBO device) was originally programmed to collect readings twice a day, as opposed to once every hour—the correct interval. The original HOBO was replaced with a new one, reading at the proper intervals, on May 11, 2022. It is in place to document bankfull events throughout each monitoring year. The stage recorder on AV1 recorded six bankfull events during MY3, with the highest reading on August 28, 2023, reading a maximum bankfull height of 0.79 feet above the top of bank. The gauge location can be found on **Figure 2** and photos are in **Appendix B**.

The stage recorder malfunctioned in 2021, and was replaced in May 2022

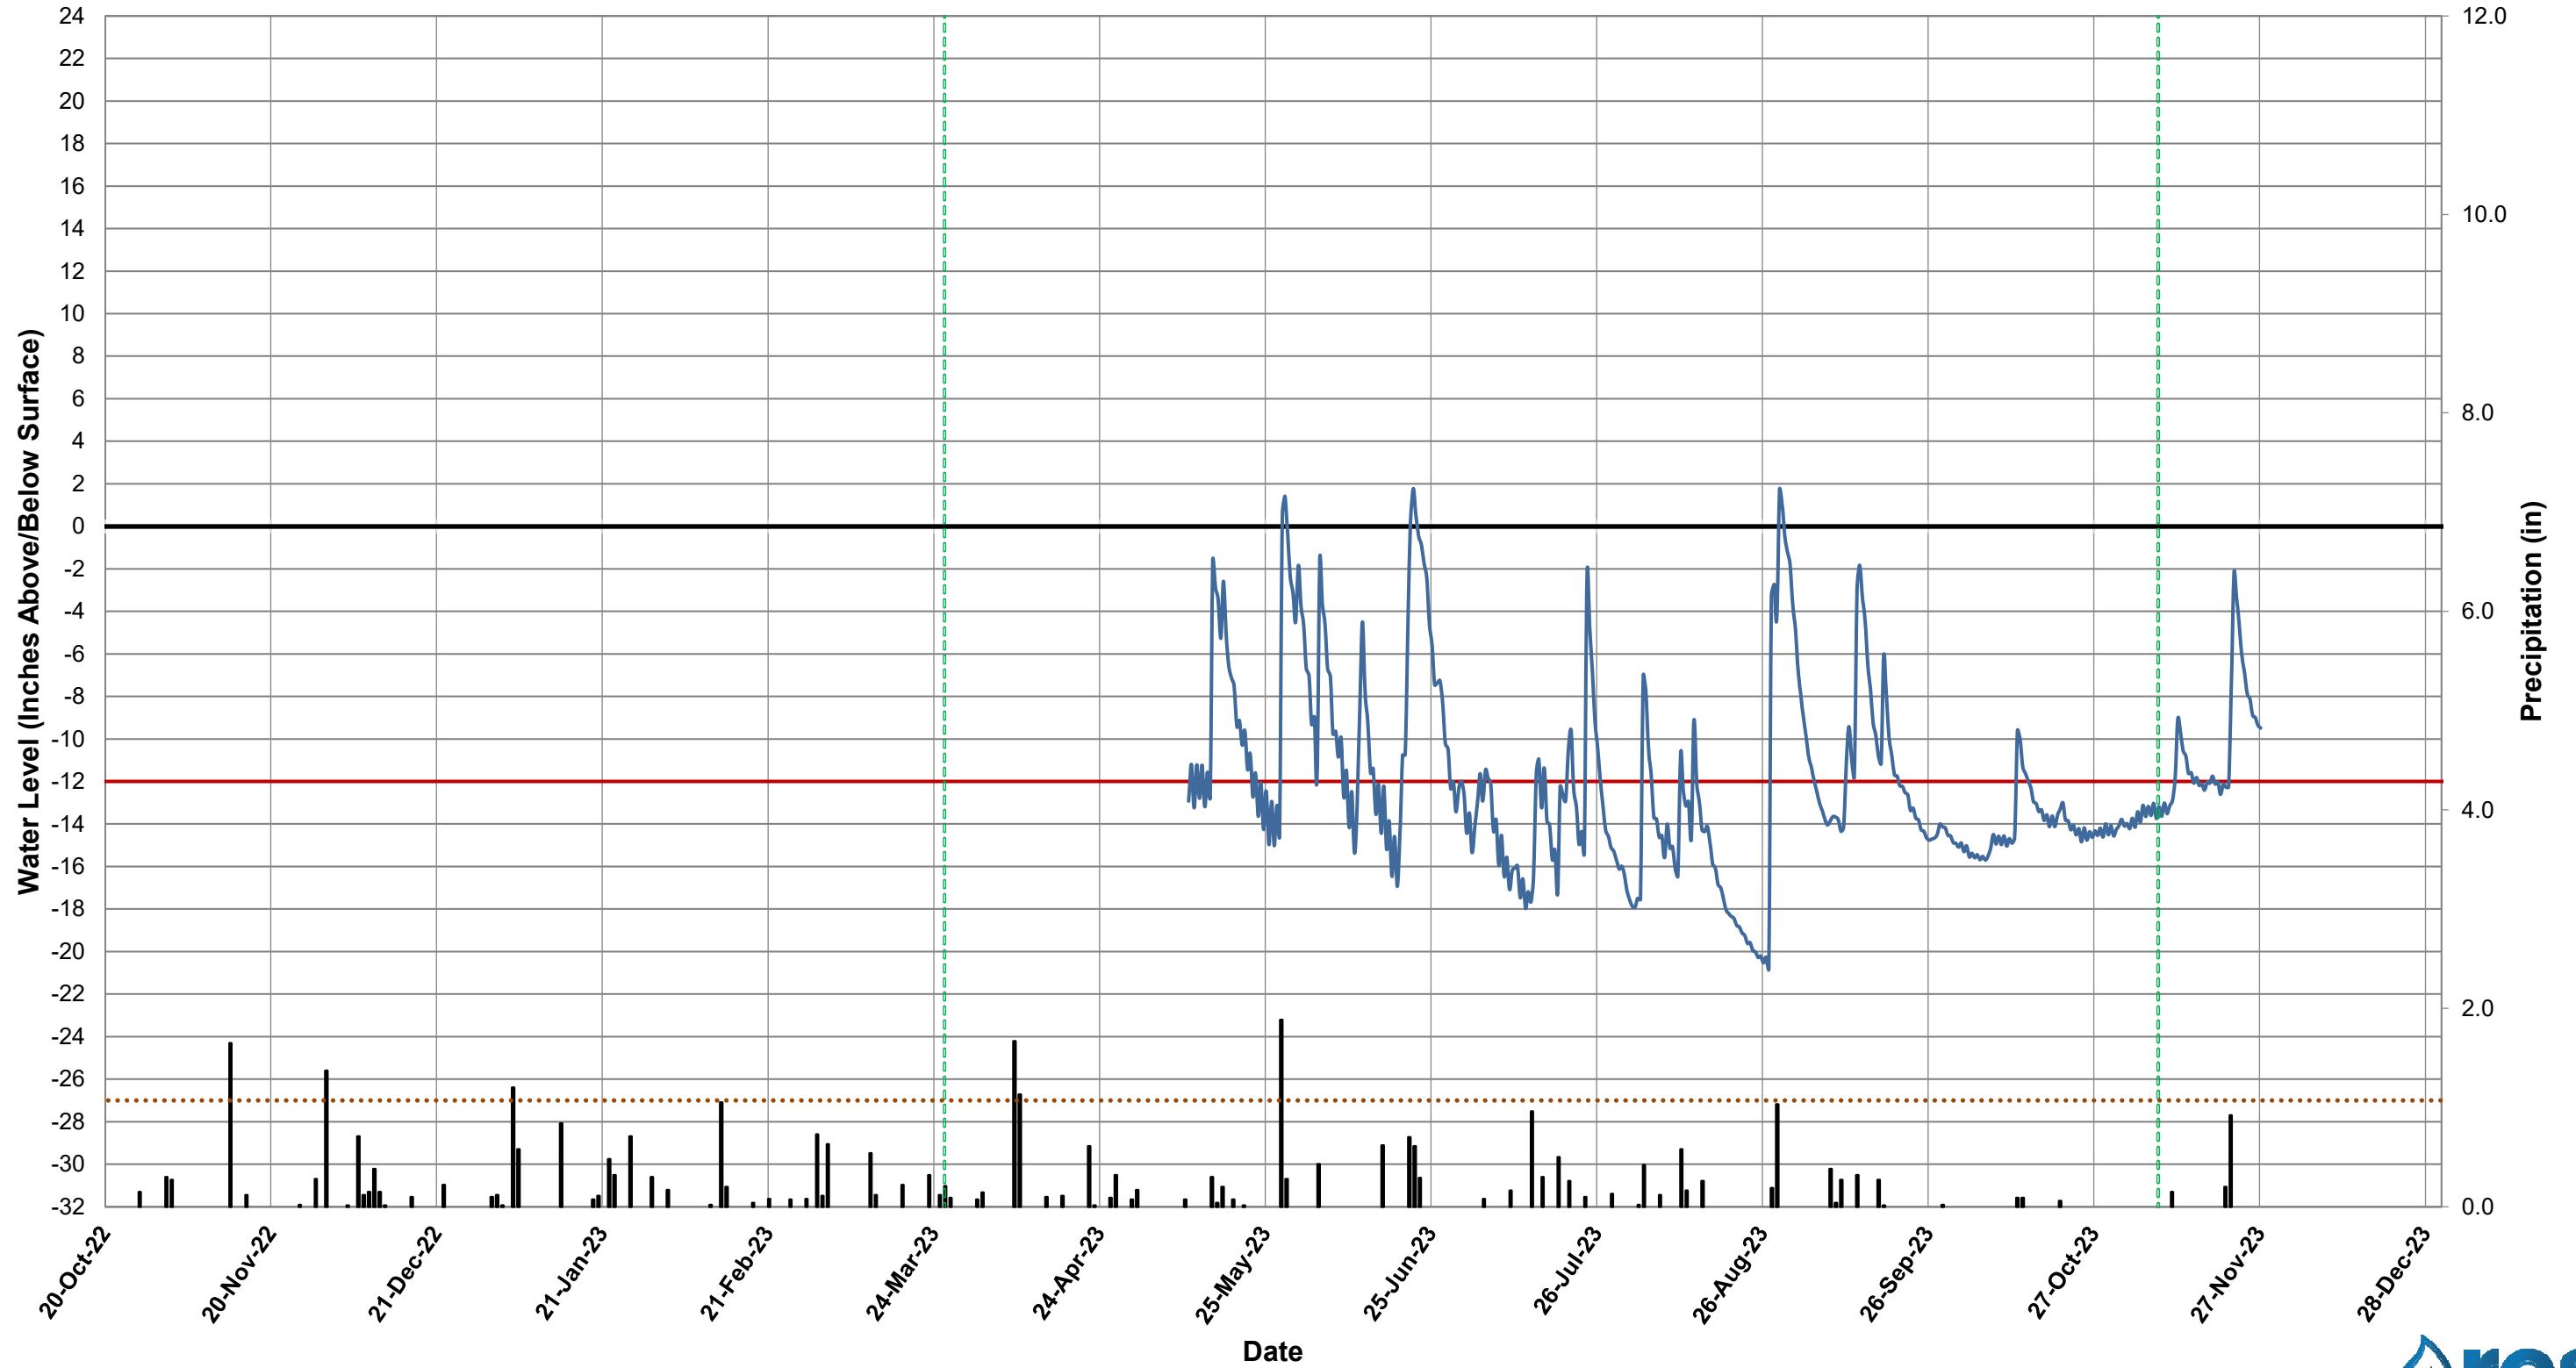
MY3 Apple Valley GW9

GW9 and GW10 were installed in May 2023 and thus do not have data for the entire growing season.

12 Consecutive Days of Hydrology
05/28/2023 - 06/09/2023

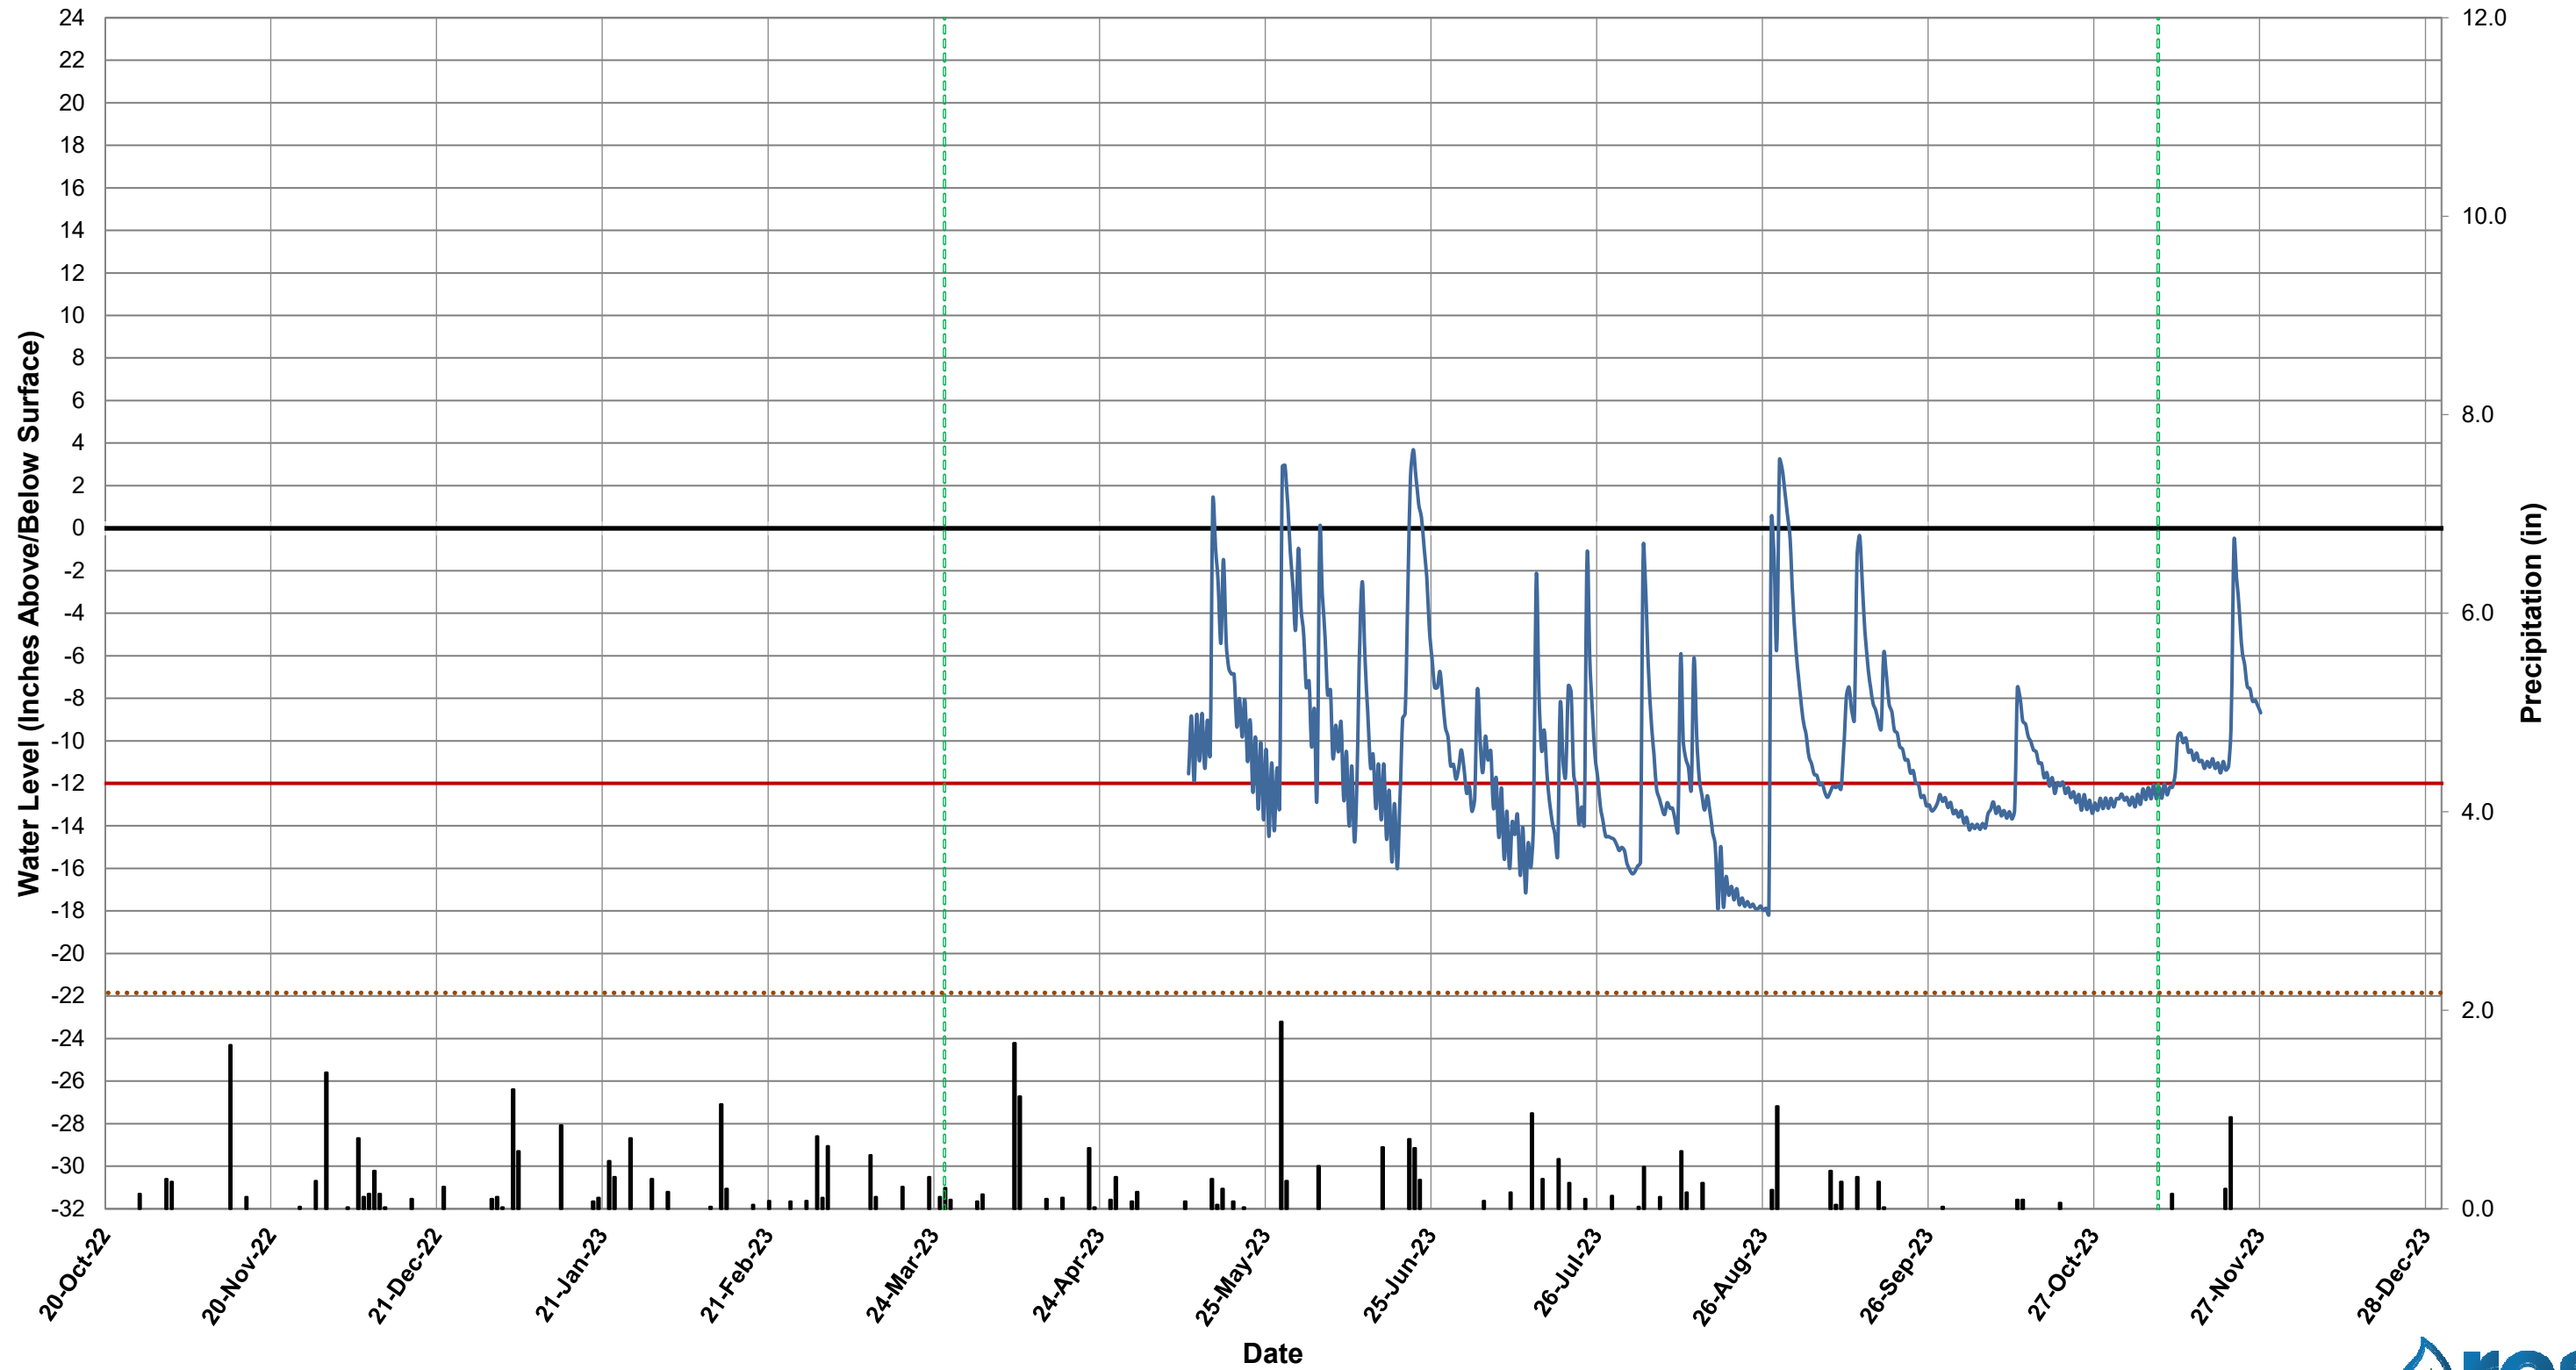
MY3 Apple Valley GW10

37 Consecutive Days of Hydrology
05/10/2023 - 06/16/2023
