**Armstrong Property Wetland and Stream Mitigation Project
Hyde County, NC**

**2008 Annual Monitoring Report
Year 1**

**NCEEP Project Number D06012-A
Tar-Pamlico River Basin**

Date: December, 2008

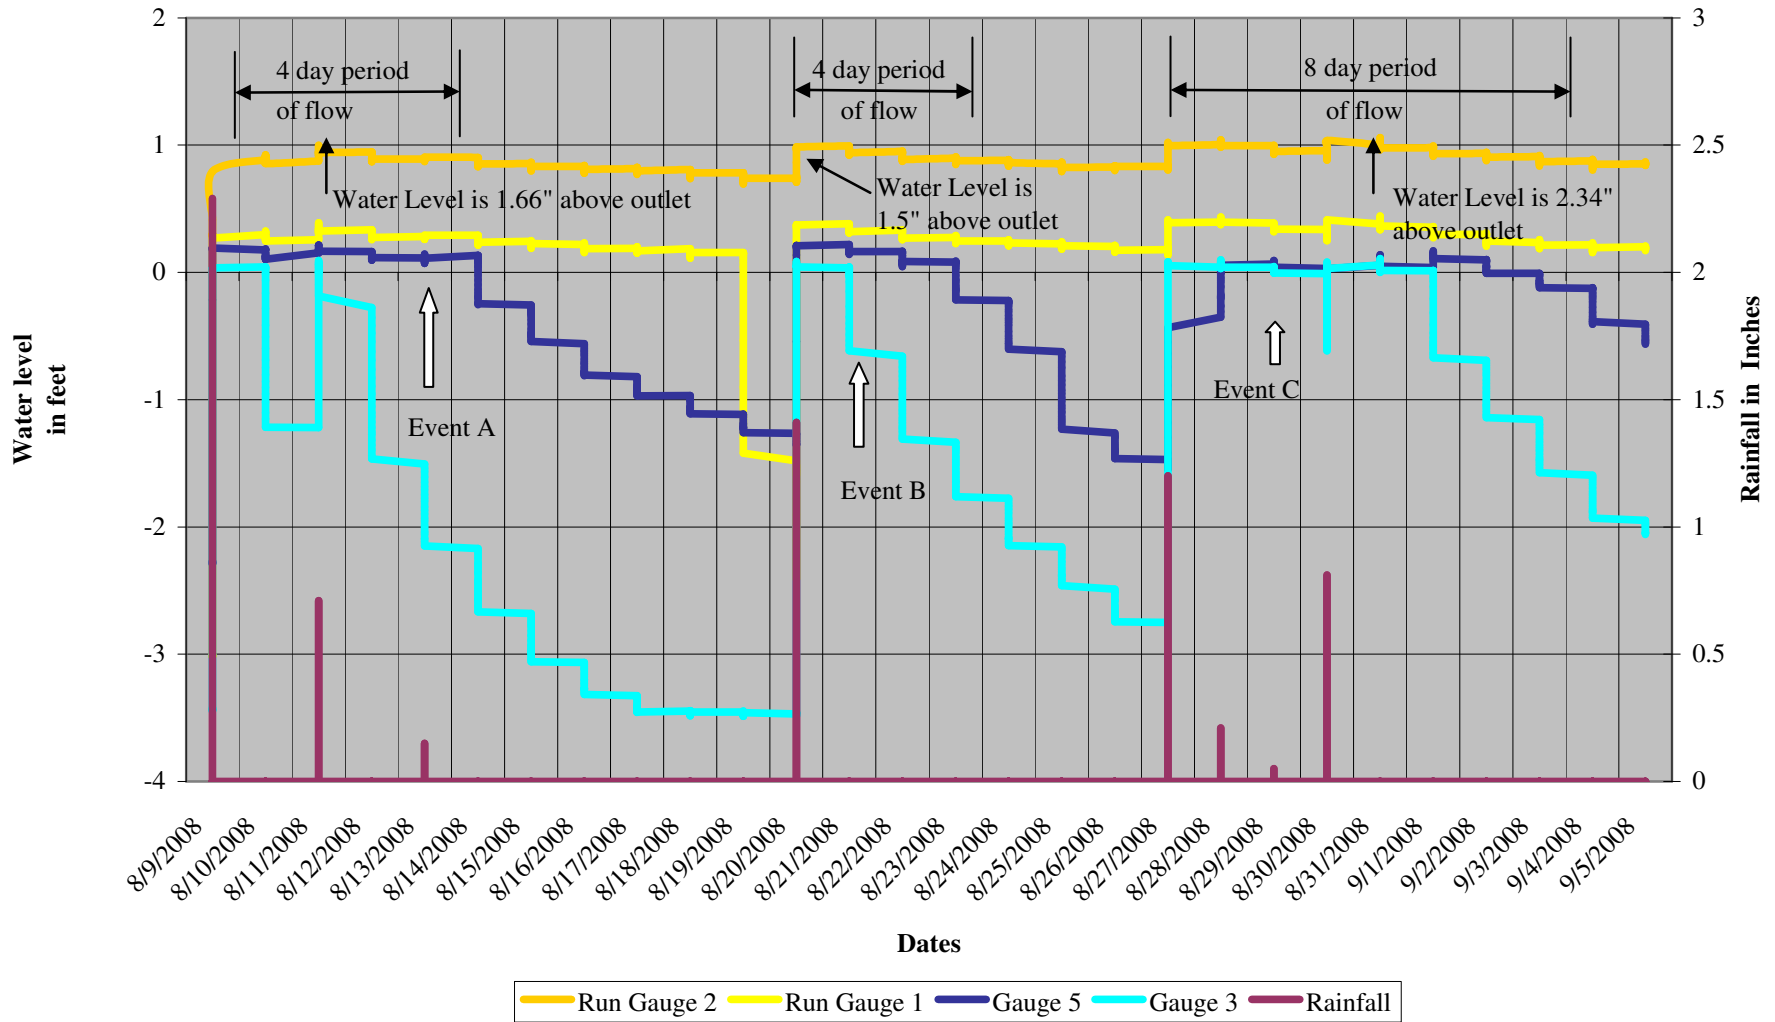
Figure F1
Comparison of Gauges for Flow

Refer to Figures F1 and F2 for the following discussion of evidence of flow within the swamp run. Figure F1 compares the water level in the two run gauges to the water level in two gauges adjacent to and closest to the swamp run (gauges 3 and 5). A period of rainfall between August 9 and September 4 resulted in flow on-site that was visually confirmed. Events A, B and C in Figure F1 are separate rainfall events that caused flooding and flow in the riverine wetland areas, subsequent drainage into the swamp run, and flow downstream thru the downvalley terminus of the project.

The water levels in riverine wetland Gauges 3 and 5 corroborate the flow in that they maintain above-ground water levels for various lengths of time until runoff gradually depletes their excess water into the swamp run. The change in water level shown in Gauge 5, which is nearest the outfall is well correlated to that in Run Gauge 2 which is also nearest the outfall end. Run Gauge 1, which is farthest from the outfall, mirrors the trend measured at Run Gauge 2 indicating

increased above-ground water levels that slowly dissipate over a period of days. Gauge 3, which is in the riverine wetland area at the uppermost reaches of the project also illustrated the same trend of short-lived above ground flooding which indicates flow downstream toward Run Gauge 1.

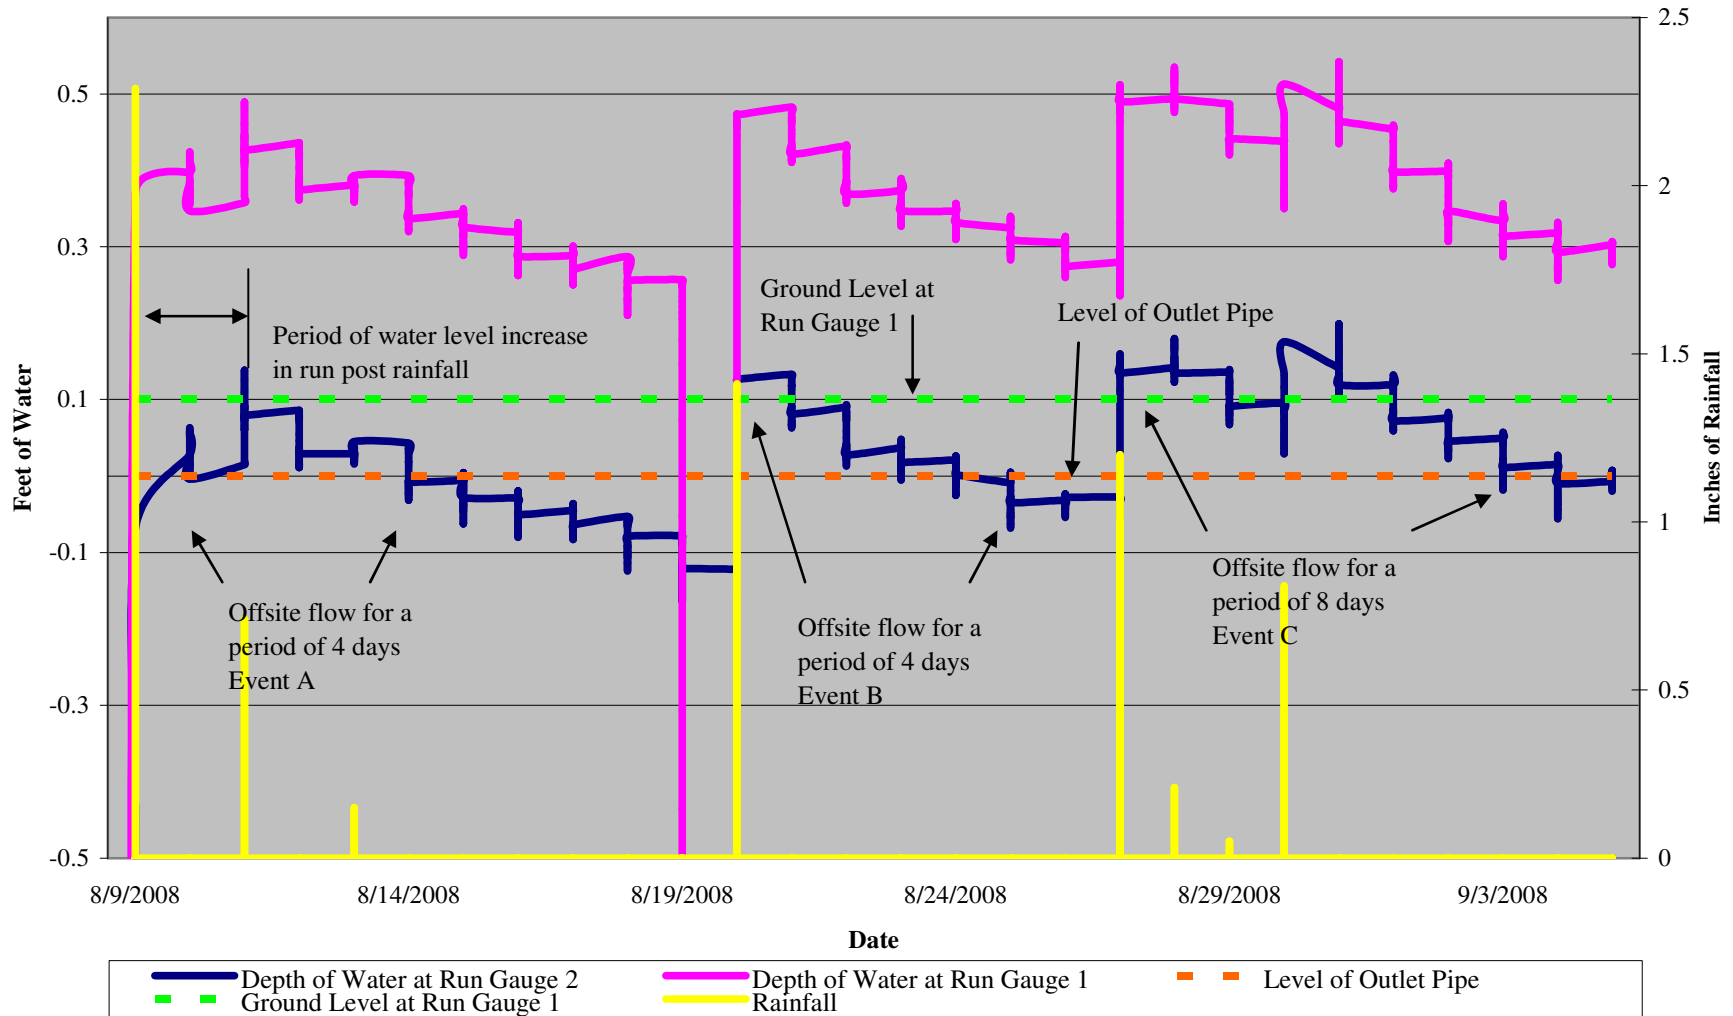
**Figure F2
Run Gauge Levels as Evidence of Flow**

Figure F2 compares the above-ground water level at both of the Swamp Run Gauges to the inlet level of the outfall pipe. Keep in mind when viewing this graph that it illustrates the *absolute* level of water above or below the outfall pipe which includes differences in ground level elevations. Run Gauge 2 can be compared directly to the level of the outfall pipe, which in Figure F2 is “Water Level” 0 feet. Since the ground level at Run Gauge 1 is higher than the outfall pipe, it must be compared to its own ground level, +.1’ (this line is omitted for clarity). The most compelling evidence of flow is found at the beginning of Event A, where water levels at both run gauges continued to rise after rainfall had ceased. Rainfall data collected onsite confirms this. The rise was small and quickly leveled off as would be expected, but it indicates flow from the riverine areas into the swamp run and eventually offsite. This occurs again during Events B and C, but to lesser degrees.

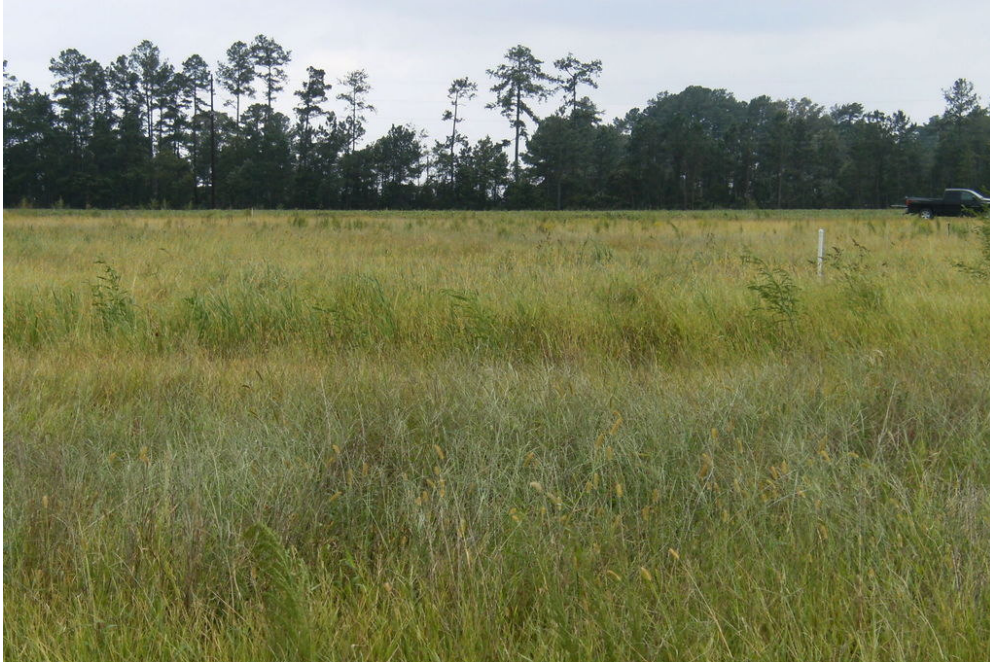
Table 6. Vegetation Problem Areas			
Feature/Issue	Plot	Probable Cause	Photo #
Herbaceous competition/Poor to moderate growth	3, 4, R1, R2	Dense herbaceous cover and/or insufficient rainfall	VPA 1, 2 and 3

VPA 1
Heavy herbaceous cover at plot 3

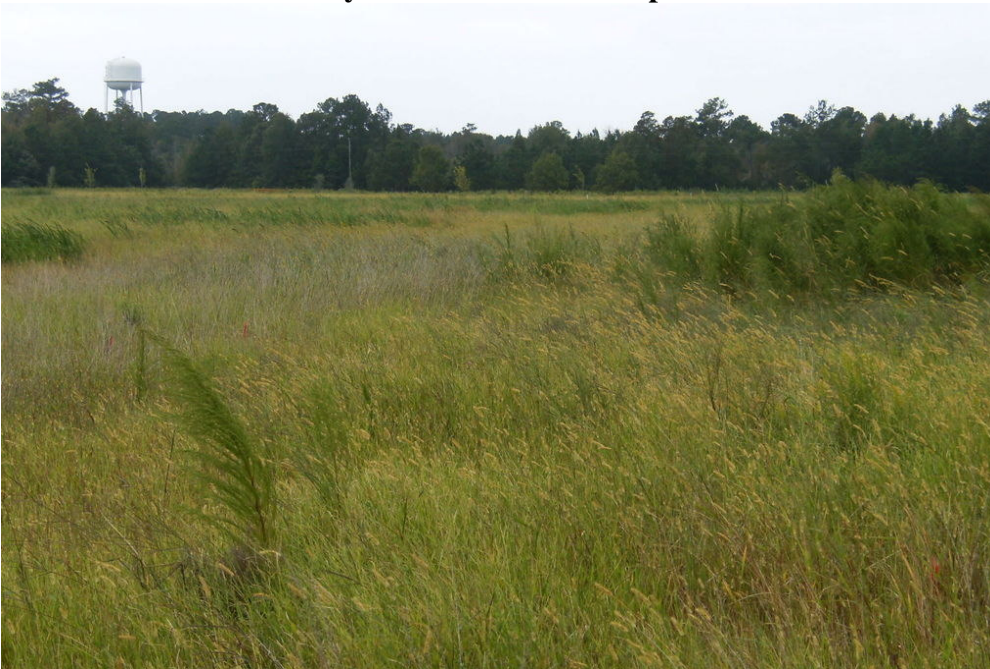
VPA 2
Heavy herbaceous cover at plot 4

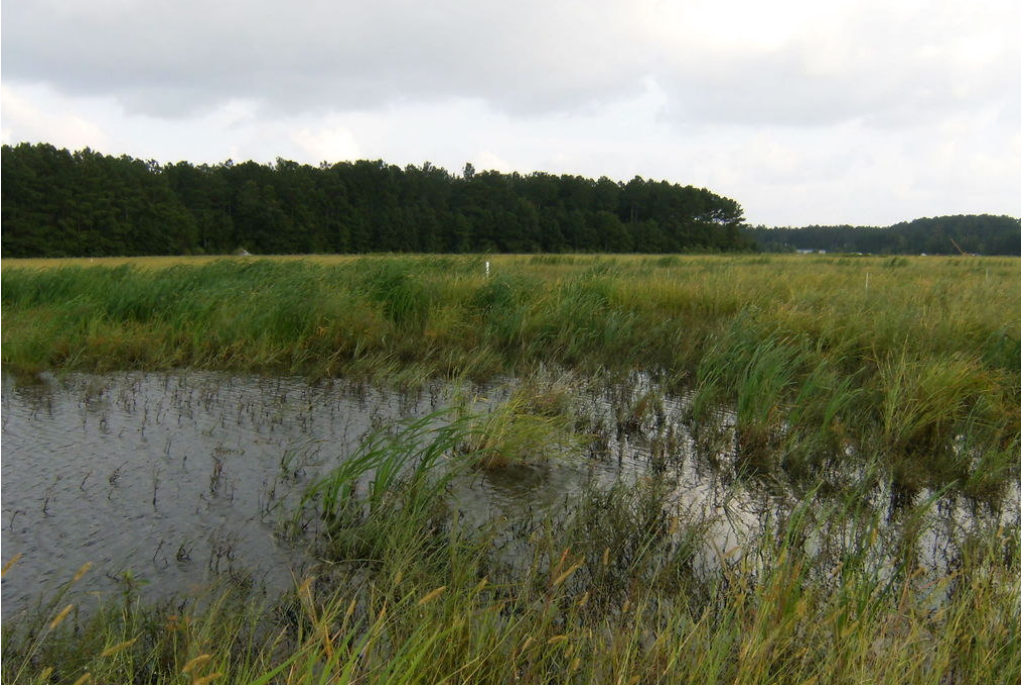
VPA 3
Heavy cattails in swamp run
Plots R1 and R2

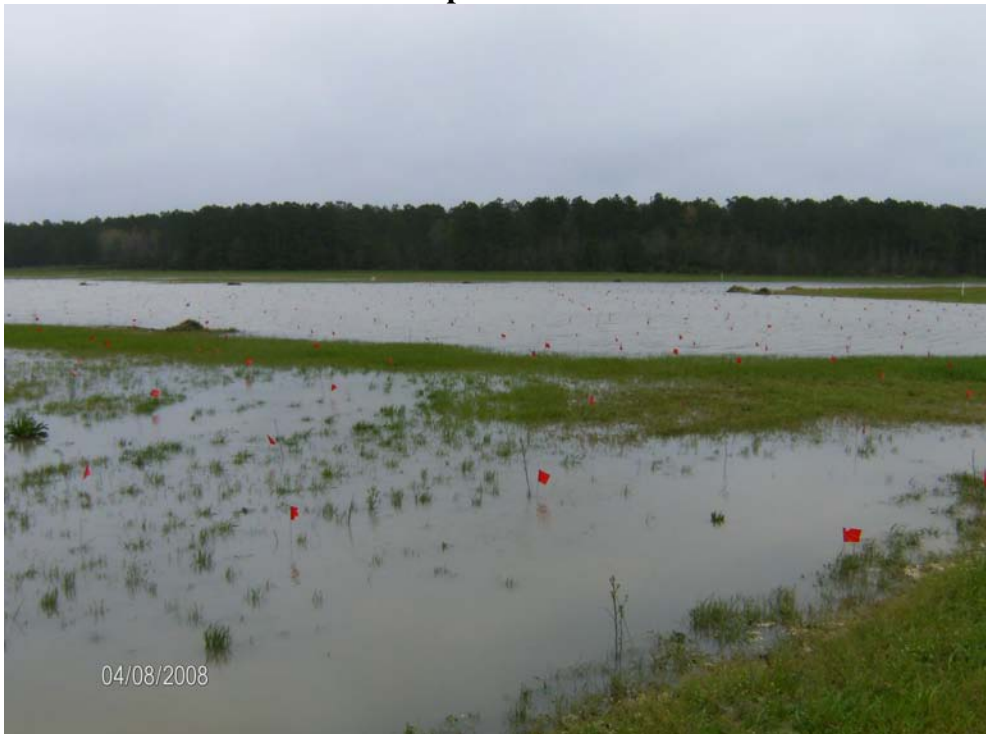
Included in the photos in Appendix A are photos of offsite flow during April, 2008 prior to installation of the run gauges. Also included in the supporting electronic documents is a short video of this same event.

**Early Season Flooding
April 2008**

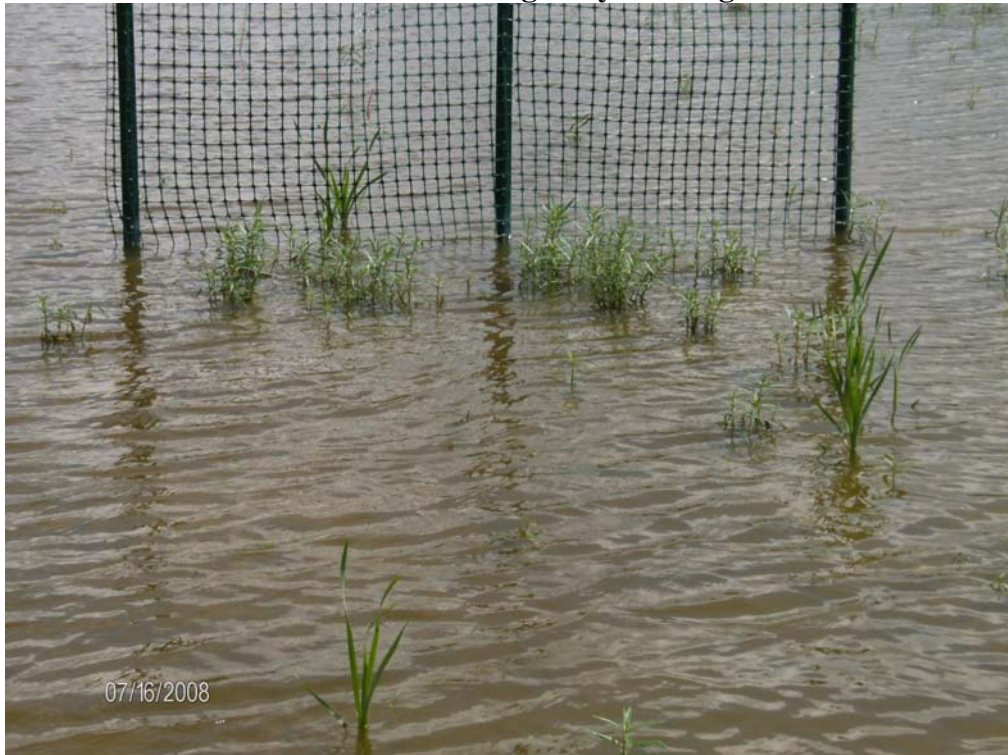
Wrack line during early flooding

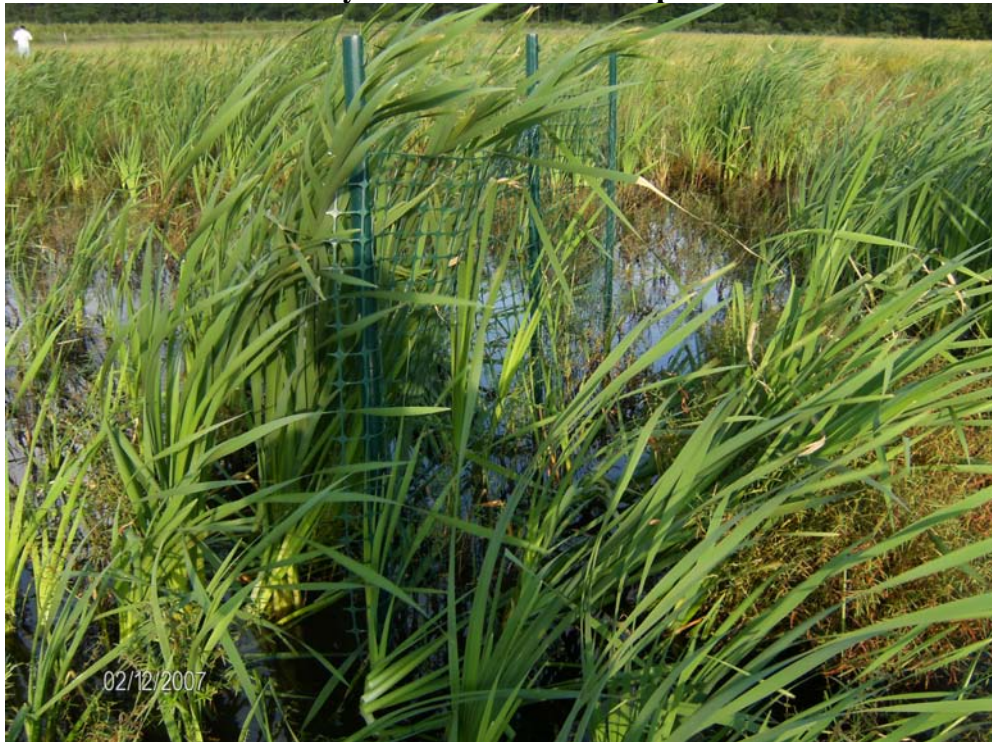
In an attempt to capture further evidence of water movement across the site, three wrack lines were installed at various positions in the swamp run. However, due to very heavy cattail growth, these wrack lines were rendered non-functional. As another means of assessing flow, or more exactly, evidence of channel formation, scouring of sedimentation, three permanent cross sections were installed at different positions along the run and monitored to assess changes in profile across the run. The baseline measurements were taken in the spring of 2008 and the cross sections were remeasured in September of 2008 to see what changes in the swamp run channel might have occurred. Figure F3 compares the baseline data to the remeasurements which indicated no evidence of macro changes in the stream channel.

**Wrack line in September, 2008
Heavy cattail cover in swamp run**

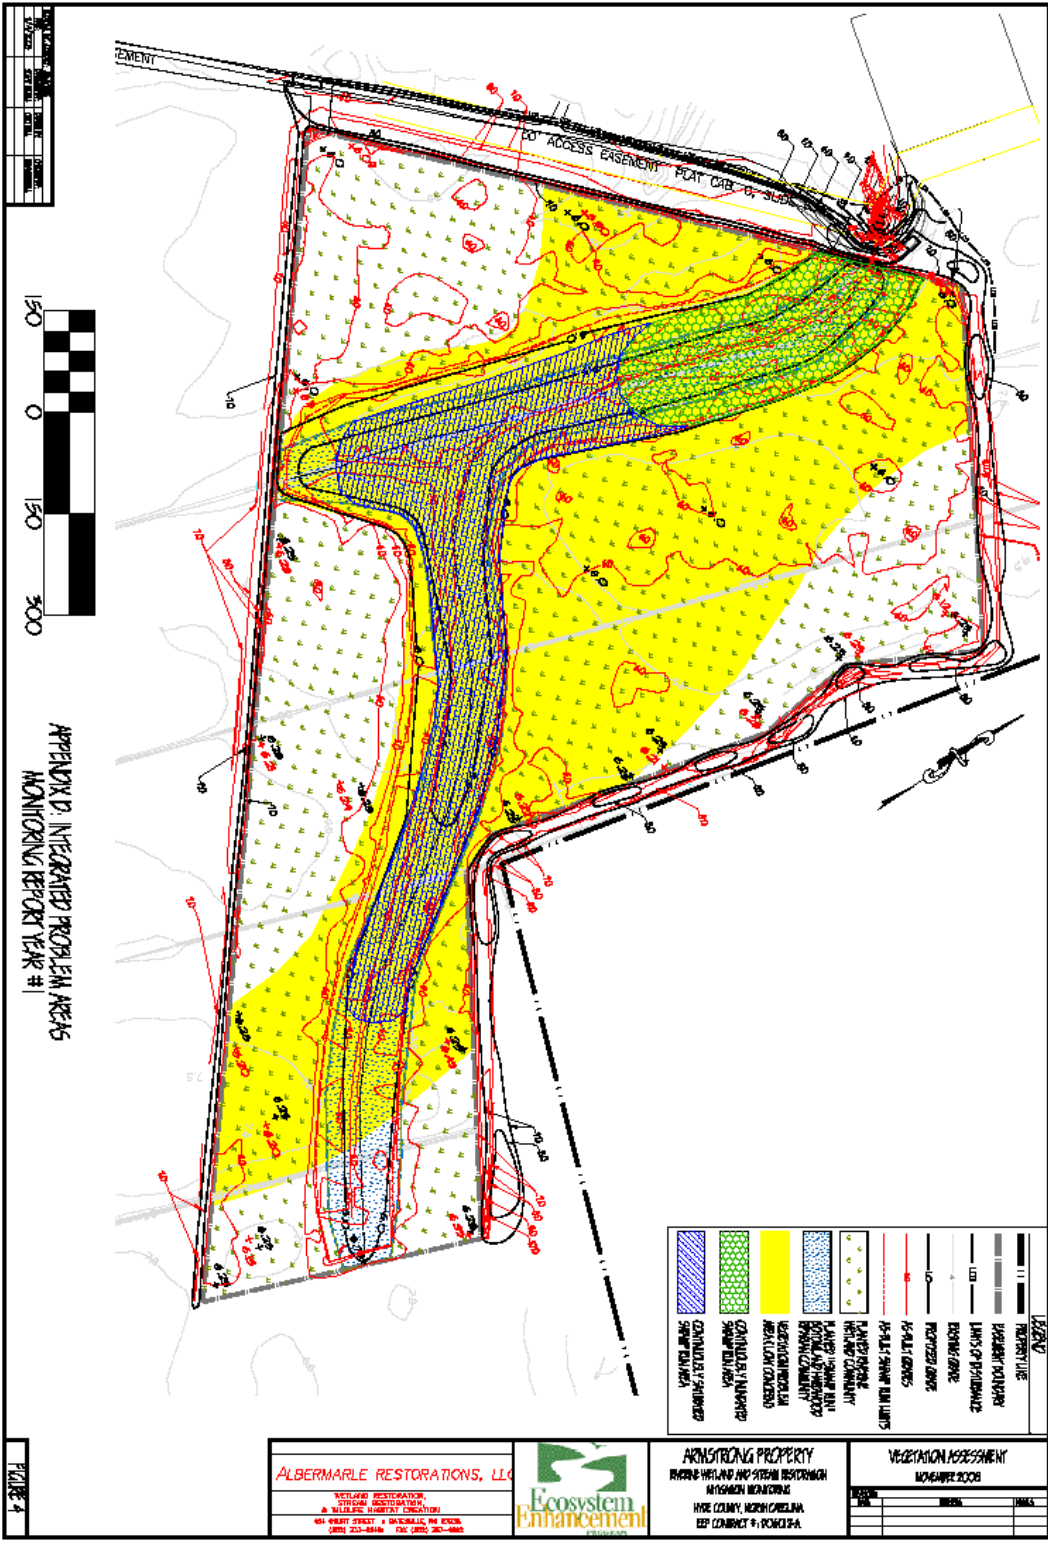
FIGURE 4

Figure 4 in Appendix D illustrates the wetter areas of the site (shaded in yellow) where the herbaceous cover is much heavier. This area supports a complete and dense cover of cattails (*T. latifolia*) and other herbaceous vegetation that is a direct and severe competitor to the trees and shrubs planted there. Seedling survival in these areas was poor (plots 3, 4, R1 and R2). Plots 1 and 2 which are on drier areas had a less dense herbaceous cover which likely allowed better tree survival. Replacement planting followed by site maintenance is scheduled for the winter of 2009. It is anticipated that the vegetative community will continue to be dominated by early successional herbaceous species so maintenance will be designed to control that factor. As the site matures there will be a gradual transition toward woody species as the dominant vegetative community.

Figure 4 in Appendix D provides an overview of the hydrologic problem areas. Much of the riverine wetland zone was flooded for a short length of time early in the growing season as evidenced by the site photos in Appendix A. For most of the summer however, the site suffered droughty conditions. Vegetation problem areas coincided with the very wettest areas of the site where dense herbaceous cover resulted in poor survival of planted seedlings.
