**Armstrong Property Wetland and Stream Mitigation Project
Hyde County, NC**

**2009 Annual Monitoring Report
Year 2**

**NCEEP Project Number D06012-A
Tar-Pamlico River Basin**

Date: January, 2010

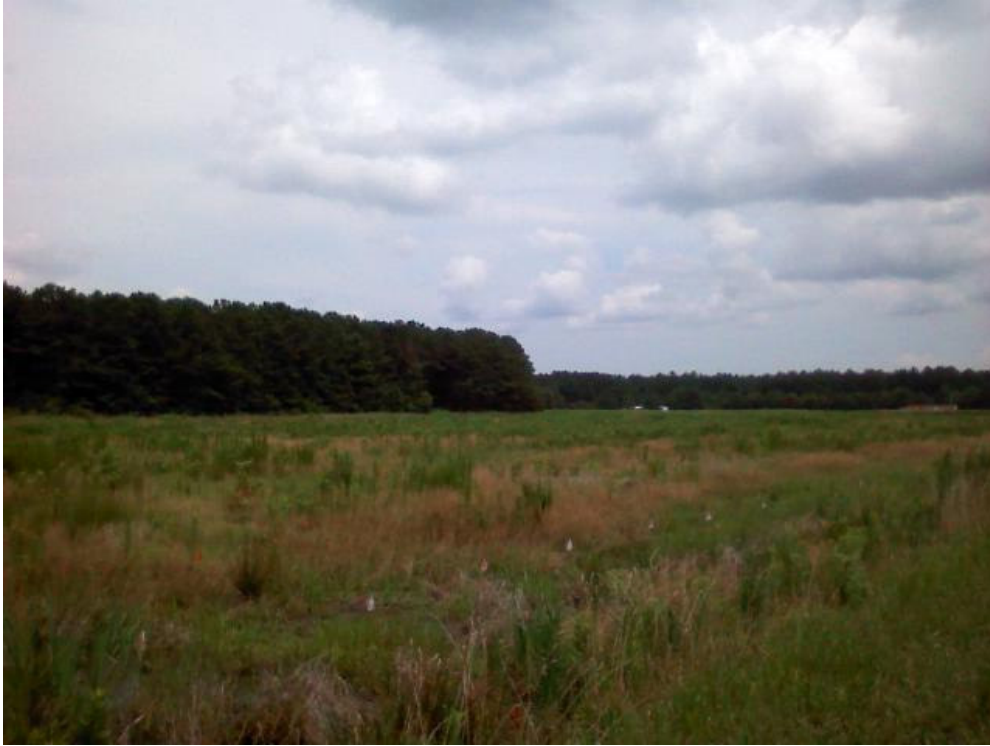
Feature/Issue	Plot	Probable Cause	Photo #
Herbaceous competition	Swamp Run and Vegetation Problem Areas as shown in Appendix D	Dense herbaceous cover	VPA 1 and 2

VPA 1
Heavy herbaceous cover at plot 1 looking east

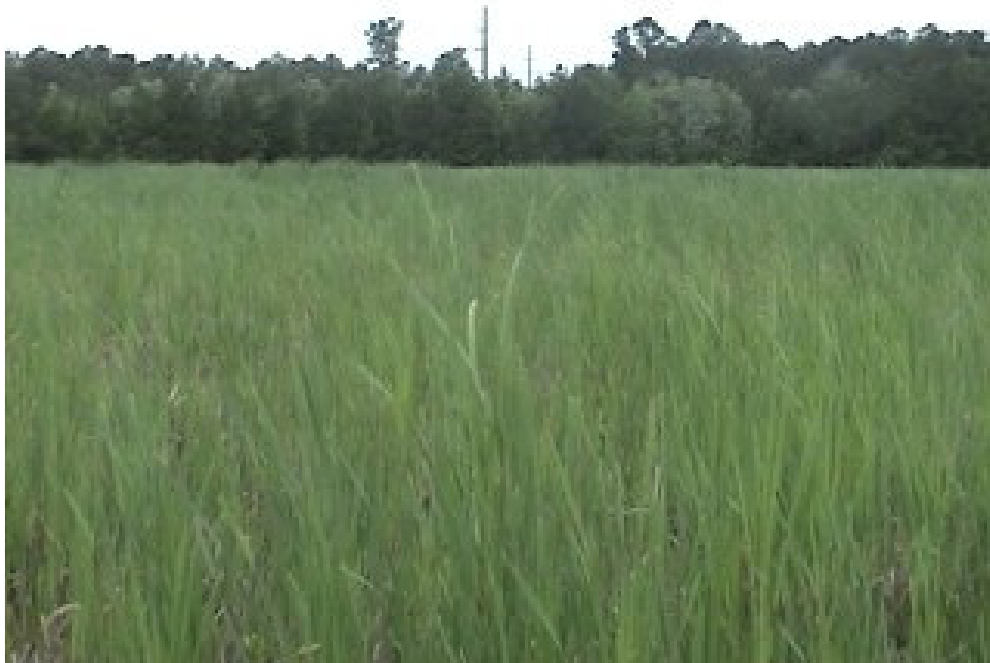
Overall tree survival is good with only a few micro areas where stocking is less than desired. The trees in the lower end of the main run have suffered most since that part of the site is almost continually under several inches of water.

VPA 2
Continued heavy cattail coverage in swamp run

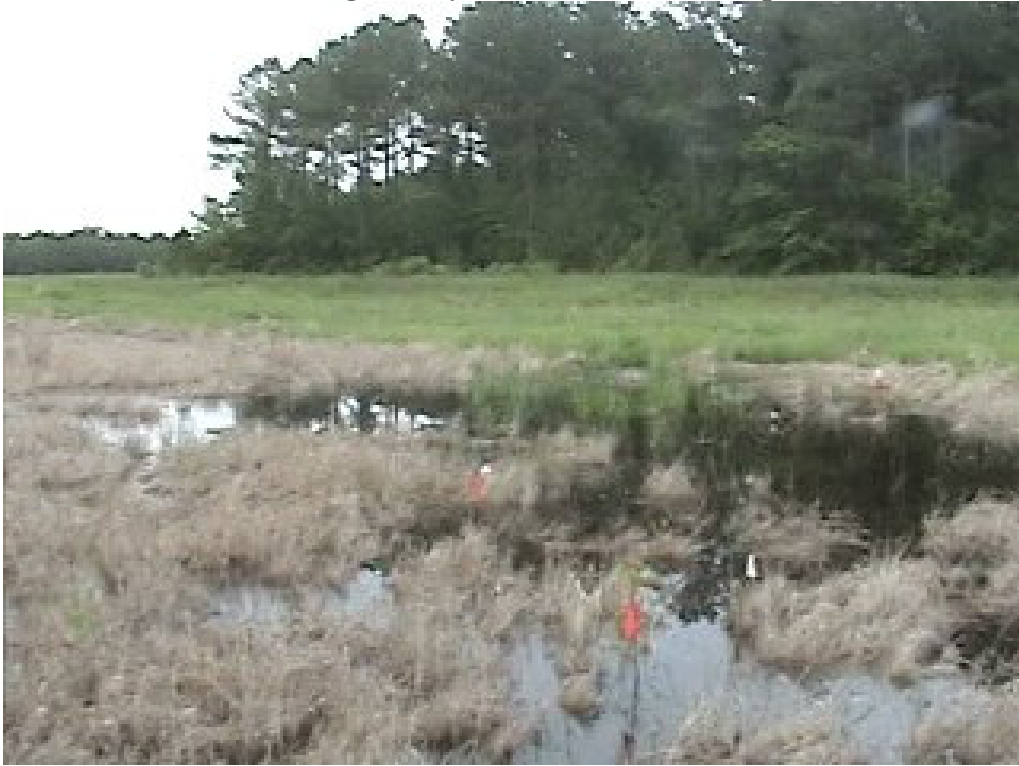
Site flooding in May, eastern side of swamp run

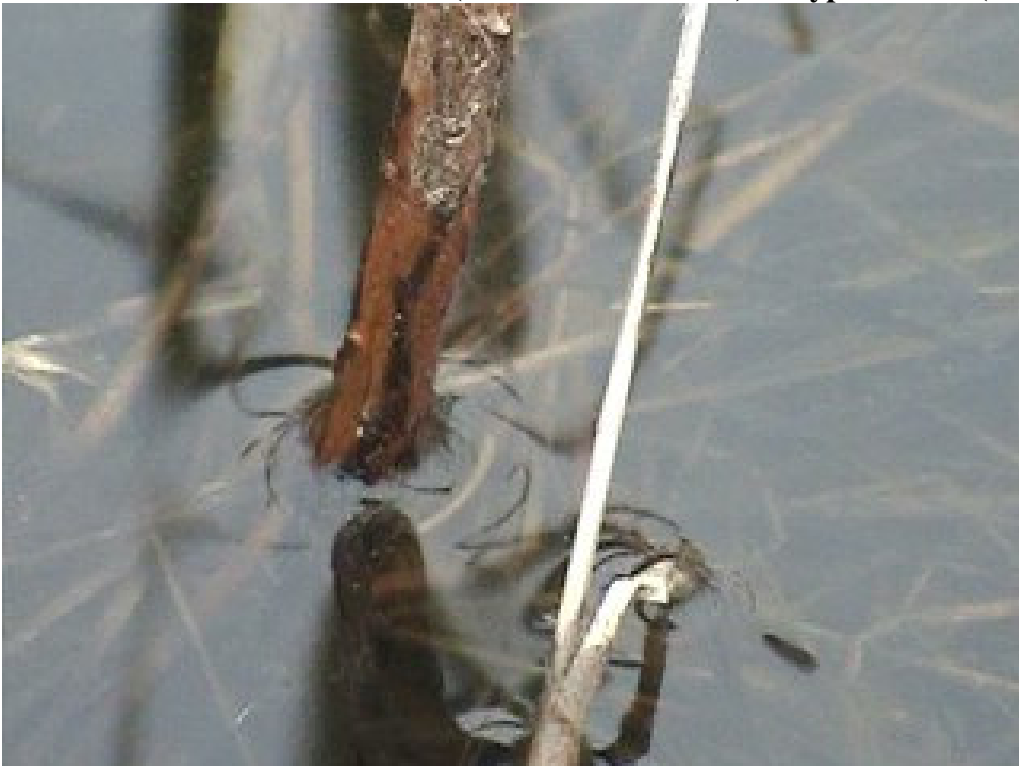
Watermarks show evidence of flow (water level decrease) on cypress stem (May)

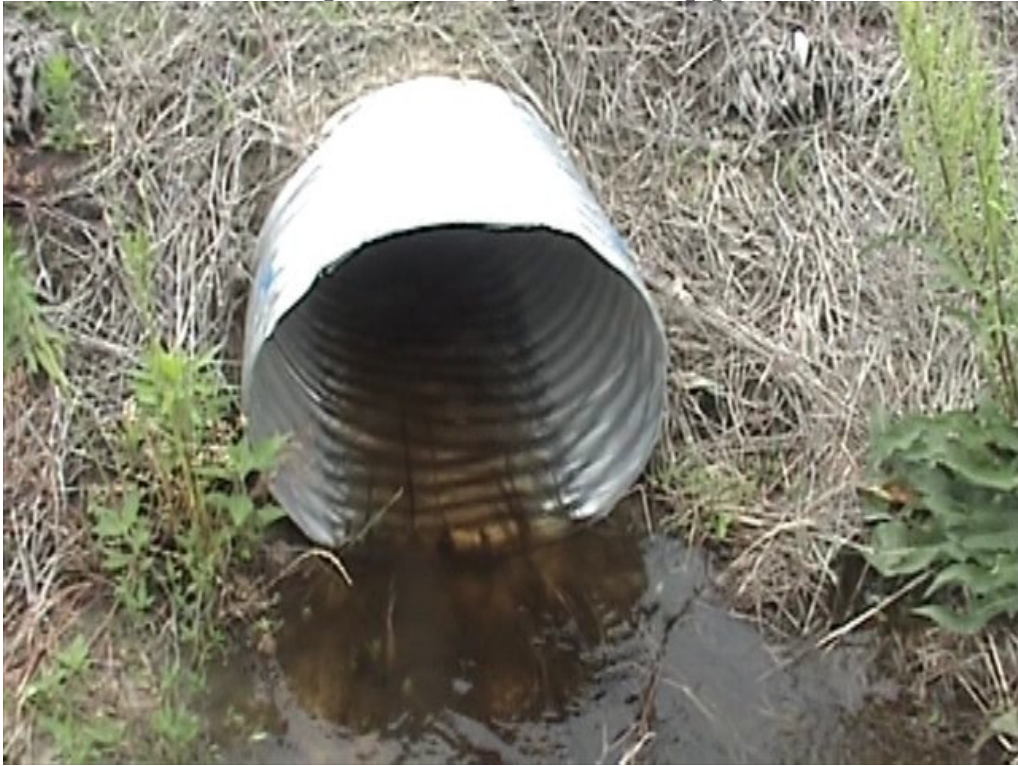
Sediment plume flowing into outfall pipe (May)

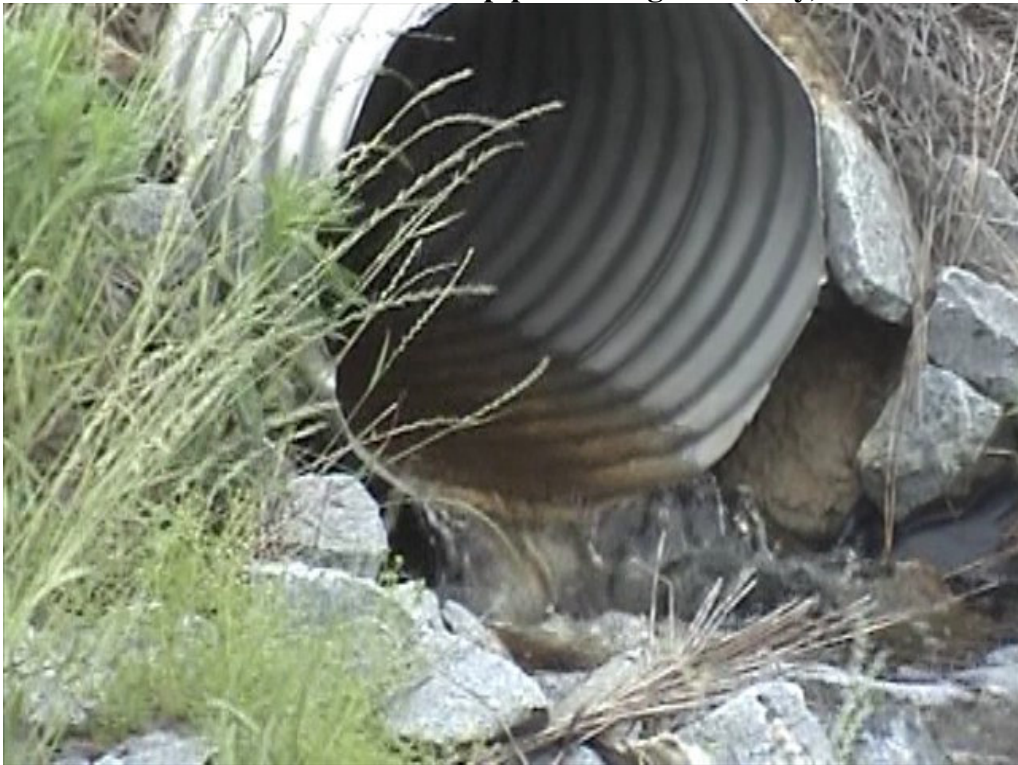
Outflow from outlet pipe showing flow (May)

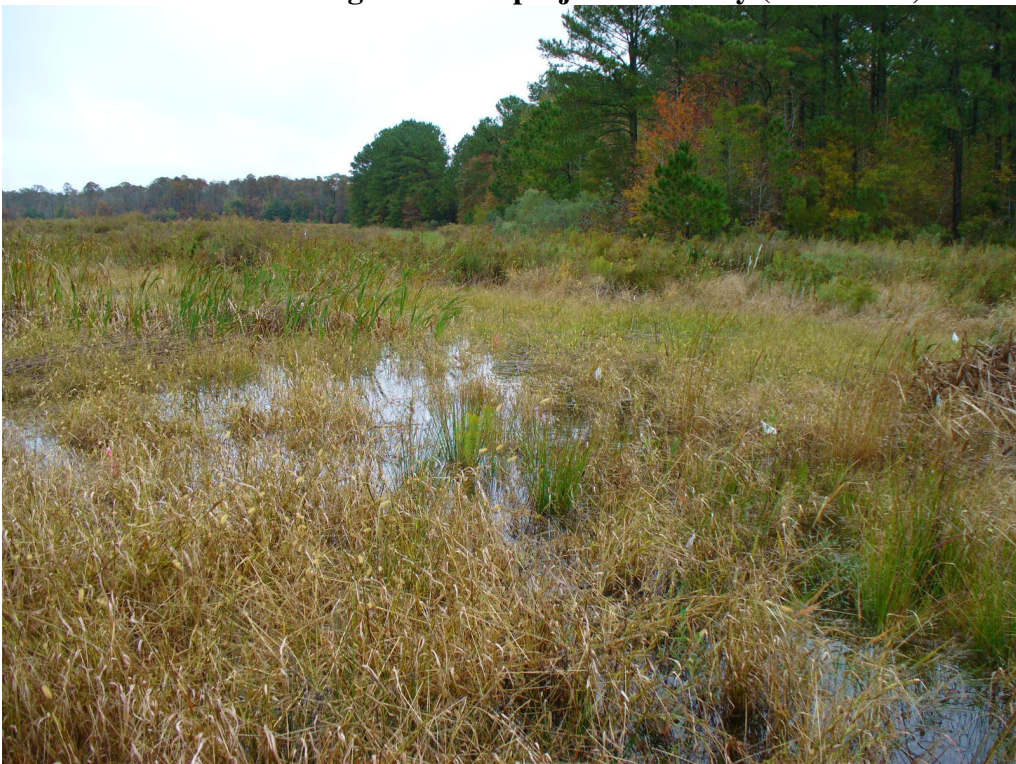
Over bank flooding to eastern project boundary (November)

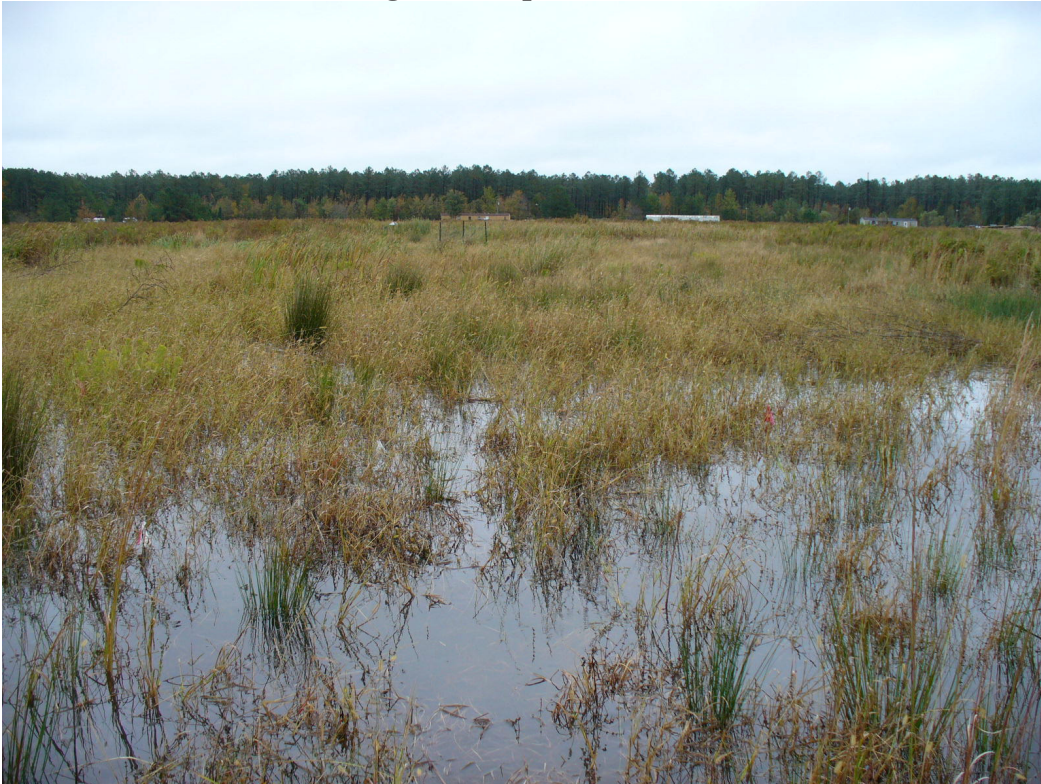
Flooding in swamp run (November)

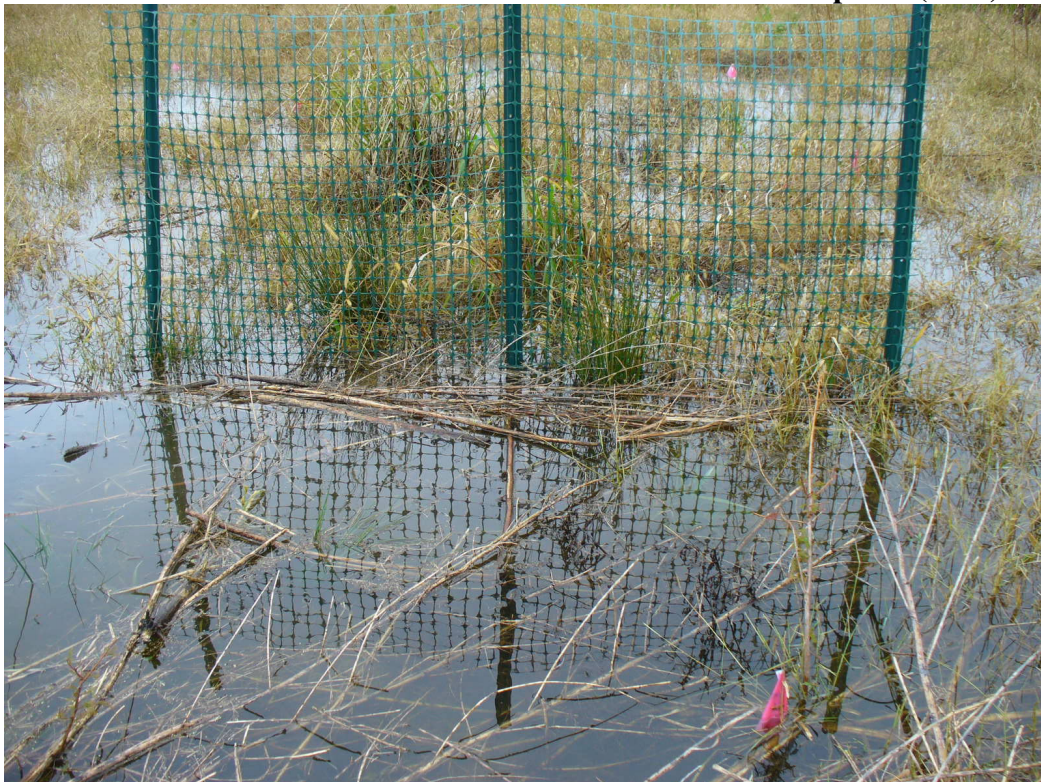
Evidence of debris movement at a wrack line in the swamp run (Nov.)

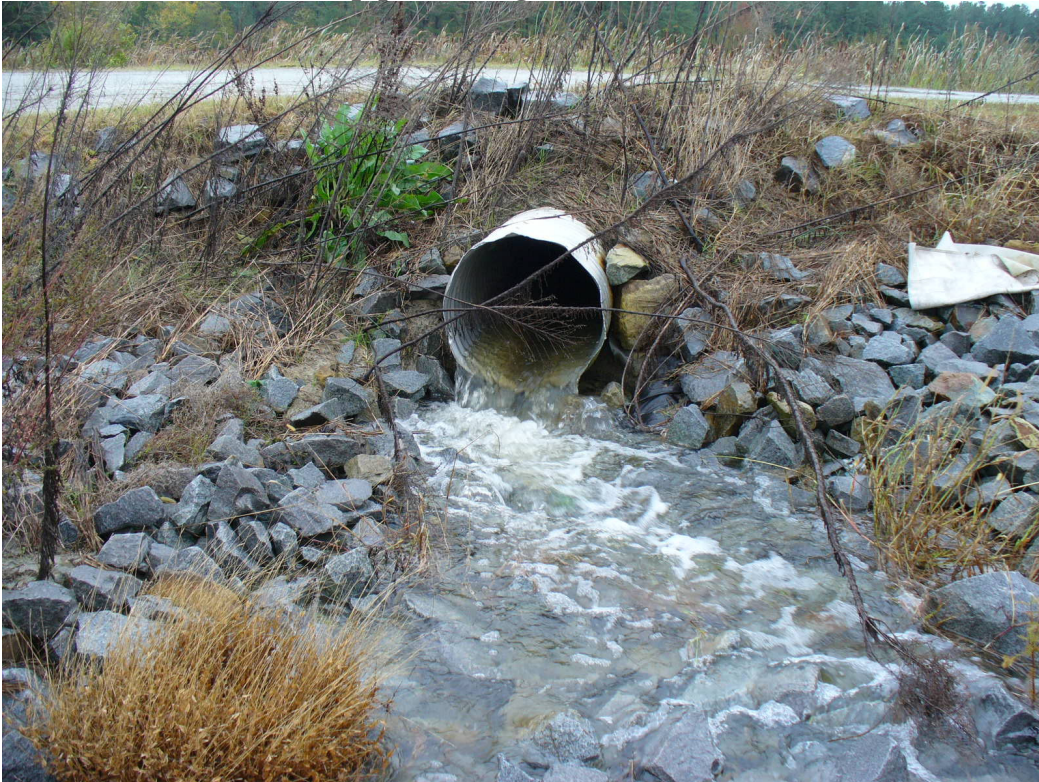
Outflow at pipe showing flow event (November)

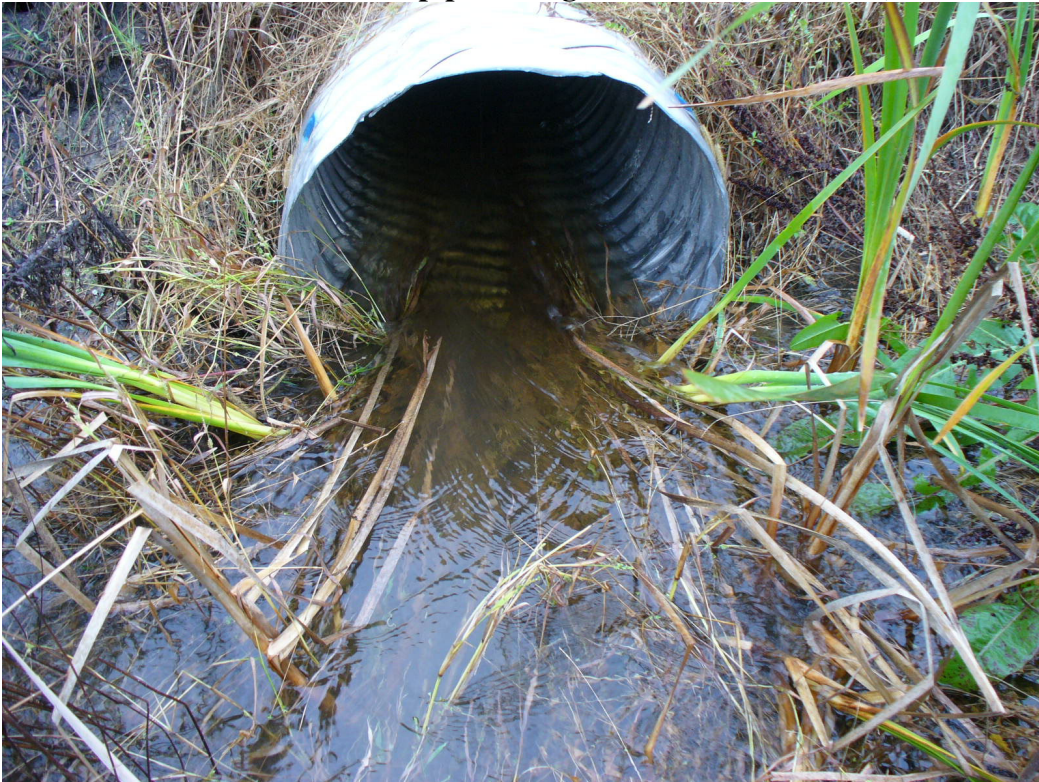
Inflow to the outlet pipe during flow event (November)

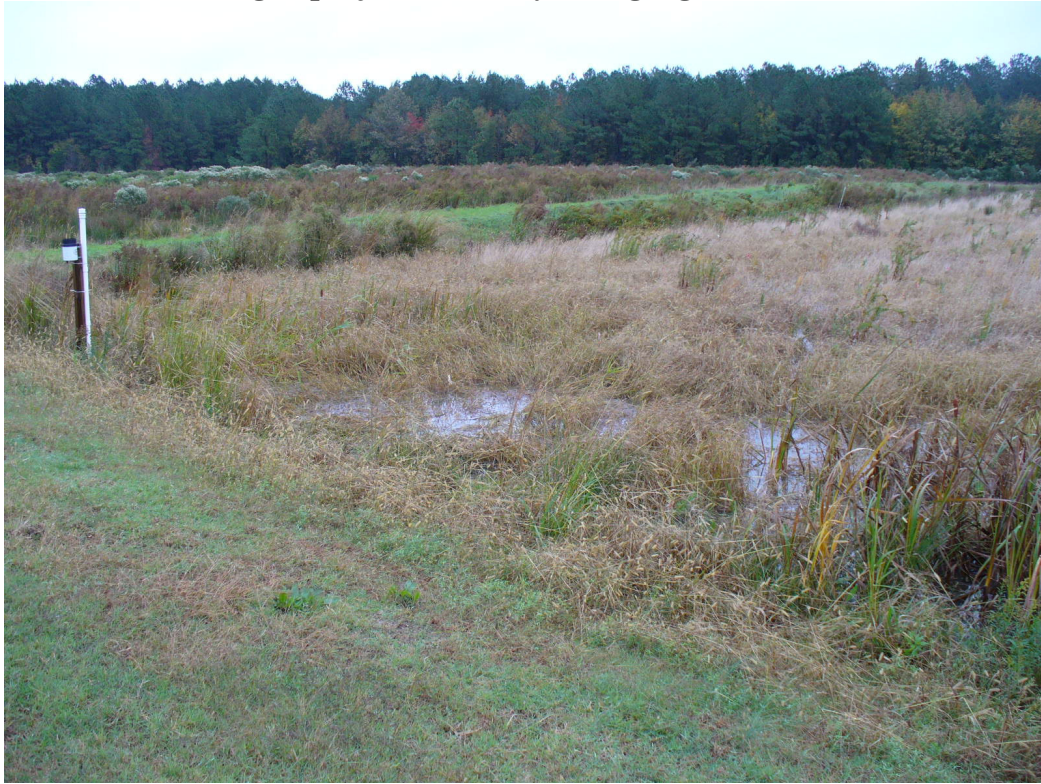
Flooding to project boundary near gauge 5 (November)

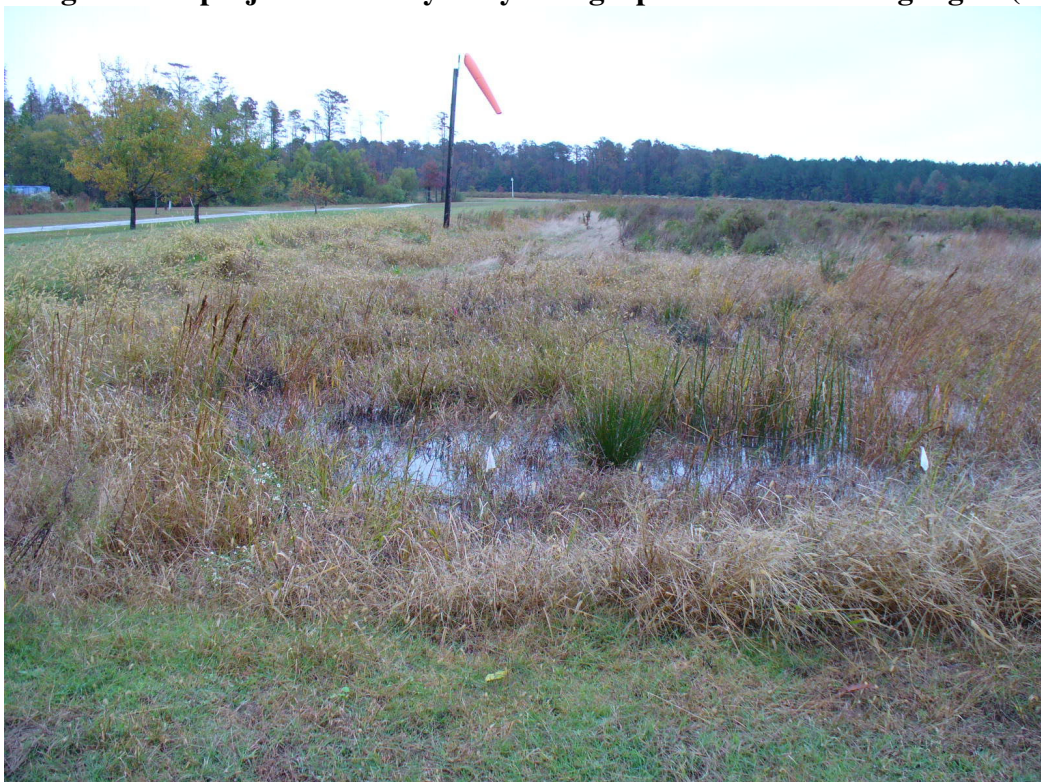
The wetland problem areas as shown in Appendix D are three general spots in the riverine wetlands area that, purely from field observations, seem slightly dryer than the rest of the site. Compared to the problem areas identified in the 2008 report, the site has greatly improved and those areas of concern are becoming minimal. The data for Gauge 2 is incomplete for 2009 due to equipment malfunction, so it is not absolutely certain that particular gauge failed to show hydrologic success early in the year. Gauge 4 showed the shortest successful hydroperiod of 13 days which is the threshold for 5% of the growing season. Both gauges indicate rapid soil recharge rates and sensitivity to rainfall, but springtime rainfall was below normal again in 2009. Gauges 3, 4 and 5 indicated better recharge after rainfall and more pronounced hydrologic periods.

Flooding event to project boundary at hydrologic problem area near gauge 1 (Nov.)

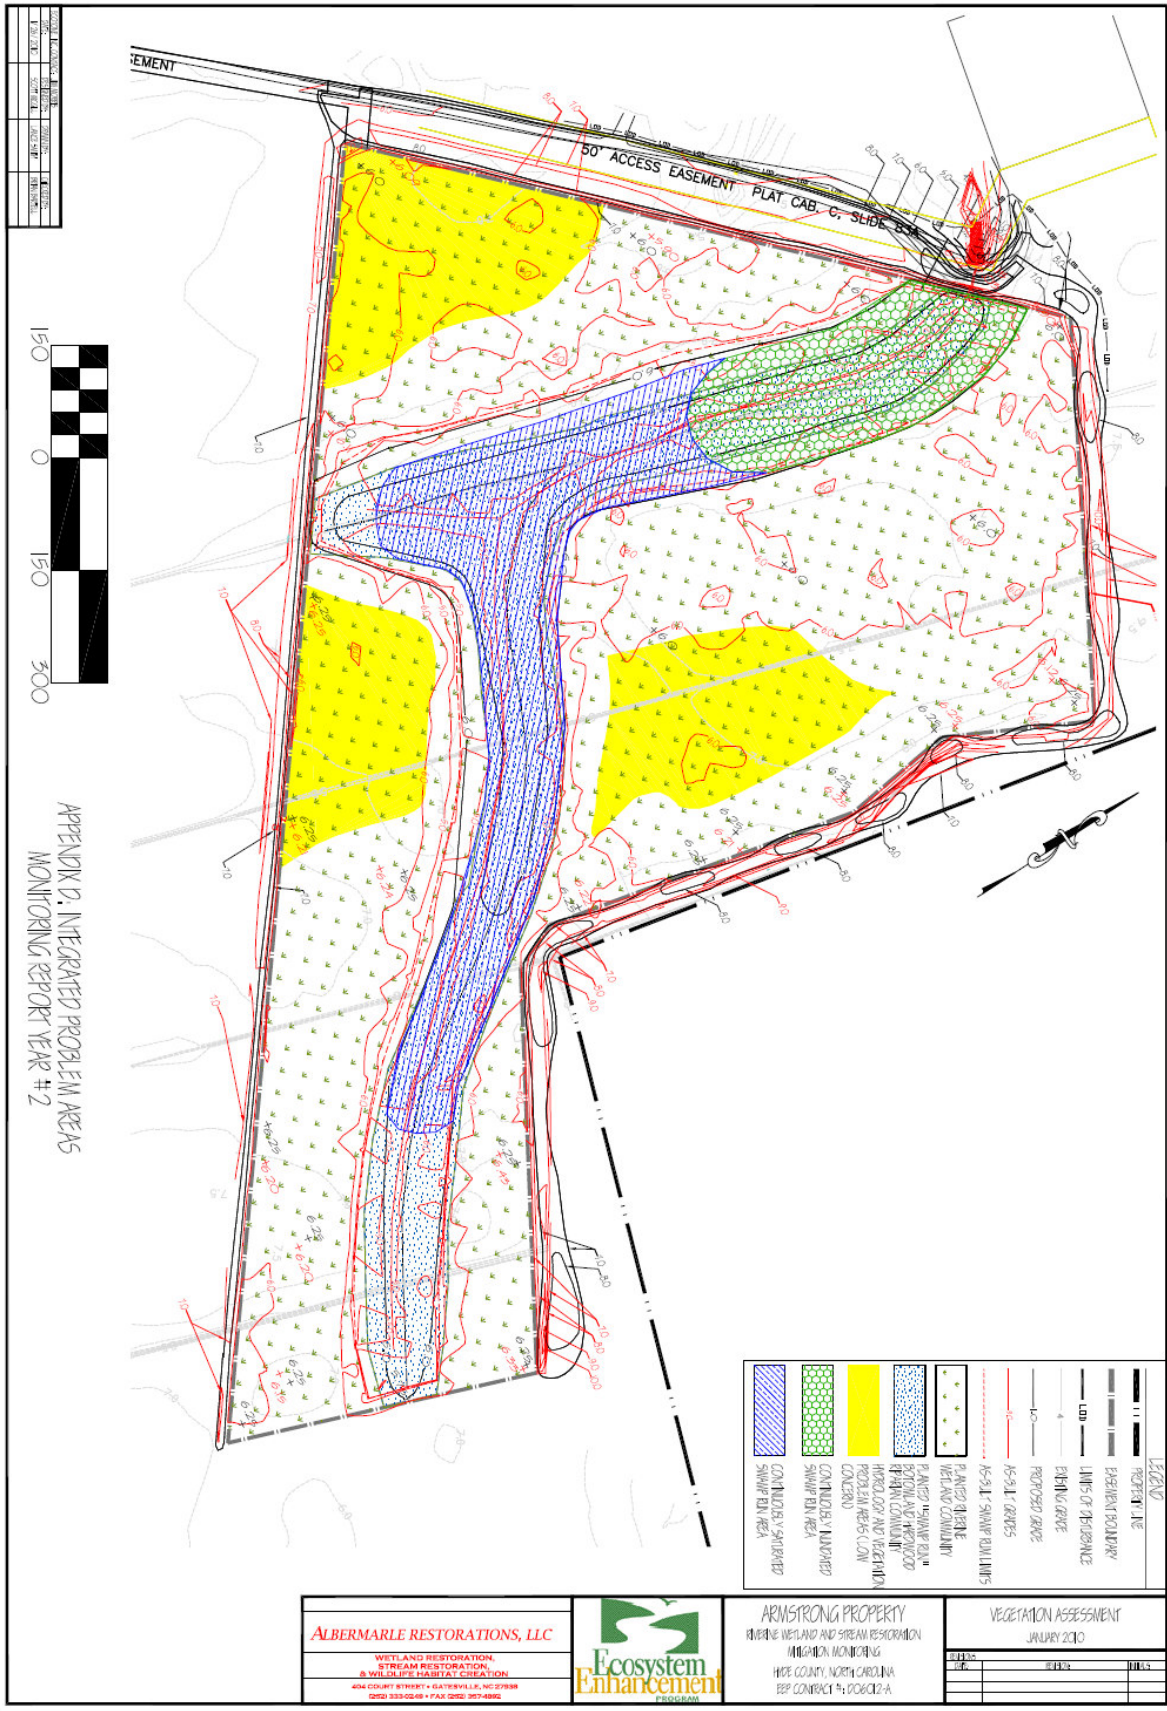
APPENDIX D. INTEGRATED PROBLEM AREAS
MONITORING REPORT YEAR # 2

Figure 4 in Appendix D illustrates the areas of the site (shaded in yellow) where the herbaceous cover is generally heavier and from visual inspections, tree survival is thought to be slightly less than that of the entire tract. Overall stocking levels are adequate but within these three areas, there are micro sites that have very low stocking levels due mainly to heavy herbaceous cover. Small, heavy thickets of coffeeweed (*Sesbania herbacia*) were also thought to be at fault to some extent, but that source of competition is now under control. No further remedial action is deemed necessary.

Figure 4 in Appendix D provides an overview of the areas where hydrology is still developing. Much of the riverine wetland zone was flooded for a short length of time early and late in the growing season as evidenced by the site photos in Appendix A. For most of the summer however, these areas suffered slightly droughty conditions due to continued below-average rainfall.
