**Armstrong Property Wetland and Stream Mitigation Project
Hyde County, NC**

**2010 Annual Monitoring Report
Year 3**

**NCEEP Project Number D06012-A
Tar-Pamlico River Basin**

Date: November, 2010

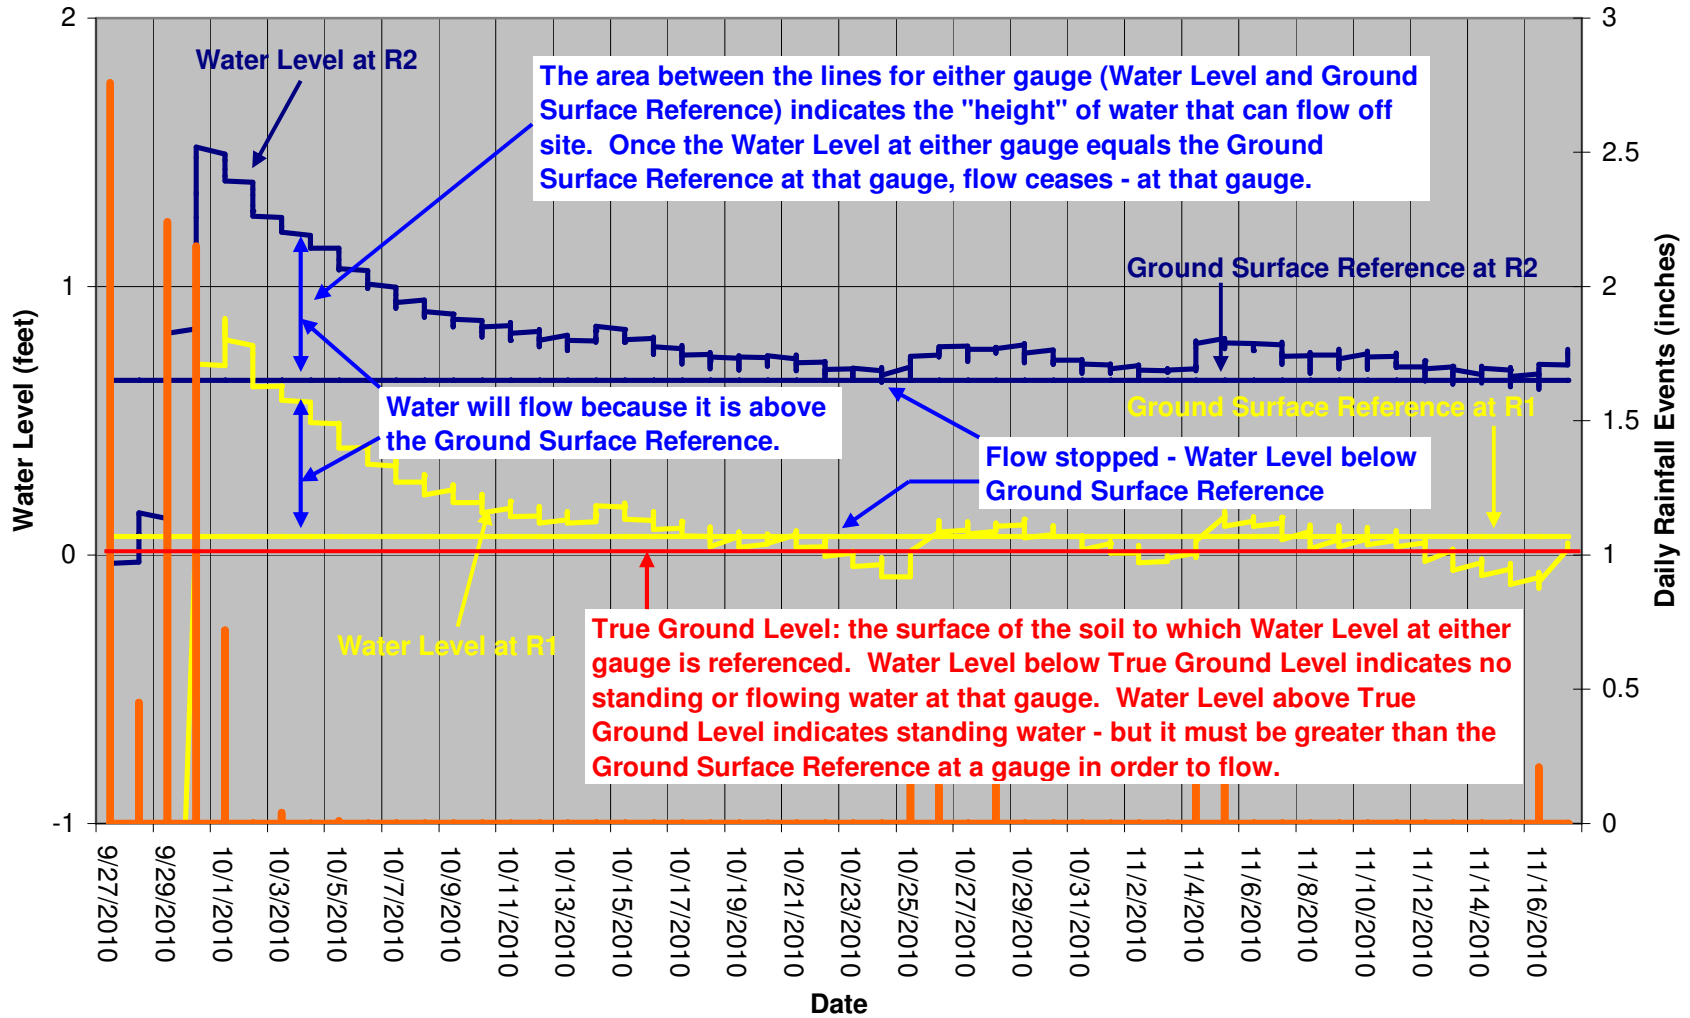
Figure F1.
Armstrong Run Monitoring Gauges 1 and 2 (R1 and R2)
Correlated to Video Evidence of Flow Across Site

Refer to Figure F1 for the following discussion of evidence of flow within the swamp runs. Figure F1 is a composite chart showing the water level at both run gauges during a period when flow in the swamp runs was visually confirmed and recorded on video. From 9/28/2010 through 10/1/2010 the site received 8.32" of rain causing the water levels to rise rapidly and gradually drain through and off the site. The ground level at gauge R1 is .07 feet above the inlet level of the outfall pipe at the downstream end of the project. The ground level at gauge R2 is .65 feet *below* the inlet level of the pipe. Gauge R2 is situated in a depression which means the area immediately surrounding gauge R2 will never completely drain offsite. These relative ground surface levels are indicated in Figure 1 as Ground Surface References.

Figure F1 illustrates the "height" of water at gauges R1 and R2 that can flow offsite. Gauge R2 is shown in blue. The difference between the Water Level at R2 and the Ground Surface Reference at R2 at any point between those lines represents the level of water that can flow offsite. Once the Water Level falls to or below the Ground Surface Reference, flow can no longer occur because it will have reached equilibrium with the level of the outlet pipe, even though the water level may still be above the True Ground Level (shown in red). The same is not quite true for gauge R1. Its Ground Surface Reference is .07 feet above the outlet pipe, but flow at this gauge can continue until the water level falls to the True Ground Level because it will be collected in the area around gauge R2.

The video documentation included with this report is from the remnants of a tropical storm at the end of September, 2010. Water level measurements over a three-day period after the rain event ended not only confirm the flow pattern described above but also illustrate how the site is capturing run-off from the field above as water levels in the project continued to rise for a day

after rain had ended. The water level at gauge R1 eventually dropped as water flowed through the site, but for two days after the rain ended, the level at gauge R2 increased as the water from the fields above the project drained into the site.

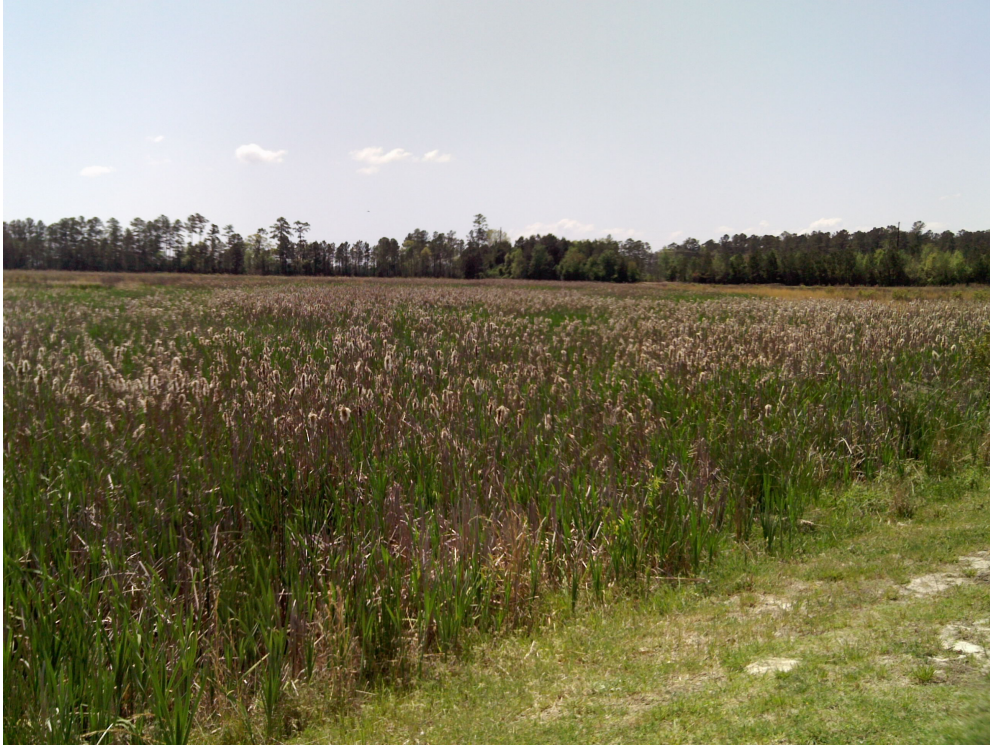
VPA 1
Continued heavy cattail cover in swamp run

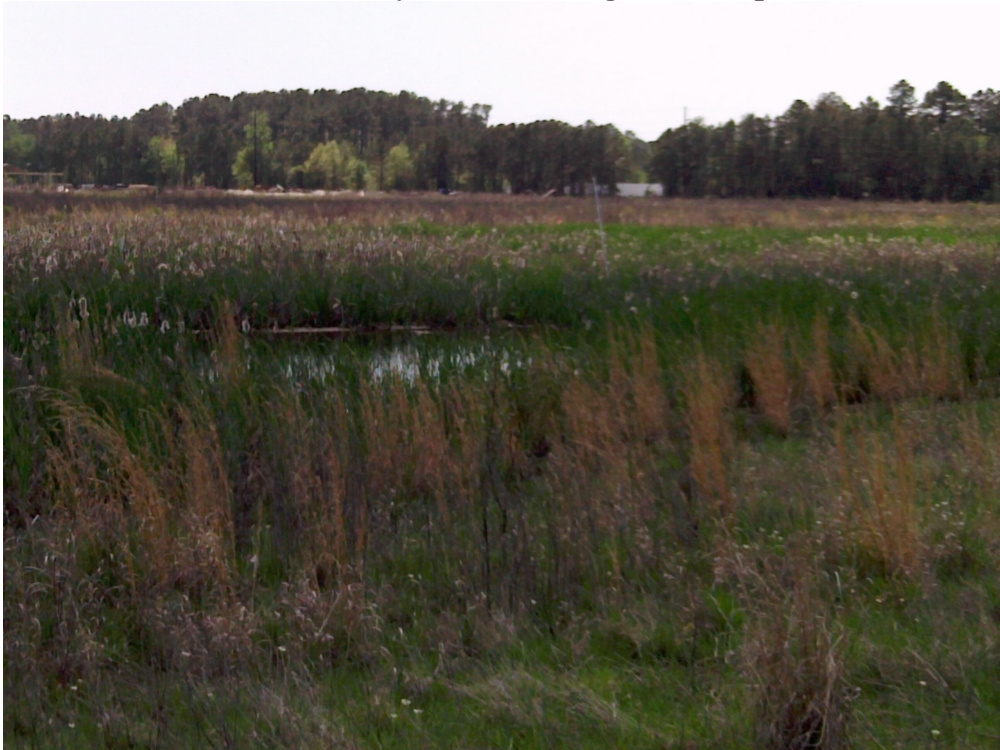
VPA 2
Continued heavy cattail coverage in swamp run

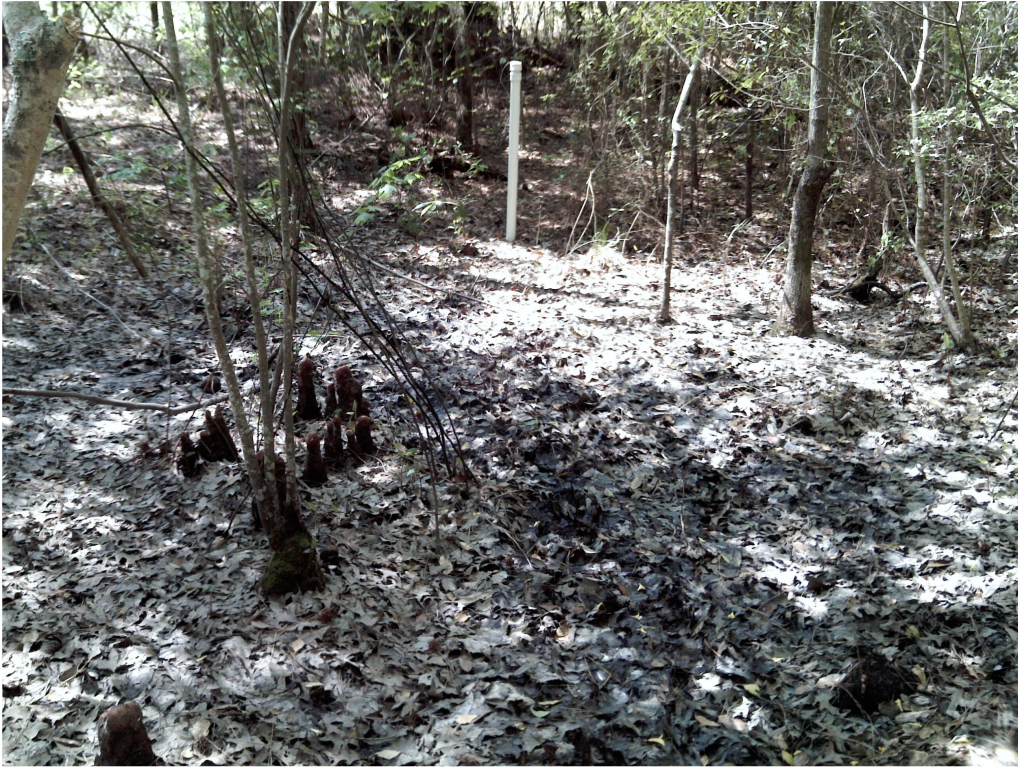
(Photo 3) Dry reference area in April 2010

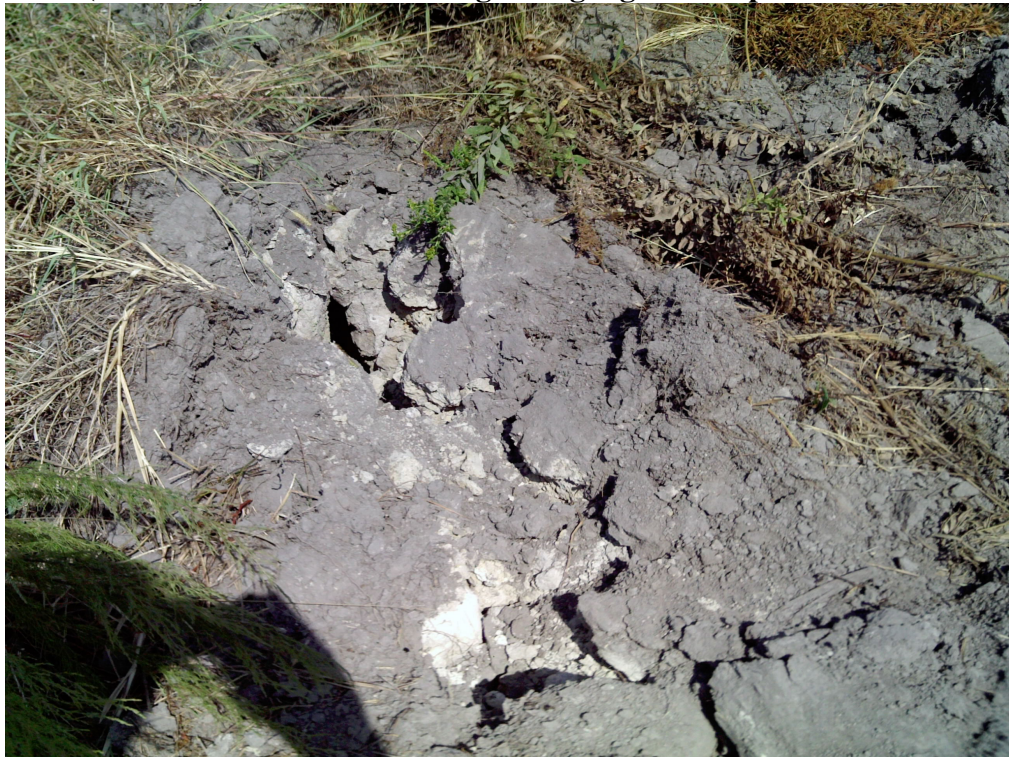
cover of herbaceous material. The soil in parts of the project was suspected to be moderately to severely compacted which, along with heavy herbaceous cover and droughty conditions during the peak of the growing season probably contributed to the mortality seen around Plot 4.

(Photo 4) Effects of subsoiling near gauge 2 in September 2010

A bulldozer with ripper shanks set approximately 30” apart and 24” deep did an excellent job of fracturing and lifting the clay layers. The heavy rainfall in late September helped resettle the soil. Replanting of the three areas will be done in November 2010 with species from the original planting schedule.

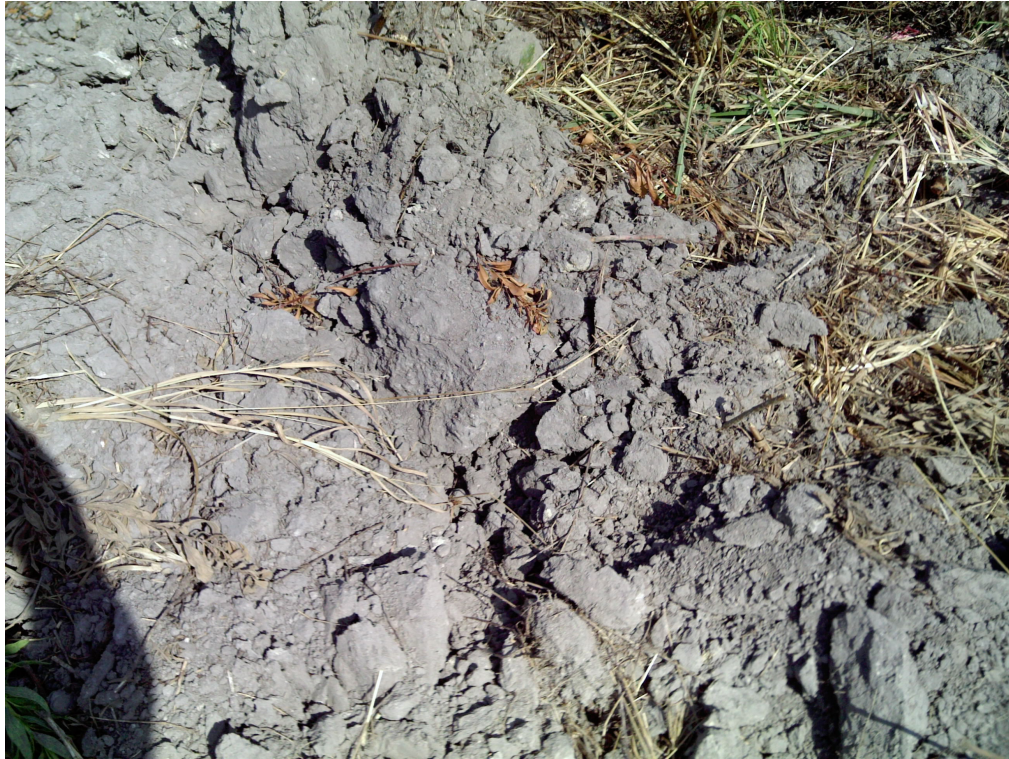
(Photo 5) Clay fracturing after subsoiling in Sept. 2010

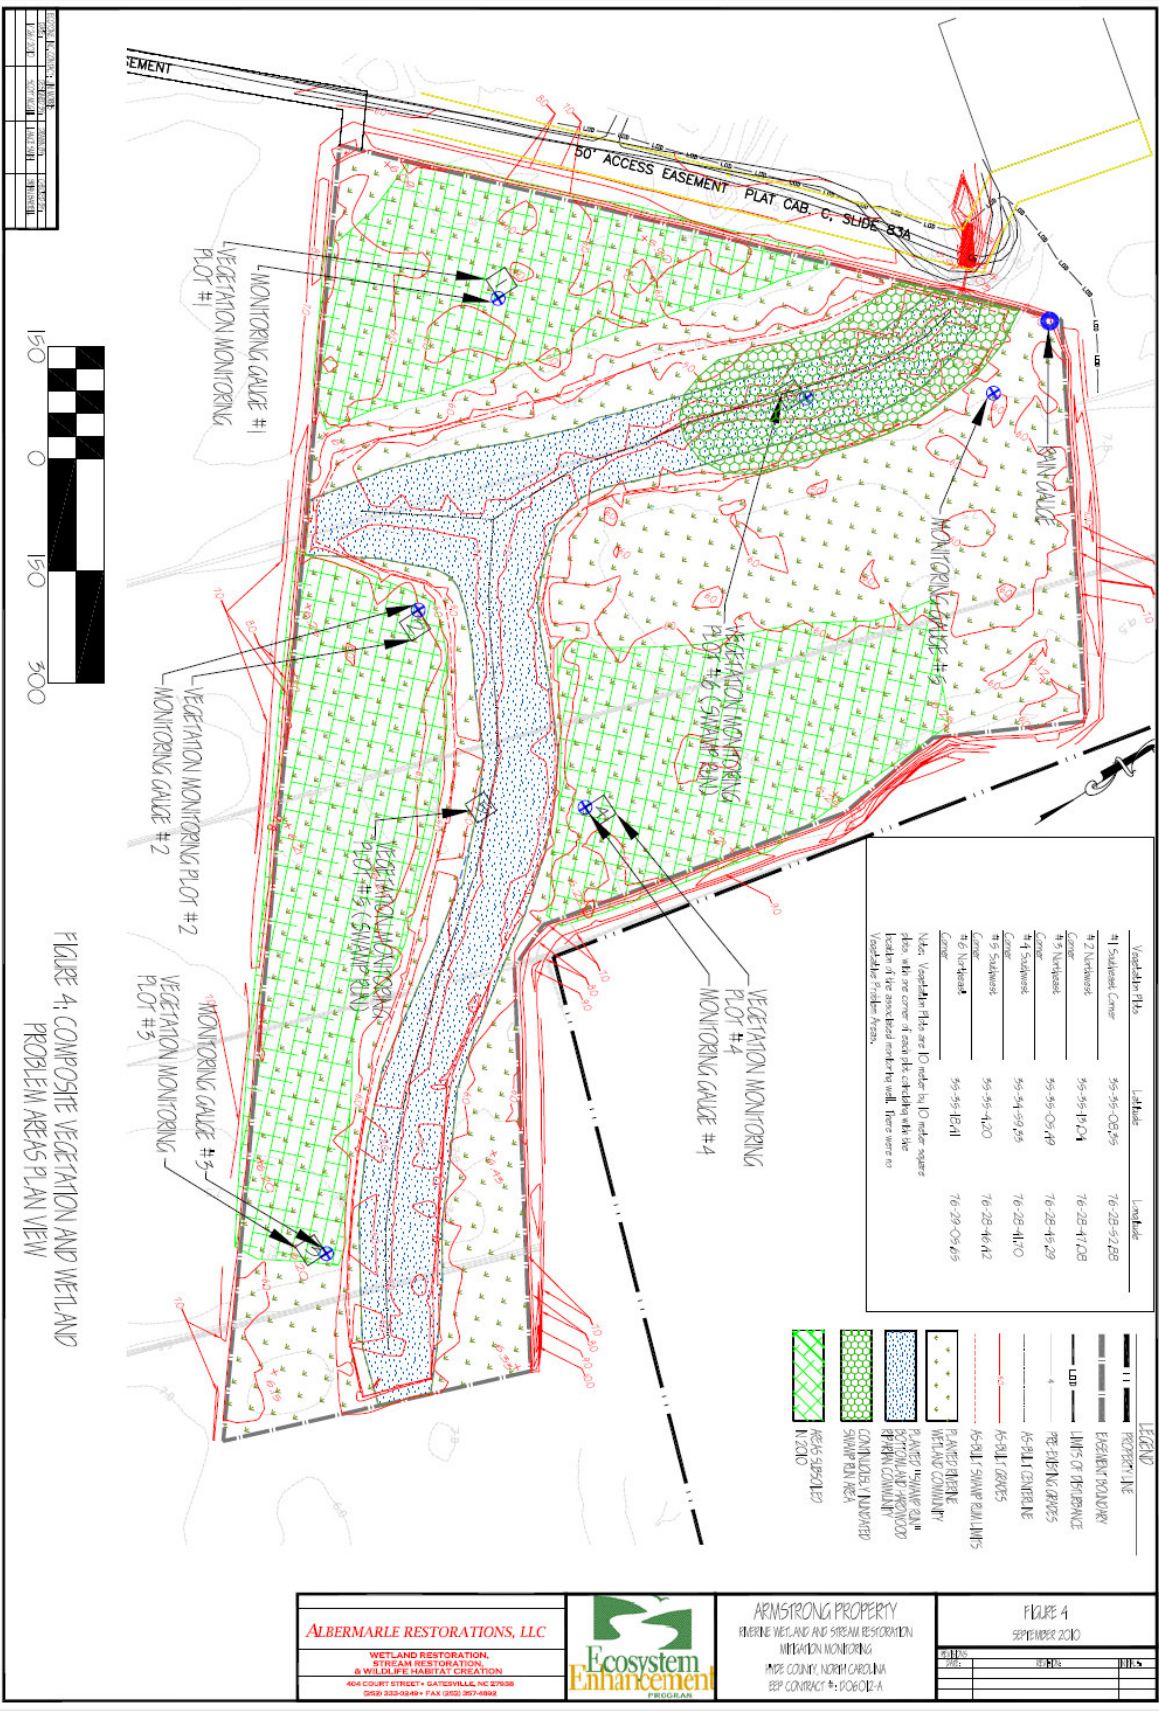
FIGURE 4: COMPOSITE VEGETATION AND WETLAND PROBLEM AREAS PLAN VIEW

Figure 4 in Appendix D provides an overview of the areas where hydrology was deemed poor enough to warrant corrective action. Much of the riverine wetland zone was flooded for a short length of time early and late in the growing season as evidenced by the site photos in Appendix A. For most of the summer however, the site suffered droughty conditions due to continued below-average rainfall.
