**Armstrong Property Wetland and Stream Mitigation Project  
Hyde County, NC**

**2011 Annual Monitoring Report  
Year 4**

**NCEEP Project Number D06012-A  
Tar-Pamlico River Basin**

Date: December, 2011

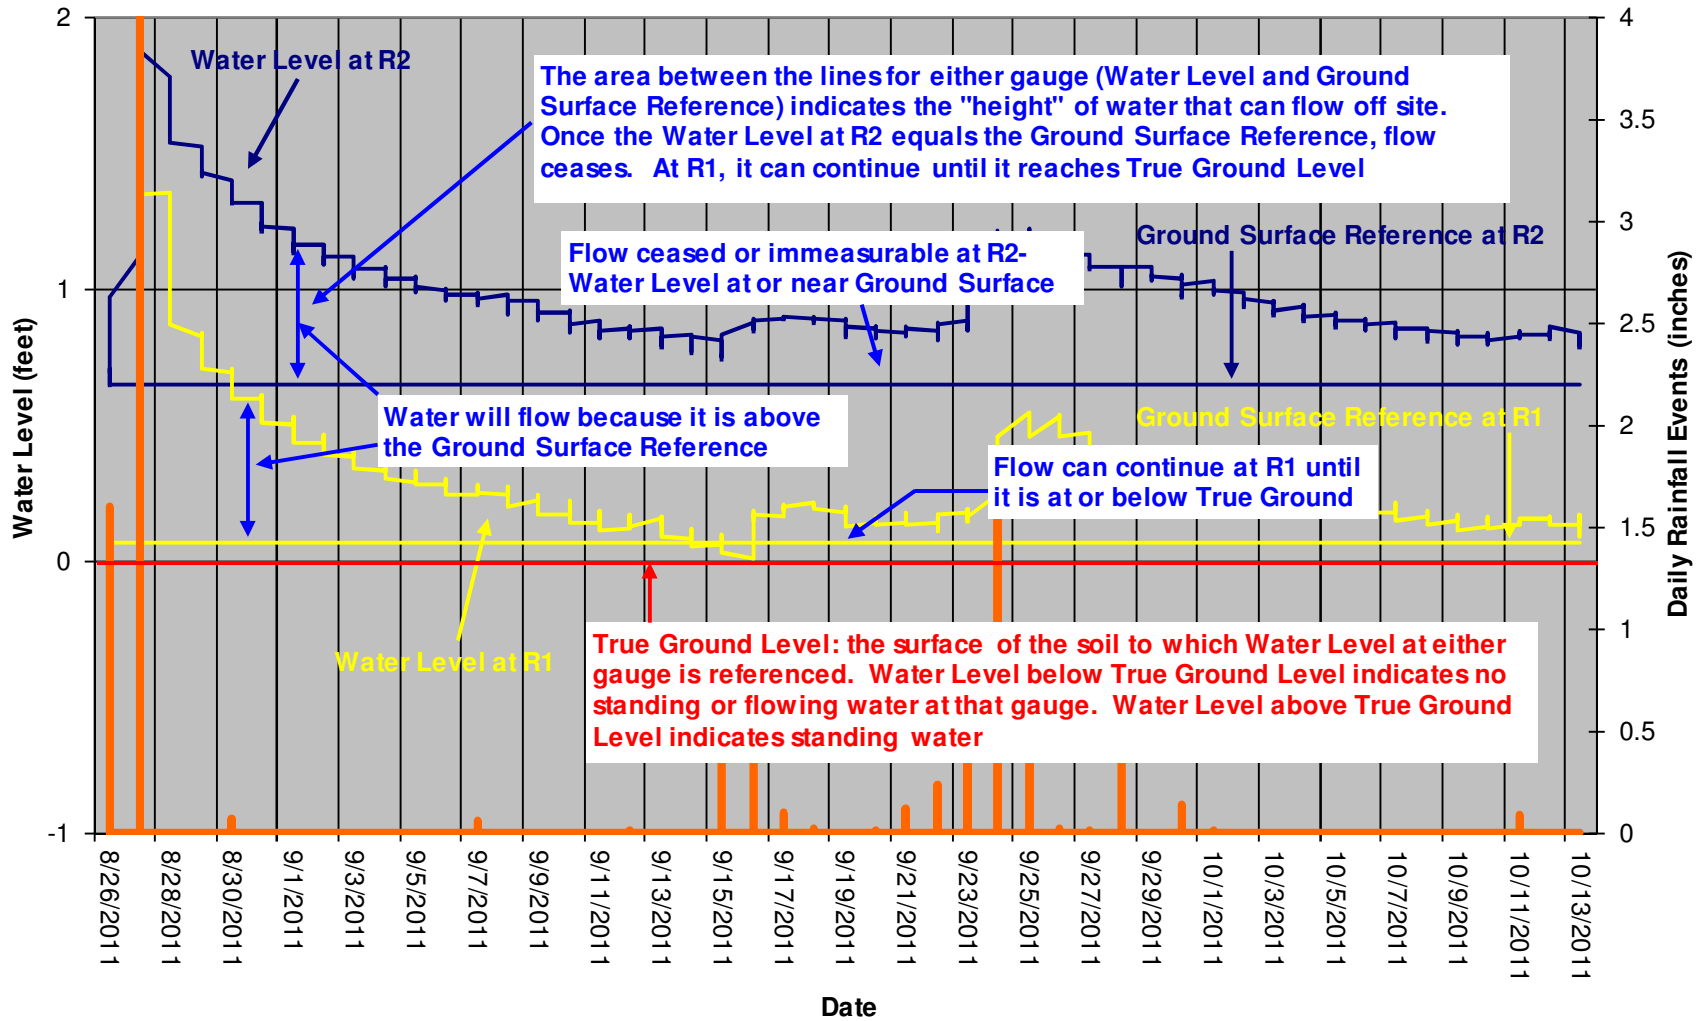
**Figure F1.  
Armstrong Run Monitoring Gauges 1 and 2 (R1 and R2)  
Correlated to Video Evidence of Flow Across Site**

Refer to Figure F1 for the following discussion of evidence of flow within the swamp runs. Figure F1 is a composite chart showing the water level at both run gauges during a period when flow in the swamp runs was visually confirmed and recorded on video. From 8/26/2011 through 10/13/2011 the site received nearly 15 inches of rain causing the water levels to rise rapidly and gradually drain through and off the site. The ground level at gauge R1 is .07 feet above the inlet level of the outfall pipe at the downstream end of the project. The ground level at gauge R2 is .65 feet *below* the inlet level of the pipe. Gauge R2 is situated in a depression which means the area immediately surrounding gauge R2 will never completely drain offsite. These relative ground surface levels are indicated in Figure 1 as Ground Surface References.

Figure F1 illustrates the “height” of water at gauges R1 and R2 that can flow offsite. Gauge R2 is shown in blue. The difference between the Water Level at R2 and the Ground Surface Reference at R2 at any point between those lines represents the level of water that can flow offsite. Once the Water Level falls to or below the Ground Surface Reference, flow can no longer occur because it will have reached equilibrium with the level of the outlet pipe, even though the water level may still be above the True Ground Level (shown in red). The same is not quite true for gauge R1. Its Ground Surface Reference is .07 feet above the outlet pipe, but flow at this gauge can continue until the water level falls to the True Ground Level because it will be collected in the area around gauge R2.

The video documentation included with this report was shot after Hurricane Irene passed though at the end of August, 2011. Water level measurements over a two-day period after the rain event ended confirm the flow pattern described above. The water level at gauge R1 eventually dropped as water flowed through the site and probably ceased sometime between September 5<sup>th</sup> and 9<sup>th</sup>. Flow at the downstream gauge R2 continued a few days longer.

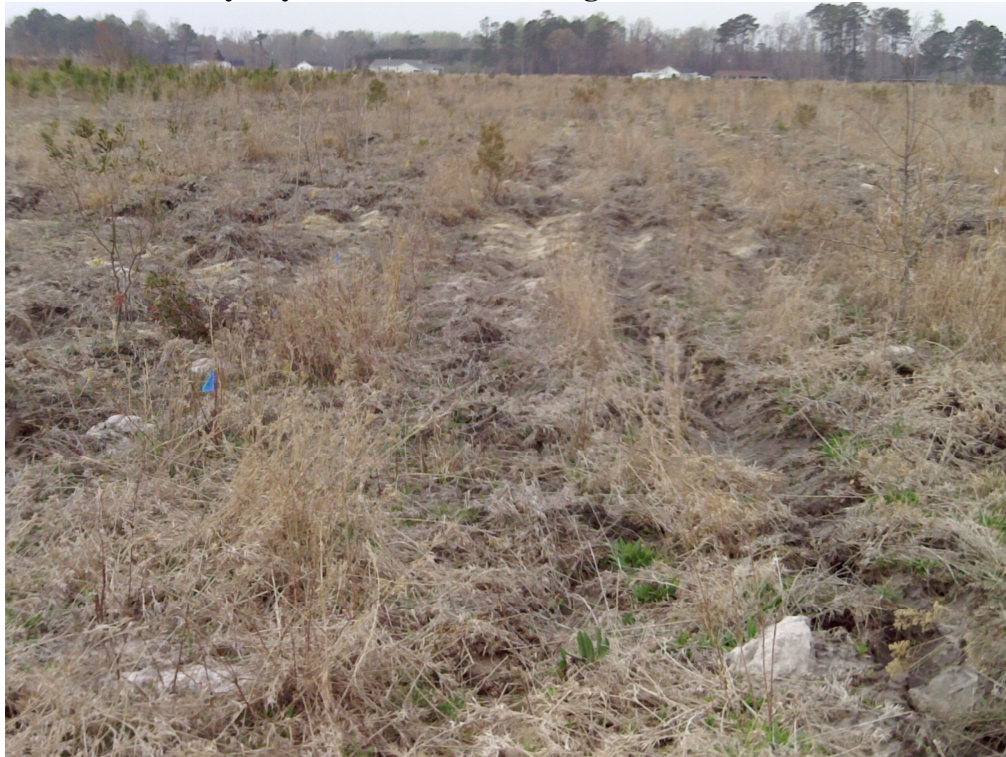
**VPA 1**  
**Very dry conditions near Gauge 2 in March 2011**

Feature/Issue	Plot	Probable Cause	Photo #
Severely droughty conditions	2, 3 and 4	Lack of rainfall	VPA 1, 2, 3 and 4

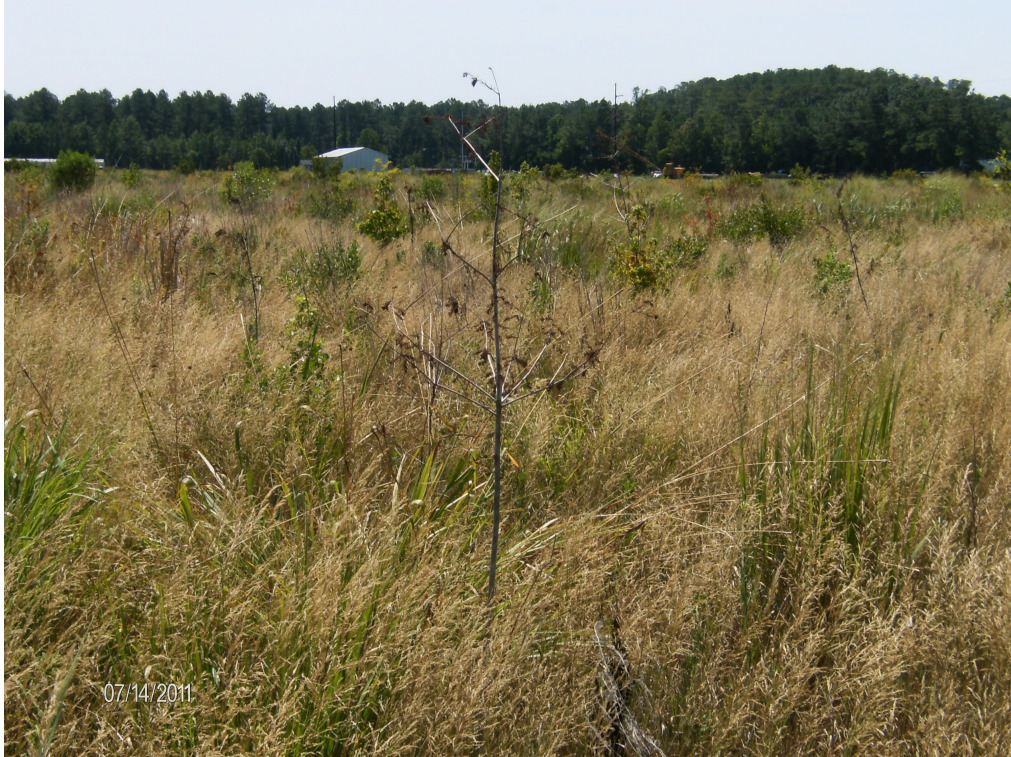
**VPA 3**

**Newly planted trees after subsoiling in 2010 suffering from droughty conditions in July.**

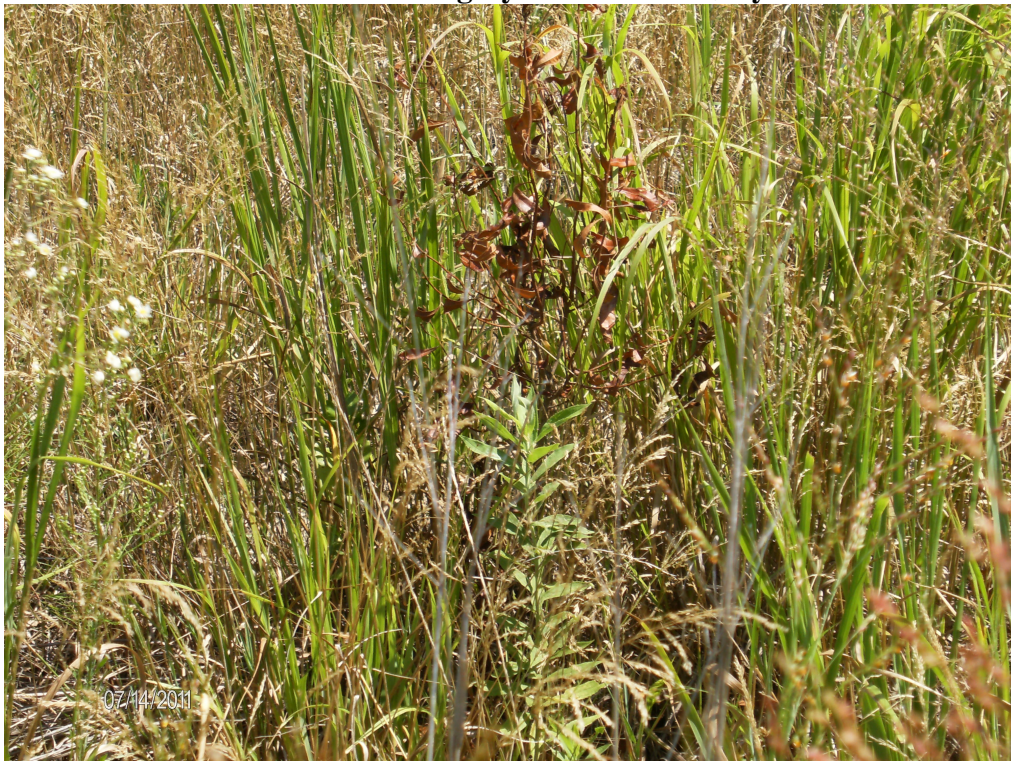
**VPA 4**

**Effects of droughty conditions in July.**

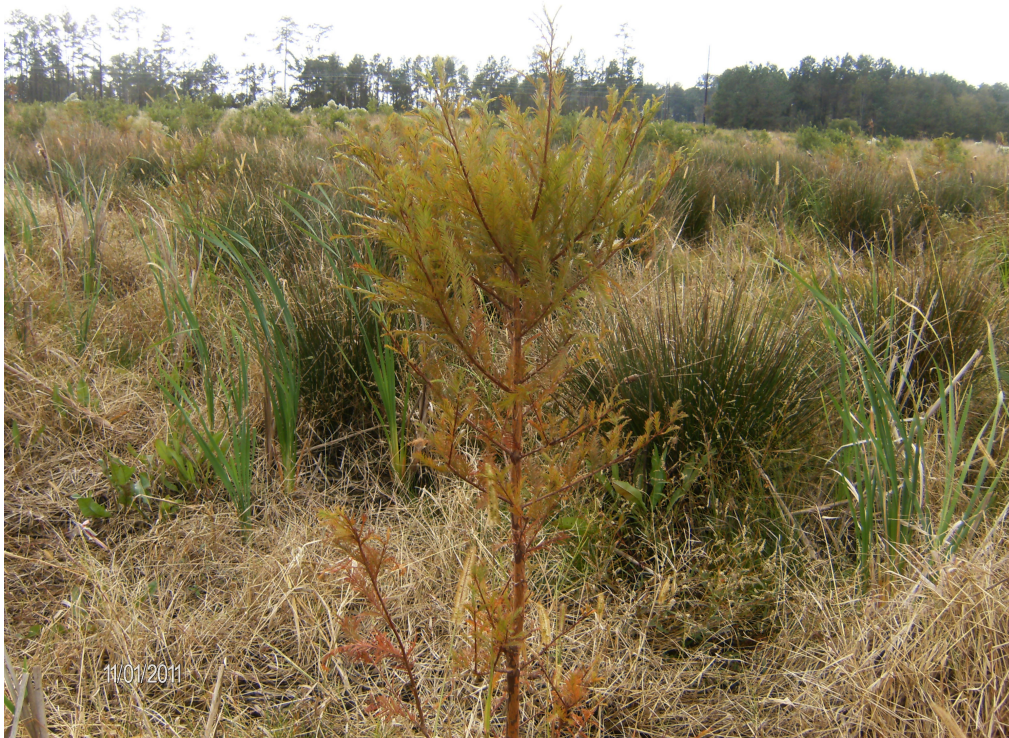
**Stems closer to or in the swamp run fared better in 2011.**

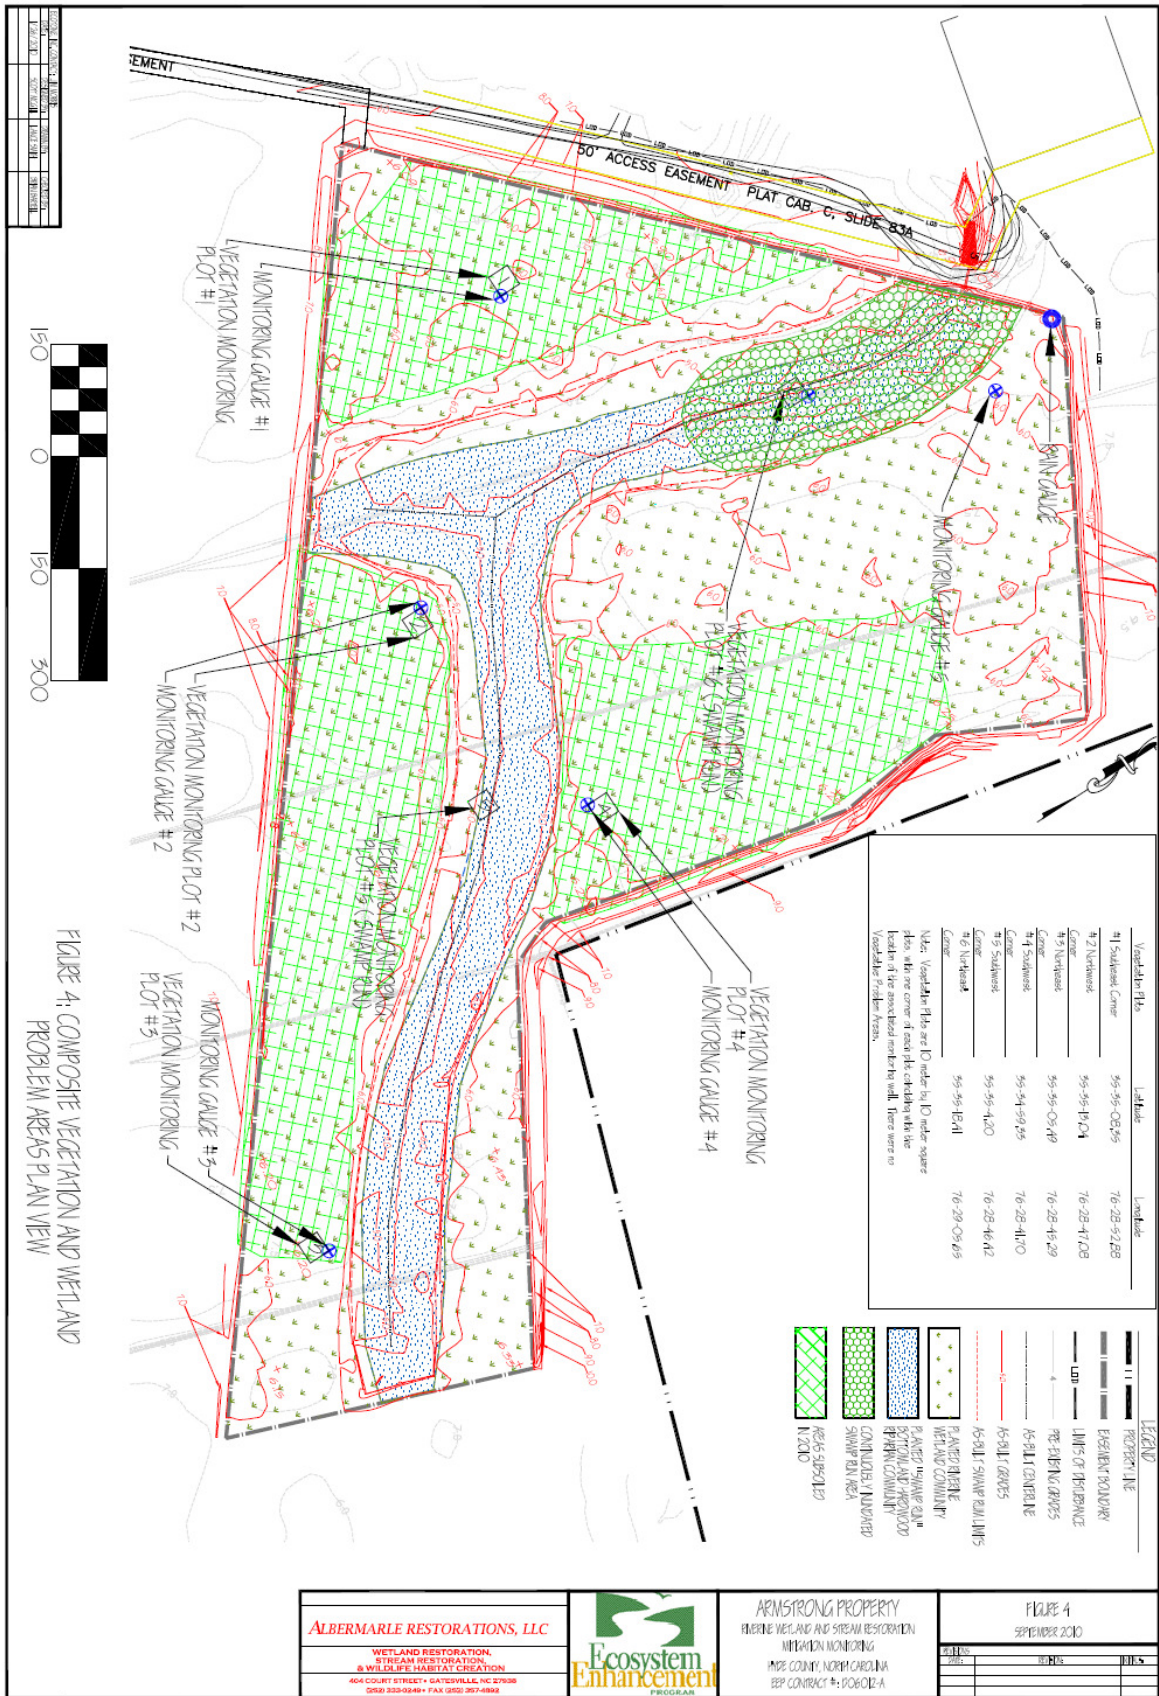
FIGURE 4: COMPOSITE VEGETATION AND WETLAND PROBLEM AREAS PLAN VIEW

Subsoiling was done in 2010 in an attempt to offer every possible enhancement and give the project the best chance for success. Refer to Figure 4 in Appendix D for a description of those areas. It was thought that soil compaction was a possible cause for poor hydrology, and that certainly may have contributed to the problem, but the following charts summarize the lack of rainfall which is clearly having a detrimental effect on success. Despite the remedial efforts, and

because of the lack of rainfall, those areas shown as subsoiled in Figure 4 continued to suffer poor hydrology.

Figure 4 in Appendix D provides an overview of the areas where hydrology was deemed poor enough to warrant corrective action which was undertaken in 2010. In previous years, much of the site was flooded at least immediately prior to the beginning of the growing season, but that was not the case in 2011 due to insufficient rainfall as evidenced by the hydrographs in Appendix C. Despite the subsoiling treatment to correct hydrologic problems, inadequate rainfall still caused poor performance. Compare the results of Gauges 1-4 to those of Gauge 7 in Table VI below. The project site is performing in a similar fashion to that of the reference site.
