YEAR 1 (2016) MONITORING REPORT
AYCOCK SPRINGS
STREAM AND WETLAND MITIGATION SITE
ALAMANCE COUNTY, NORTH CAROLINA
DMS PROJECT NO. 96312
FULL DELIVERY CONTRACT NO. 5791

CAPE FEAR RIVER BASIN
CATALOGING UNIT 03030002

Data Collection – May-October 2016

December 2016

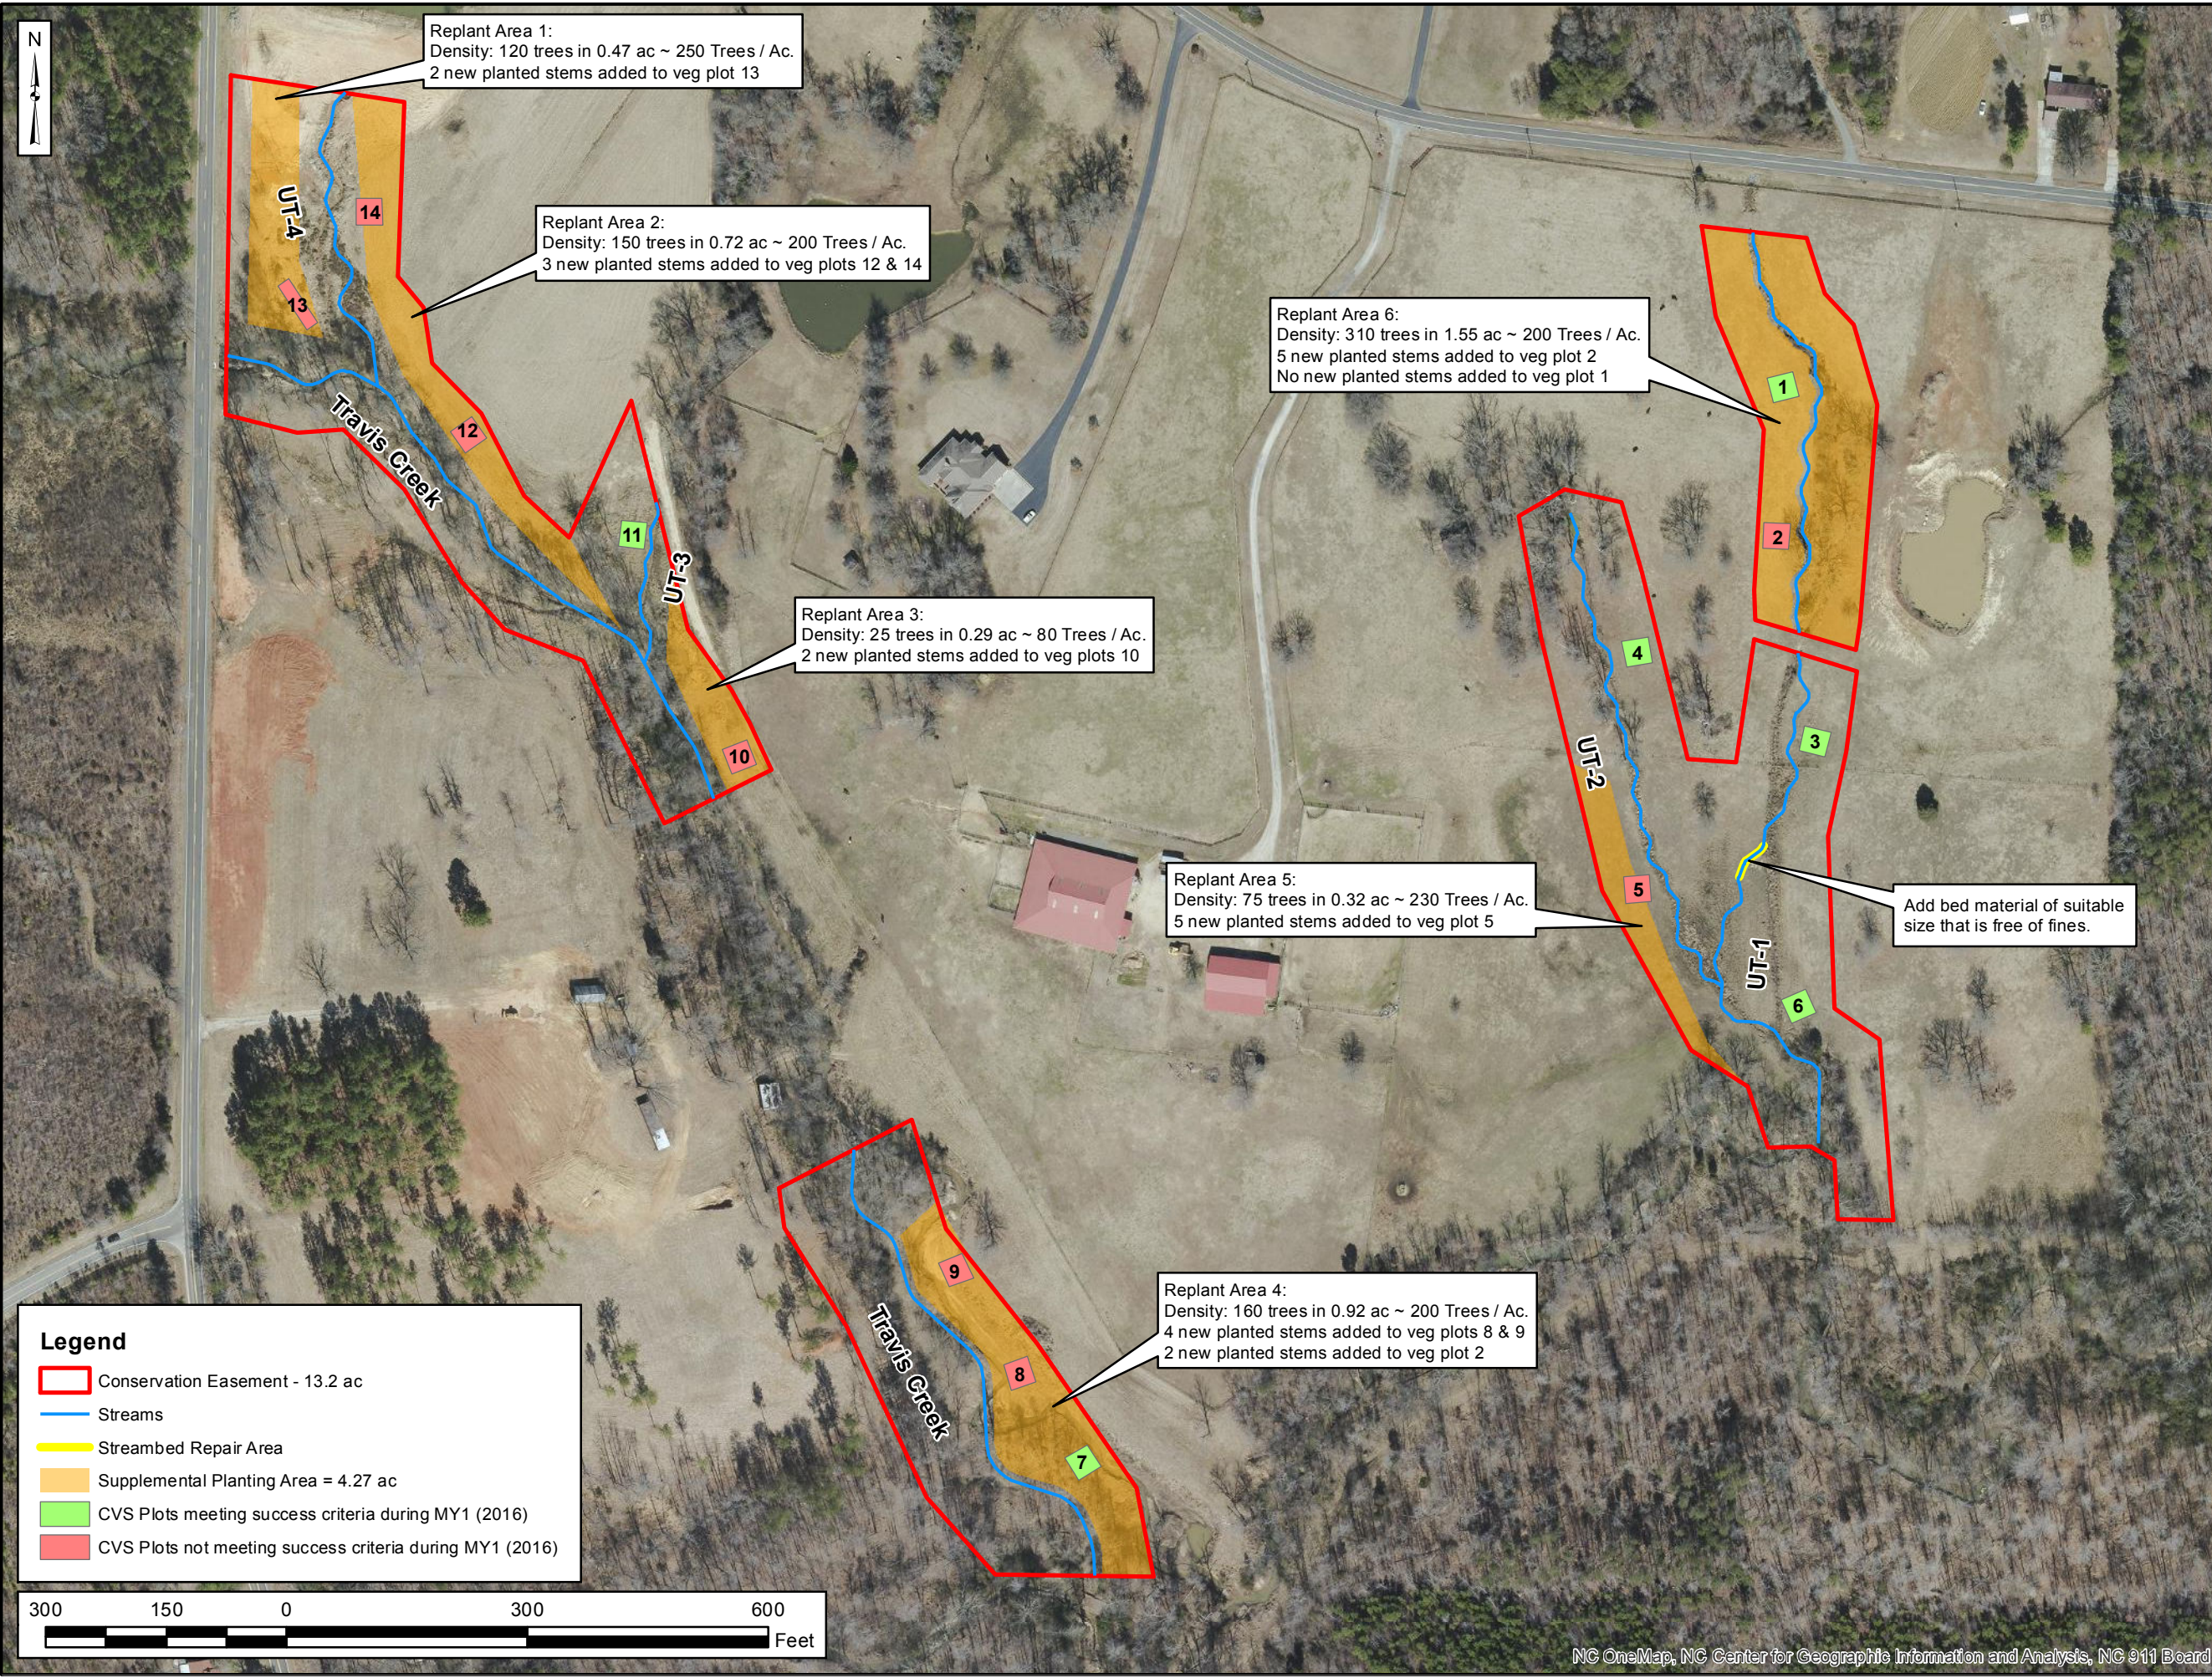
Replant Area 1:
Density: 120 trees in 0.47 ac ~ 250 Trees / Ac.
2 new planted stems added to veg plot 13

Replant Area 2:
Density: 150 trees in 0.72 ac ~ 200 Trees / Ac.
3 new planted stems added to veg plots 12 & 14

It should be noted that RS is not proposing to bring up the density of vegetation plot 13 to success standards. This plot is within an existing wooded area and has a number of large natural recruit species (boxelder and American elm). An on-site determination will be made if any additional planted stems are warranted for this area. For now, we have proposed two additional stems be added to plot 13.

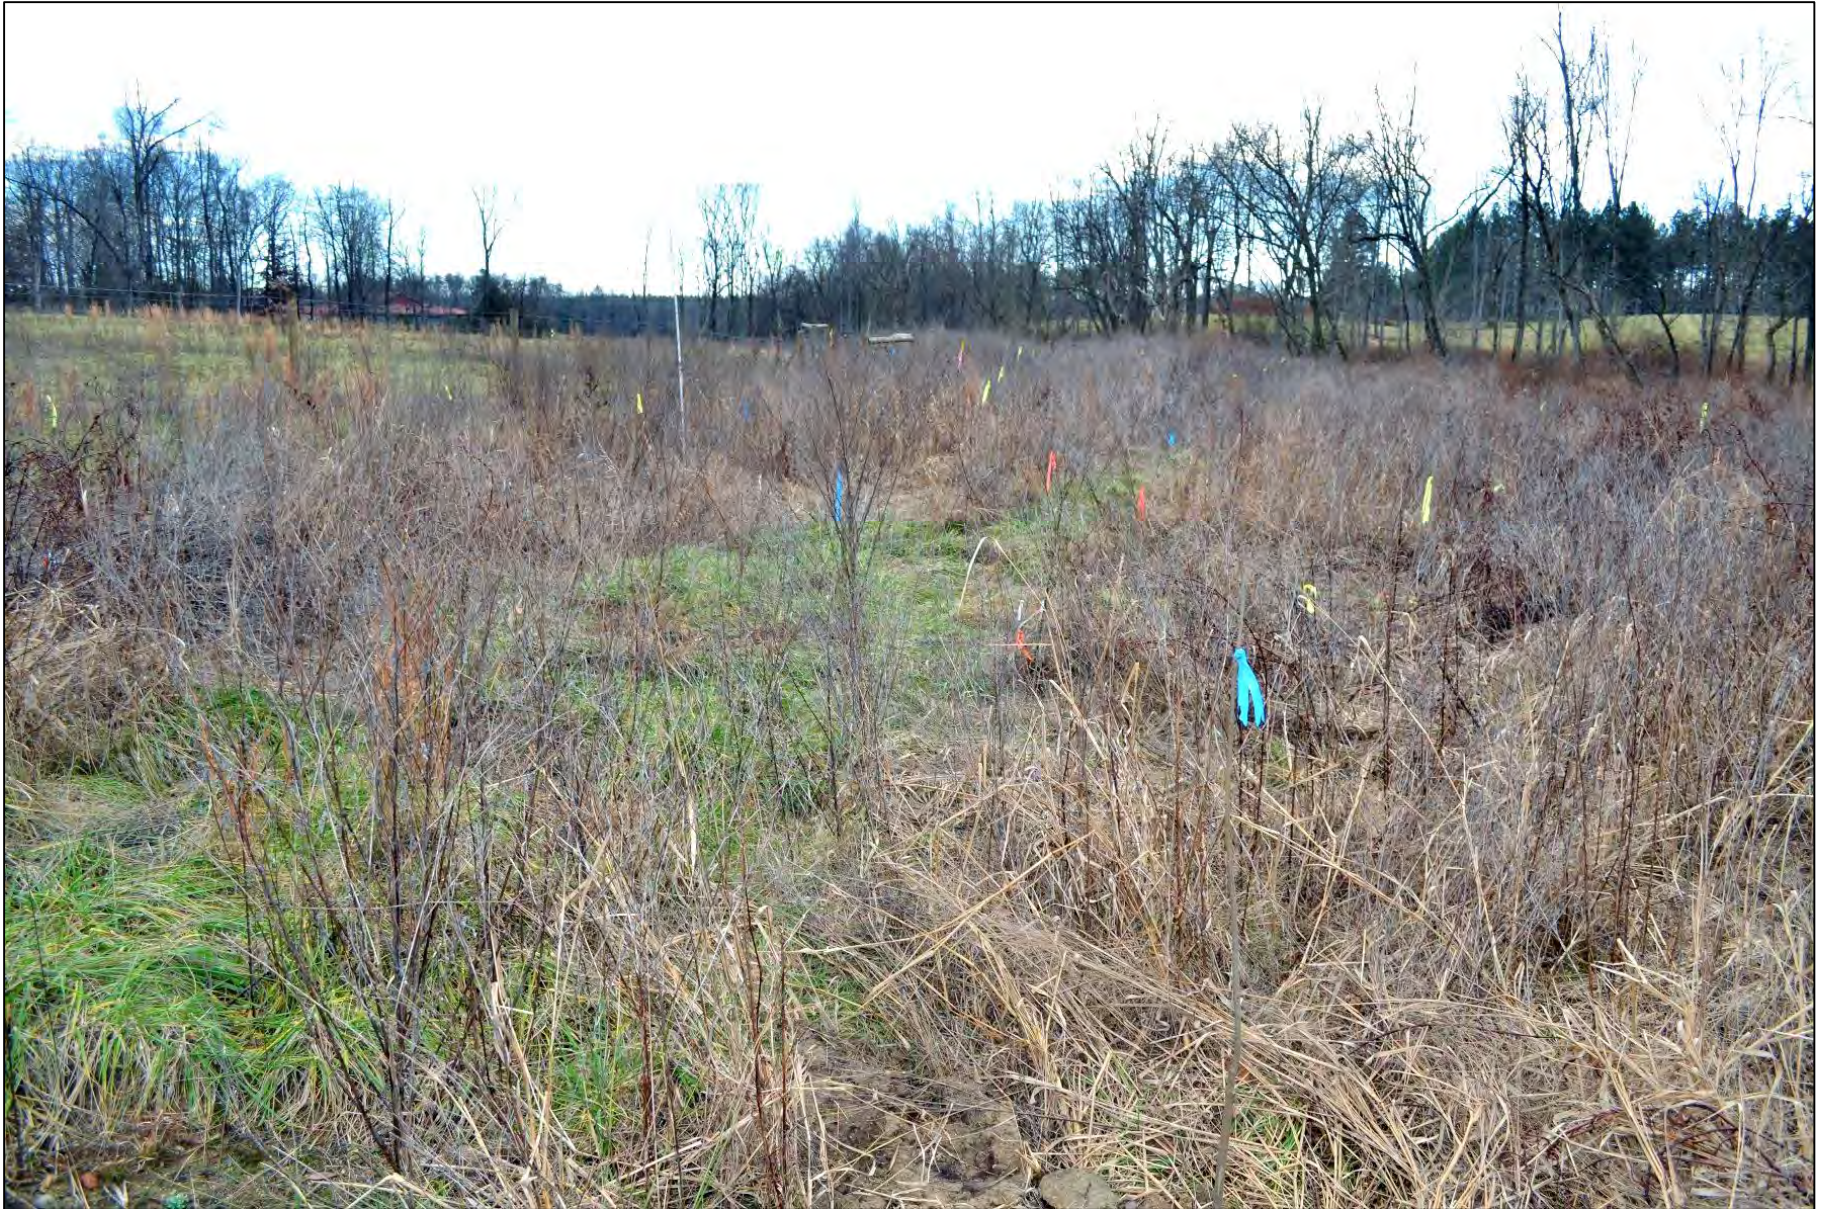
Photo 1: Looking SW. along Replant Area -1

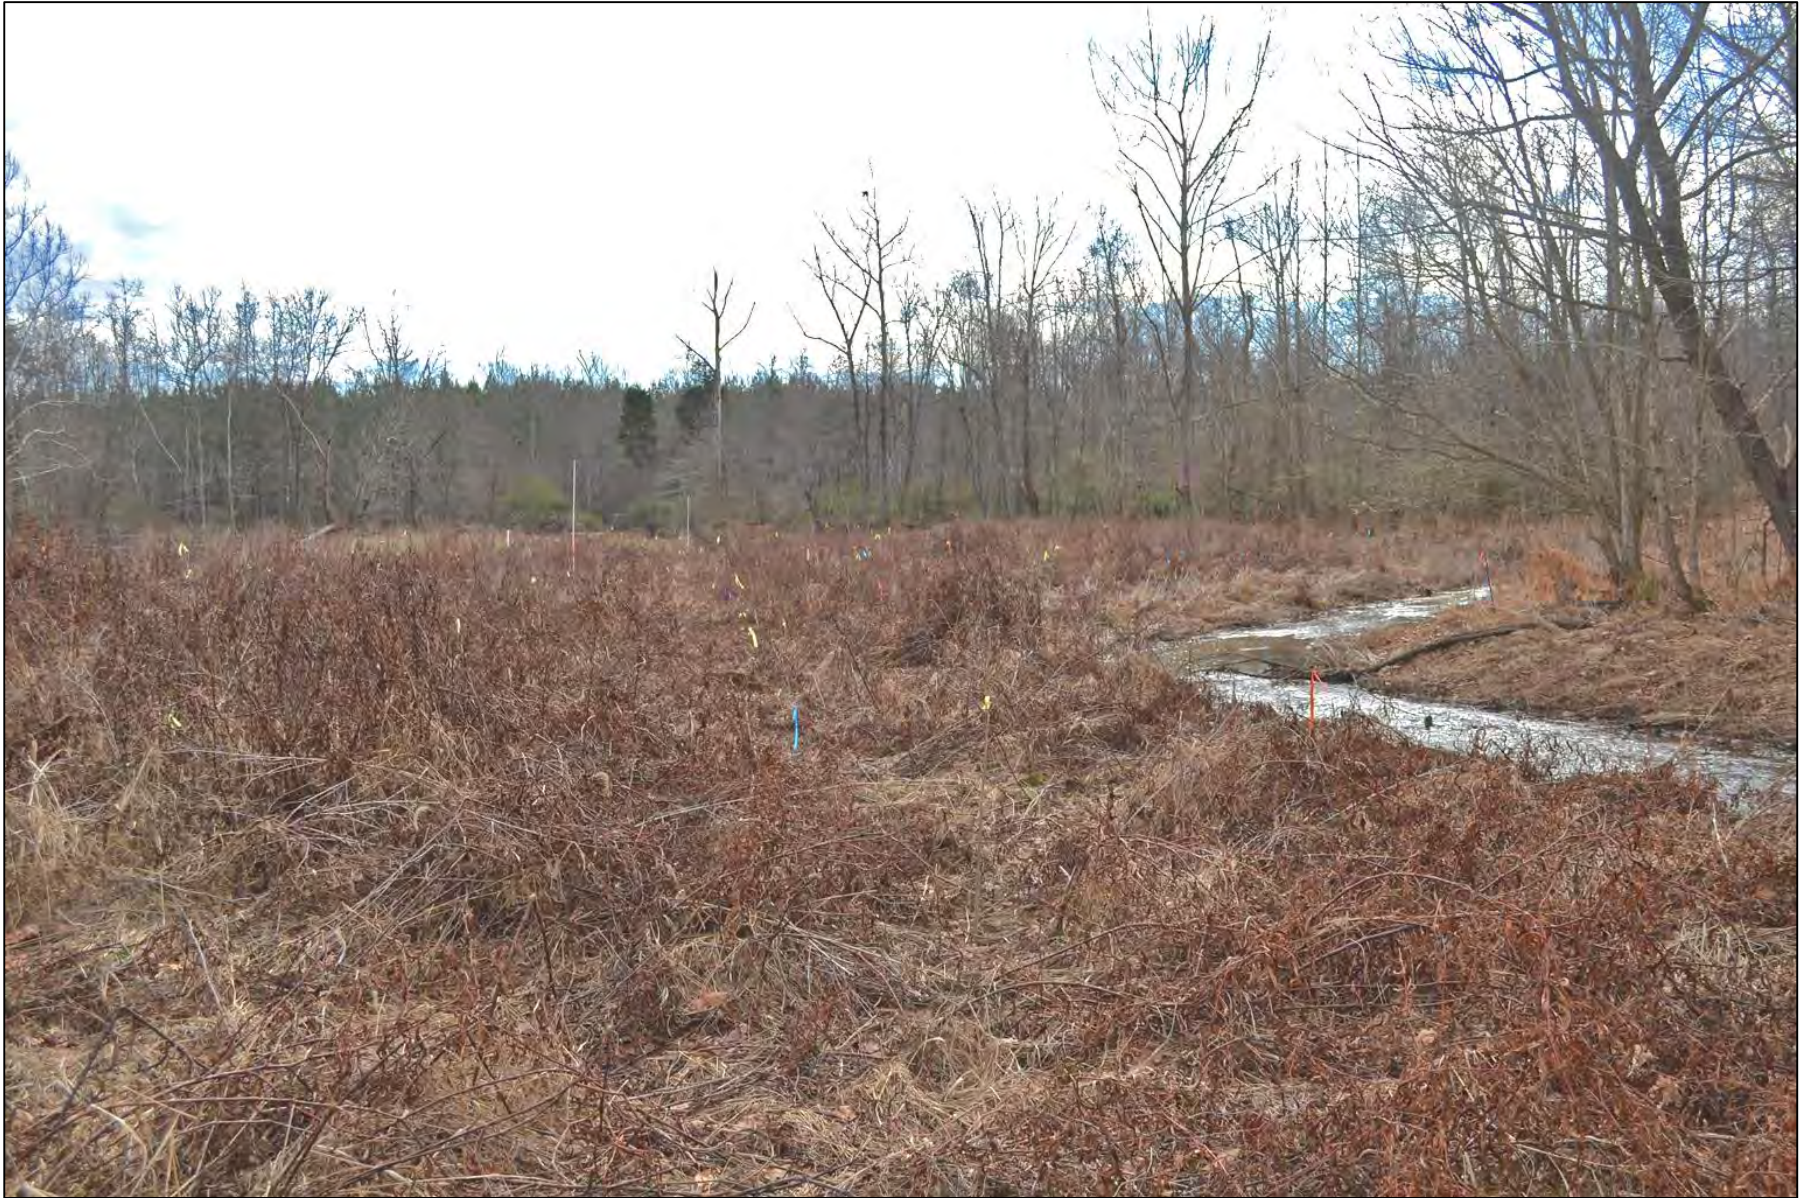
Photo 2: Looking S. in Replant Area 2, just N. of veg. plot 14

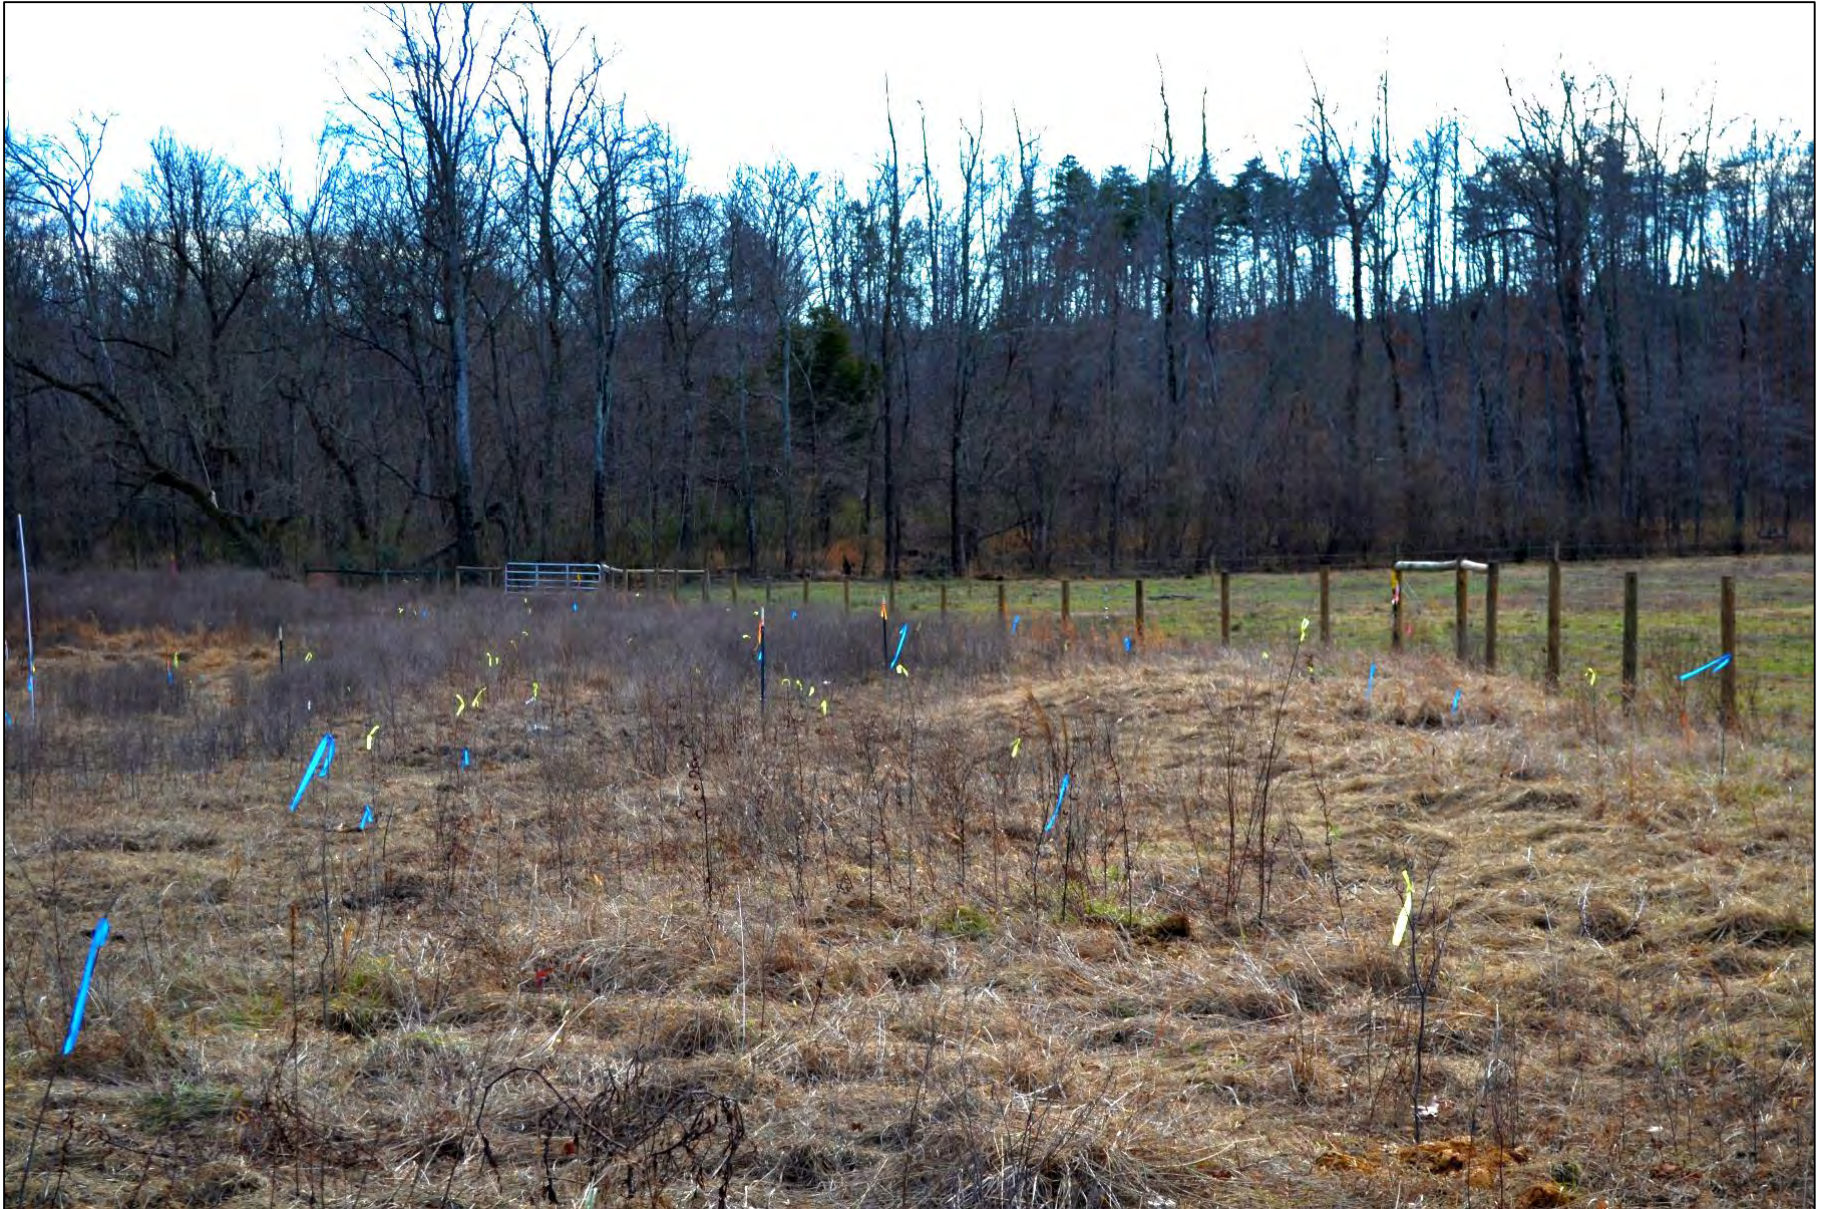
Photo 3: Looking SE. in Replant Area 4, near veg. plot 9

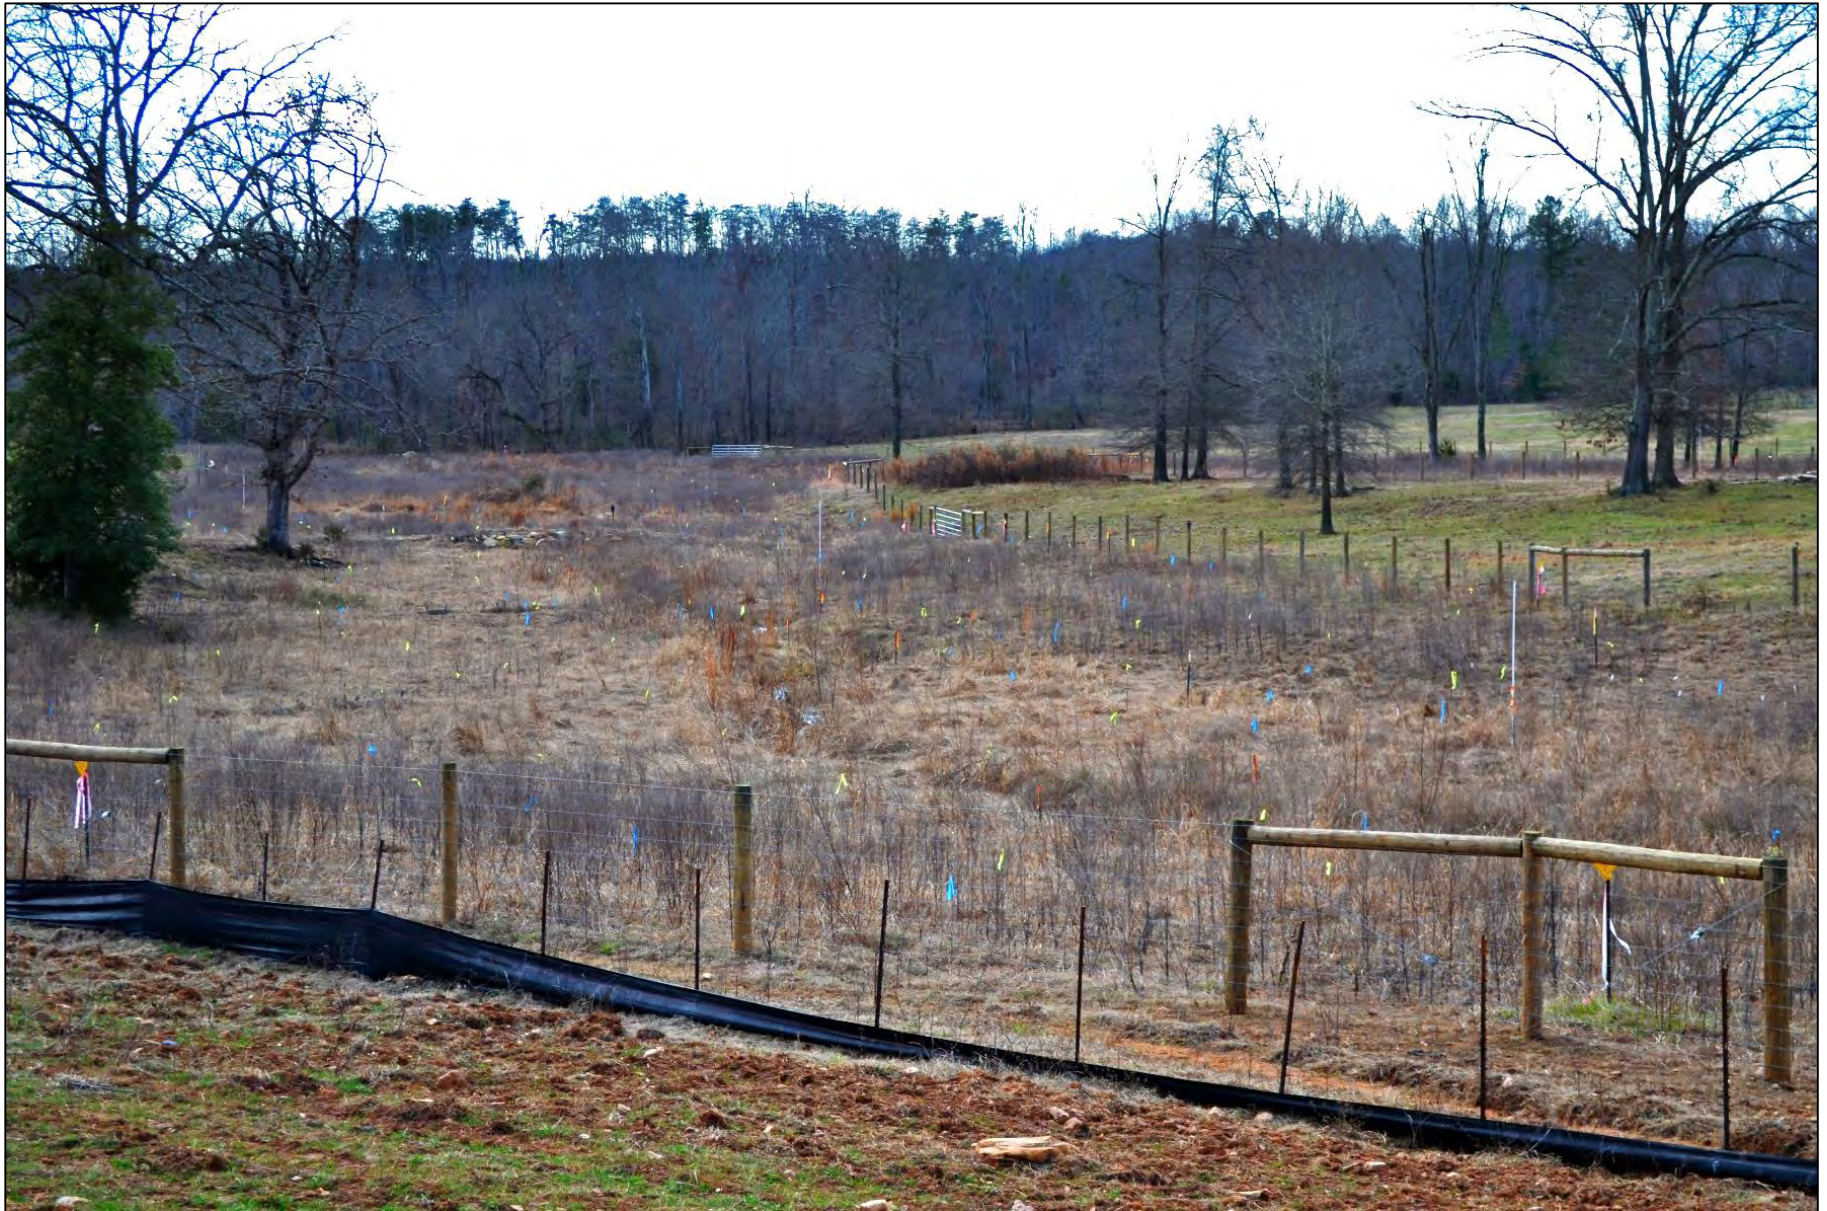
Photo 5: Looking S. in Replant Area 5, N. of veg. plot 5

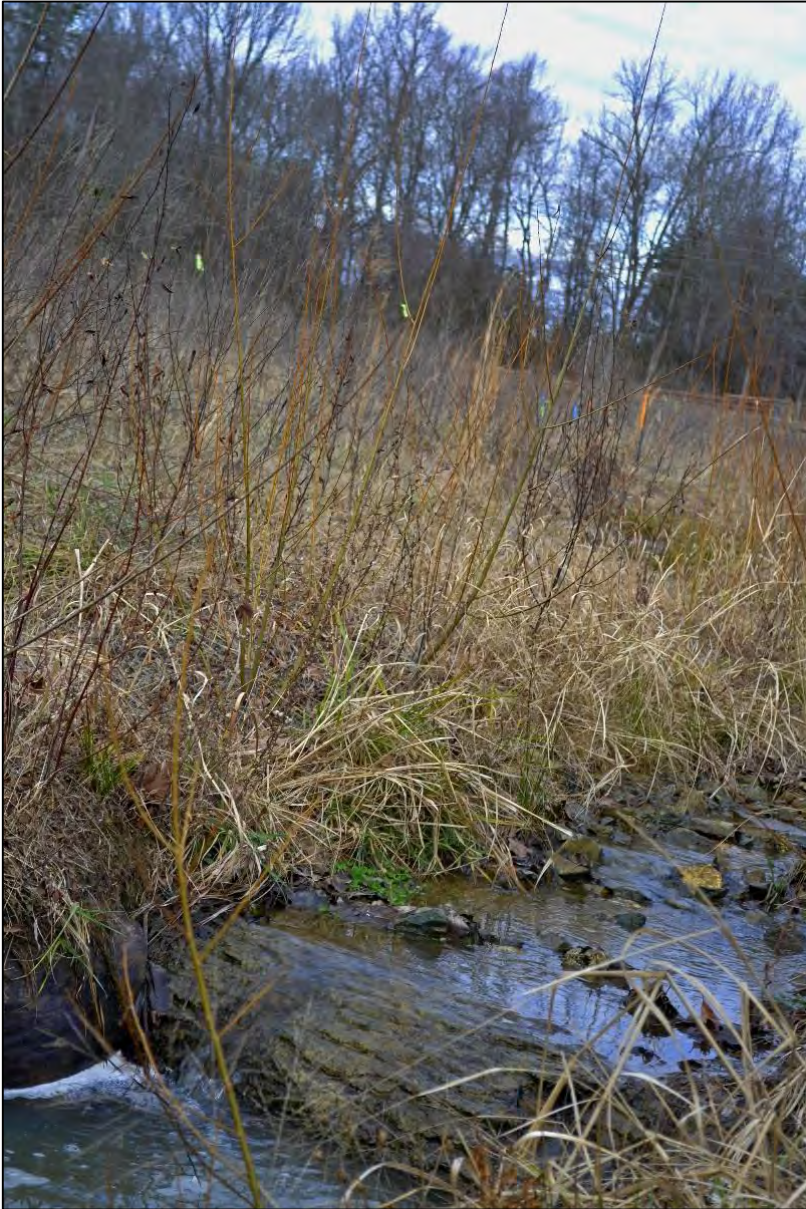
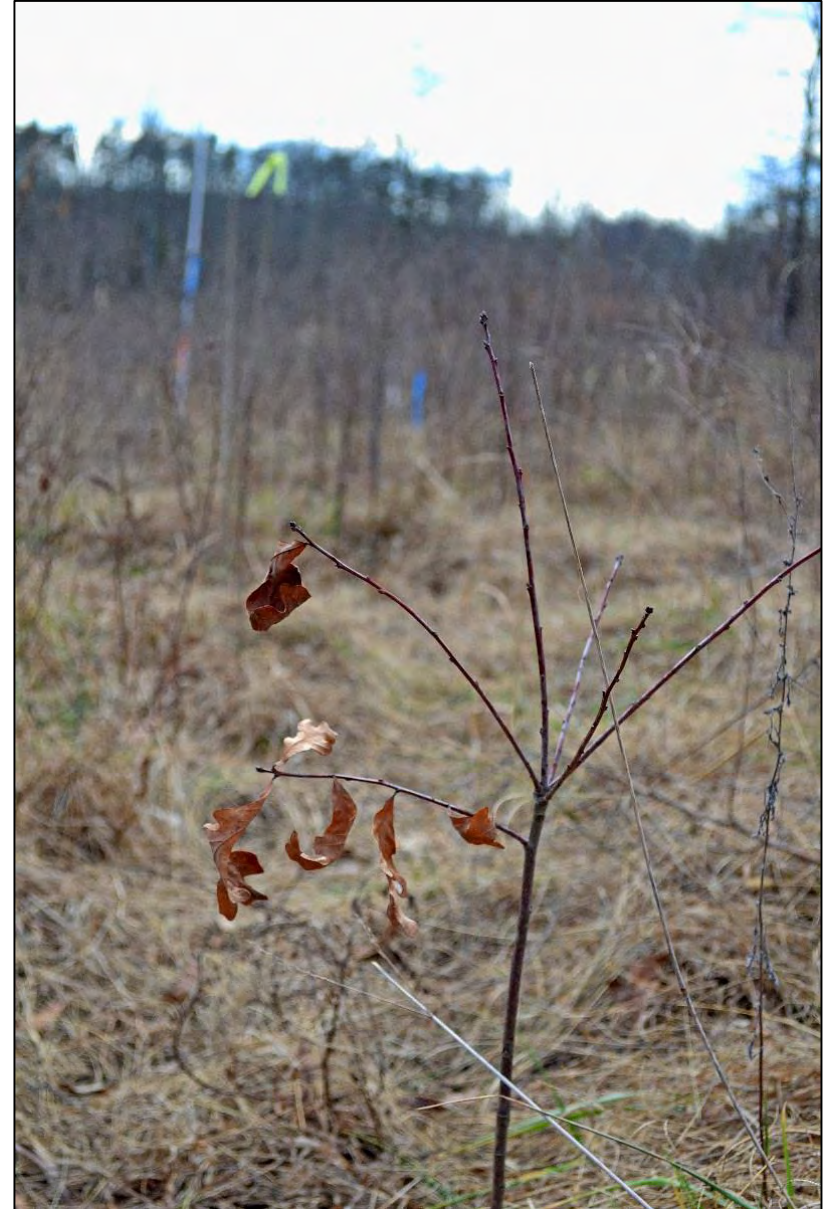
Photo 6 / 7: Live stake establishment on bank in Replant area 6

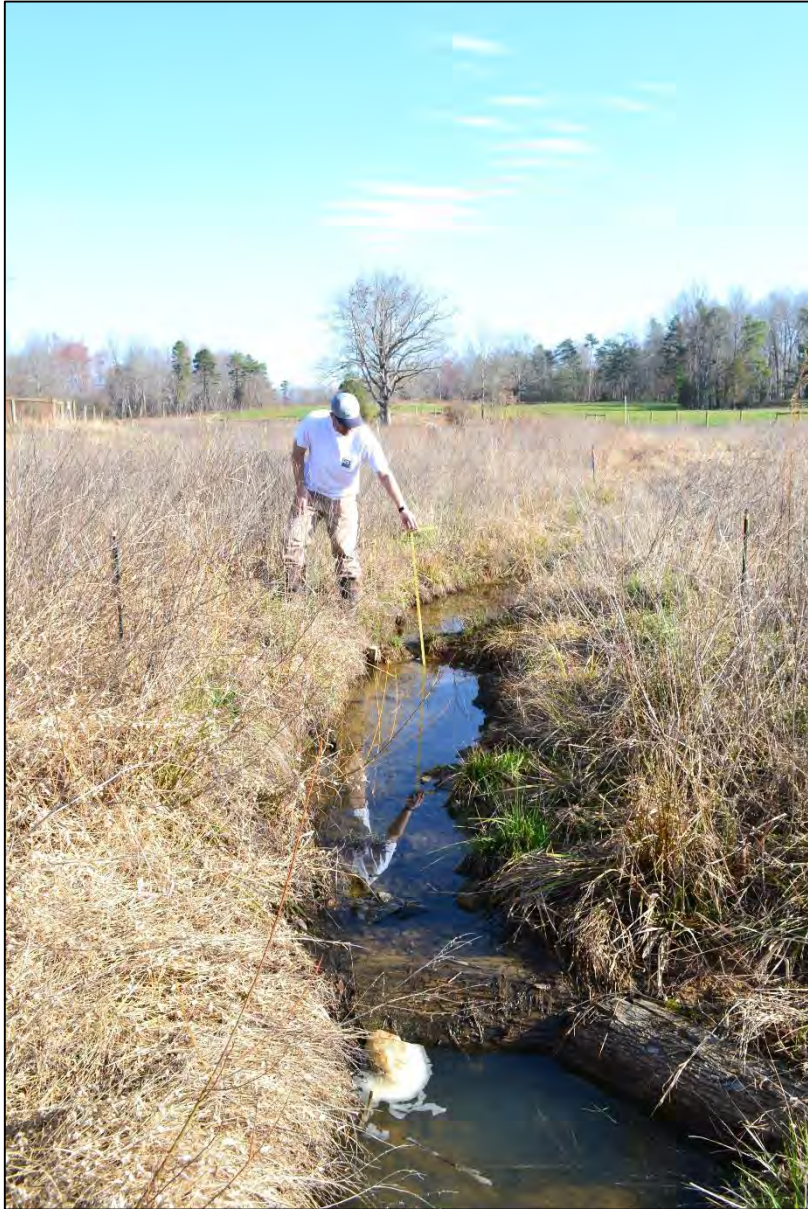
Map of Area – UT 1, XC 9, 10, 11

The year 1 (2016) measurements for cross-sections 9 and 10 on UT-1 show stream bed erosion when compared with as-built data. Stream bed erosion was noted shortly after as-built measurements were taken, and were the result of the above mentioned rain events. It is evident bed material used during construction in this area was finer than it should have been. Two riffles show bed erosion, totaling approximately 50 feet

The observed degradation in and adjacent to cross-sections 9 and 10 on UT-1 encompasses approximately 50 linear feet of stream (1 percent of the project length). As noted above, bed material placed during construction was too fine. All of UT-1 used bed material harvested on-site. It is uncommon for us not to catch too fine of material during the harvesting and placing of bed material however it does happen. In this case, it appears that an oversight did occur and too fine of material was used along this stretch. Fine materials washed from the riffle during heavy rainfall events, resulting in minor bed scour and a small, less than 6 inch head cut beginning to develop at the top of riffle. Suitable sized channel bed material is proposed to be installed at the proper elevation in two riffles within UT-1. Bed material will be installed such that bank toe protection is provided and planting with willow stakes will occur. Bank toe protection designates that channel bed material will extend up the lower one-third of the bank. The riffle will be monitored by established cross-sections 9 and 10. This work will occur in winter of 2016/2-17 and will be done by hand in order to minimize impact within the conservation easement.

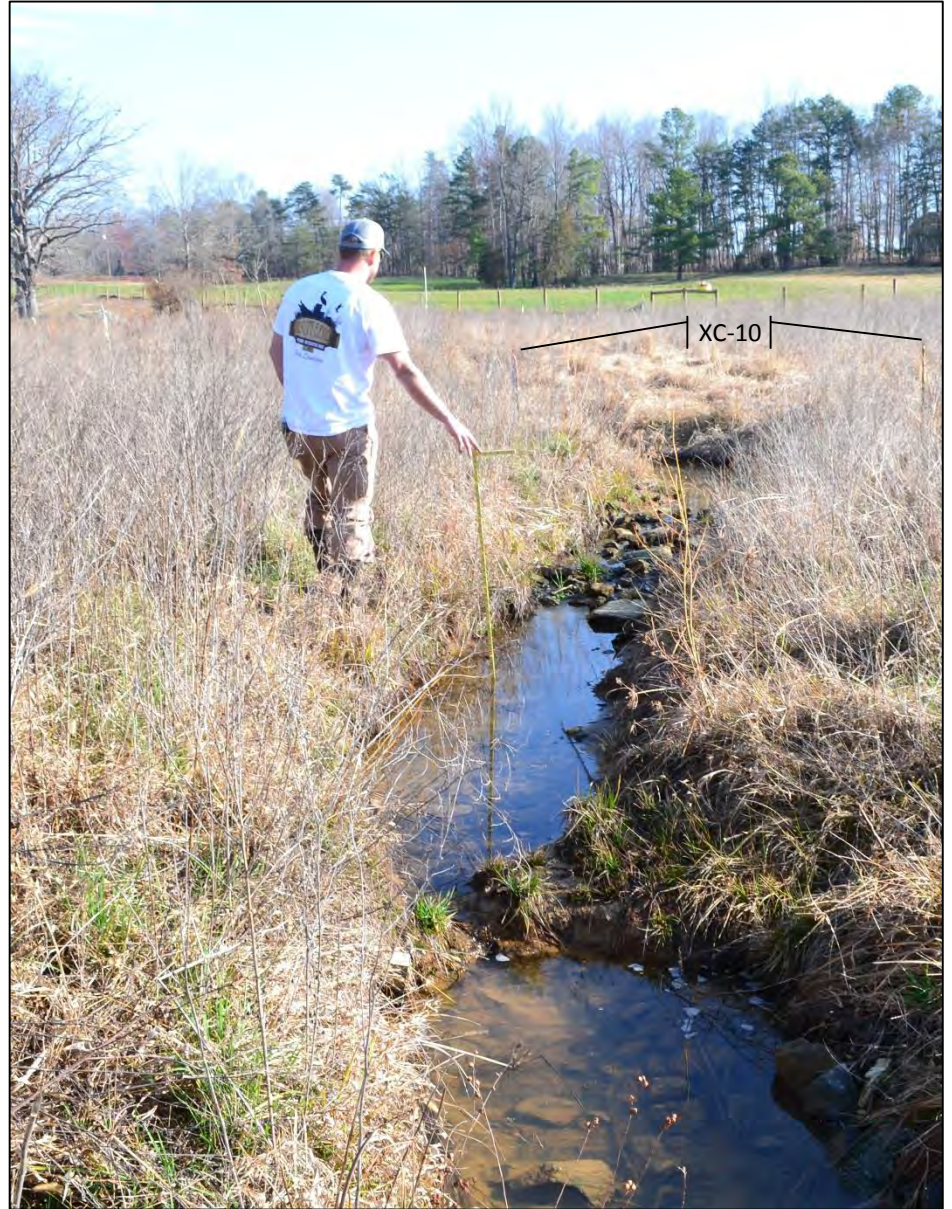
Photo 1: Substrate loss, 6" head-cut at UT 1, XC 9

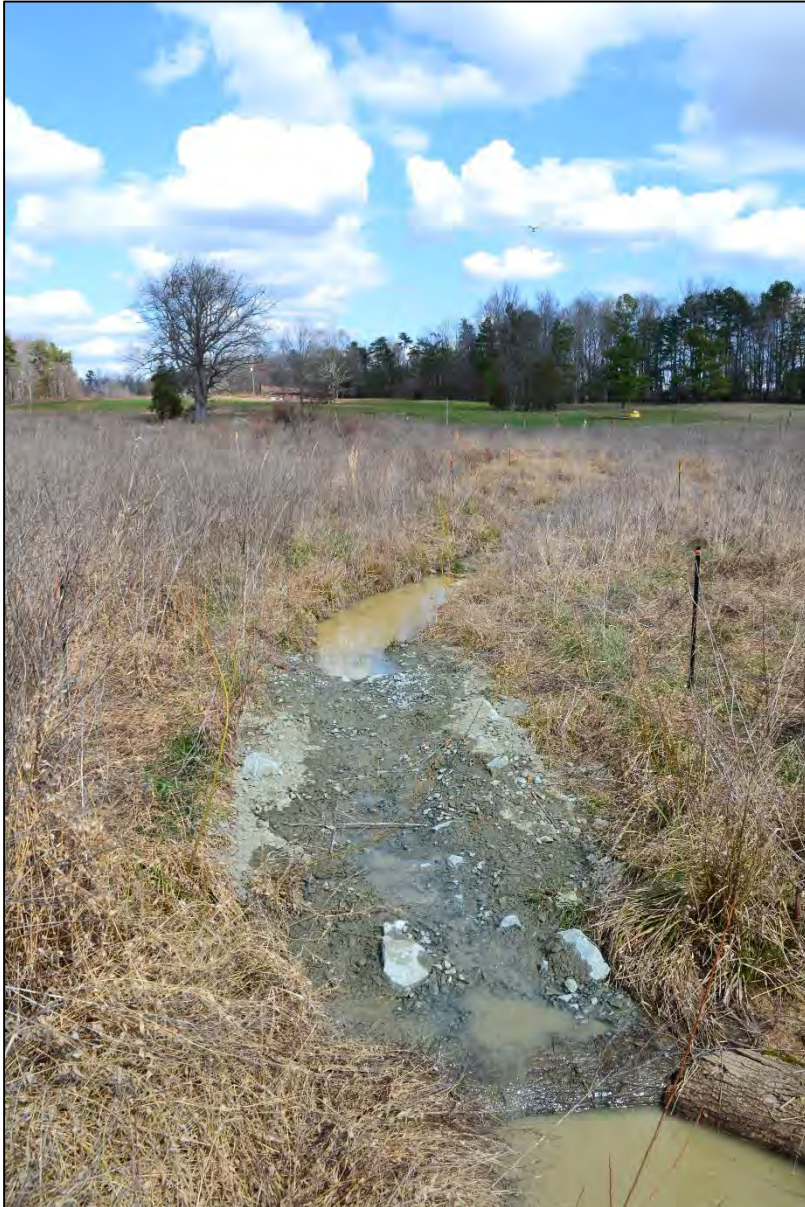
Photo 2: Pool, upstream of 6" head-cut at UT 1, XC 9 (XC 10 in background)

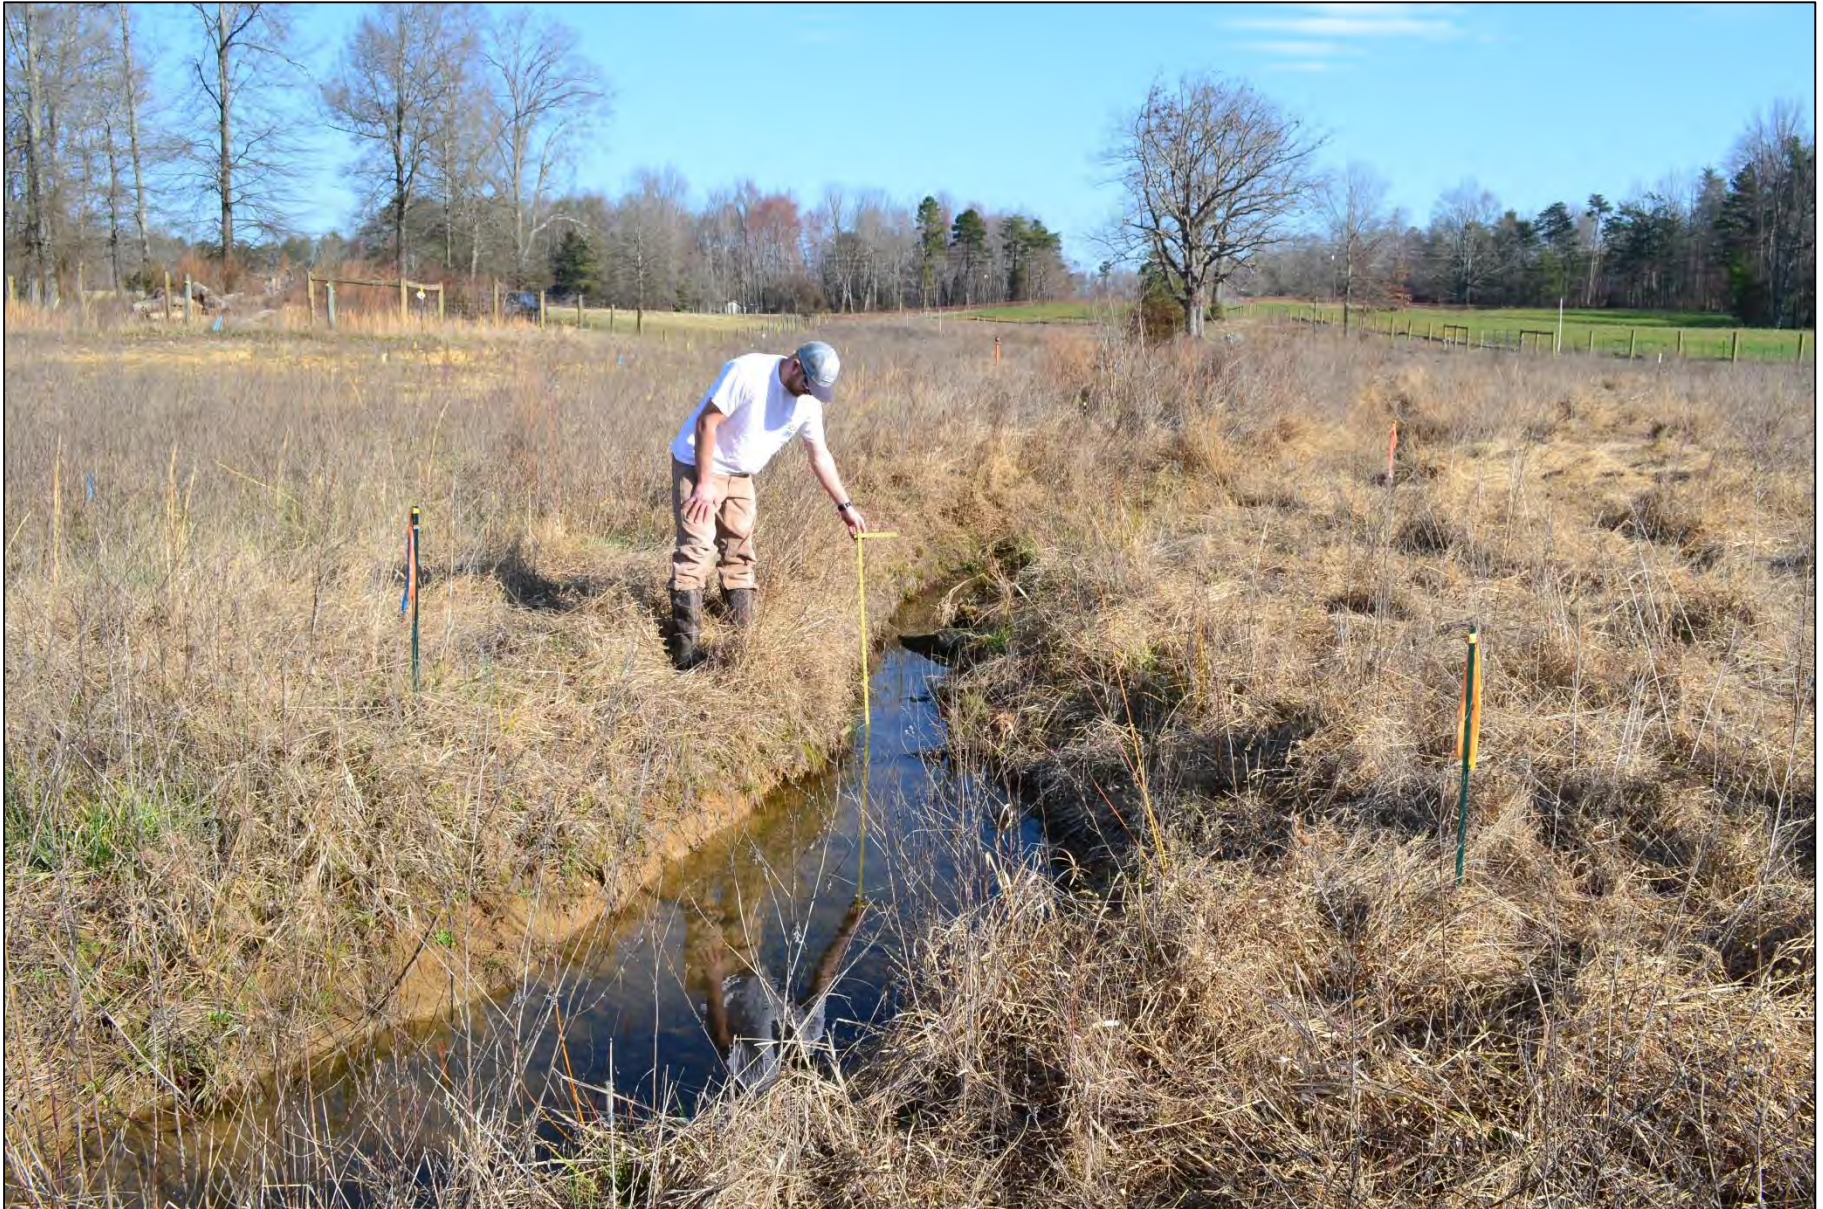
Photo 3: Substrate loss, upstream riffle of XC 10 (pool)

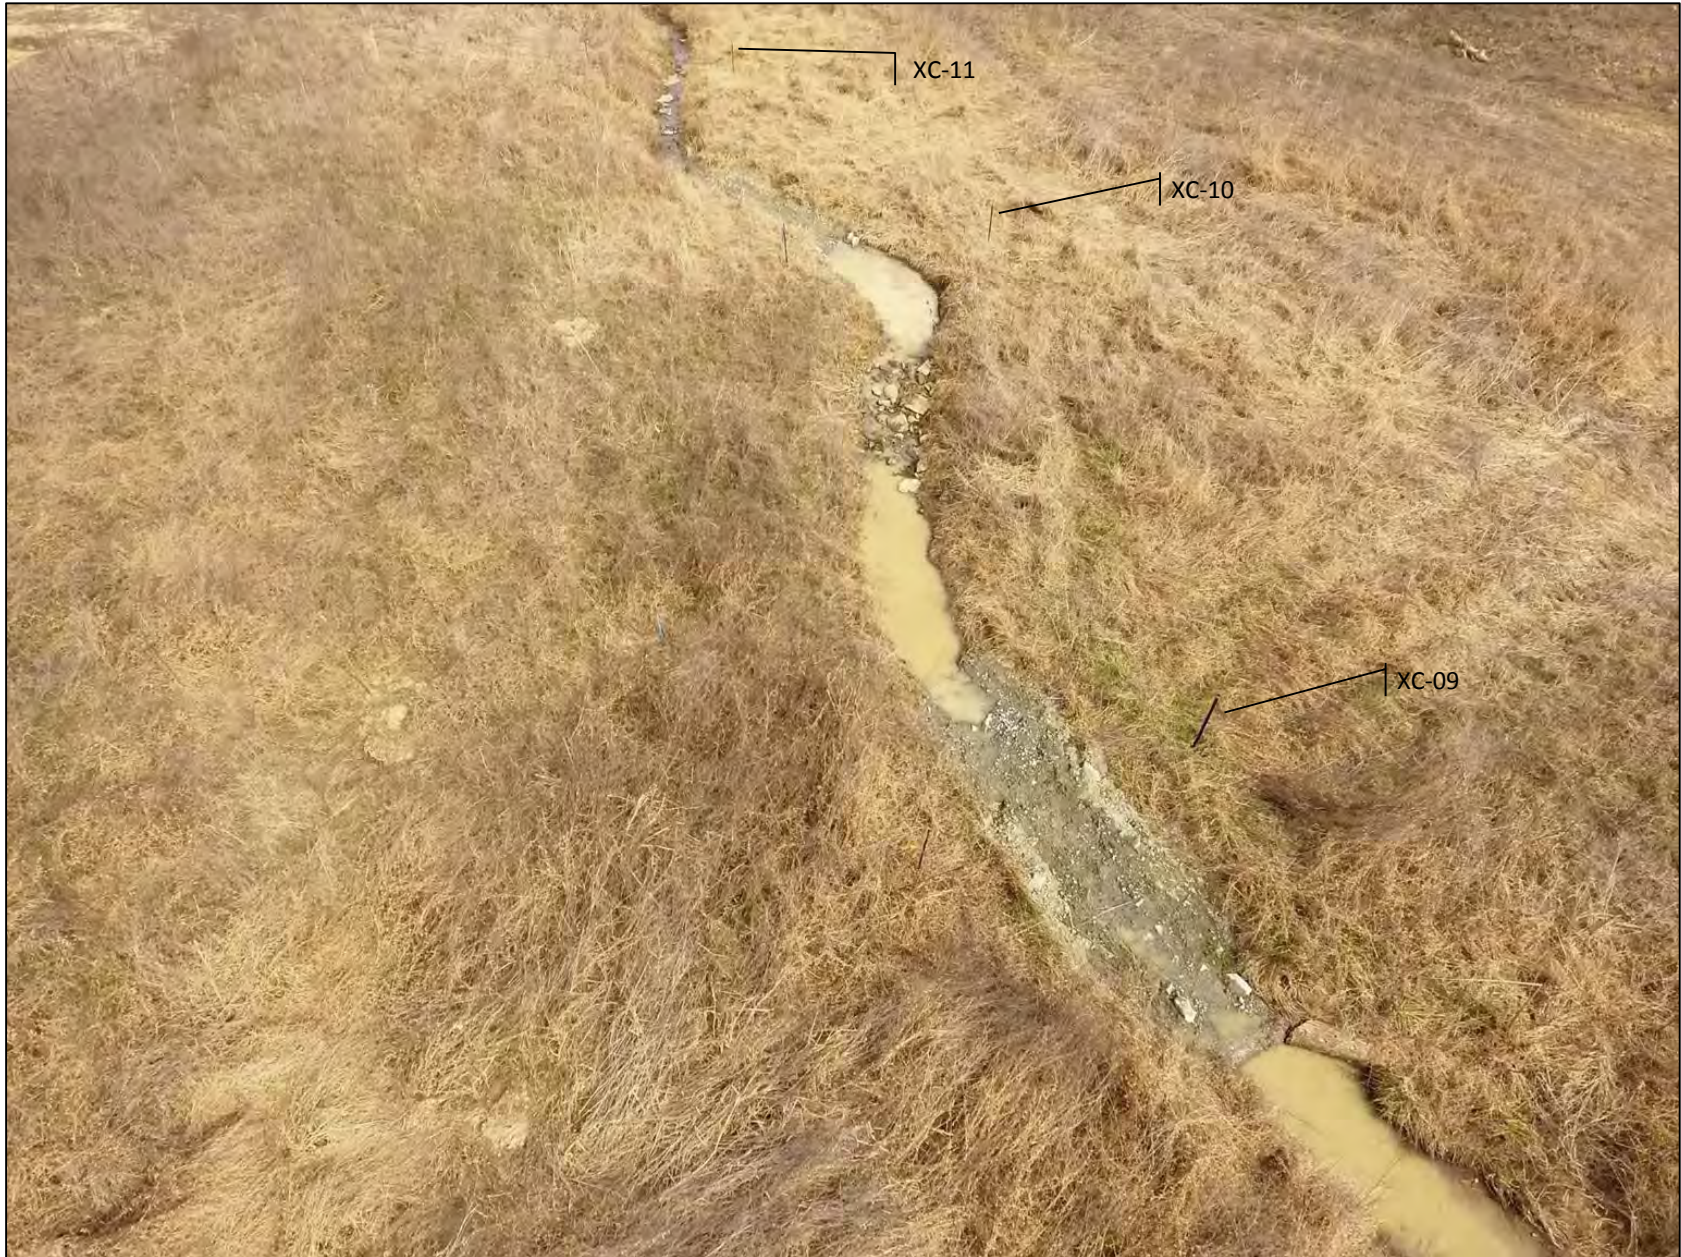
Photo 5: post replacement overview
