YEAR 1 (2016) MONITORING REPORT
AYCOCK SPRINGS
STREAM AND WETLAND MITIGATION SITE
ALAMANCE COUNTY, NORTH CAROLINA
DMS PROJECT NO. 96312
FULL DELIVERY CONTRACT NO. 5791

CAPE FEAR RIVER BASIN
CATALOGING UNIT 03030002

Data Collection – May-October 2016

December 2016

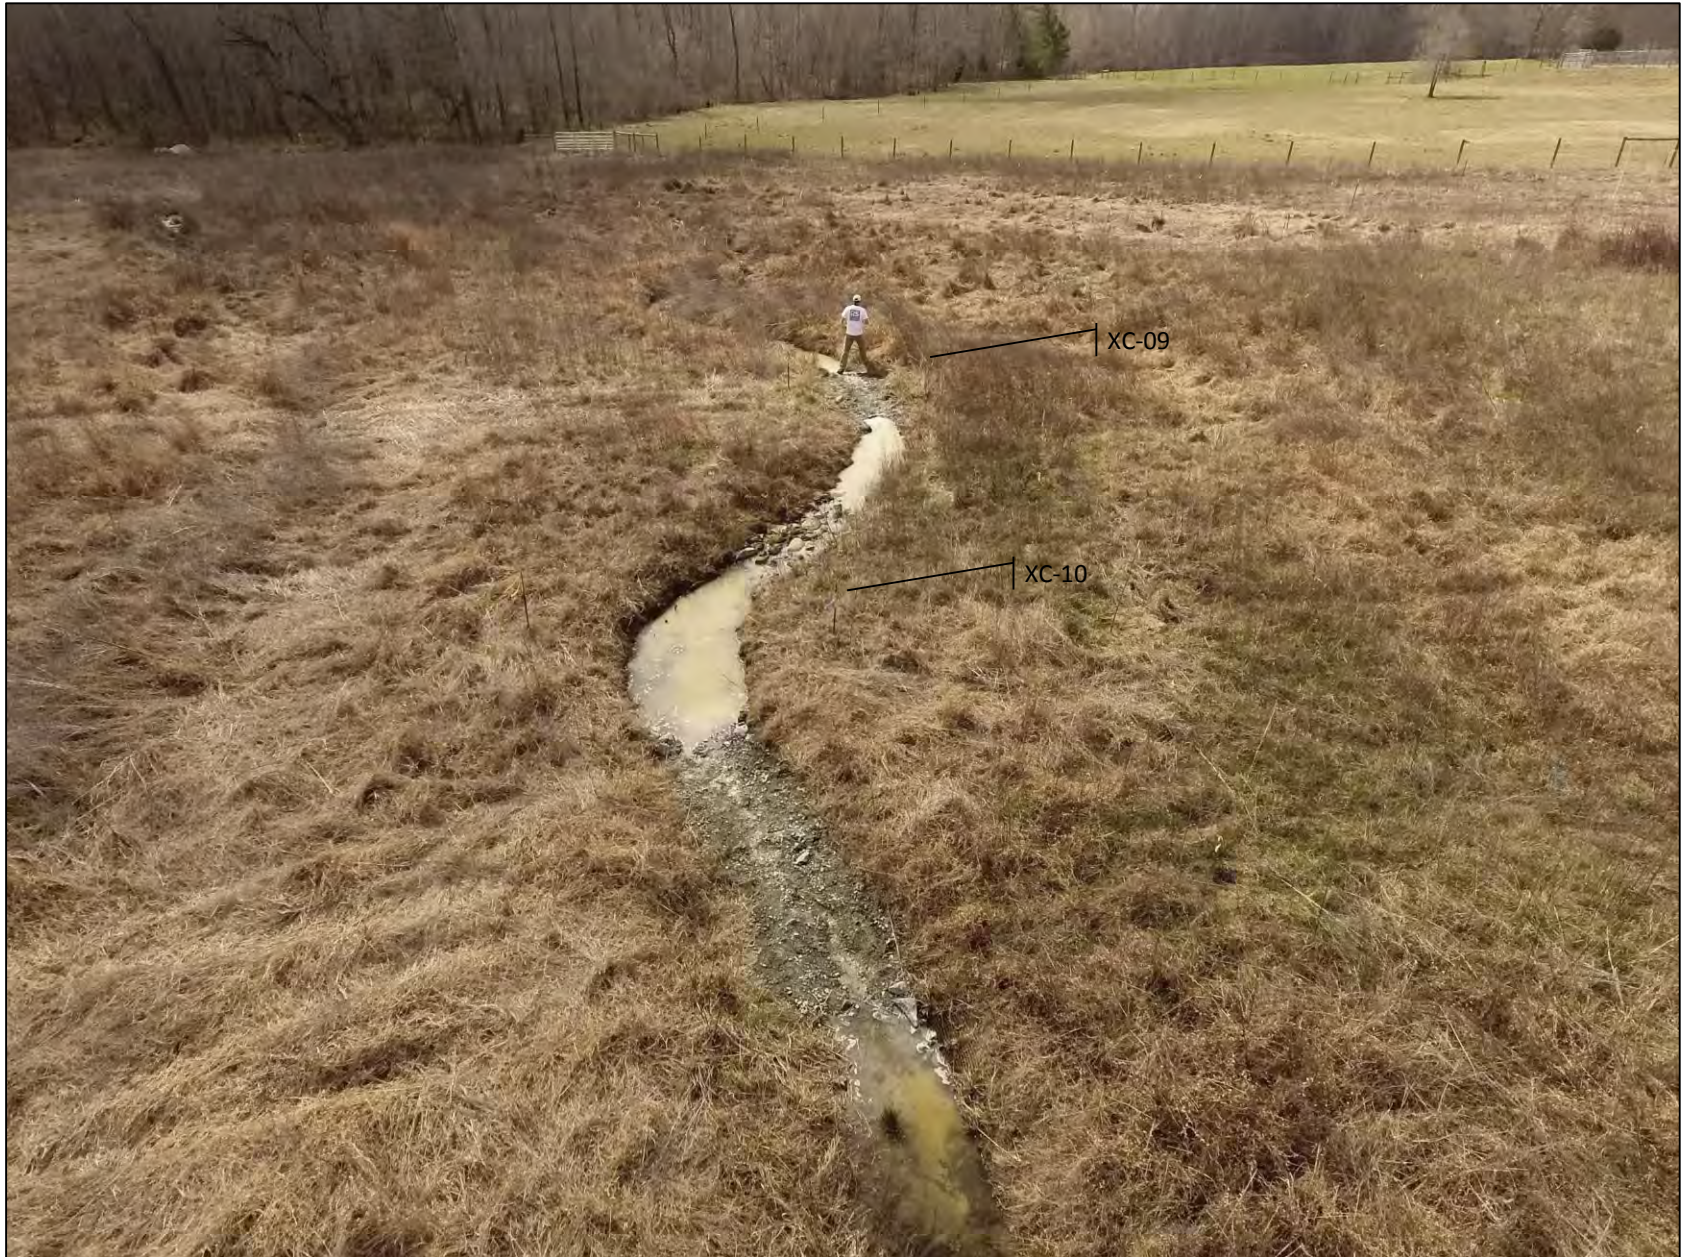
Photo 6: UT-1 looking downstream from XC-11

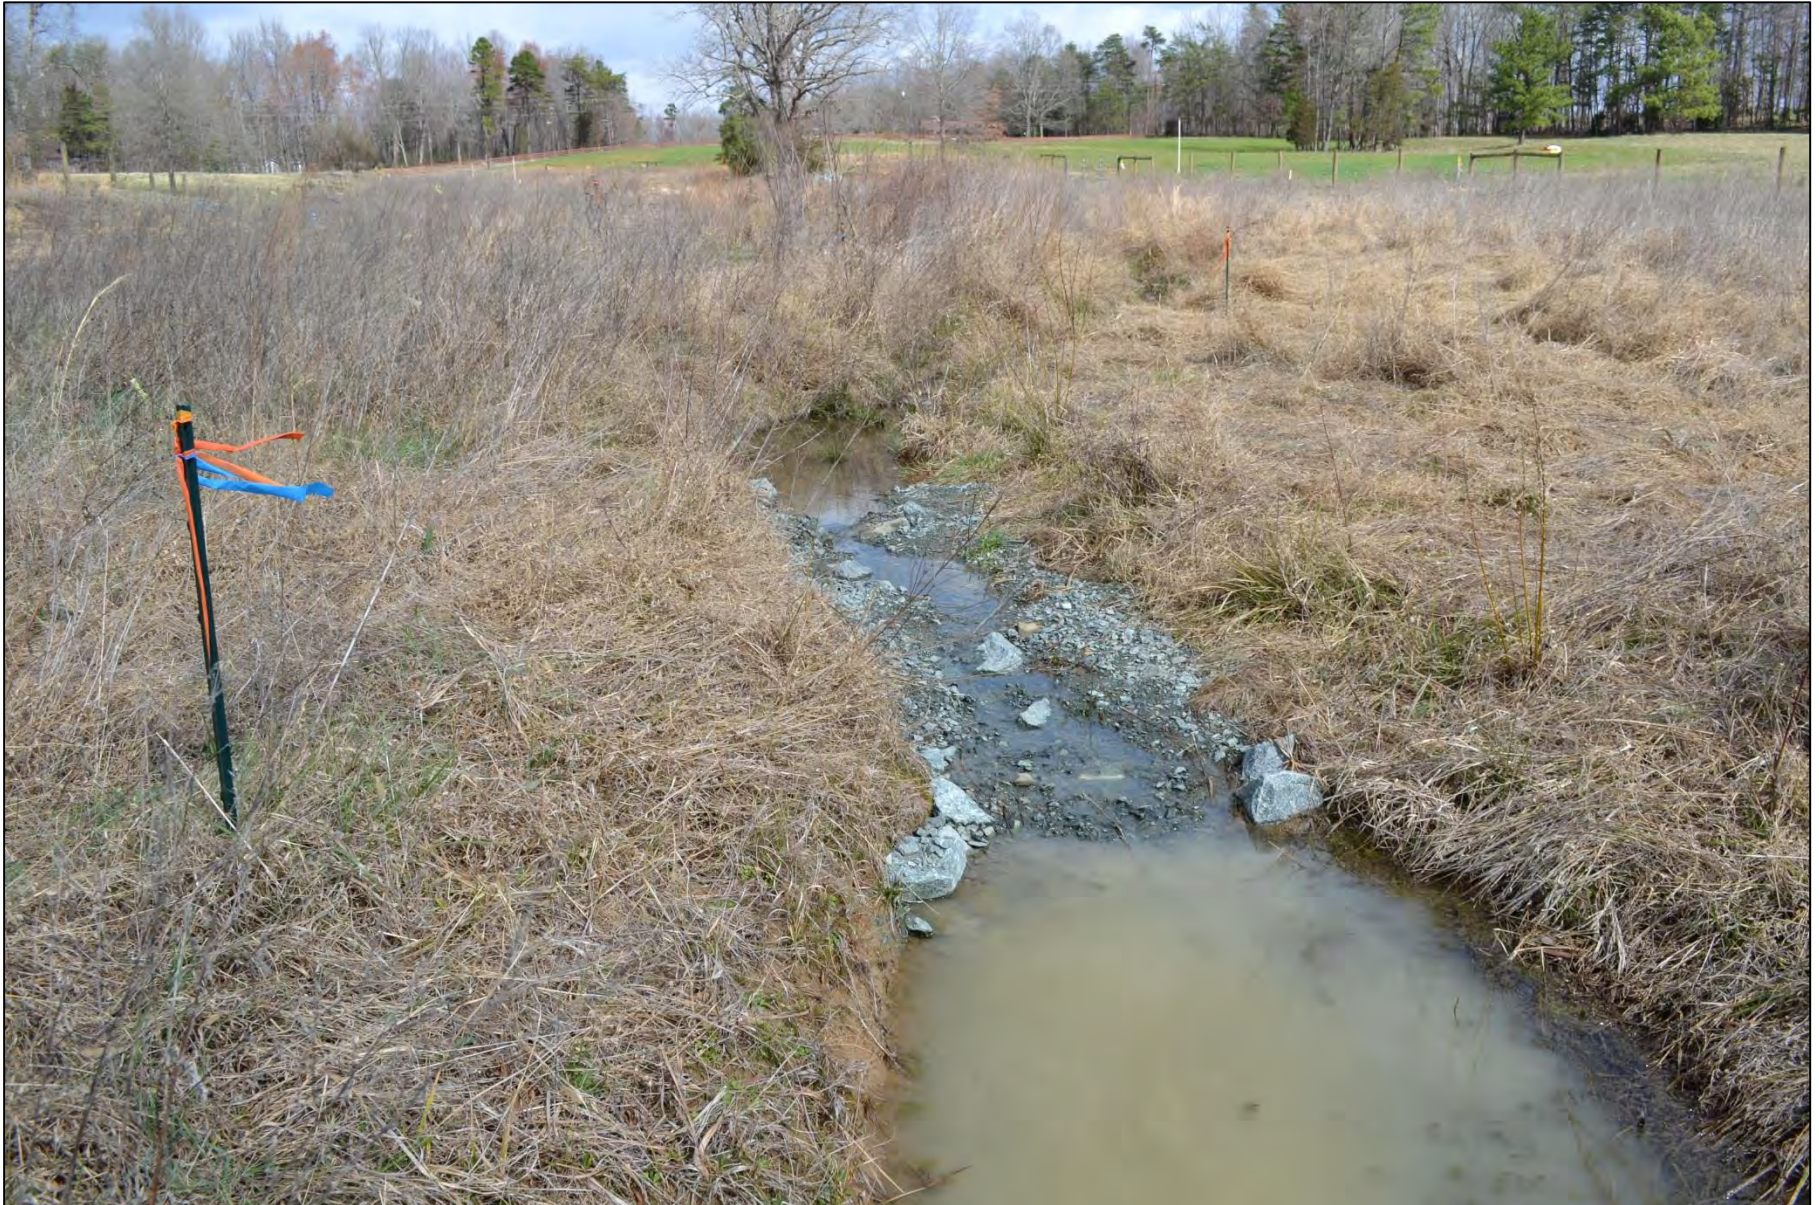
Photo 7: XC-10 – Post 3-1-2017 0.92 inch rain event (Per USGS Gauge at BUFFALO CREEK (SR2819 NR MCLEANSVILLE, NC) ~ 7 miles from Site
