YEAR 2 (2017) MONITORING REPORT
AYCOCK SPRINGS
STREAM AND WETLAND MITIGATION SITE
ALAMANCE COUNTY, NORTH CAROLINA
DMS PROJECT NO. 96312
FULL DELIVERY CONTRACT NO. 5791

CAPE FEAR RIVER BASIN
CATALOGING UNIT 03030002

Data Collection – May-October 2017

January 2018

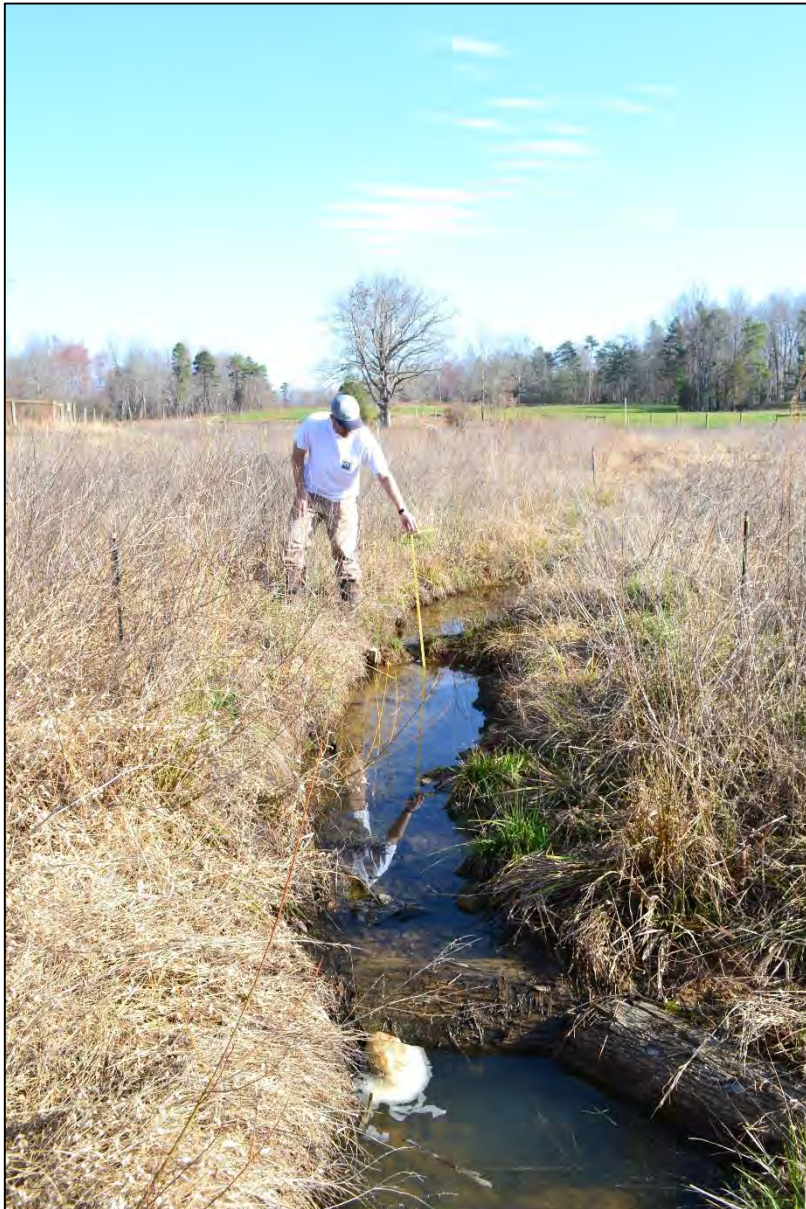
Photo 1: Substrate loss, 6" head-cut at UT 1, XC 9

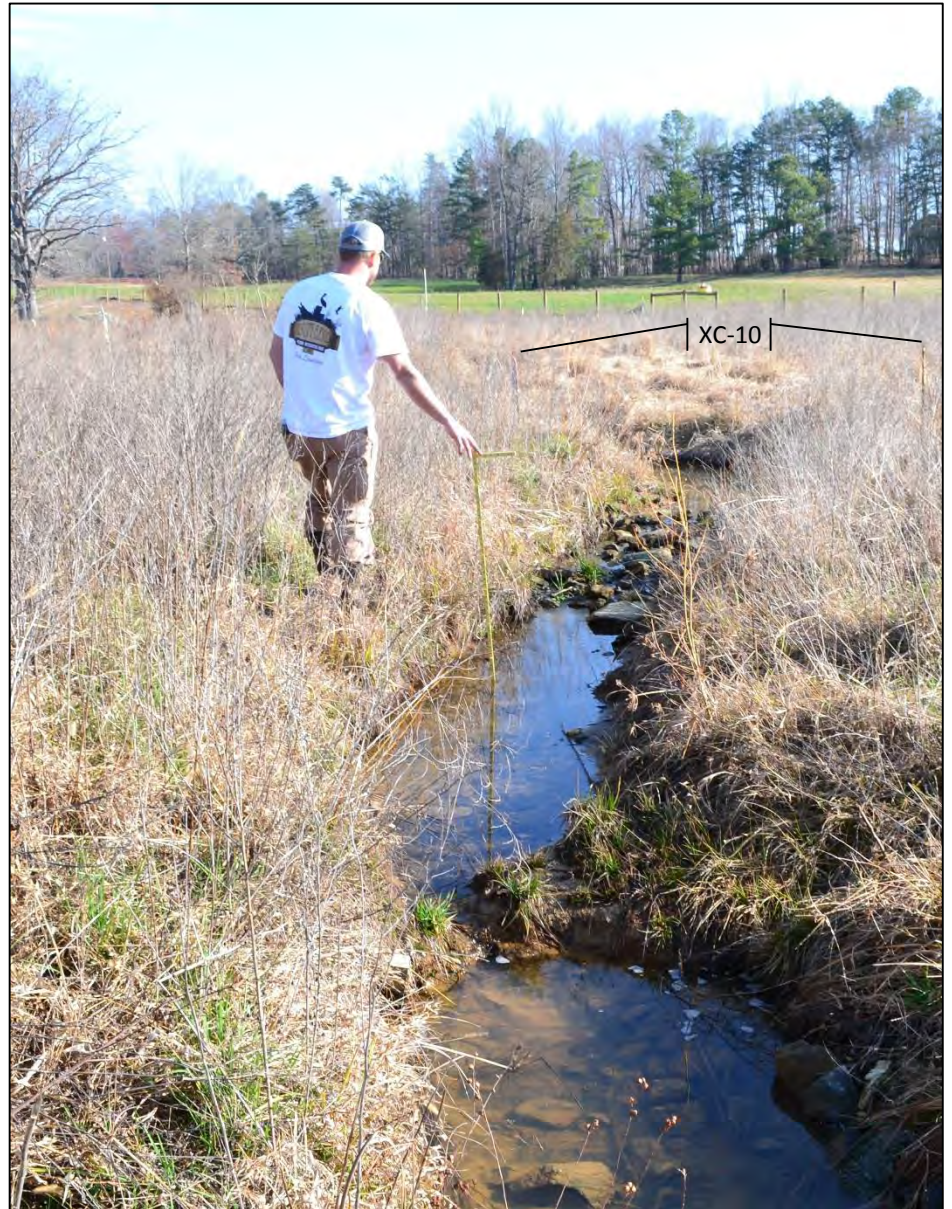
Photo 2: Pool, upstream of 6" head-cut at UT 1, XC 9 (XC 10 in background)

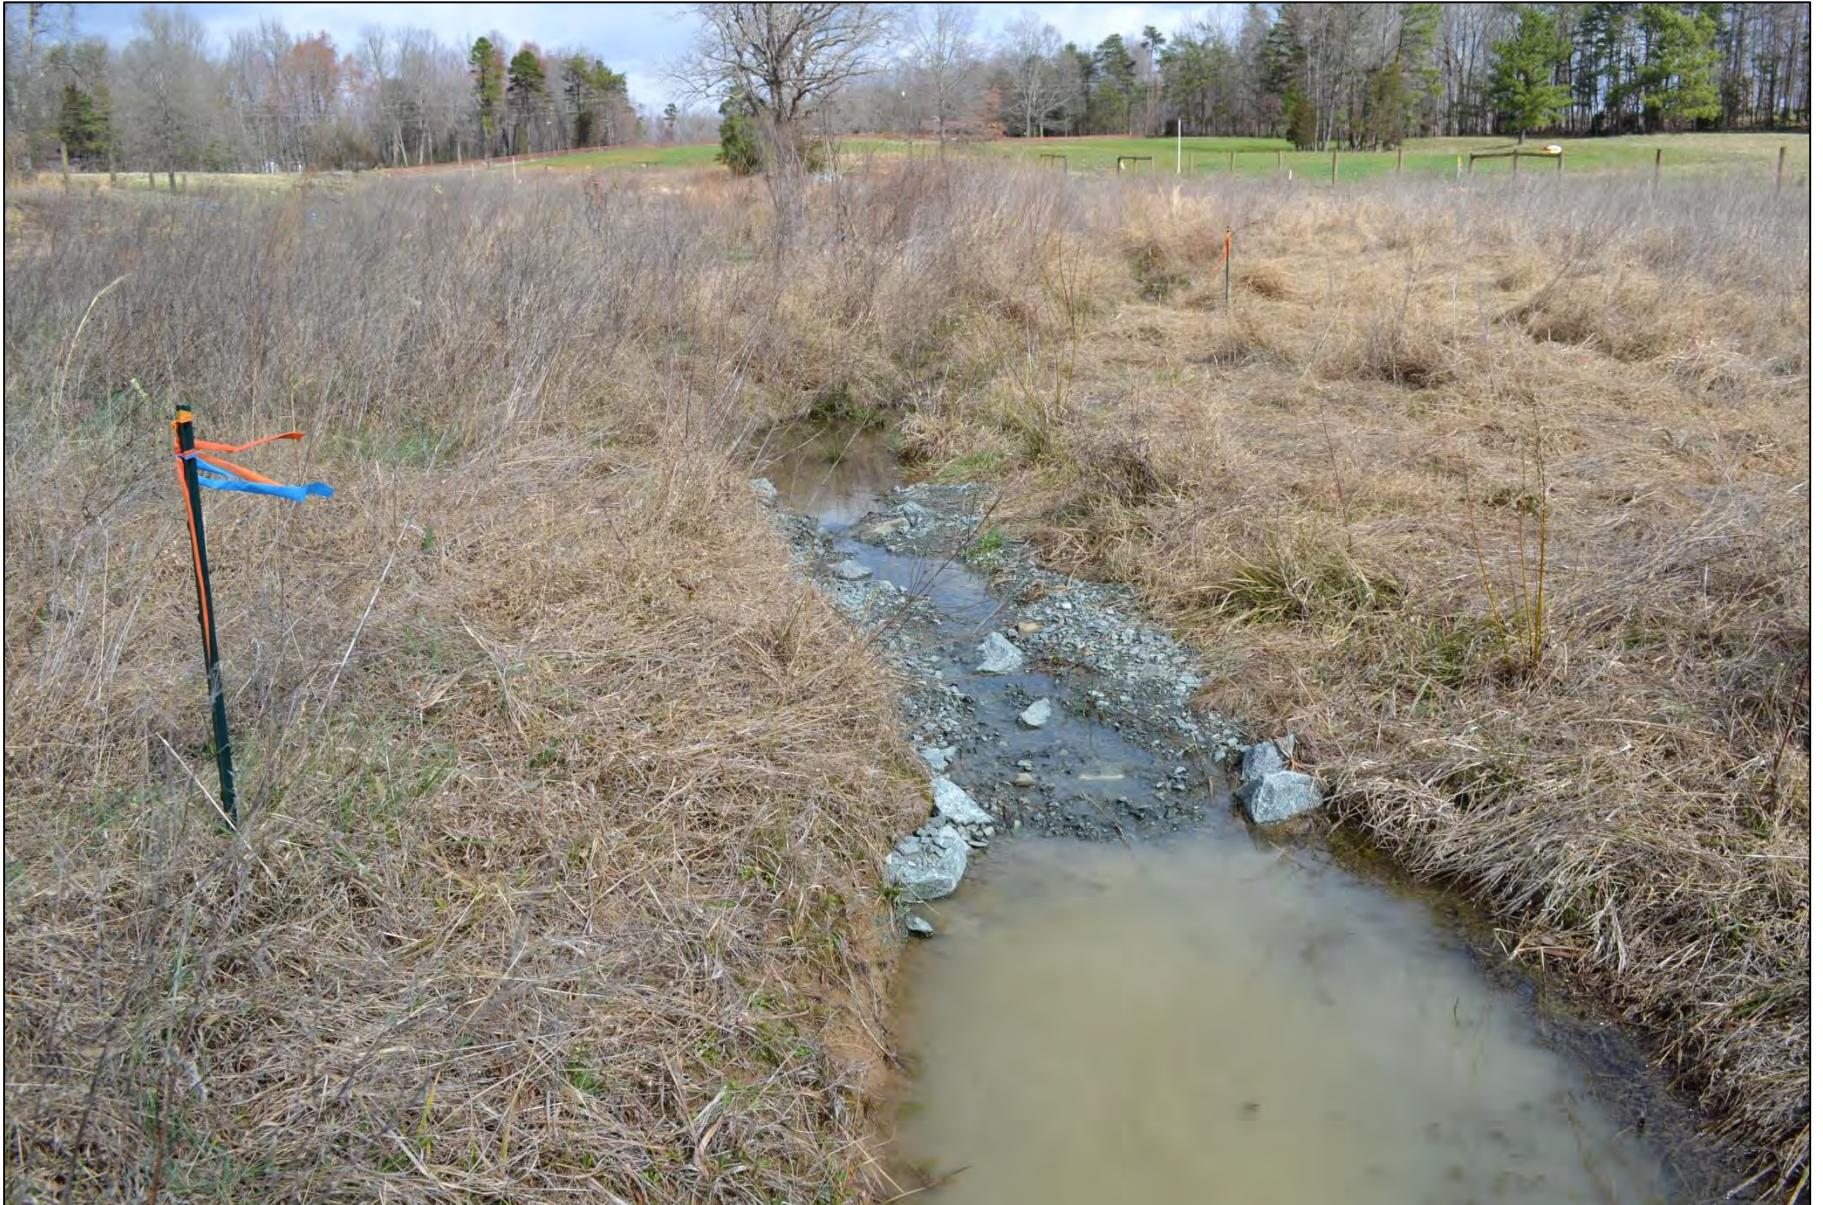
Photo 7: XC-10 – Post 3-1-2017 0.92 inch rain event (Per USGS Gauge at BUFFALO CREEK (SR2819 NR MCLEANSVILLE, NC) ~ 7 miles from Site
