YEAR 3 (2018) MONITORING REPORT
AYCOCK SPRINGS
STREAM AND WETLAND MITIGATION SITE
ALAMANCE COUNTY, NORTH CAROLINA
DMS PROJECT NO. 96312
FULL DELIVERY CONTRACT NO. 5791

CAPE FEAR RIVER BASIN
CATALOGING UNIT 03030002

Data Collection – May-October 2018

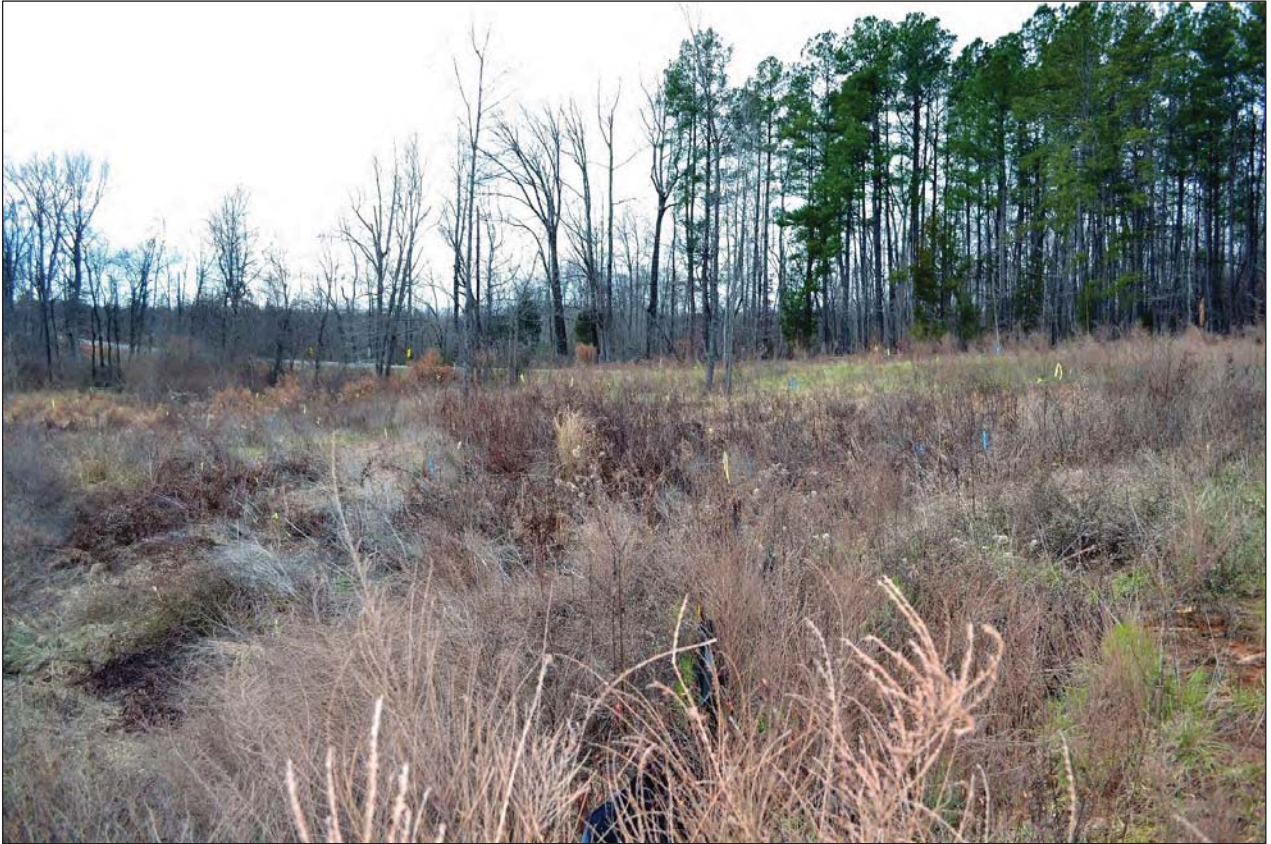
Photo 1: Looking SW. along Replant Area -1

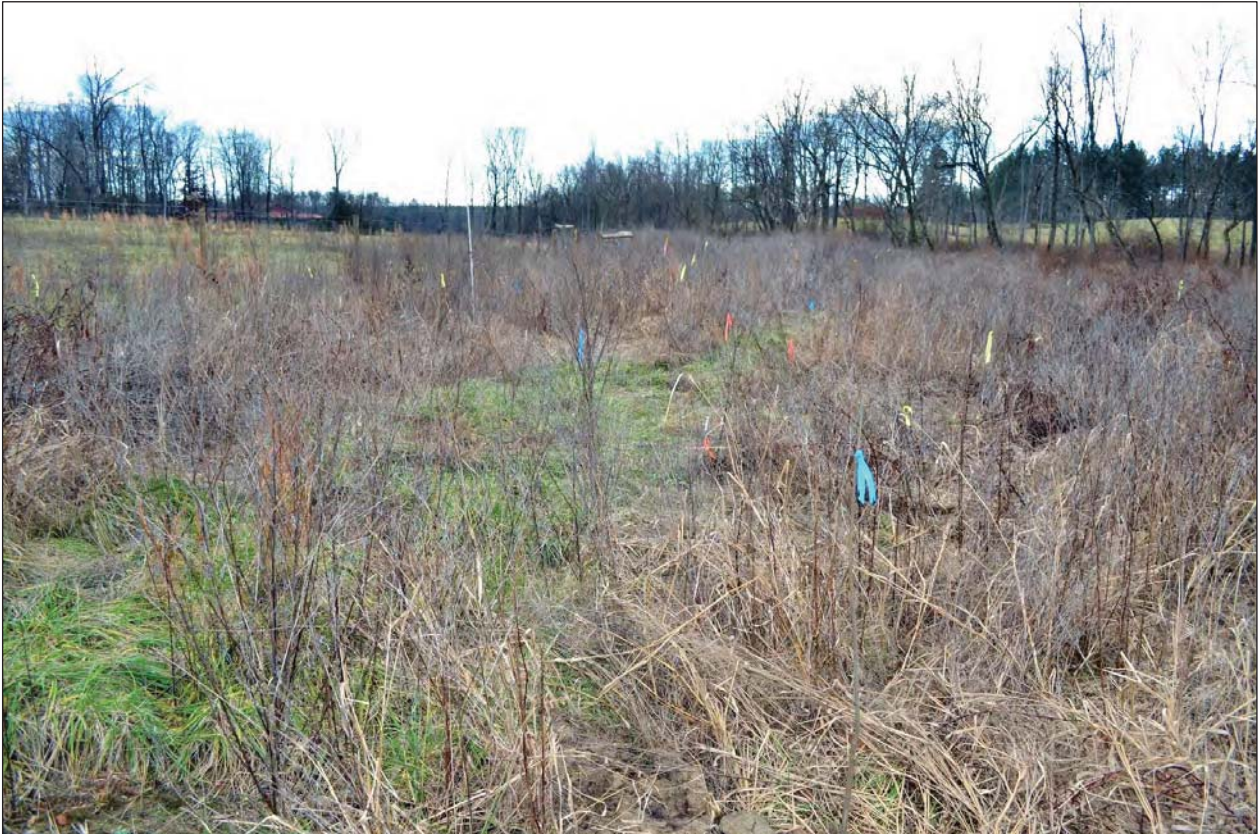
Photo 2: Looking S. in Replant Area 2, just N. of veg. plot 14

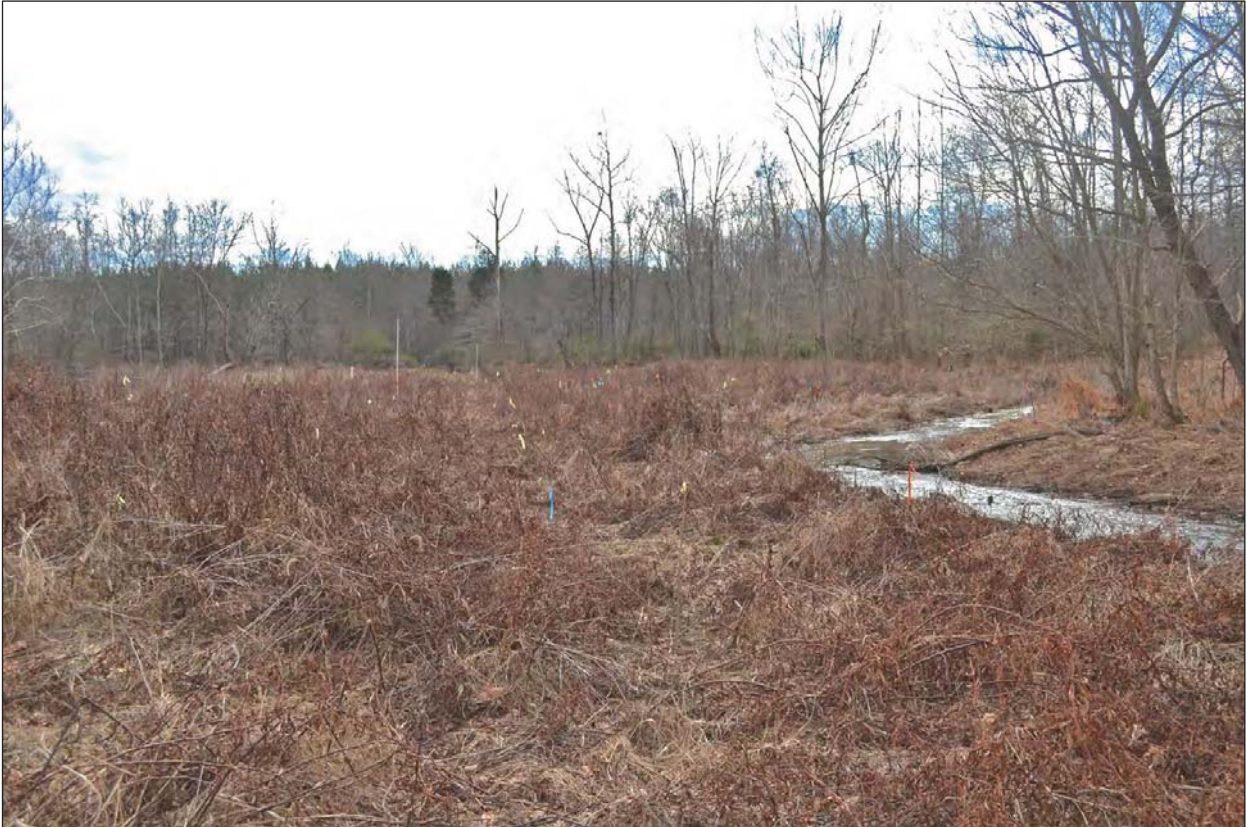
Photo 3: Looking SE. in Replant Area 4, near veg. plot 9

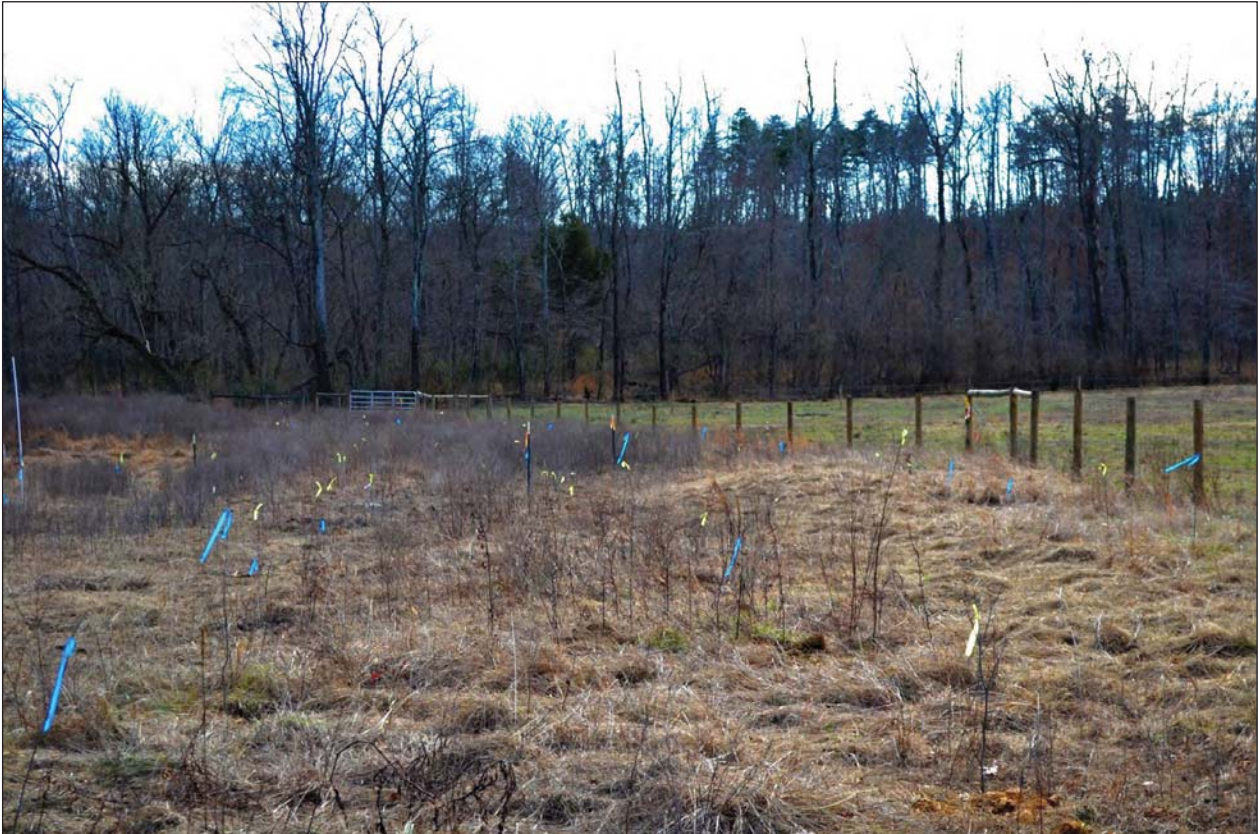
Photo 5: Looking S. in Replant Area 5, N. of veg. plot 5

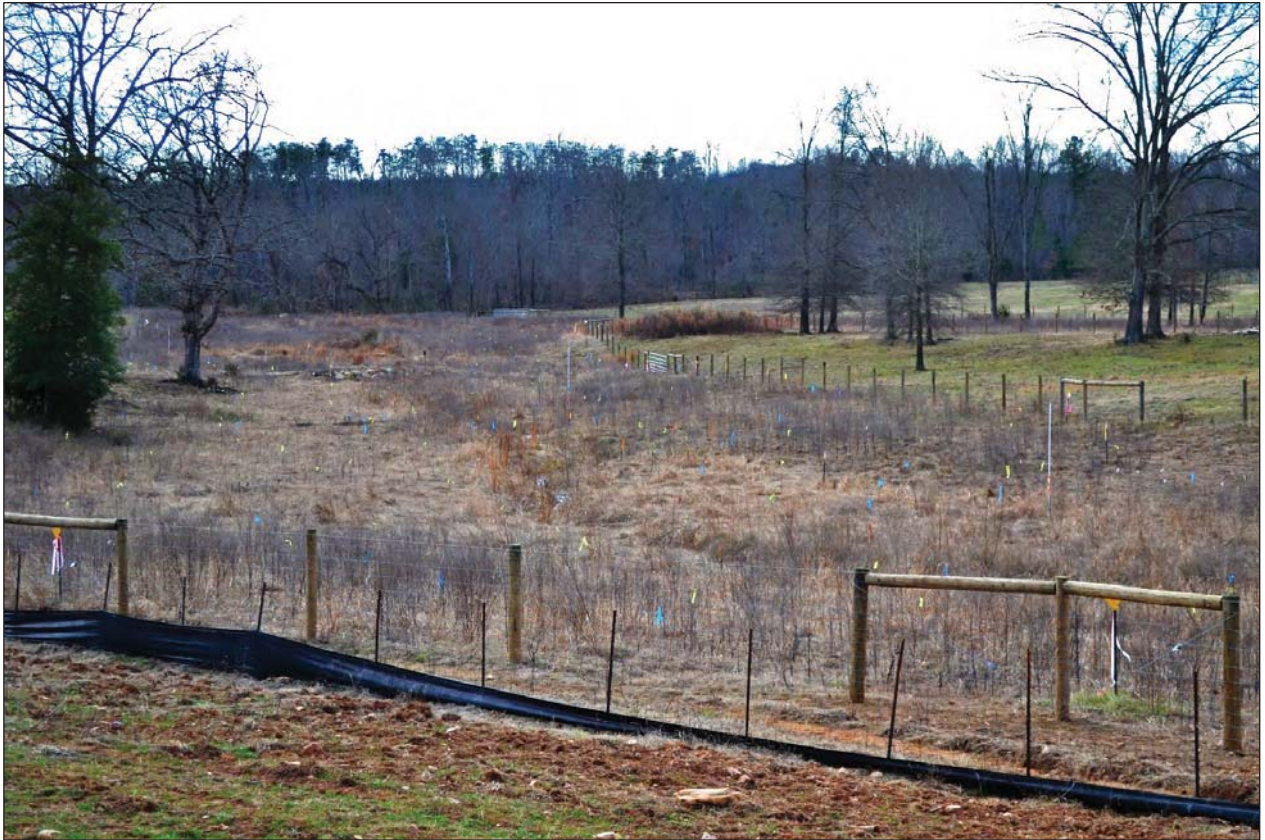
Photo 4: Looking S. in Replant Area 6, from outside of the easement

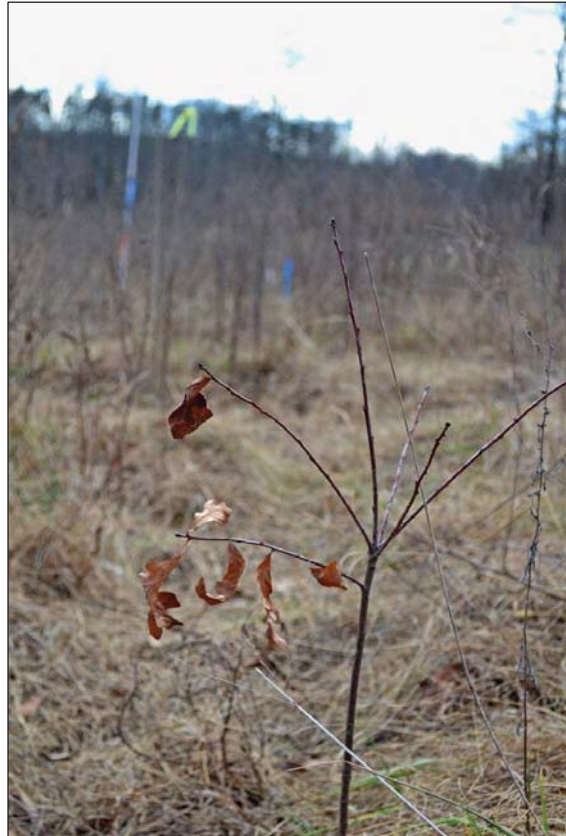
Photo 6 / 7: Live stake establishment on bank in Replant area 6

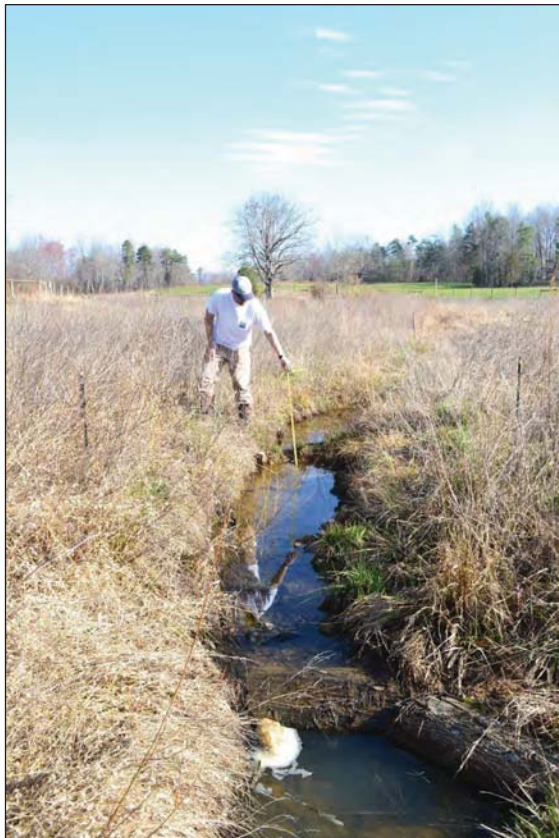
The degradation observed during Year 1 (2016) in and adjacent to cross-sections 9 and 10 on UT-1 encompasses approximately 12 linear feet and 15 linear feet of stream, respectively (<1 percent of the project length). As noted above, bed material placed during construction was too fine. All of UT-1 used bed material harvested on-site. The material used along these stream reaches was too fine and washed from the riffles during heavy rainfall events, resulting in minor bed scour and a small, less than 6 inch head cut beginning to develop at the top of riffle. Suitable sized channel bed material was installed on February 23, 2017 at the proper elevation in the two riffles within UT-1. Bed material was installed such that bank toe protection is provided and planting with willow stakes will occur. Bank toe protection designates that channel bed material will extend up the lower one-third of the bank. This will be monitored by existing established cross-sections 9 and 10.

Photo 1: Substrate loss, 6" head-cut at UT 1, XC 9

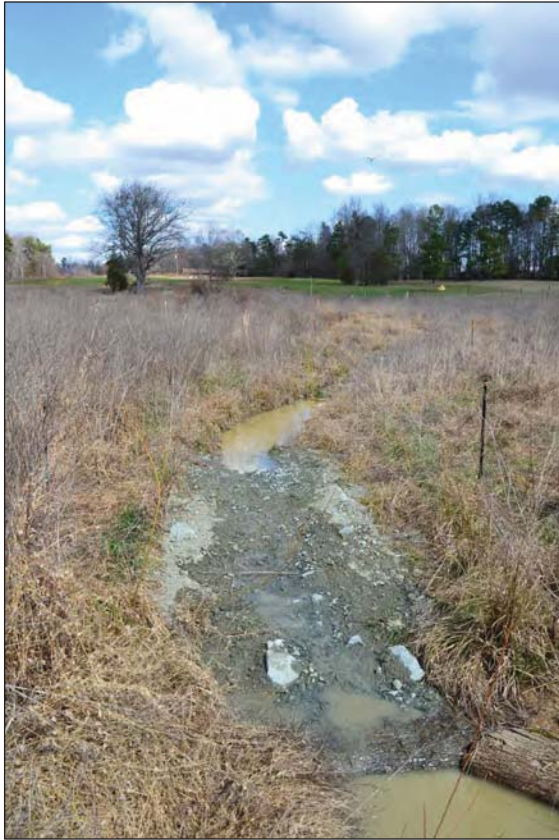
Photo 2: Pool, upstream of 6" head-cut at UT 1, XC 9 (XC 10 in background)

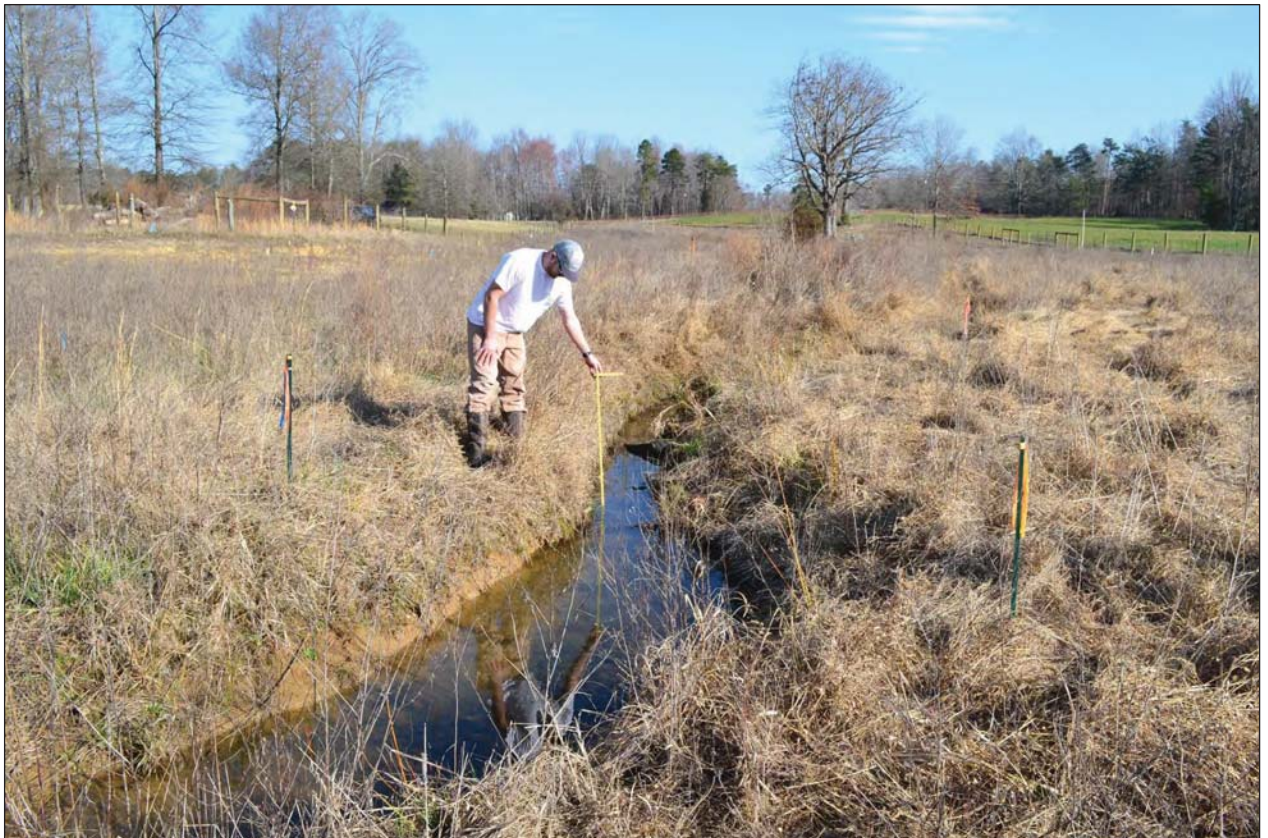
Photo 3: Substrate loss, upstream riffle of XC 10 (pool)

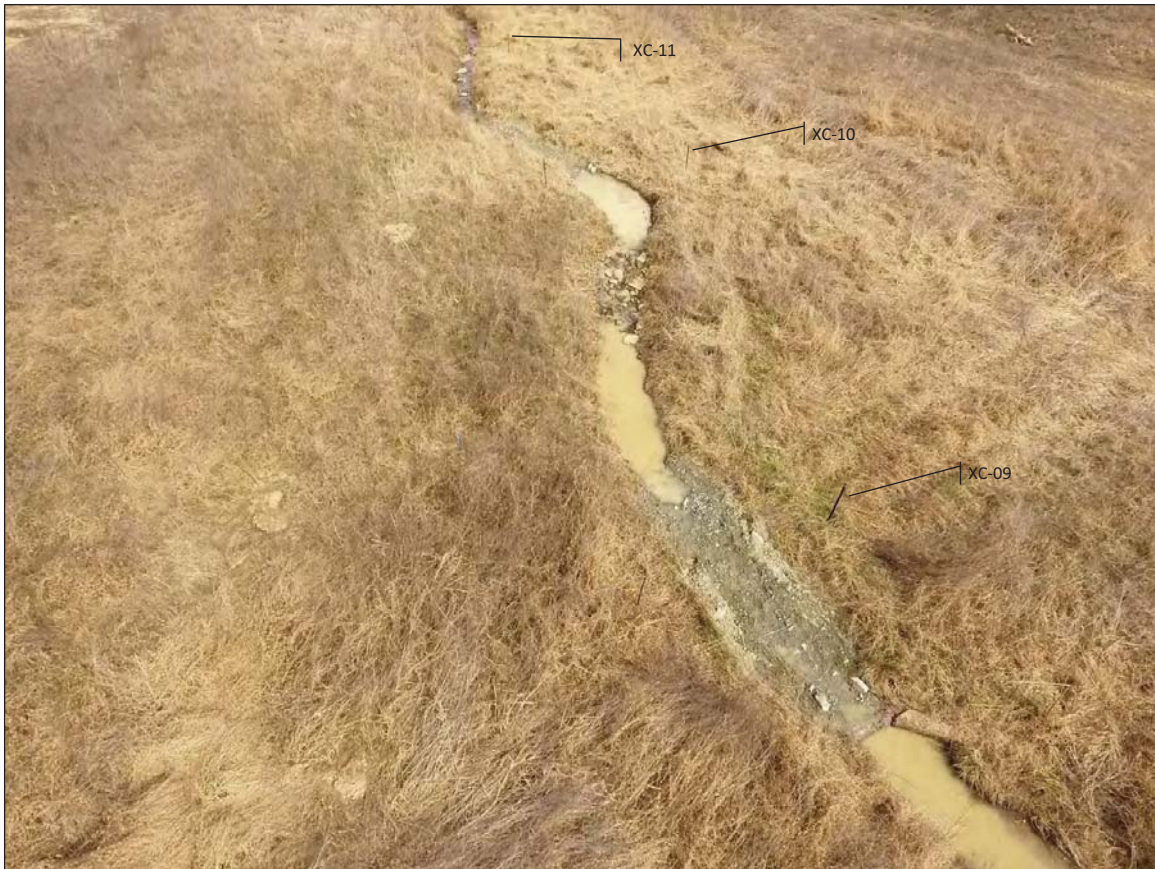
Photo 5: post replacement overview

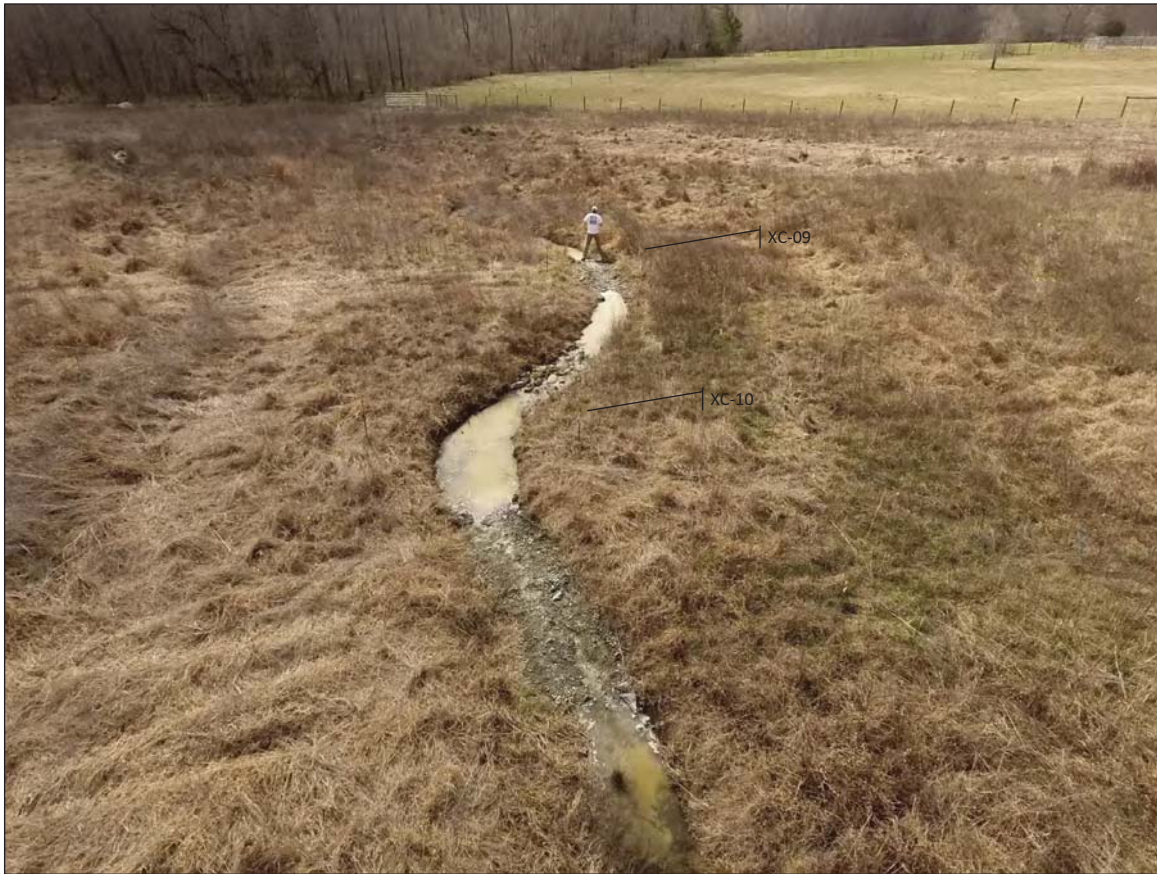
Photo 6: UT-1 looking downstream from XC-11

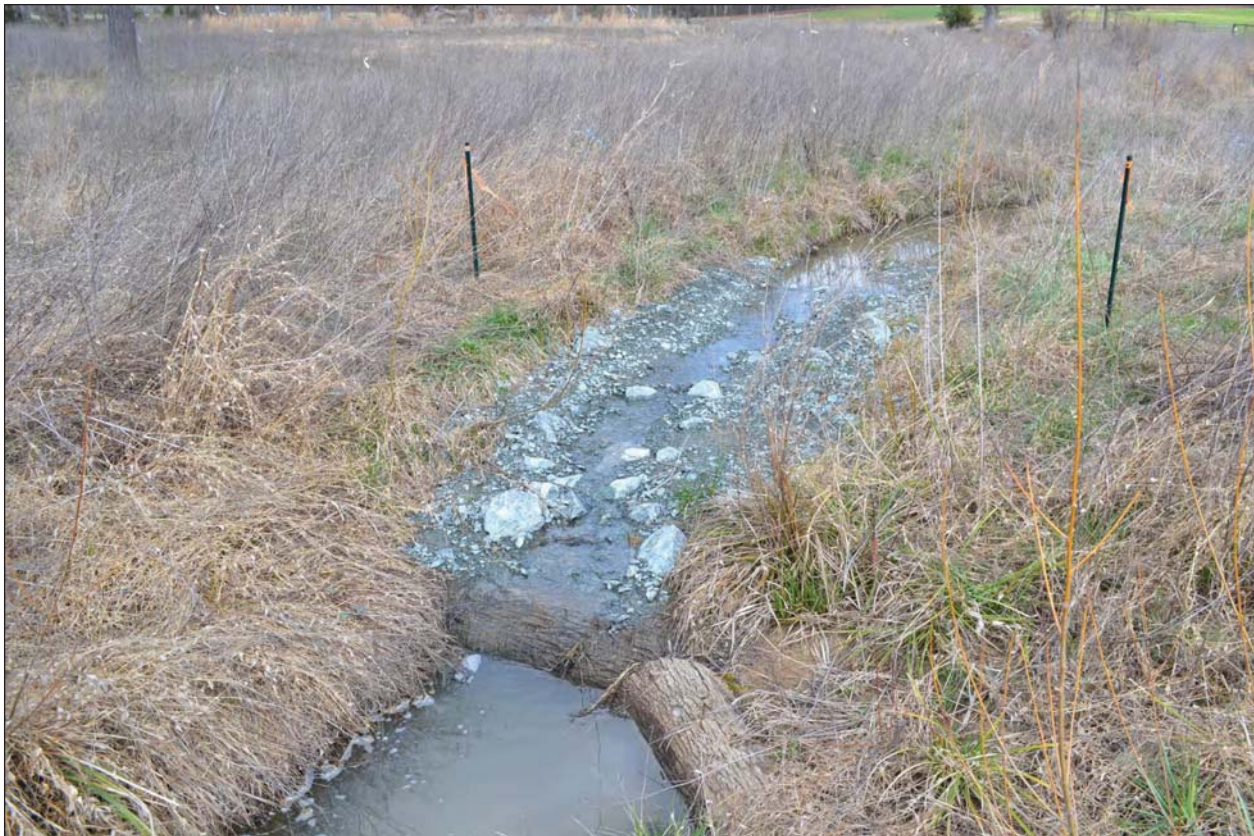
Photo 7: XC-9 – Post 3-1-2017 0.92 inch rain event (Per USGS Guage at BUFFALO CREEK (SR2819 NR MCLEANSVILLE, NC) ~ 7 miles from Site

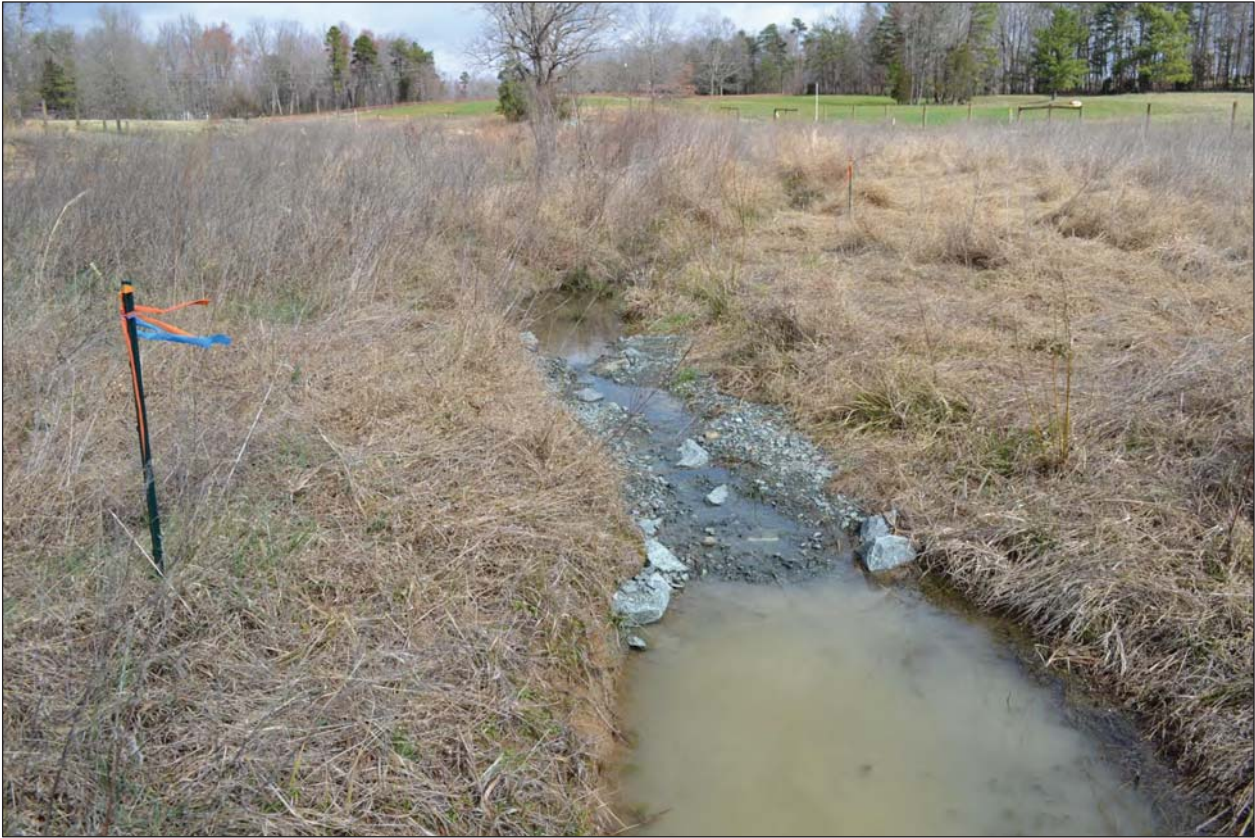
Photo 7: XC-10 – Post 3-1-2017 0.92 inch rain event (Per USGS Guage at BUFFALO CREEK (SR2819 NR MCLEANSVILLE, NC) ~ 7 miles from Site

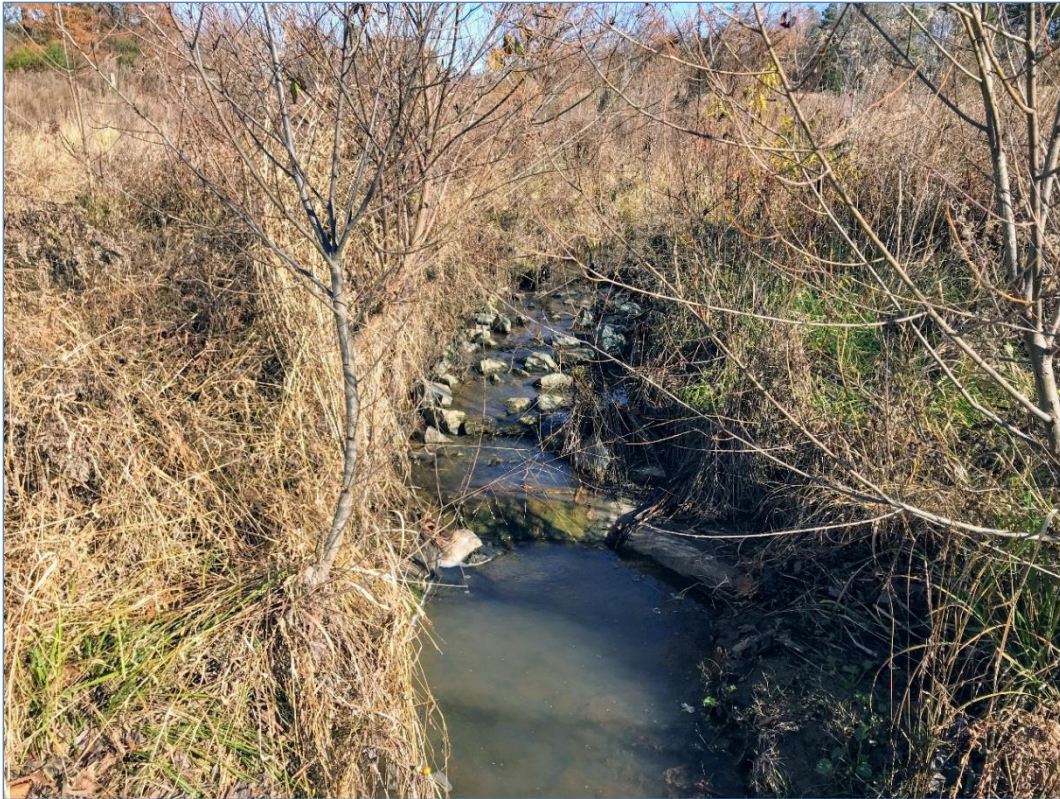
Photo 3: 02-23-2017 Repair near UT-1 XC 9

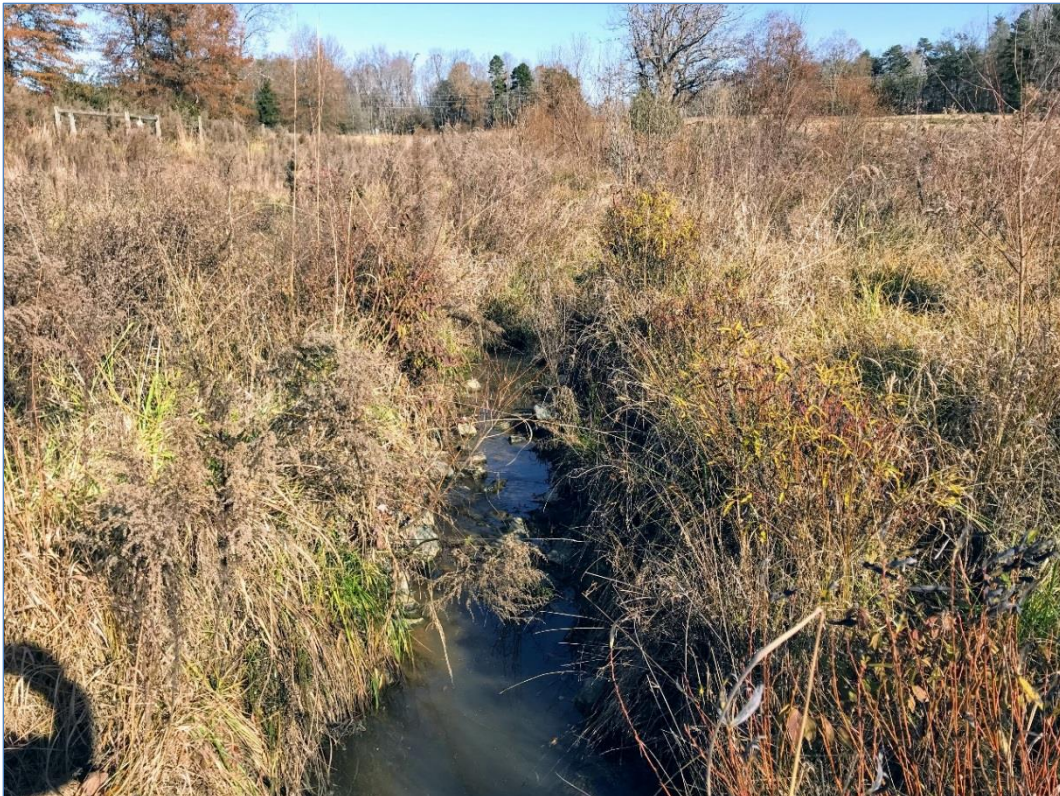
Photo 4: 02-23-2017 Repair near UT-1 XC 10

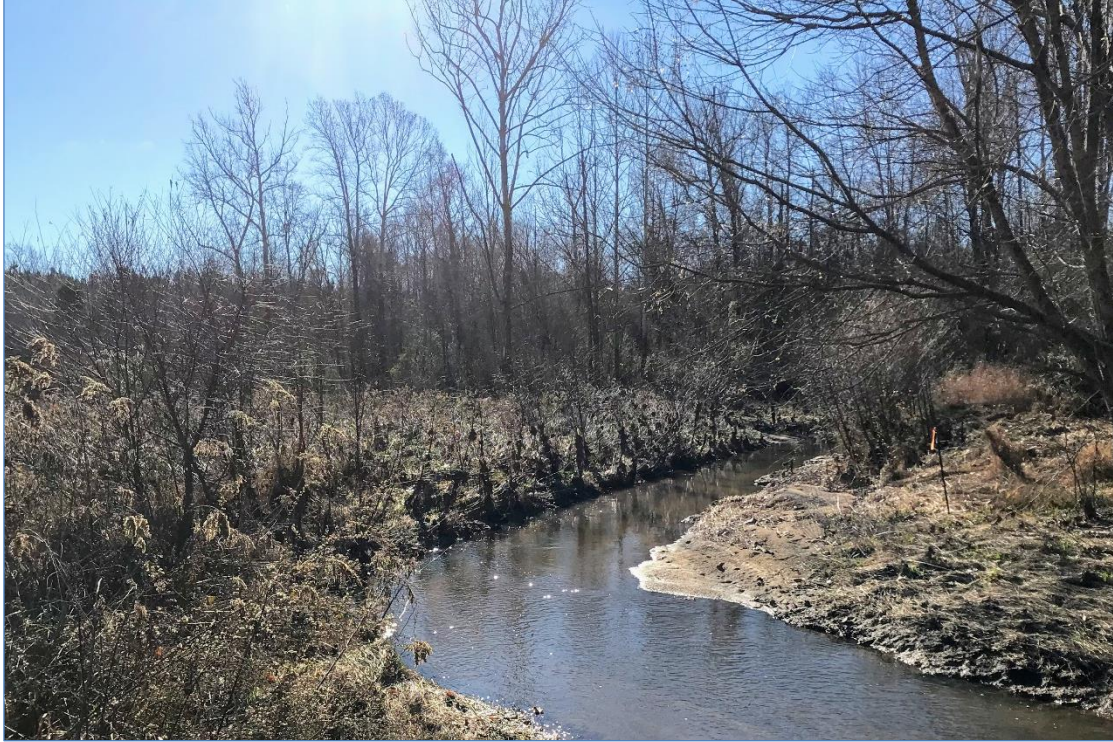
Photo 5: Travis Creek XS-3P (Rack litter along willows)
