YEAR 4 (2019) MONITORING REPORT
AYCOCK SPRINGS
STREAM AND WETLAND MITIGATION SITE

ALAMANCE COUNTY, NORTH CAROLINA
DMS PROJECT No. 96312
FULL DELIVERY CONTRACT No. 5791
NCDWR PROJECT No. 20140335
USACE ACTION ID No. SAW-2014-01711

Data Collection – May-November 2019

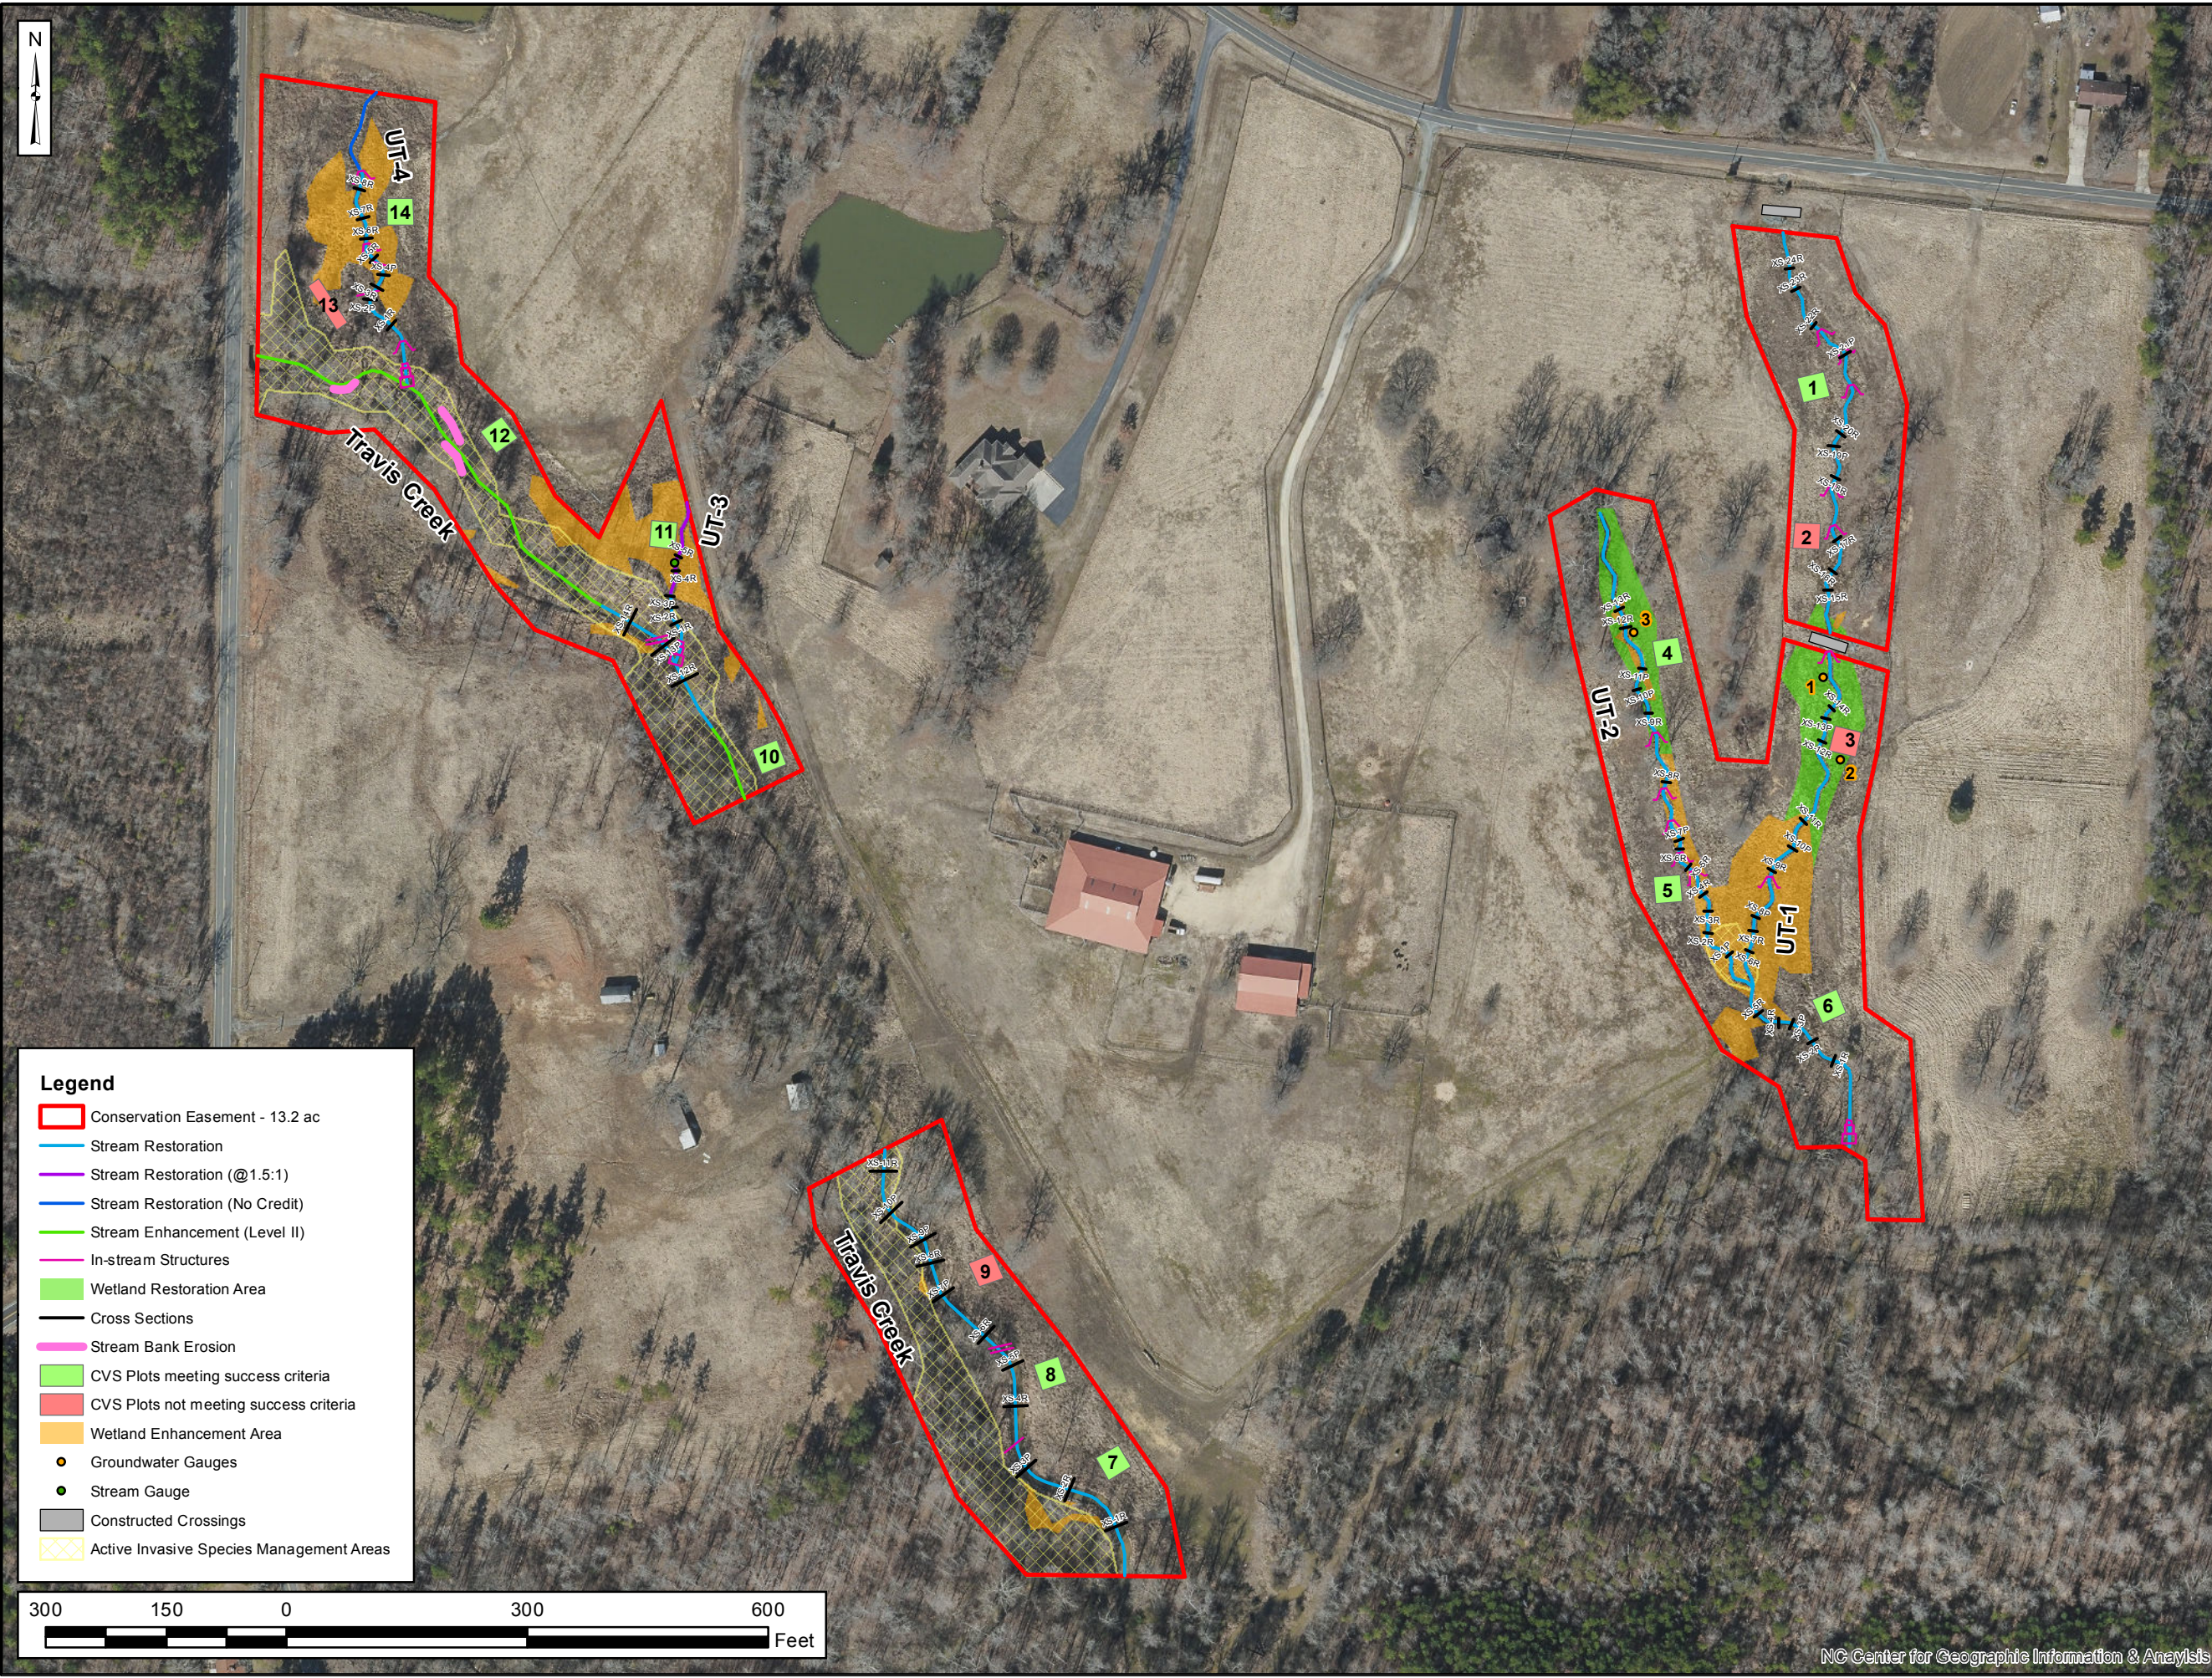
Figure 2. Current Conditions Plan View (CCPV)

- a. Figure 2 – Please update the CCPV to differentiate between Restoration, Enhancement II, etc. Also, the surface water gauge for UT3 is not shown on the map.
The stream layer was updated to differentiate between mitigation types. The surface gauge is also now visible.

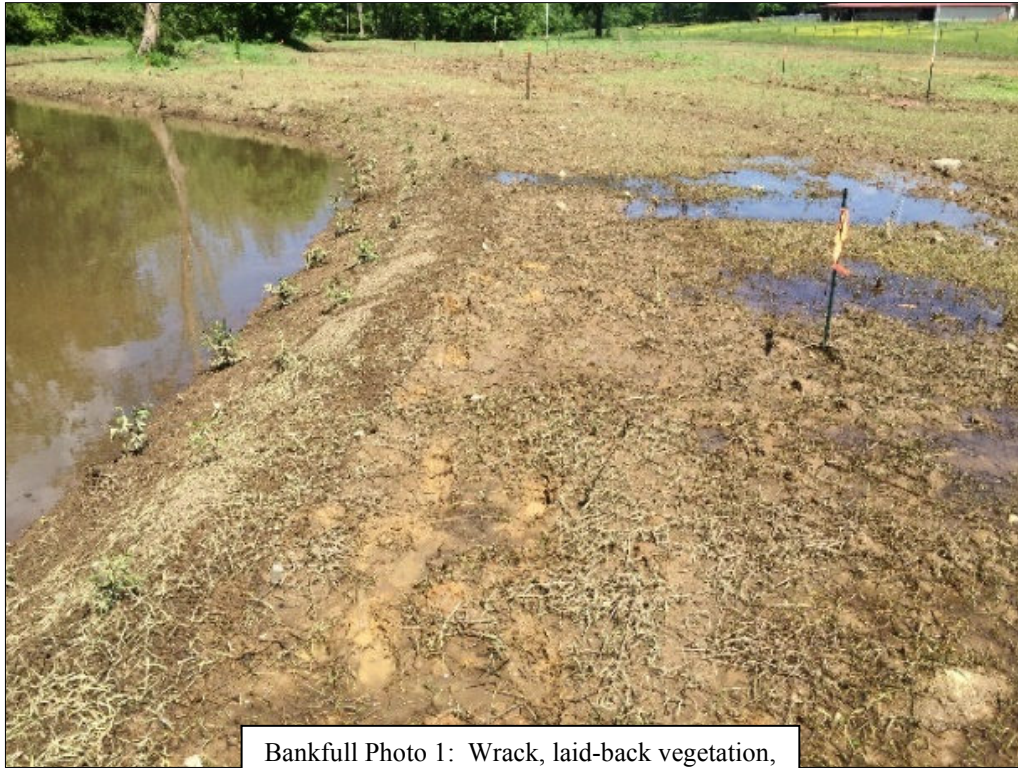
Bankfull Photo 1: Wrack, laid-back vegetation, and sediment in the floodplain of Travis Creek

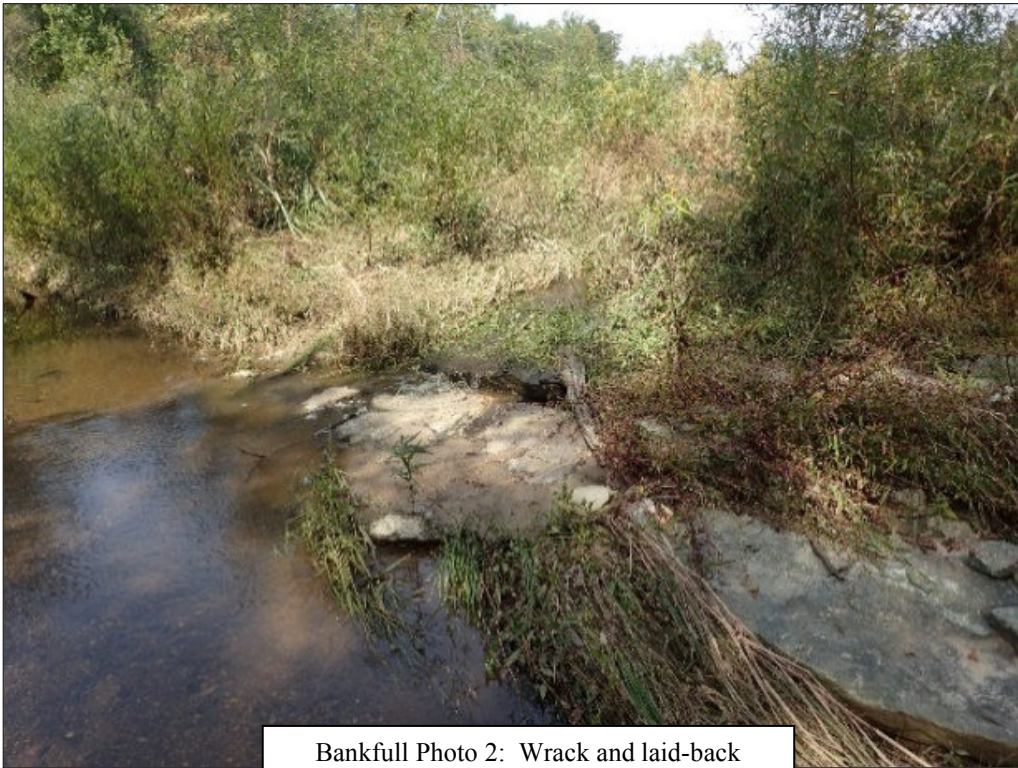
Bankfull Photo 2: Wrack and laid-back vegetation on the top of bank of Travis Creek

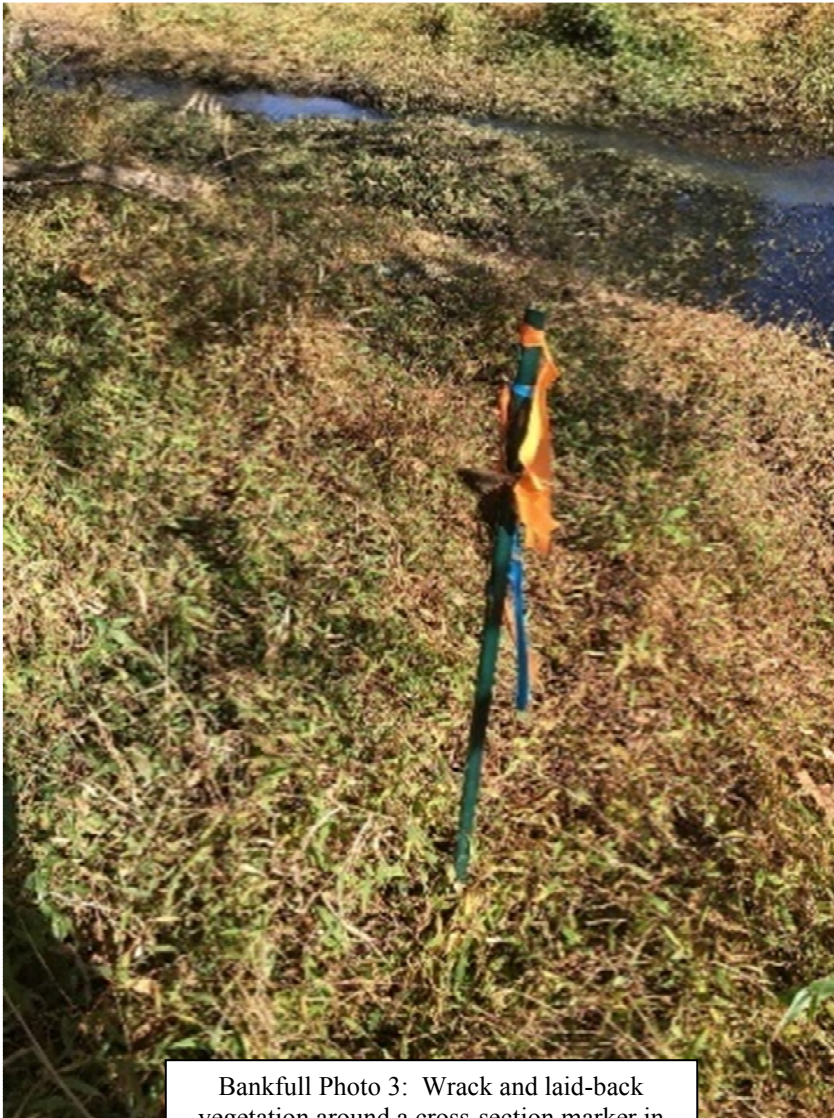
Bankfull Photo 3: Wrack and laid-back vegetation around a cross-section marker in the floodplain of Travis Creek

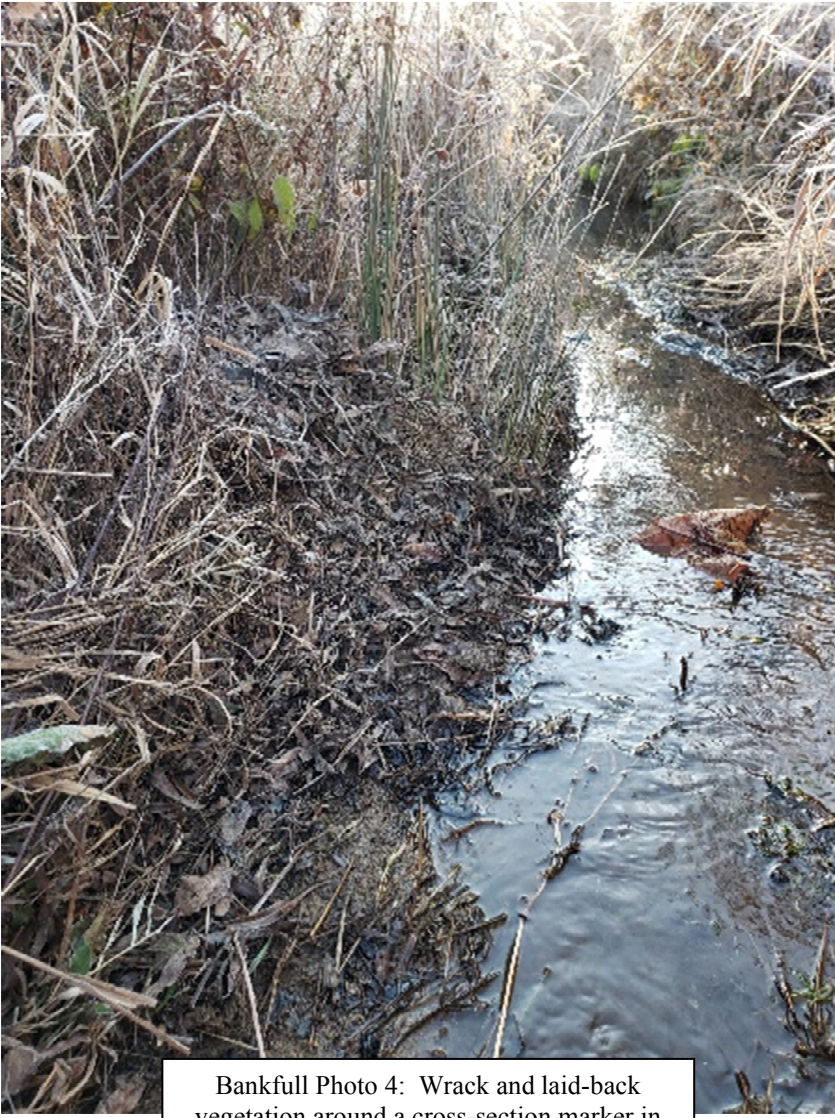
Bankfull Photo 4: Wrack and laid-back vegetation around a cross-section marker in the floodplain of UT1
