YEAR 5 (2020) MONITORING REPORT
AYCOCK SPRINGS
STREAM AND WETLAND MITIGATION SITE
ALAMANCE COUNTY, NORTH CAROLINA
DMS PROJECT No. 96312
FULL DELIVERY CONTRACT No. 5791
NCDWR PROJECT No. 20140335
USACE ACTION ID No. SAW-2014-01711

CAPE FEAR RIVER BASIN
CATALOGING UNIT 03030002

Aycock Springs Year 5, 2020 Monitoring Summary

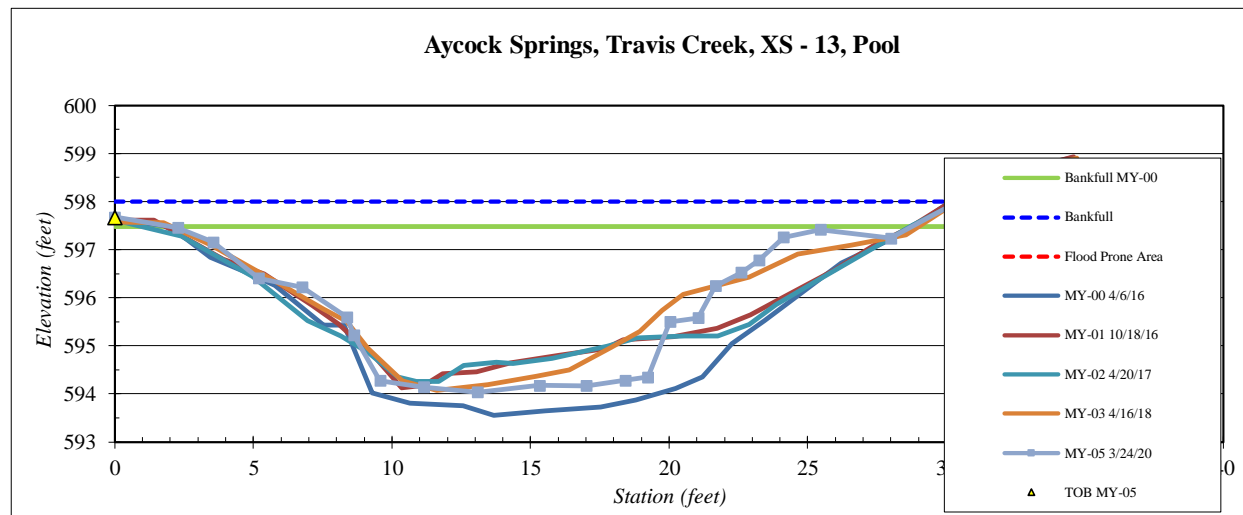
Note: Sediment Deposition in pool appears natural and is not expected to lead to instability.

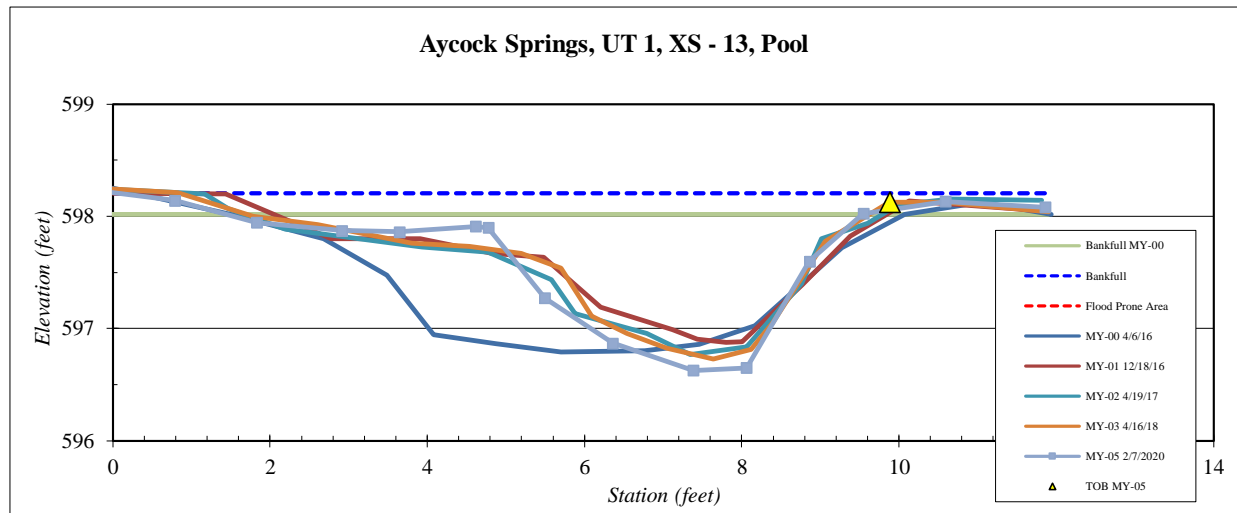
Note: Point bar development appears stable through year 5 monitoring.

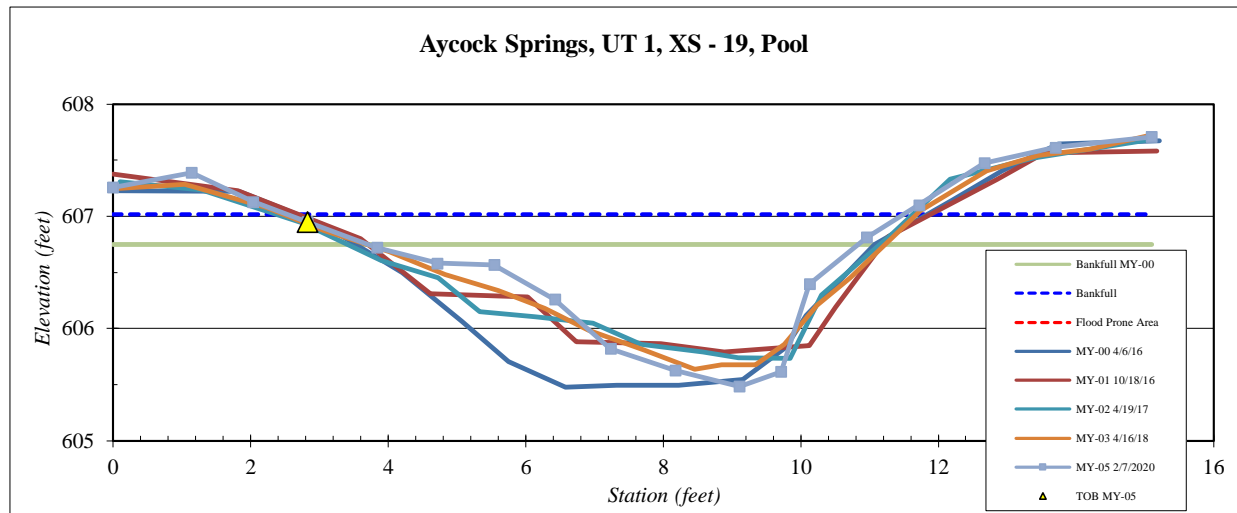
Note: Point bar development appears stable through year 5 monitoring.

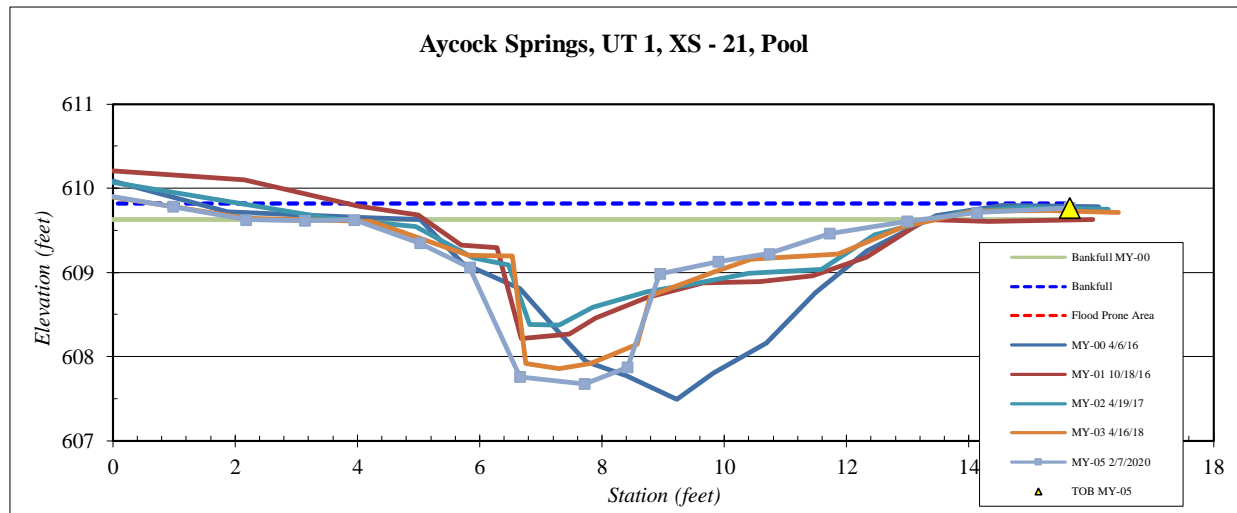
Note: Point bar development appears stable through year 5 monitoring.

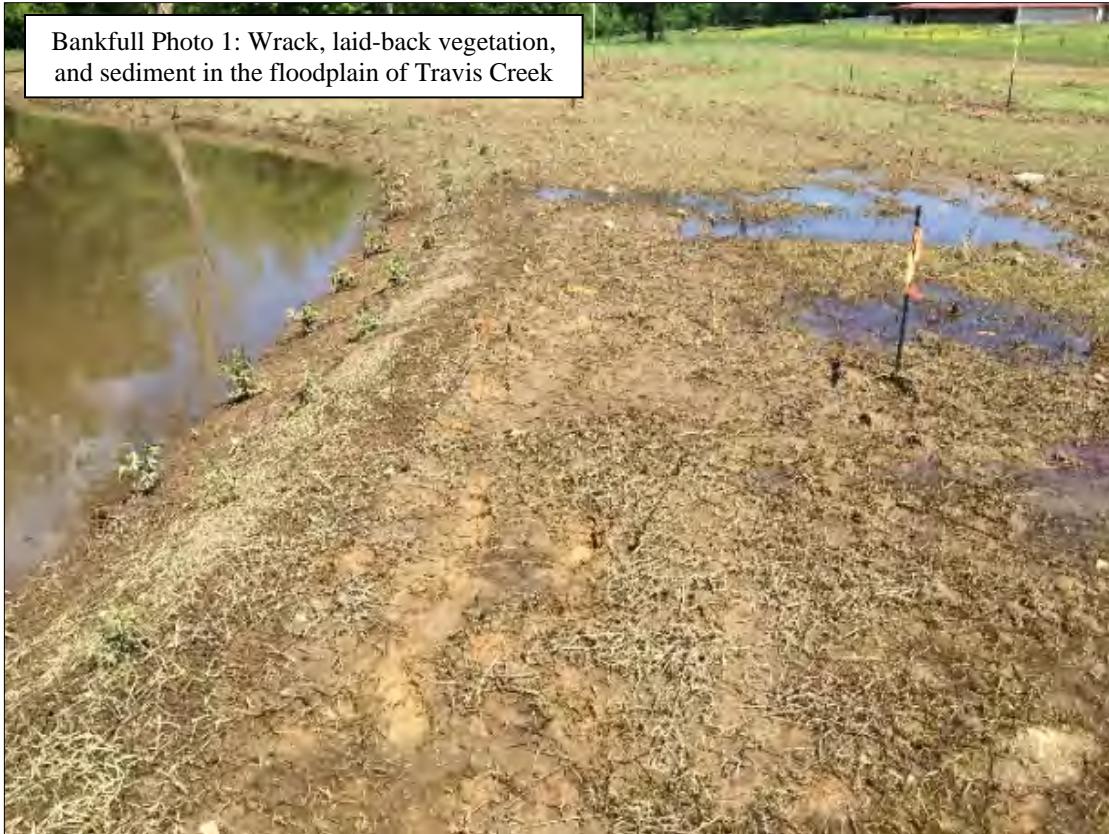
Bankfull Photo 1: Wrack, laid-back vegetation, and sediment in the floodplain of Travis Creek

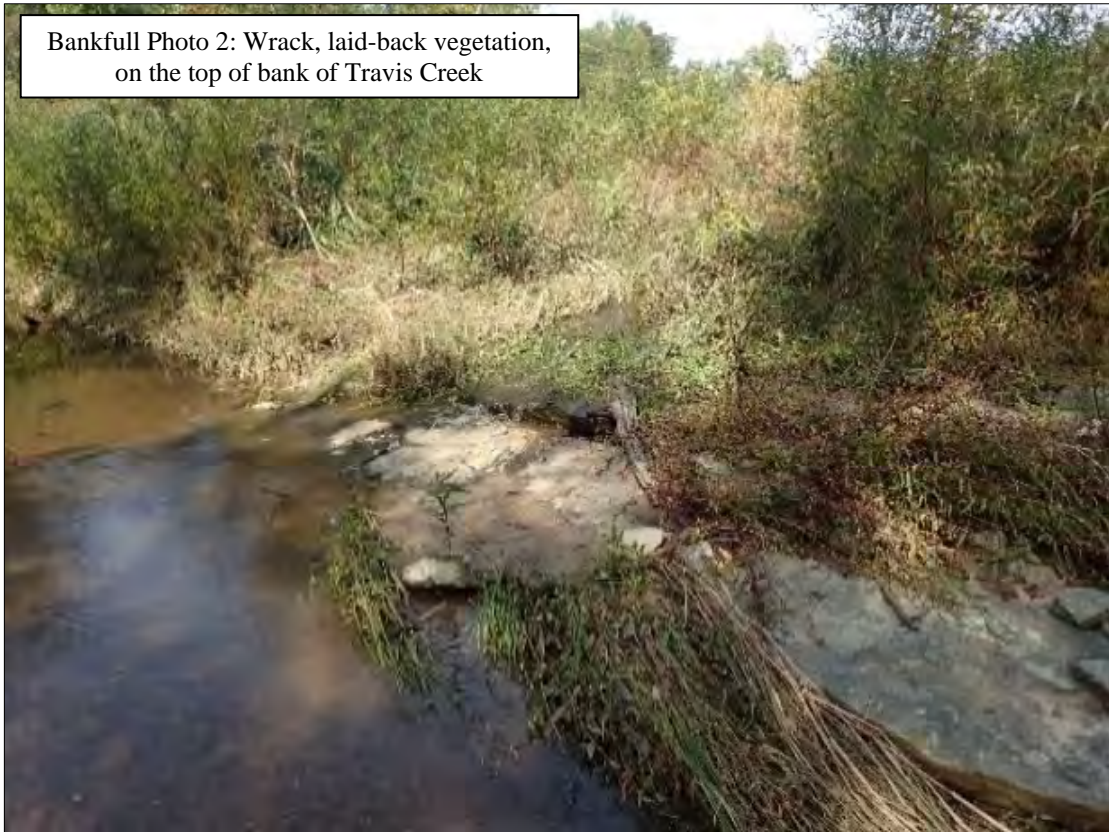
Bankfull Photo 2: Wrack, laid-back vegetation, on the top of bank of Travis Creek

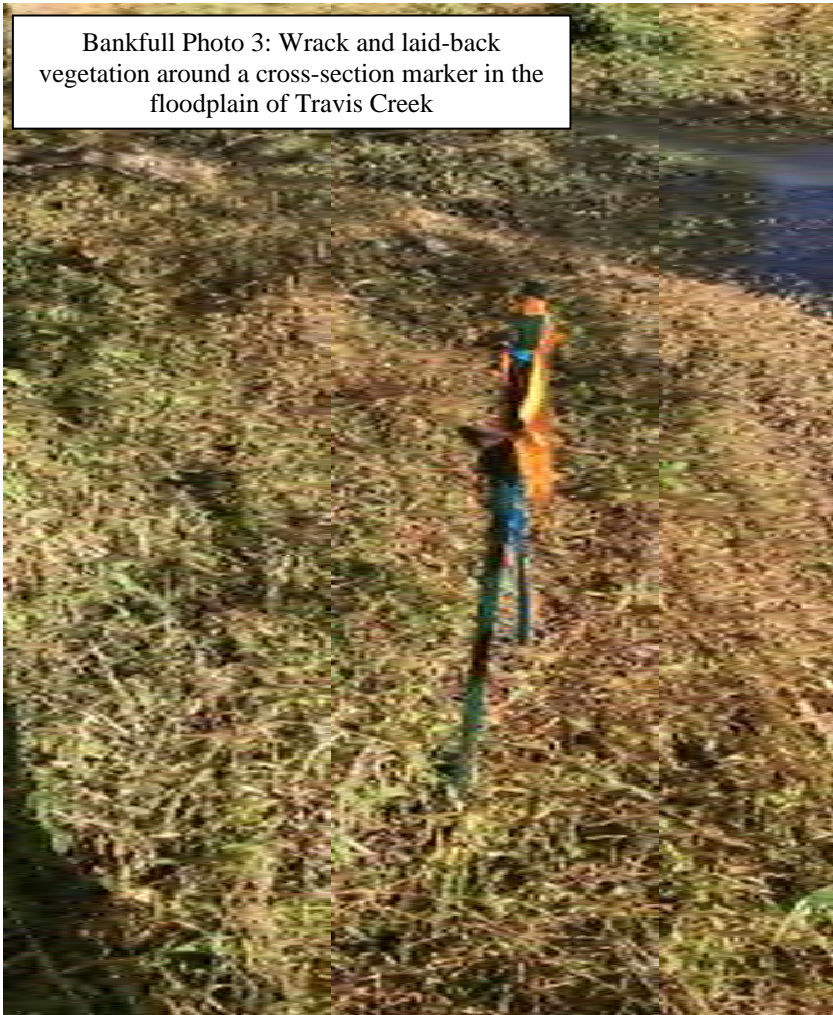
Bankfull Photo 3: Wrack and laid-back vegetation around a cross-section marker in the floodplain of Travis Creek

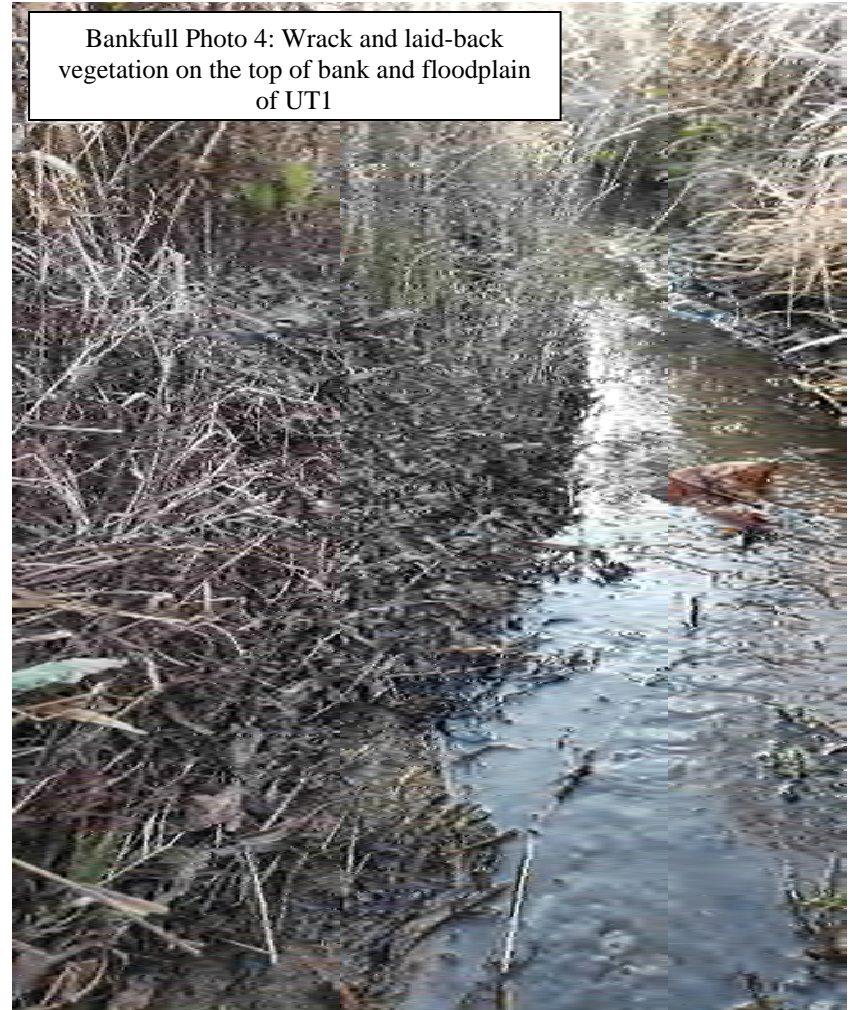
Bankfull Photo 4: Wrack and laid-back vegetation on the top of bank and floodplain of UT1

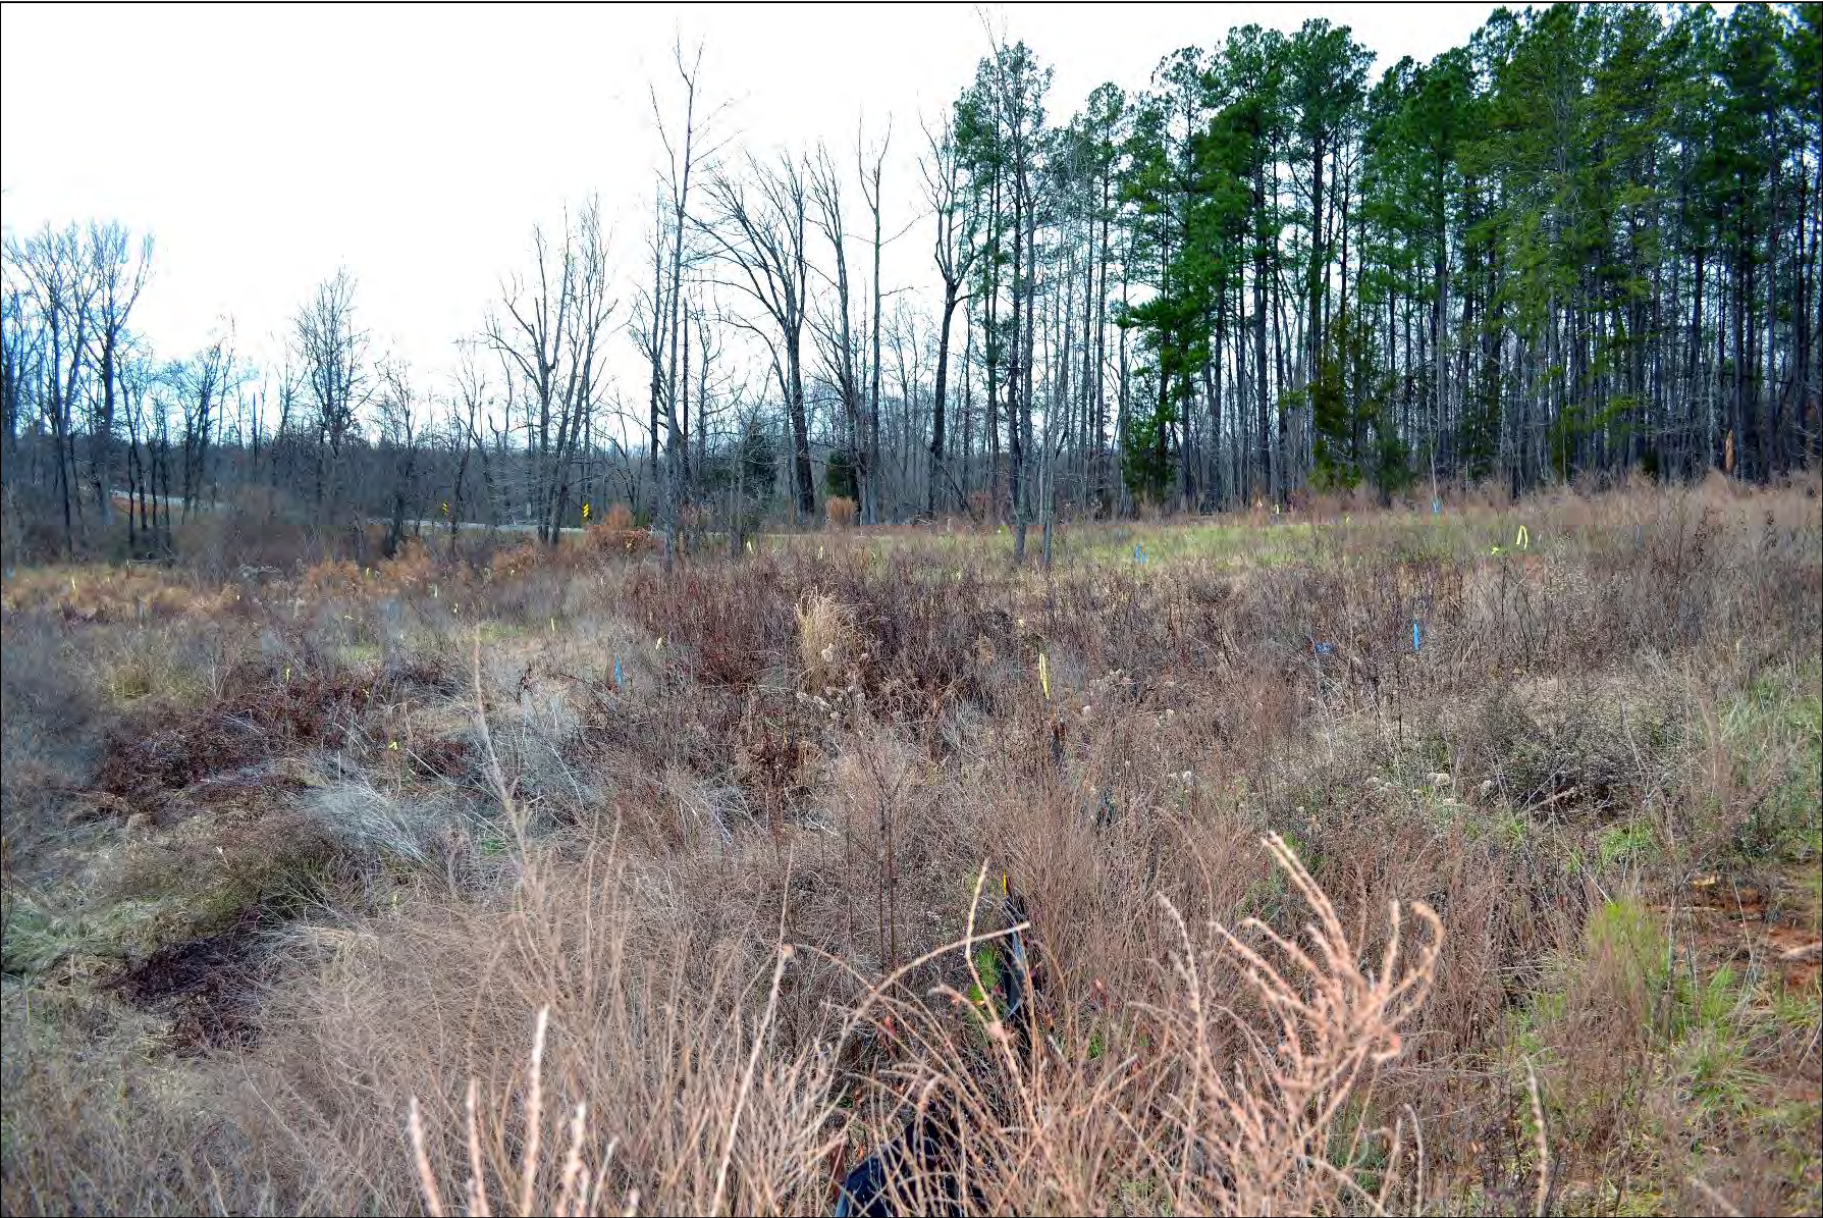
Photo 1: Looking SW. along Replant Area -1

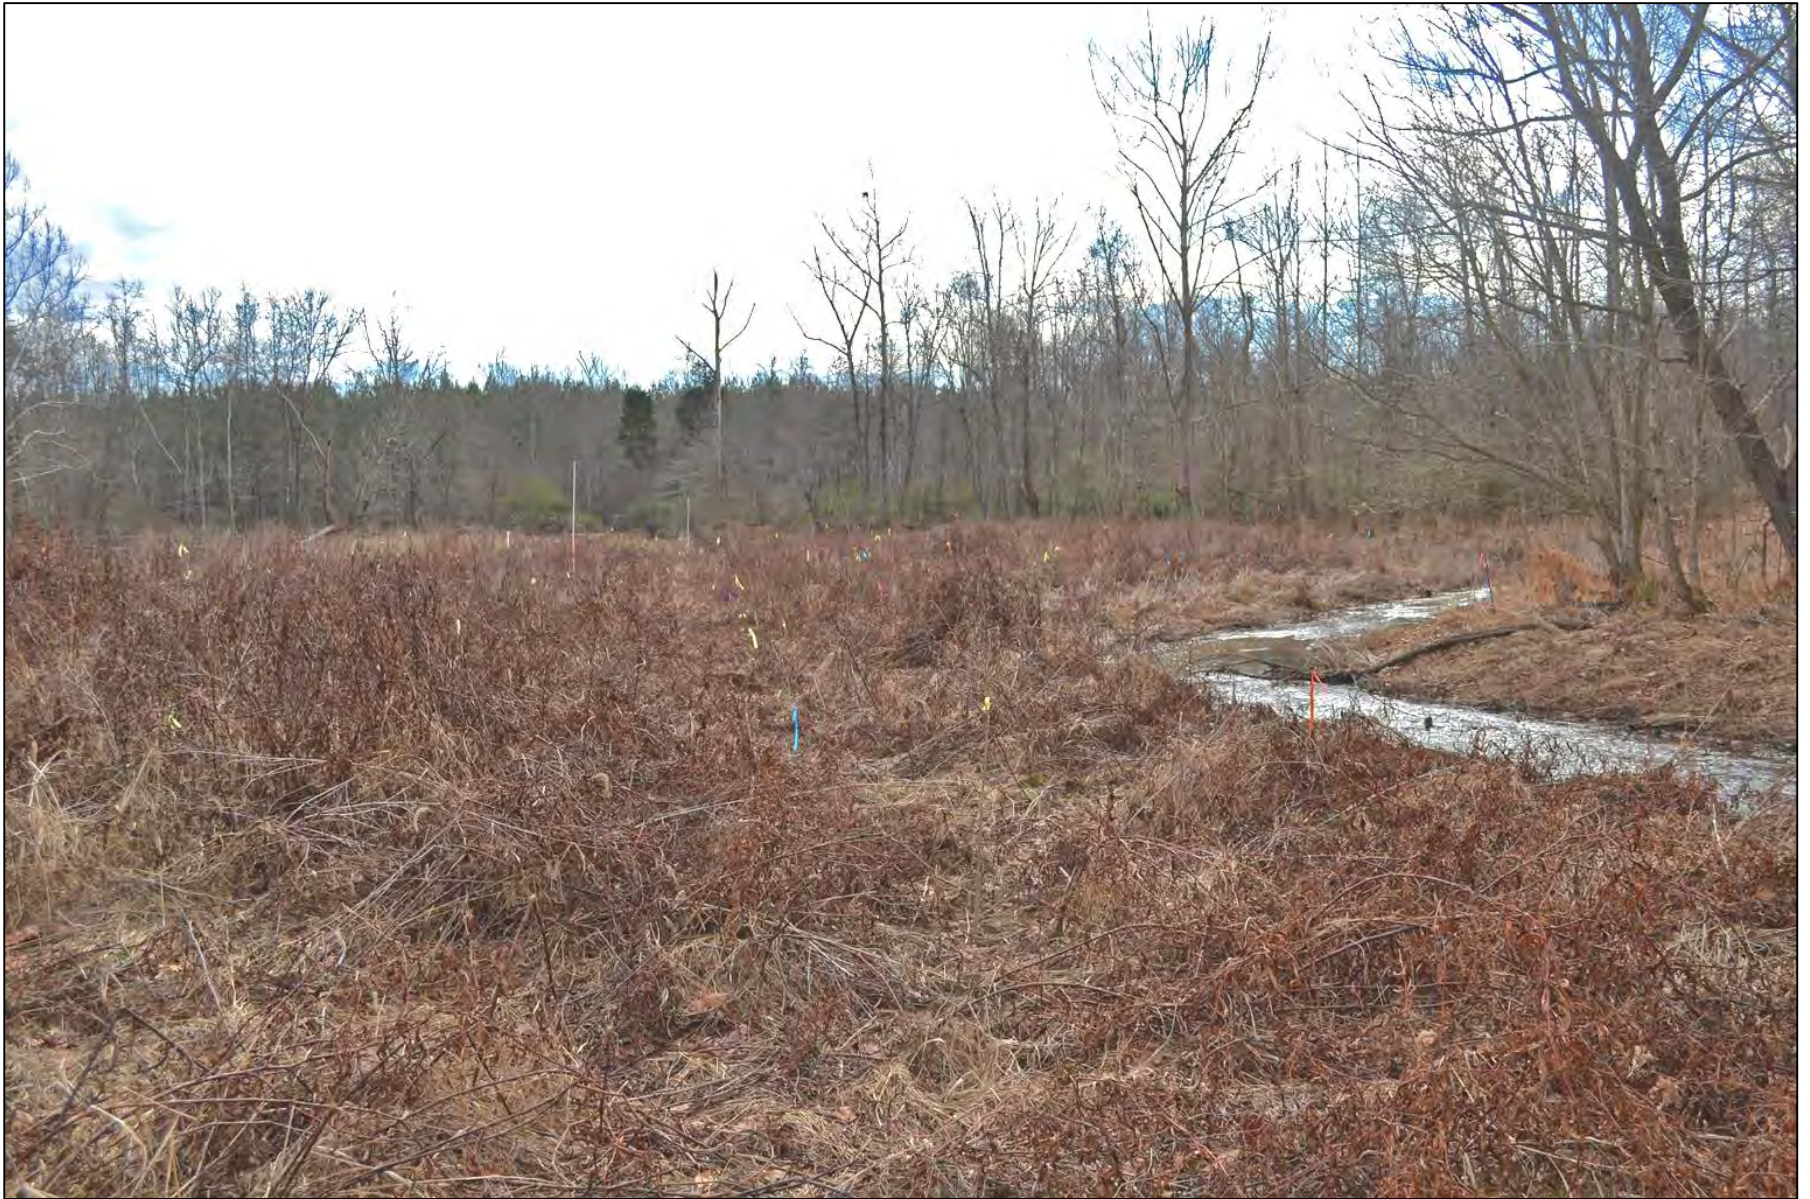
Photo 3: Looking SE. in Replant Area 4, near veg. plot 9

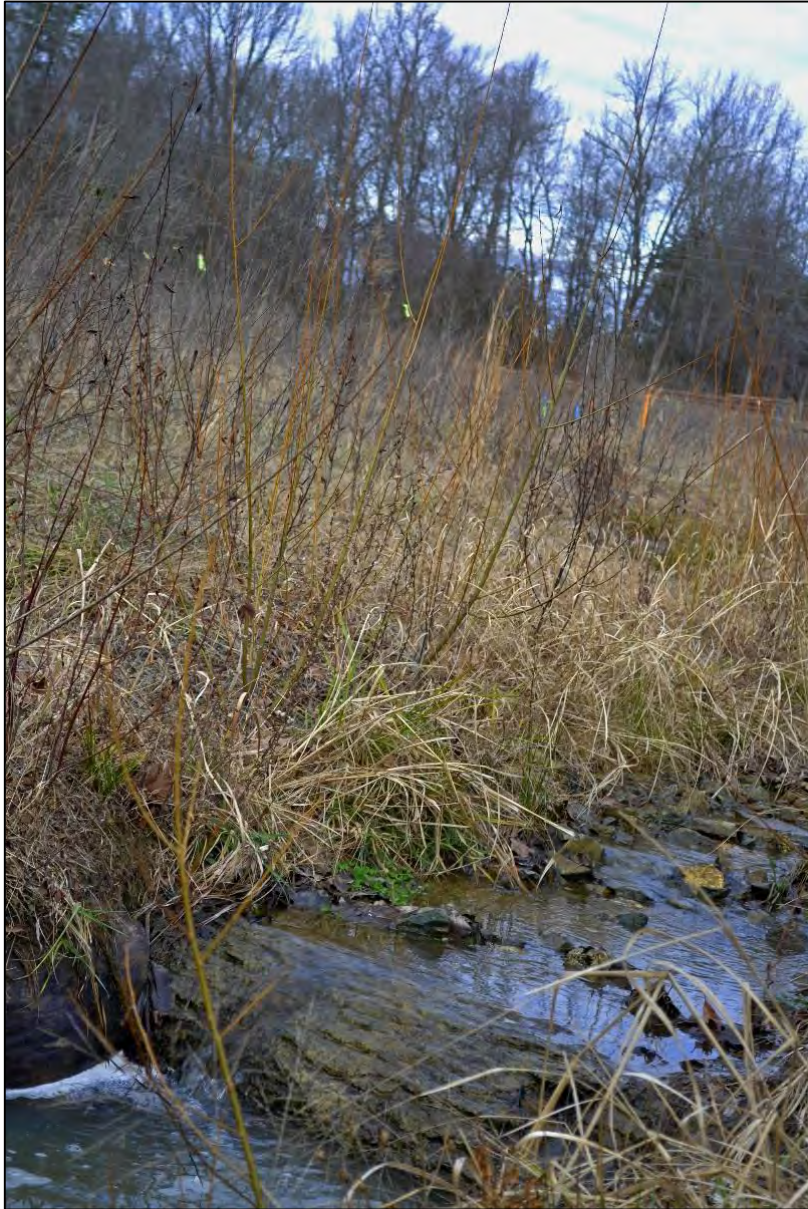
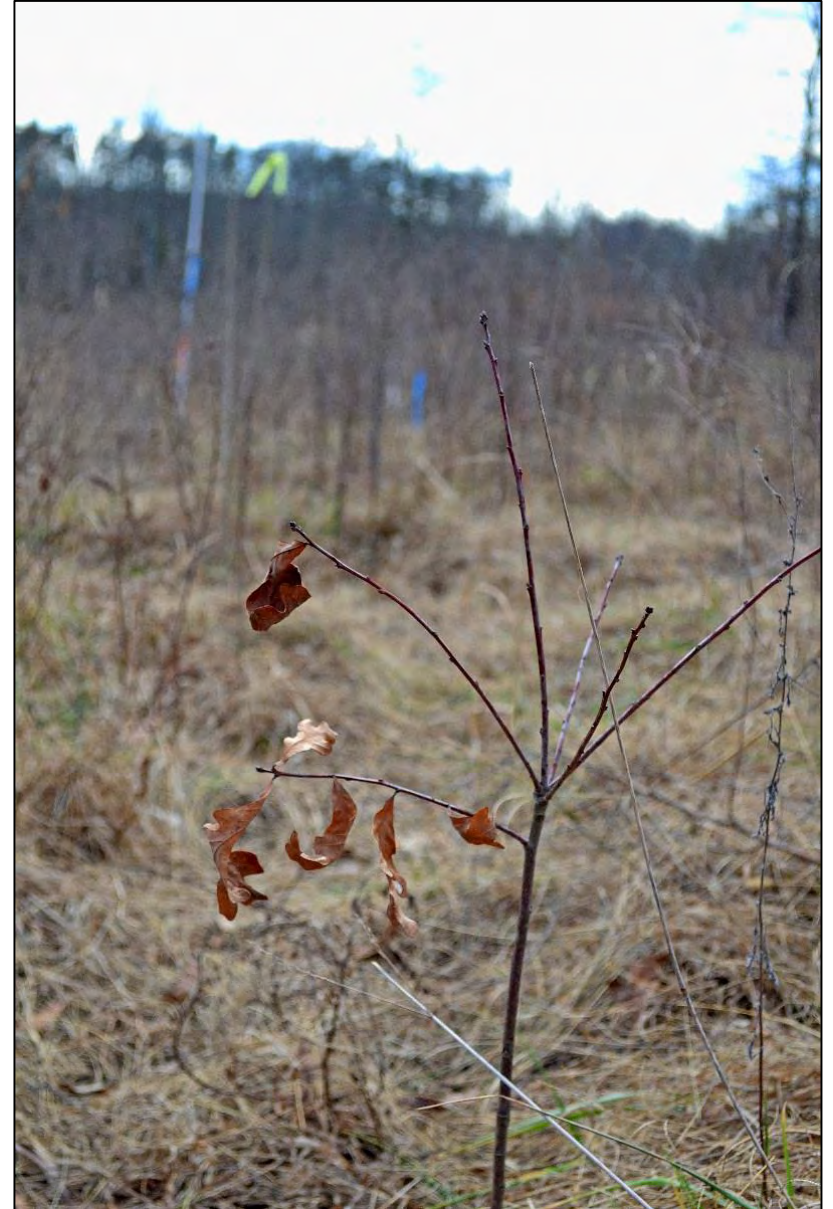
Photo 6 / 7: Live stake establishment on bank in Replant area 6

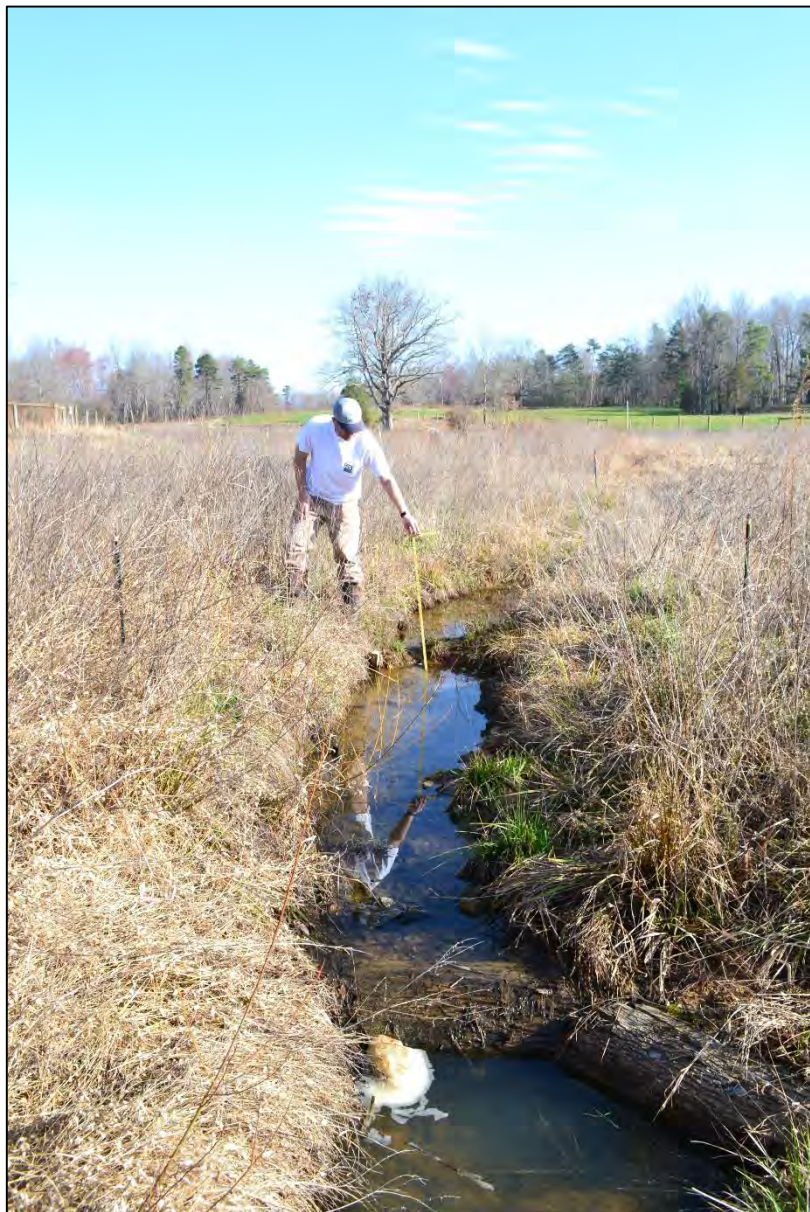
The year 1 (2016) measurements for cross-sections 9 and 10 on UT-1 showed stream bed erosion compared with as-built data. Stream bed erosion was noted shortly after as-built measurements were taken and were the result of the above mentioned rain events. It was evident bed material used during construction in this area was finer than it should have been. Two riffles showed bed erosion, totaling approximately 50 feet in length (approximately 1 percent of the project length). RS created and implemented a remedial action plan during the winter of 2016/2017 (see Section 3.0 and Appendix G). These repairs appear stable during Year 5 (2020) monitoring, and they will continue to be monitored during subsequent monitoring years.

Photo 1: Substrate loss, 6" head-cut at UT 1, XC 9

The degradation observed during Year 1 (2016) in and adjacent to cross-sections 9 and 10 on UT-1 encompasses approximately 12 linear feet and 15 linear feet of stream, respectively (<1 percent of the project length). As noted above, the bed material placed during construction was too fine. All of UT-1 used bed material harvested onsite. The material used along this stream reach was too fine and washed from the riffles during heavy rainfall events, resulting in minor bed scour and a small, less than 6-inch head cut, began to develop at the top of the riffle. Suitable sized channel bed material was installed on February 23rd, 2017, at the proper elevation in the two riffles within UT-1. Bed material was installed such that bank toe protection is provided, and planting with willow stakes occurred. Bank toe protection designates that channel bed material will extend up the lower one-third of the bank. This will be monitored by existing established cross-sections 9 and 10.

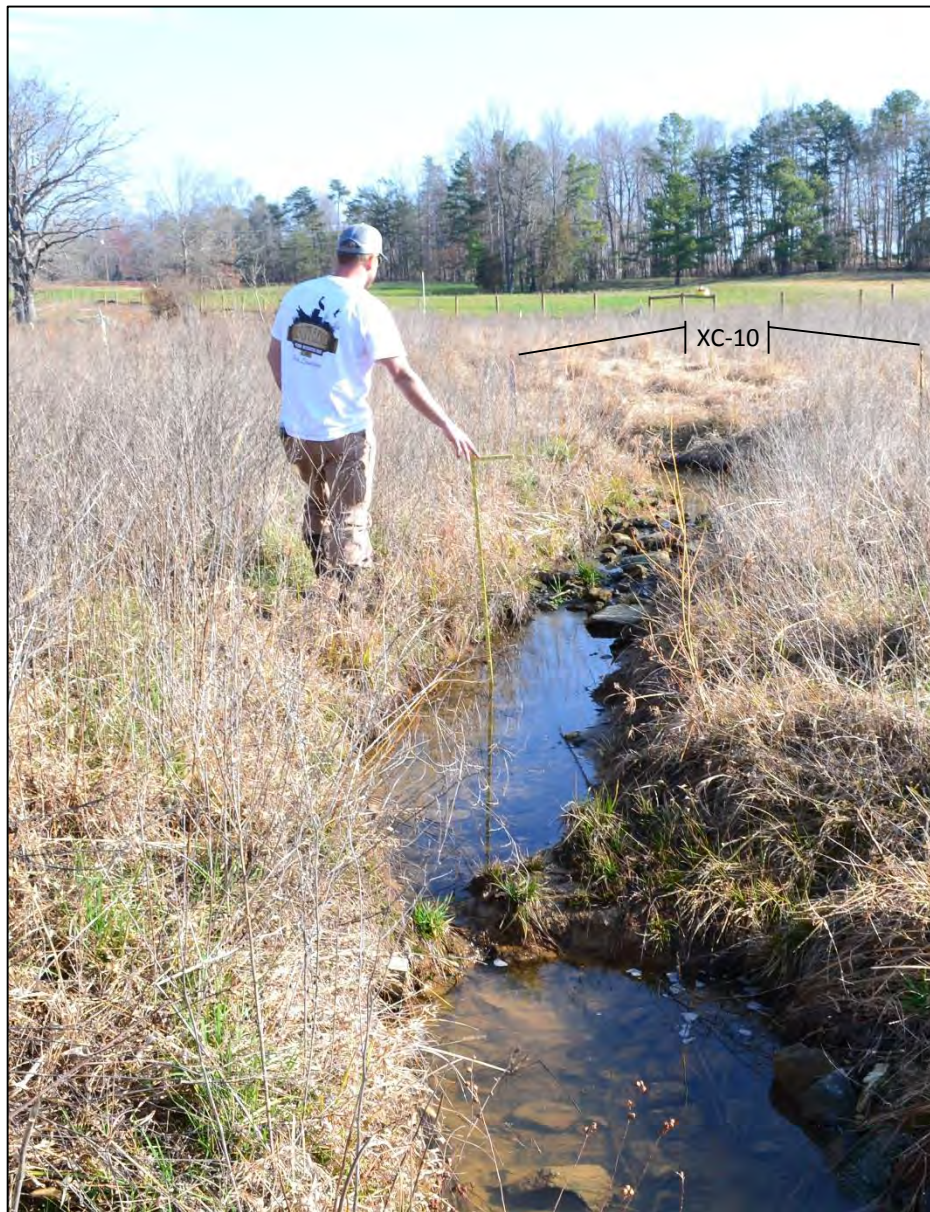
Photo 2: Pool, upstream of 6" head-cut at UT 1, XC 9 (XC 10 in background)

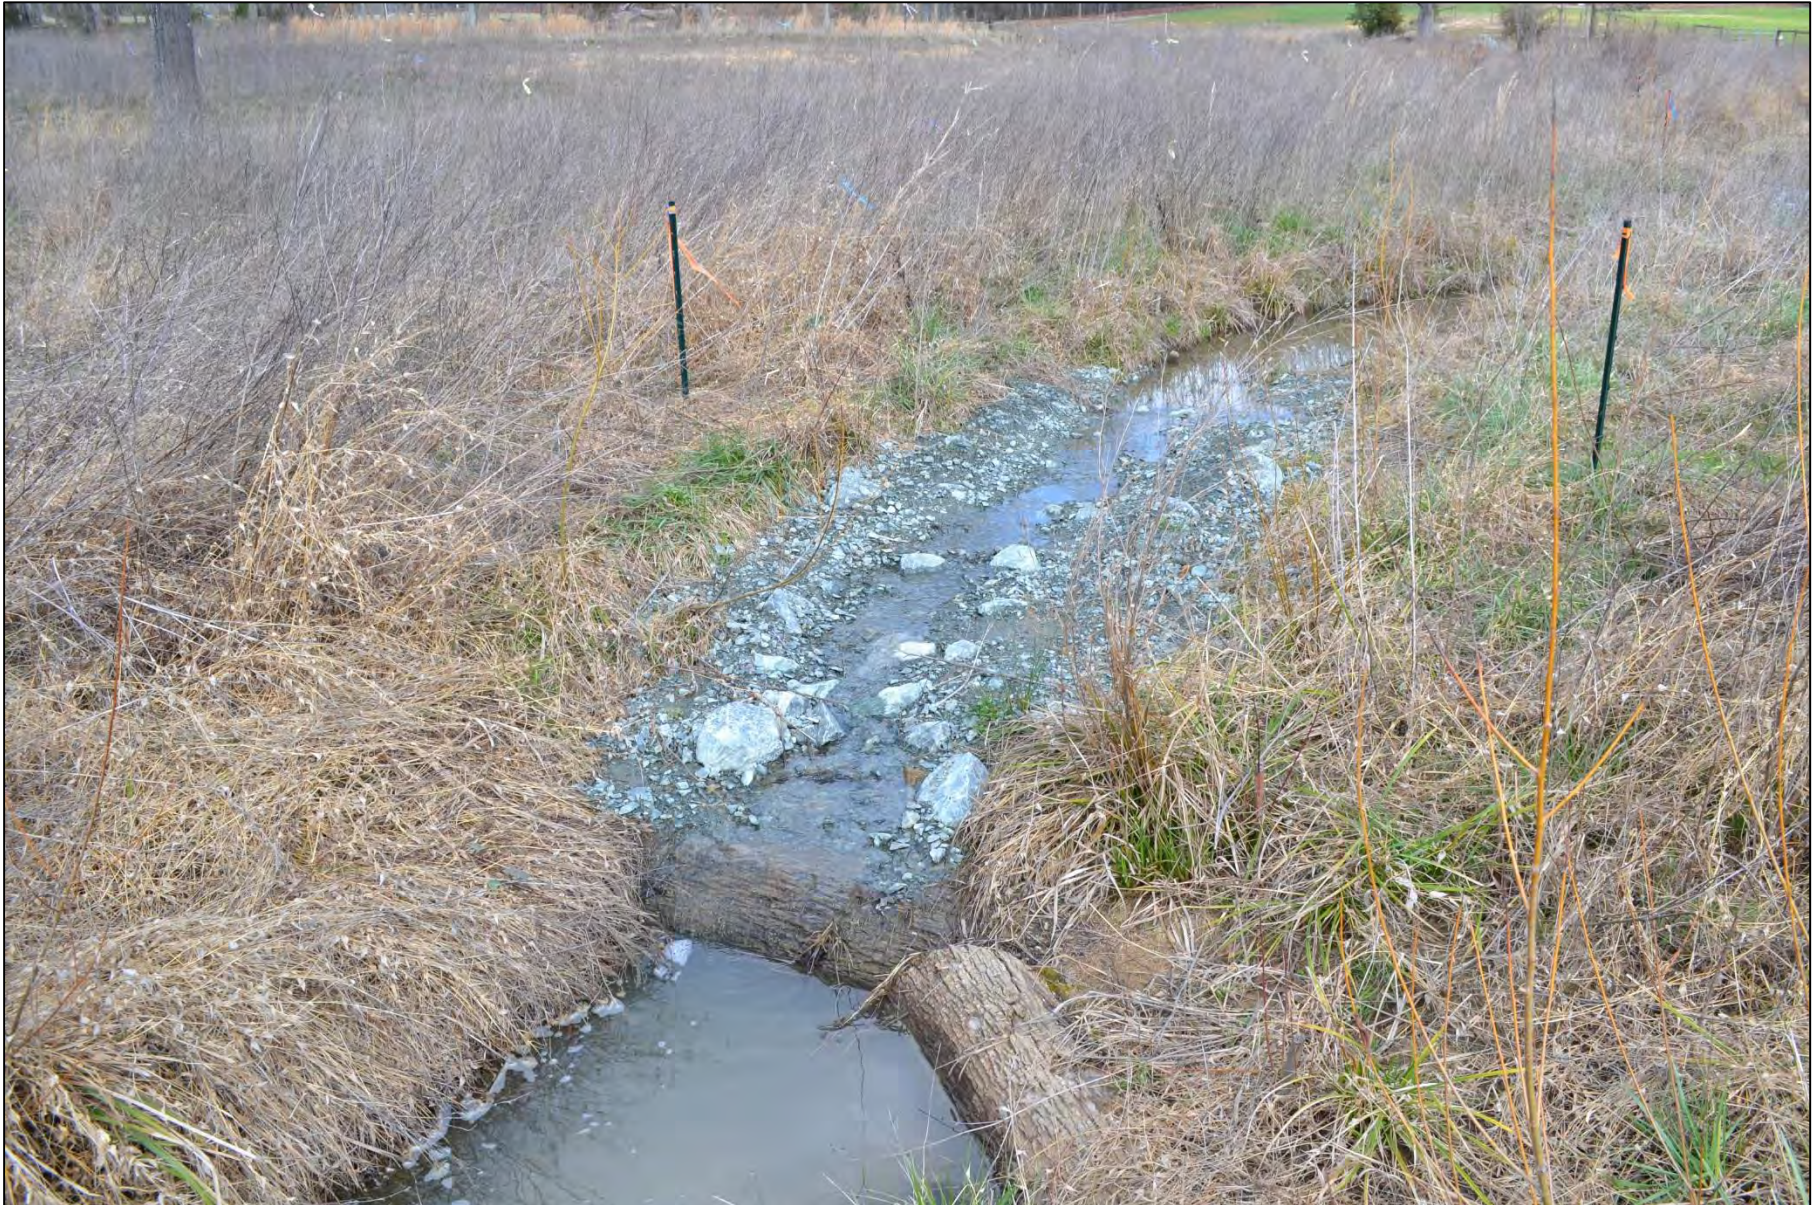
Photo 7: XC-9 – Post 3-1-2017 0.92 inch rain event (Per USGS Guage at BUFFALO CREEK (SR2819 NR MCLEANSVILLE, NC) ~ 7 miles from Site
