**YEAR 7 (2022) MONITORING REPORT**  
**AYCOCK SPRINGS**  
**STREAM AND WETLAND MITIGATION SITE**

ALAMANCE COUNTY, NORTH CAROLINA  
DMS PROJECT No. 96312  
FULL DELIVERY CONTRACT No. 5791  
NCDWR PROJECT No. 20140335  
USACE ACTION ID No. SAW-2014-01711

**Data Collection – January-October 2022**

**February 2023**

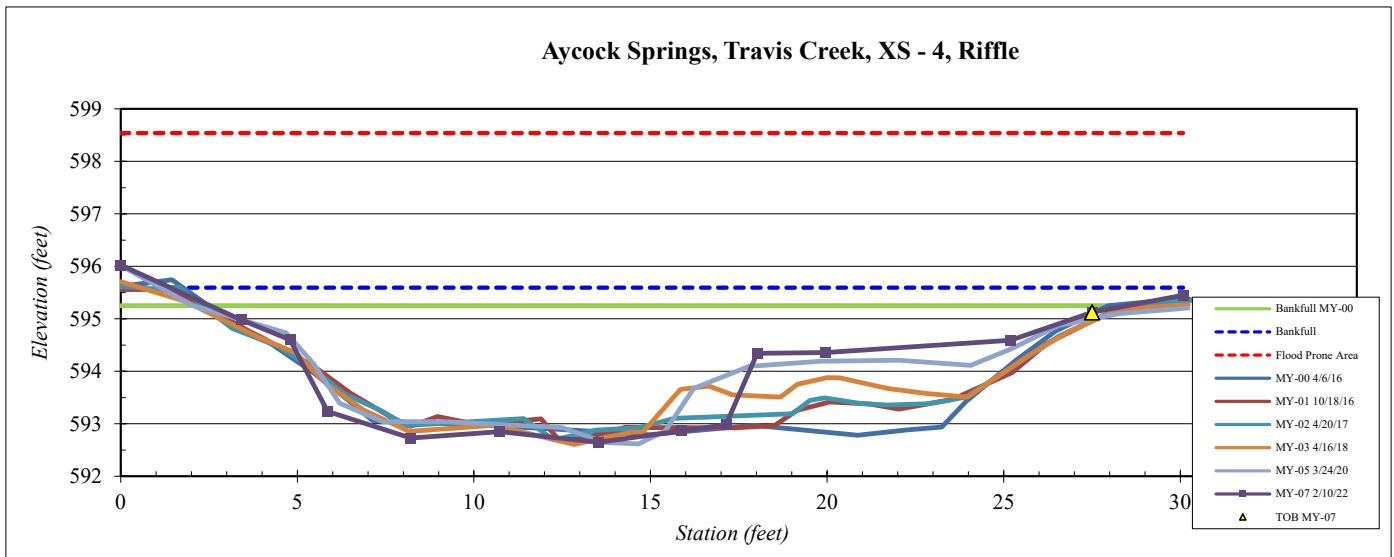
Note: Sediment deposition appears natural and is not expected to lead to instability.

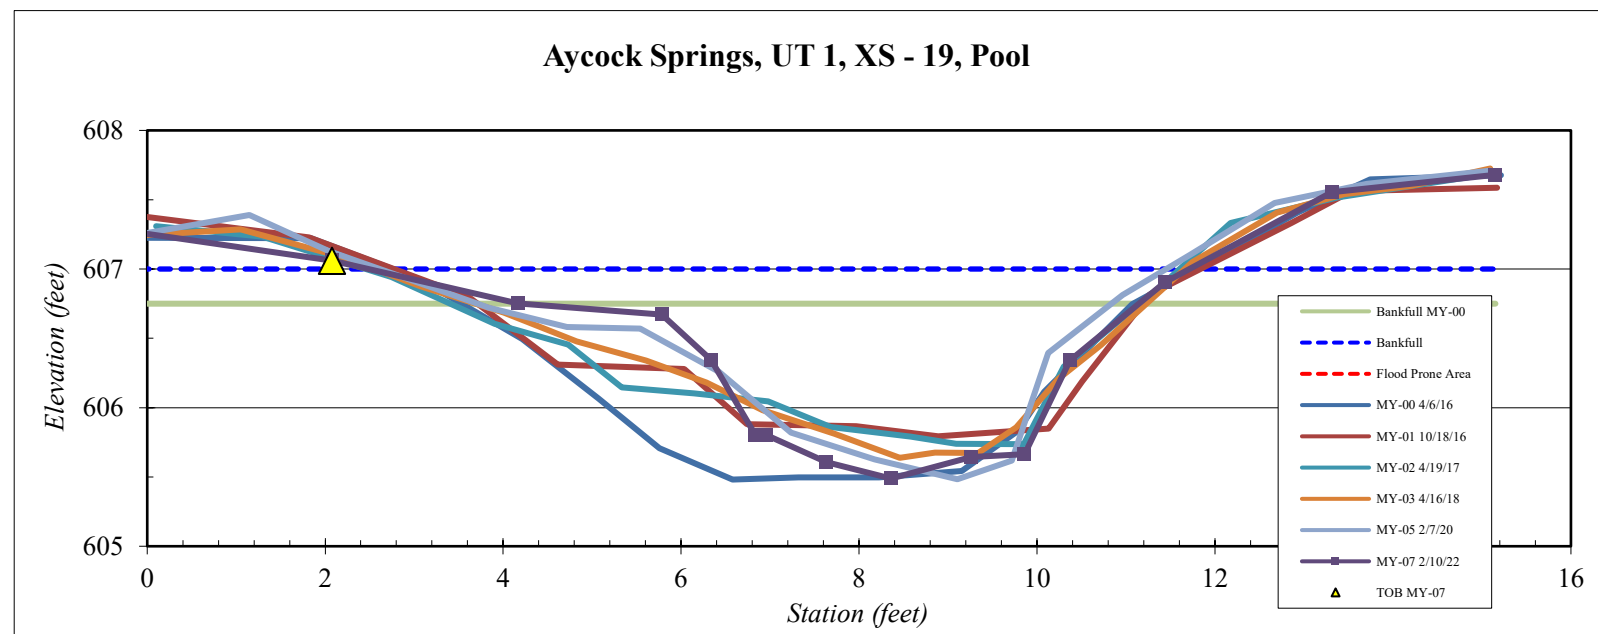
Note: Point bar development appears to have stabilized during years 1-7.

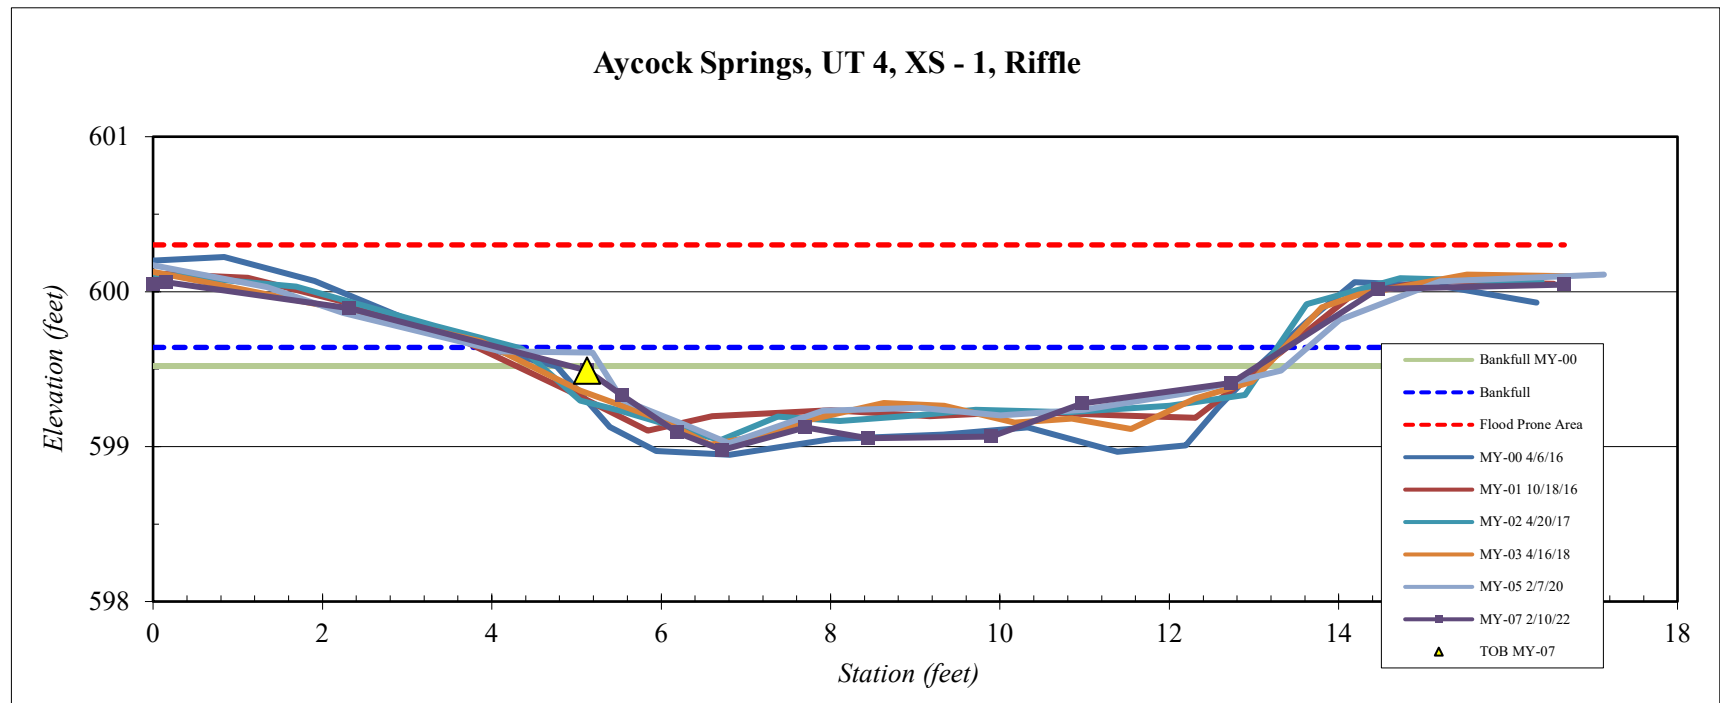
**NOTE:** Reduced BHR is the result of small changes in a very small channel. No signs of instability were observed along this reach

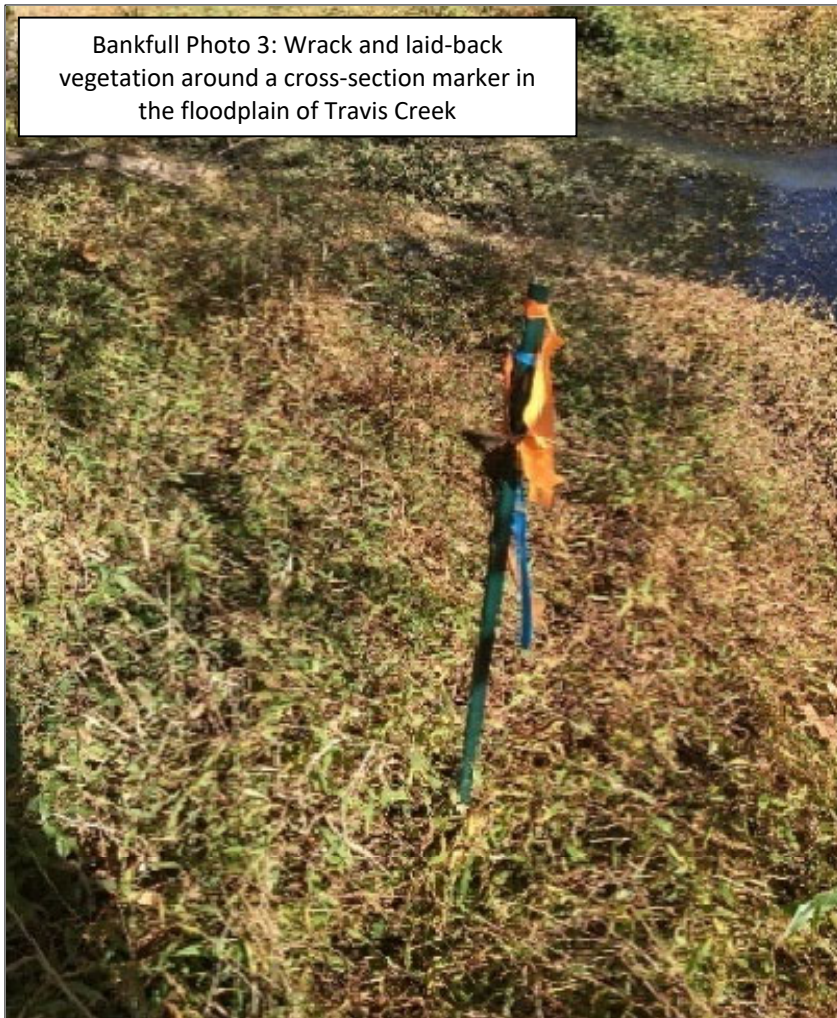
Bankfull Photo 3: Wrack and laid-back vegetation around a cross-section marker in the floodplain of Travis Creek

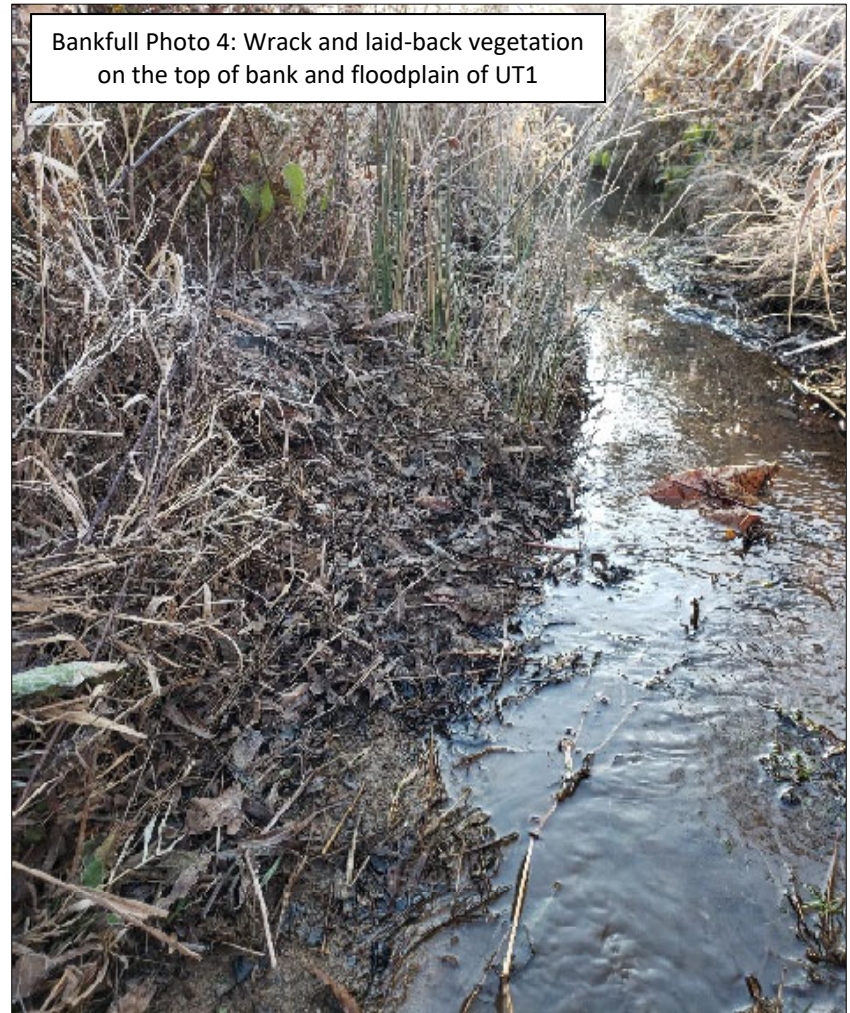
Bankfull Photo 4: Wrack and laid-back vegetation on the top of bank and floodplain of UT1

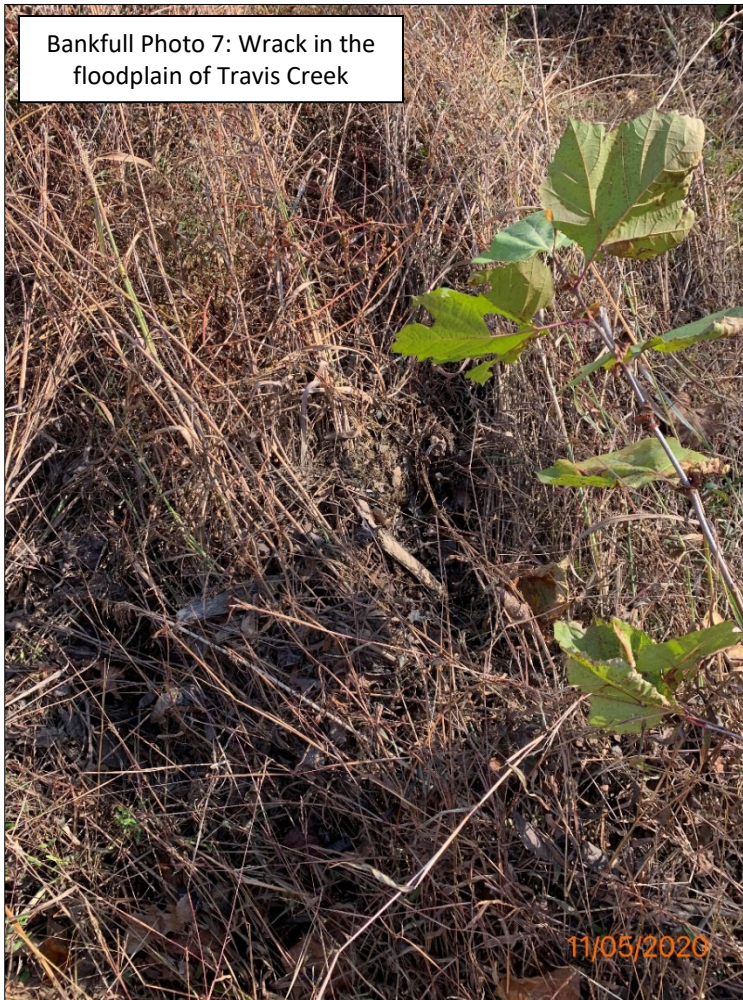
Bankfull Photo 7: Wrack in the floodplain of Travis Creek

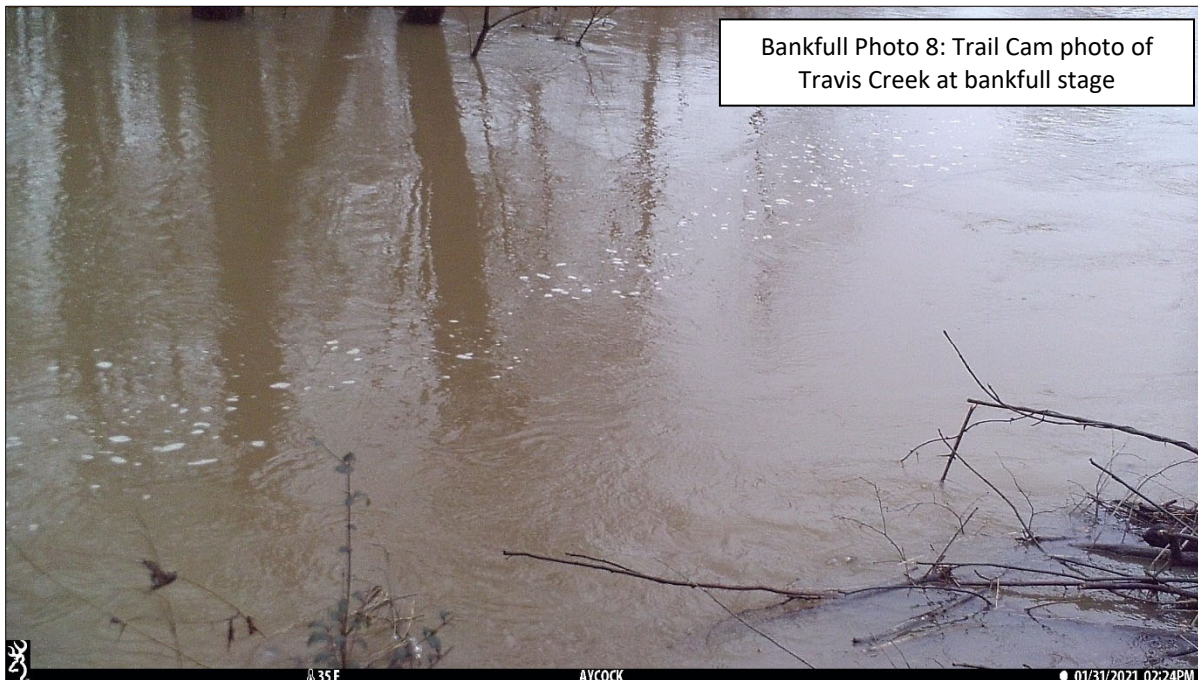
Bankfull Photo 8: Trail Cam photo of Travis Creek at bankfull stage

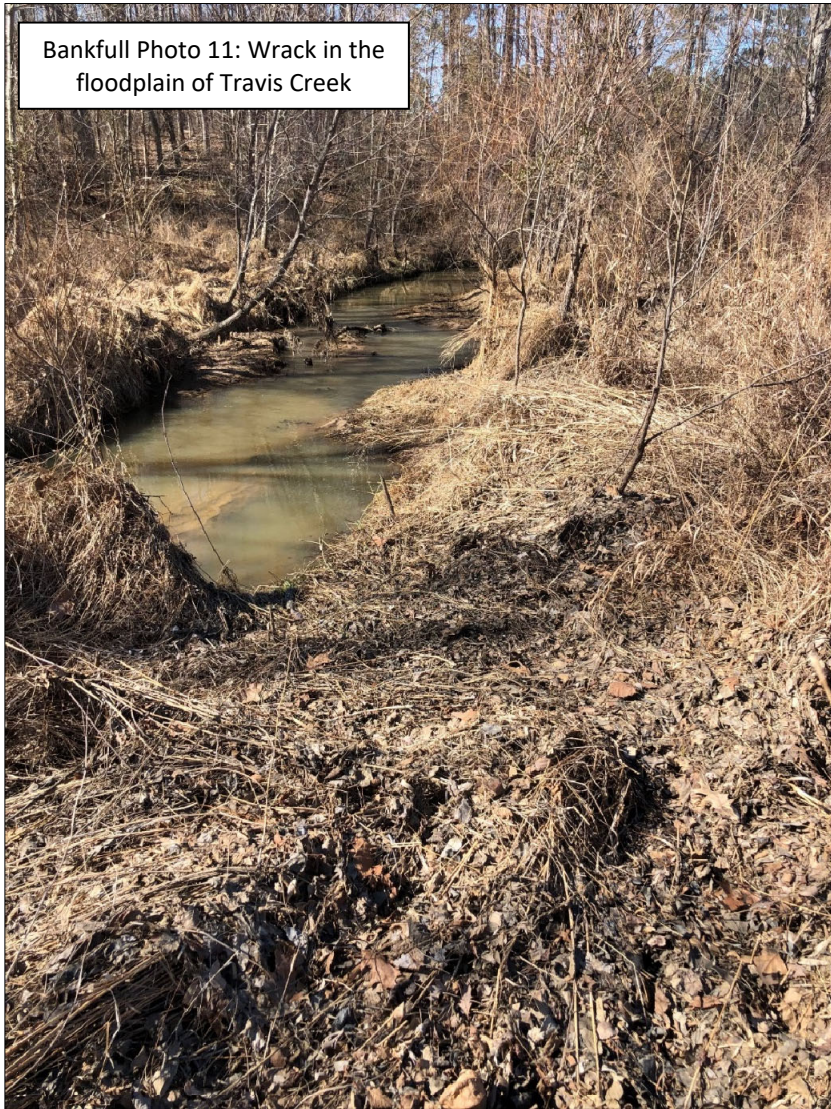
Bankfull Photo 11: Wrack in the floodplain of Travis Creek

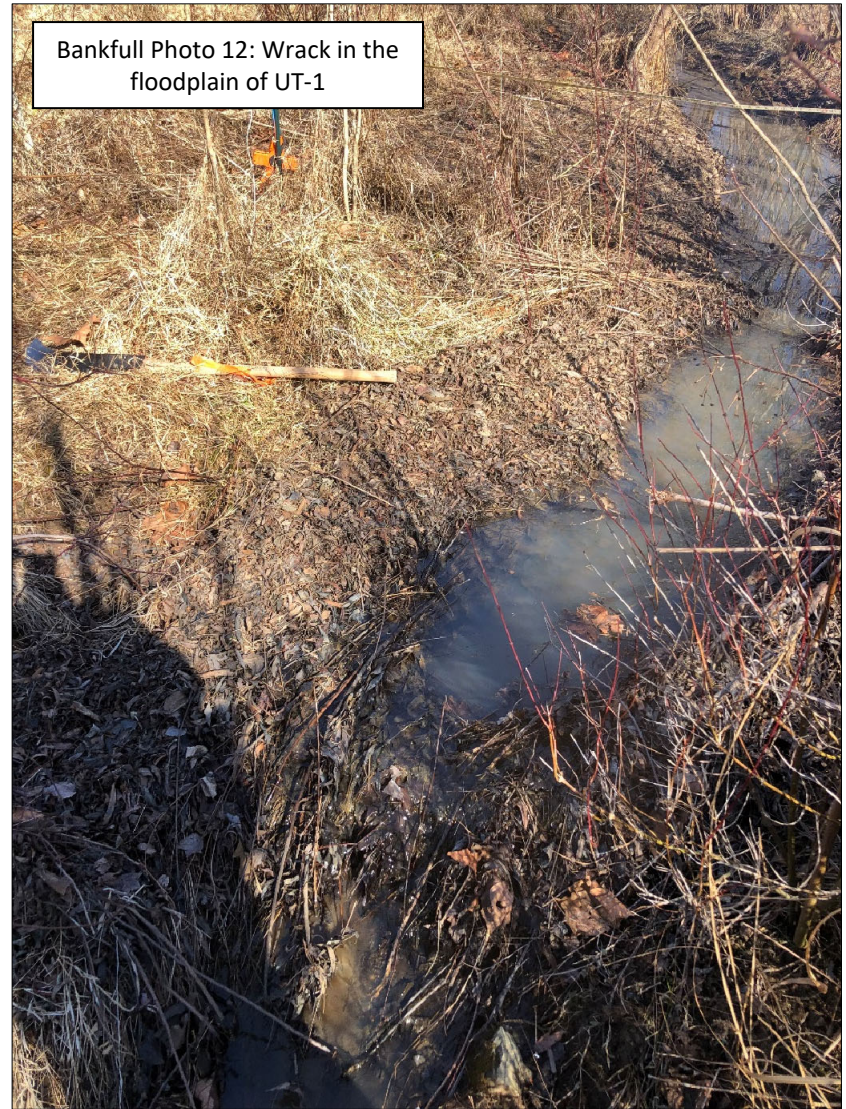
Bankfull Photo 12: Wrack in the floodplain of UT-1

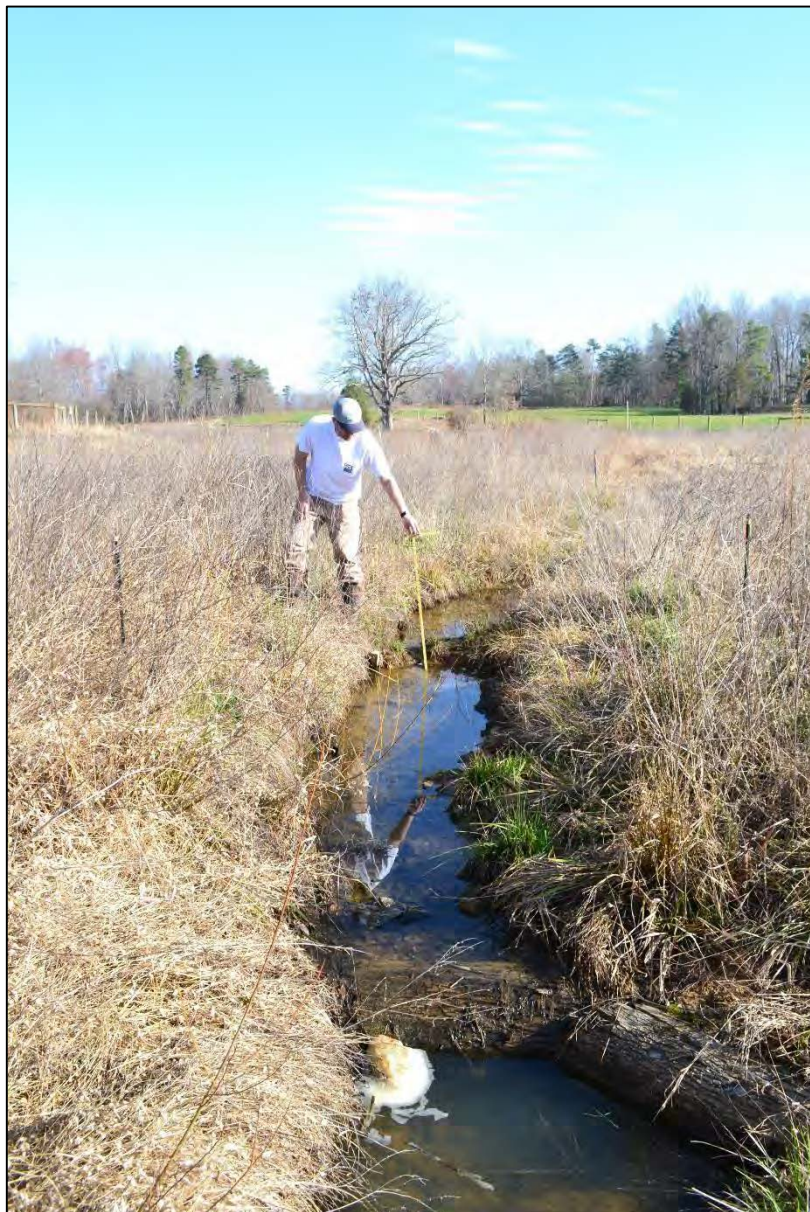
Photo 1: Substrate loss, 6" head-cut at UT 1, XC 9

The degradation observed during Year 1 (2016) in and adjacent to cross-sections 9 and 10 on UT-1 encompasses approximately 12 linear feet and 15 linear feet of stream, respectively (<1 percent of the project length). All bed material used during construction was harvested onsite. The material used along this stream reach was too fine and washed from the riffles during heavy rainfall events, resulting in minor bed scour, and a small, less than 6-inch head cut at the top of the riffle. Suitable sized channel bed material was installed on February 23, 2017, at the proper elevation in the two riffles within UT-1. Bed material was installed to provide bank toe protection, and planting with willow stakes occurred. Bank toe protection designates that channel bed material will extend up the lower one-third of the bank. This area has been monitored by cross-sections 9 and 10, which have shown that the riffles have stabilized since the repair.

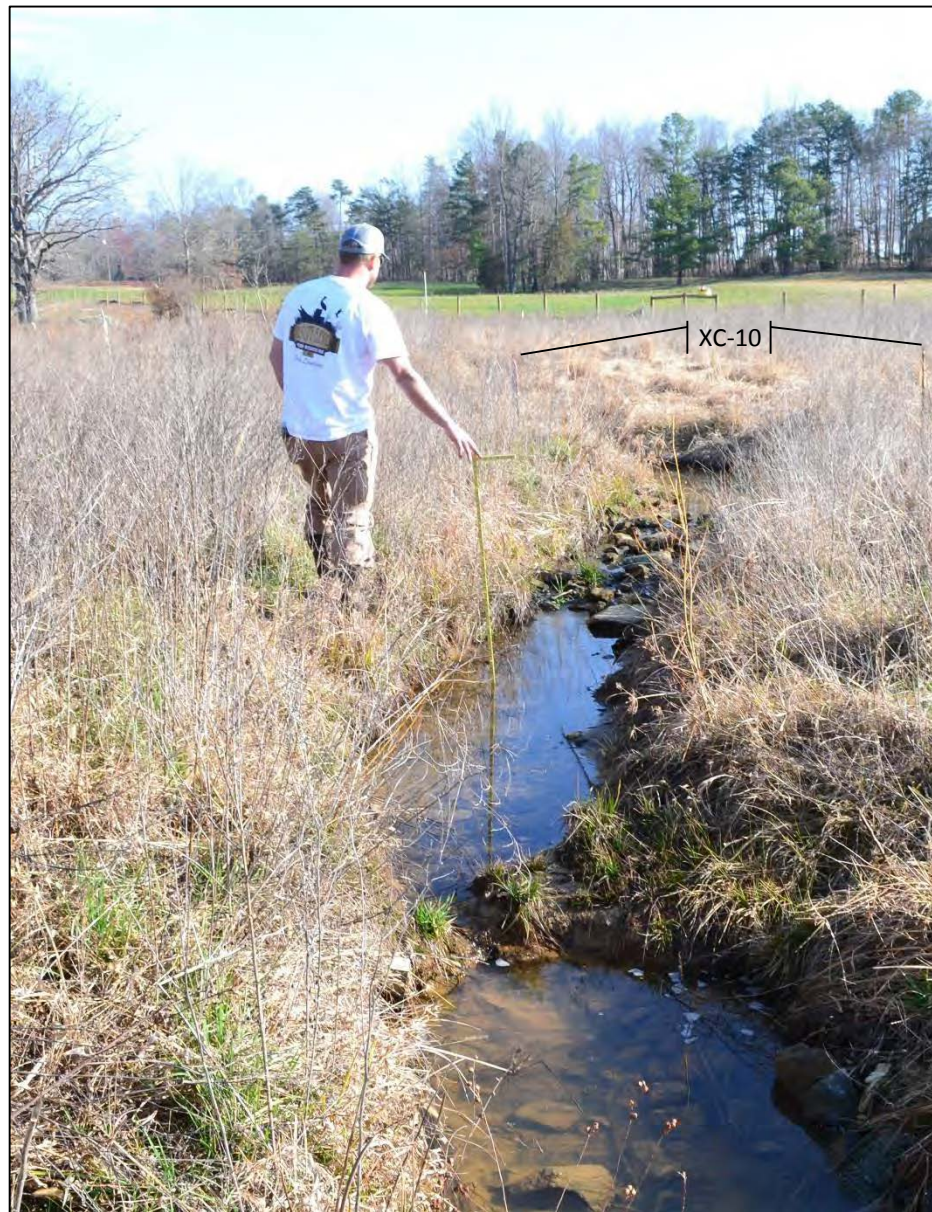
Photo 2: Pool, upstream of 6" head-cut at UT 1, XC 9 (XC 10 in background)

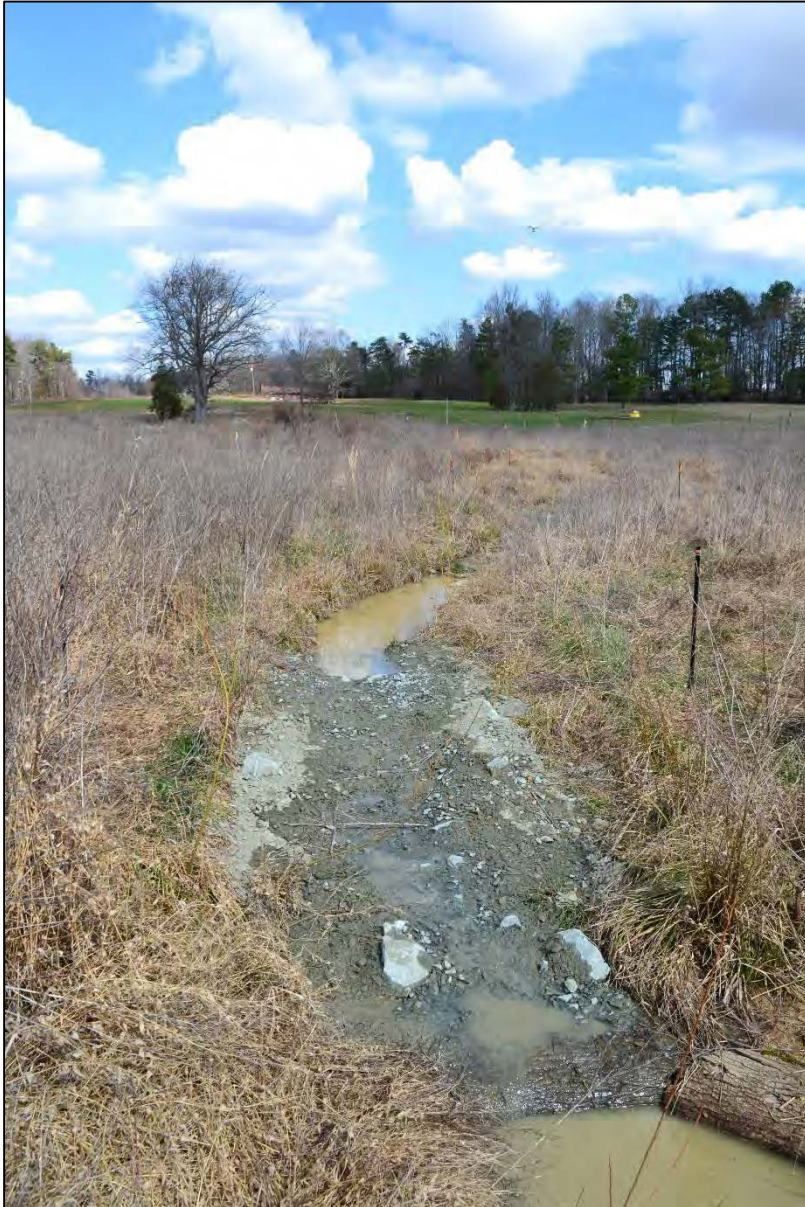
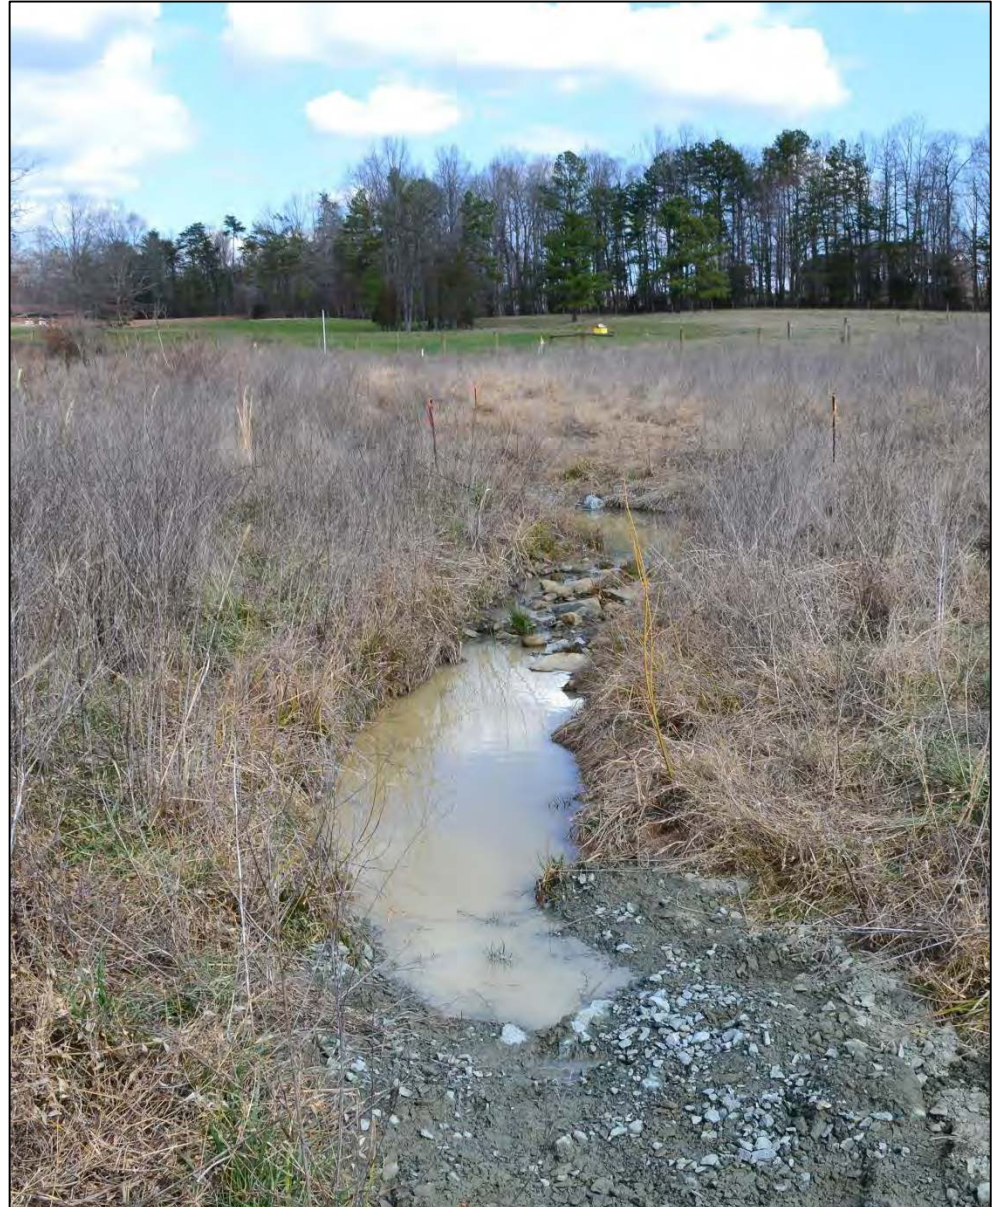
Photo 3: Substrate replacement at UT 1, XC 9

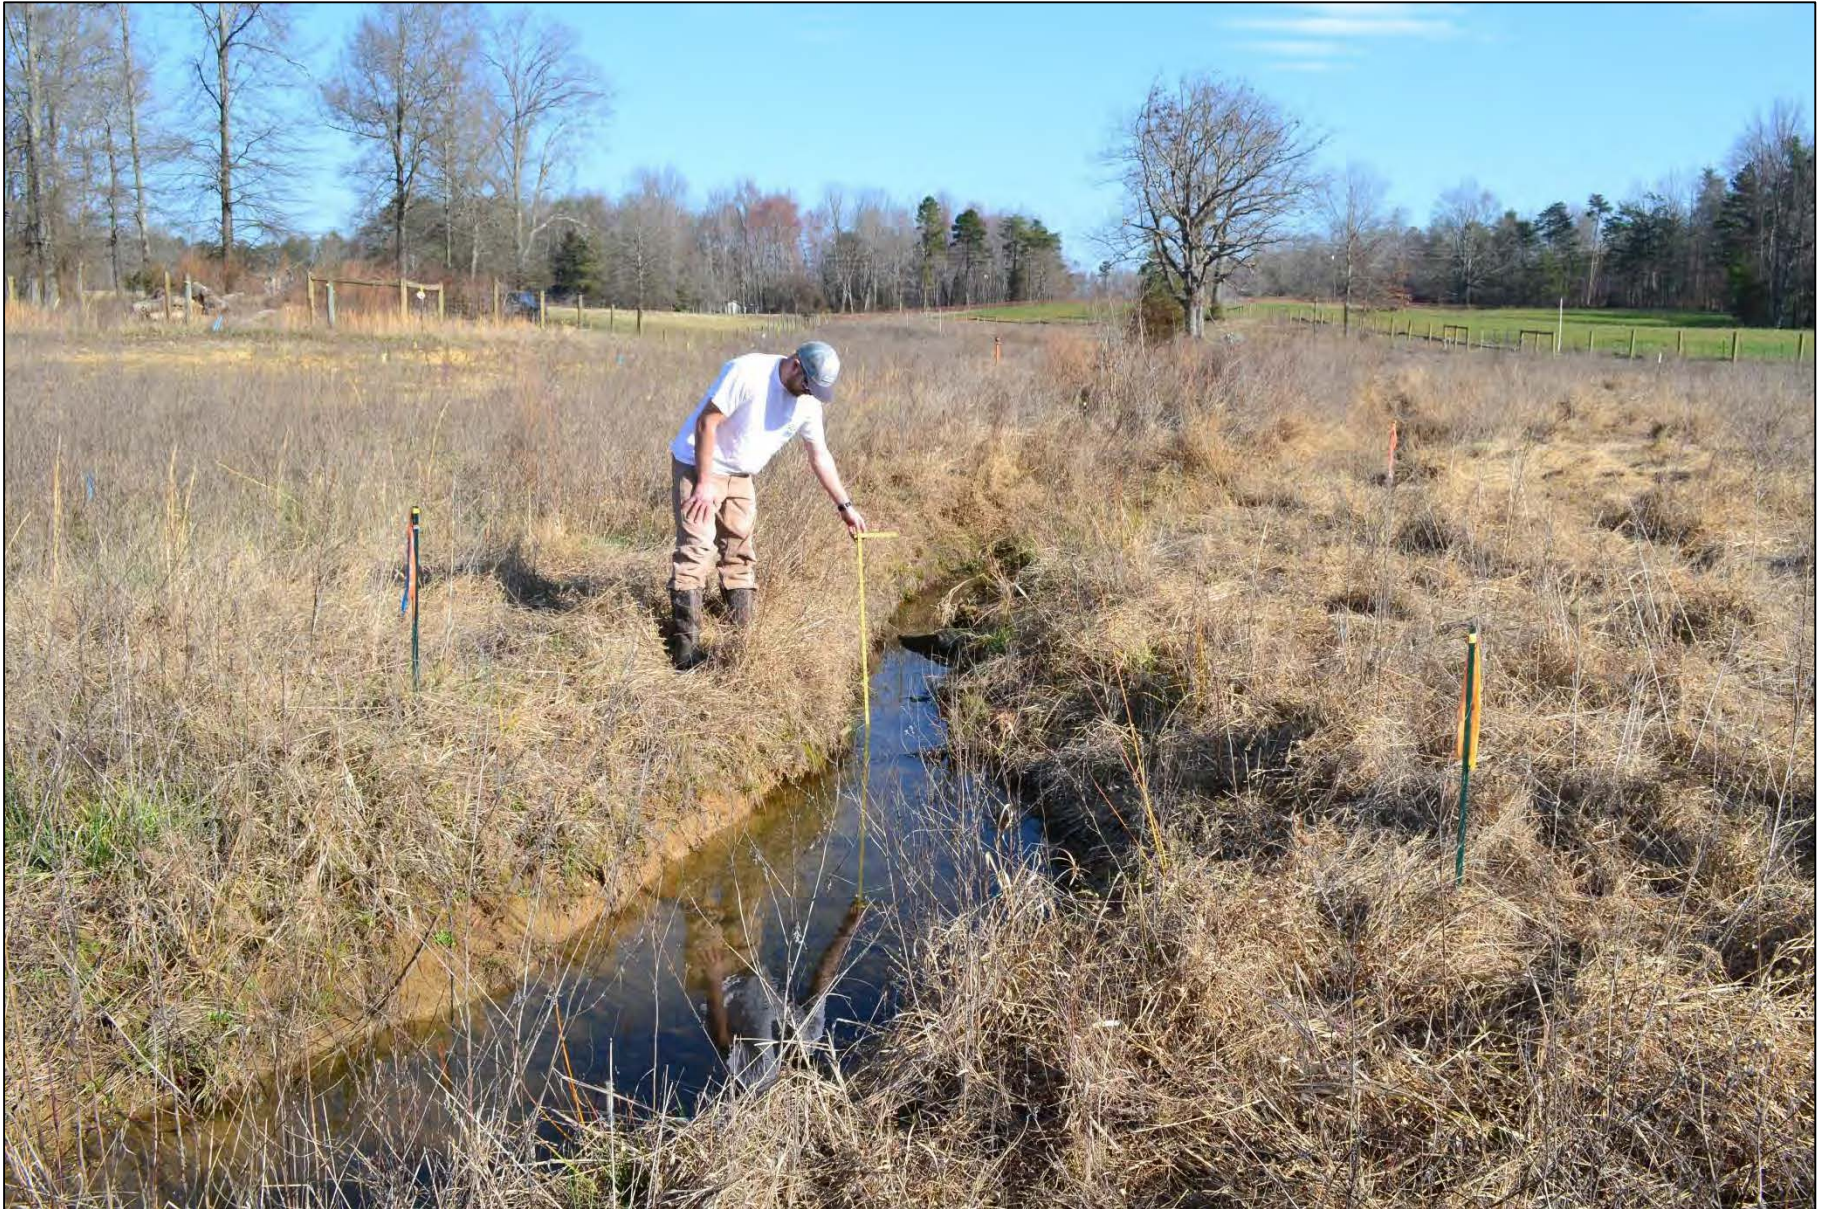
Photo 3: Substrate loss, upstream riffle of XC 10 (pool)

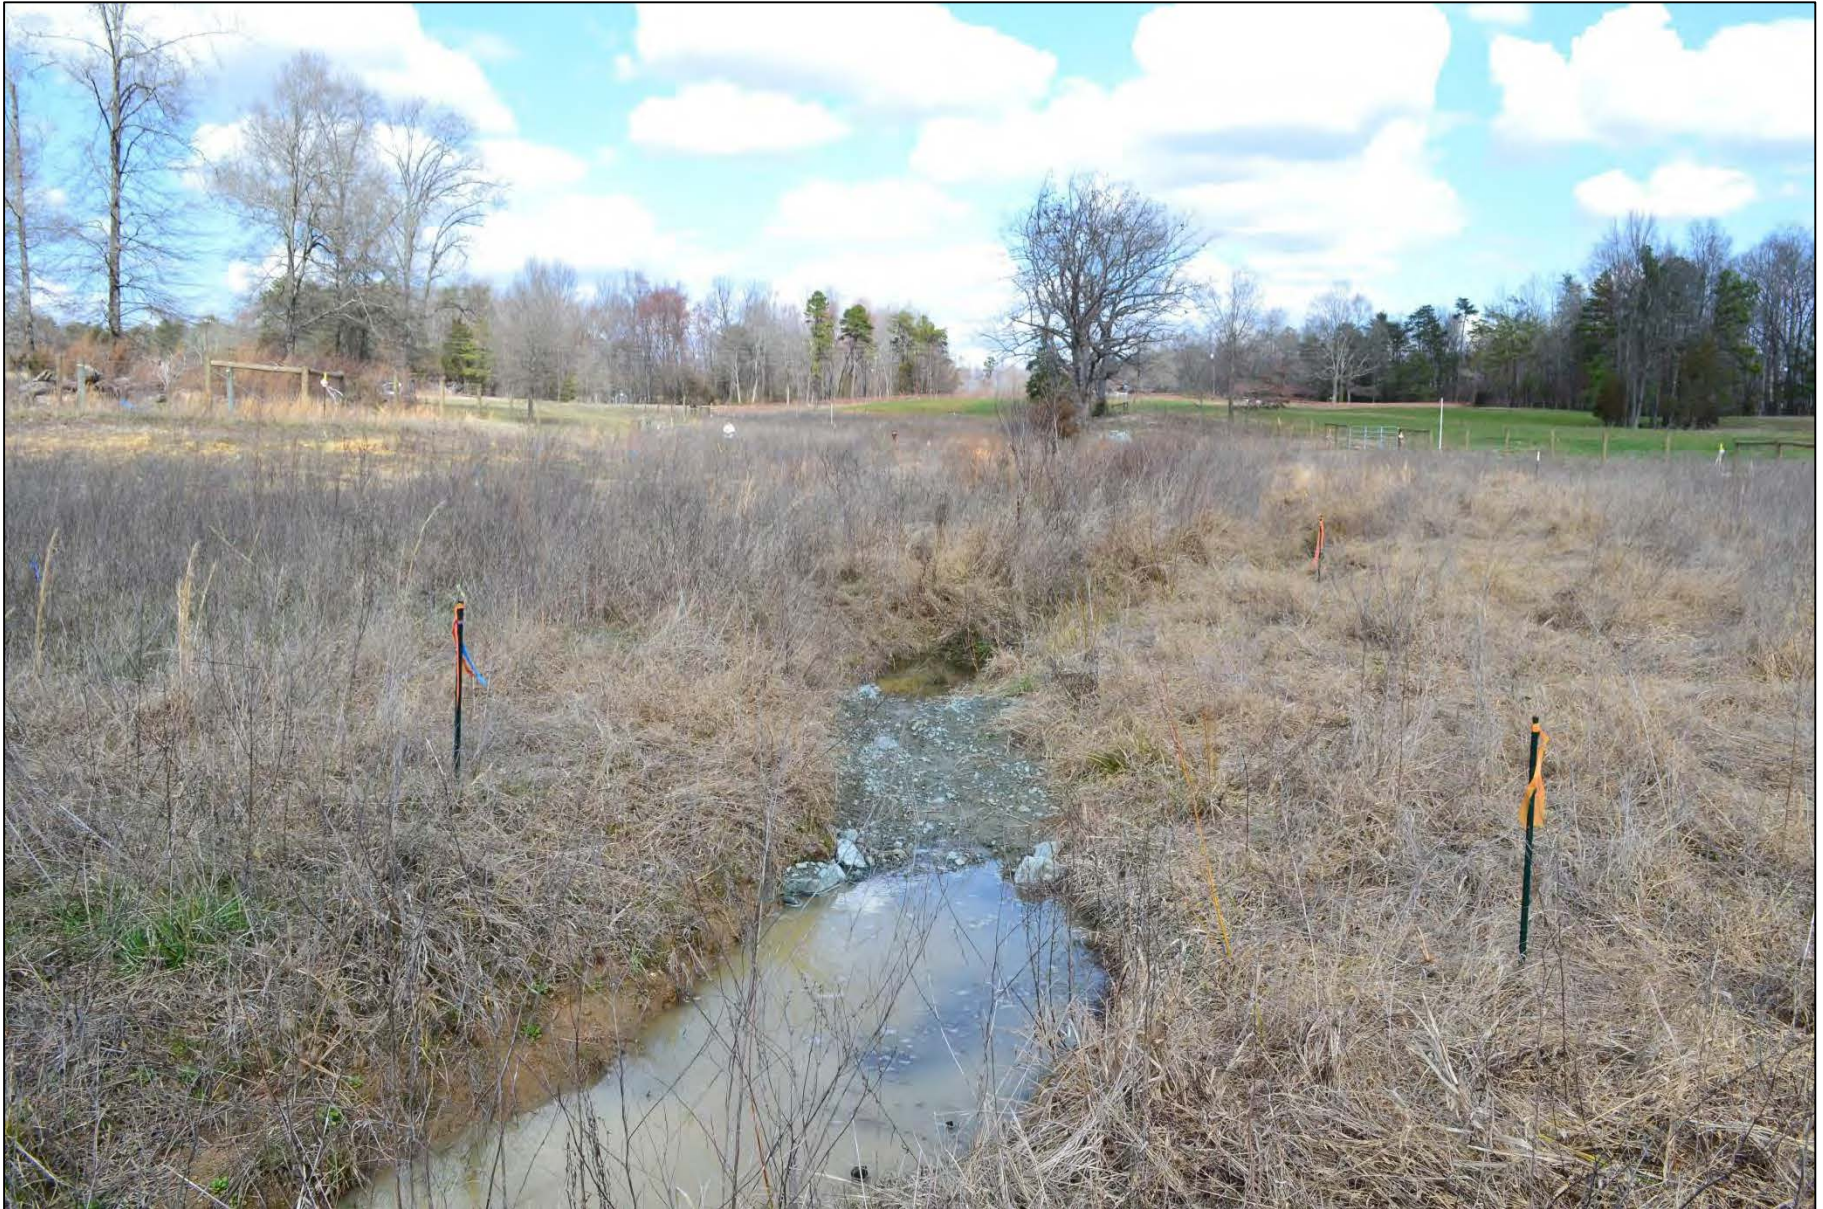
Photo 4: Substrate replaced, upstream riffle of XC 10 (pool)

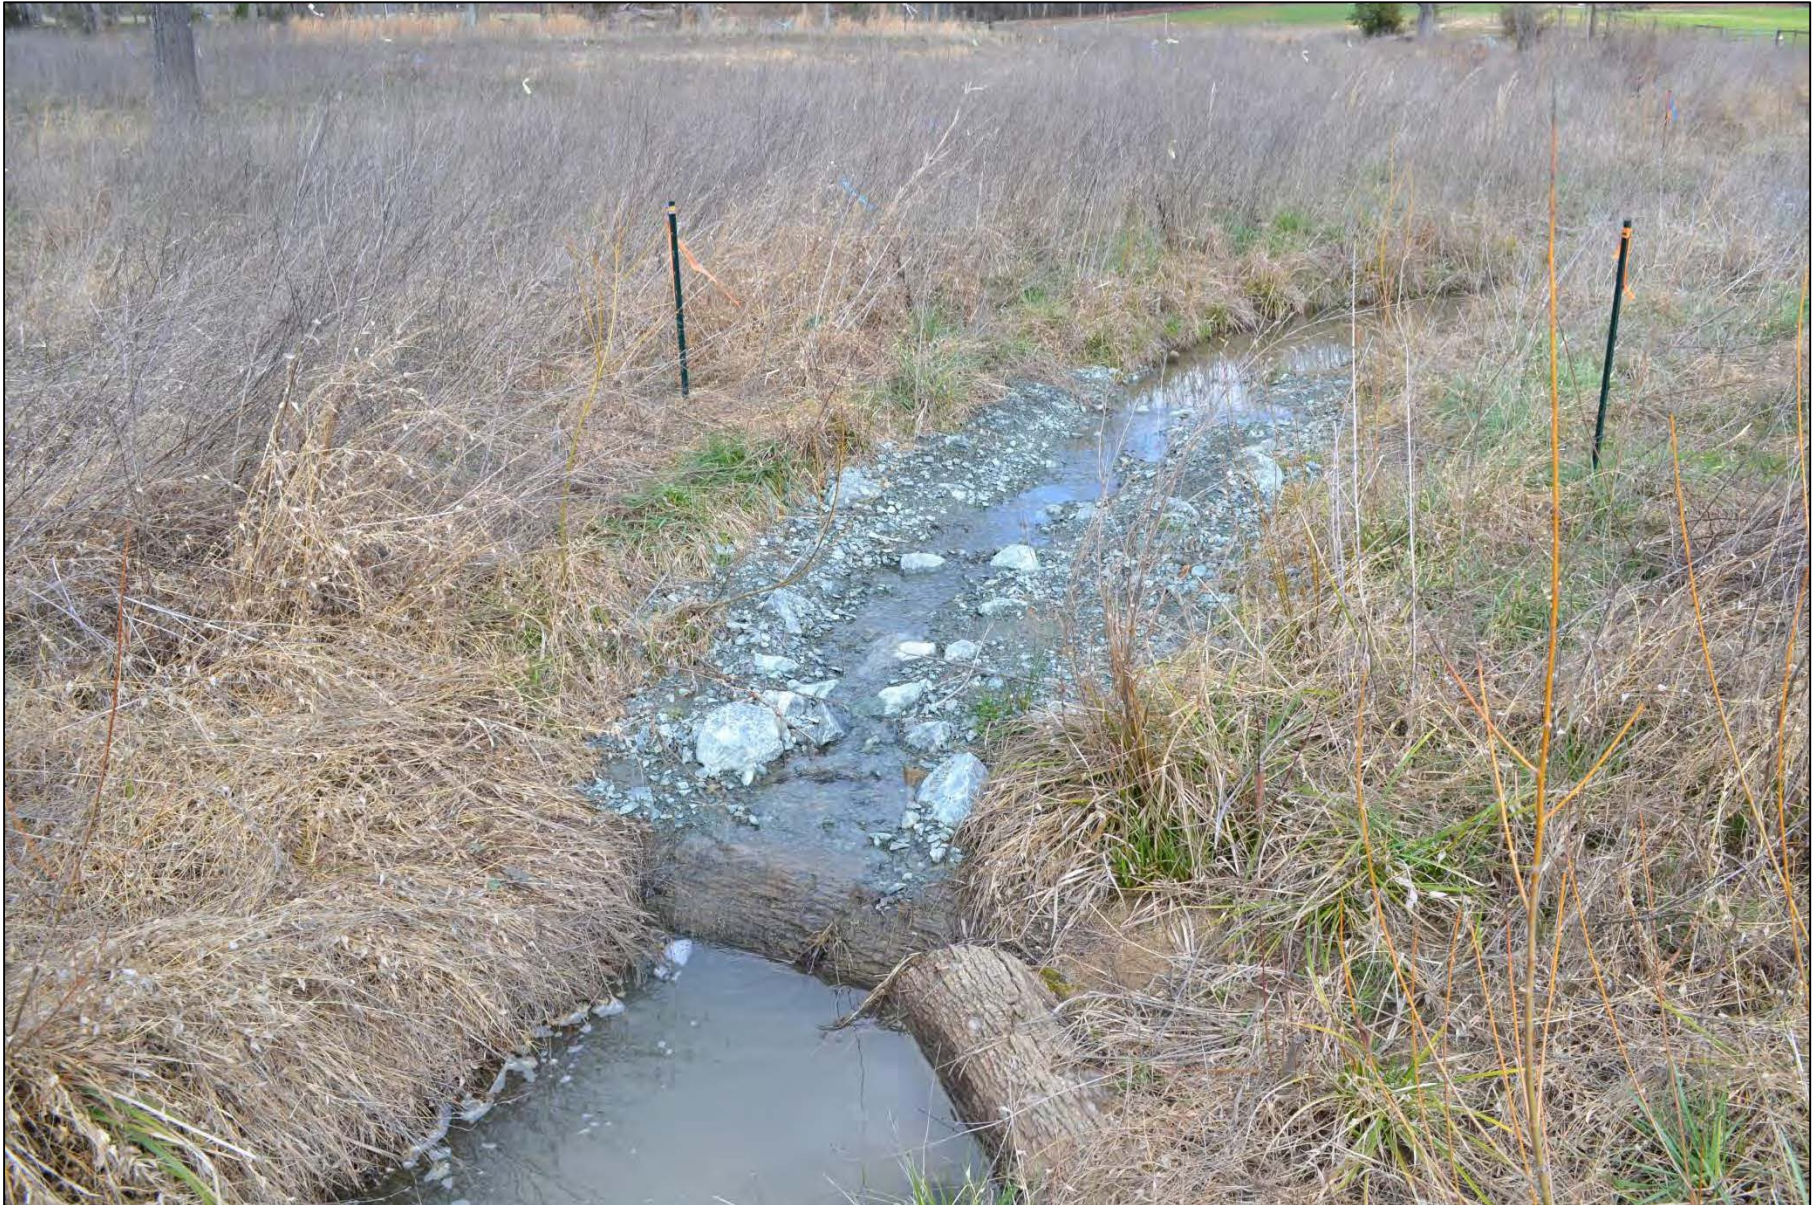
Photo 7: XC-9 – Post 3-1-2017 0.92 inch rain event (Per USGS Guage at BUFFALO CREEK (SR2819 NR MCLEANSVILLE, NC) ~ 7 miles from Site

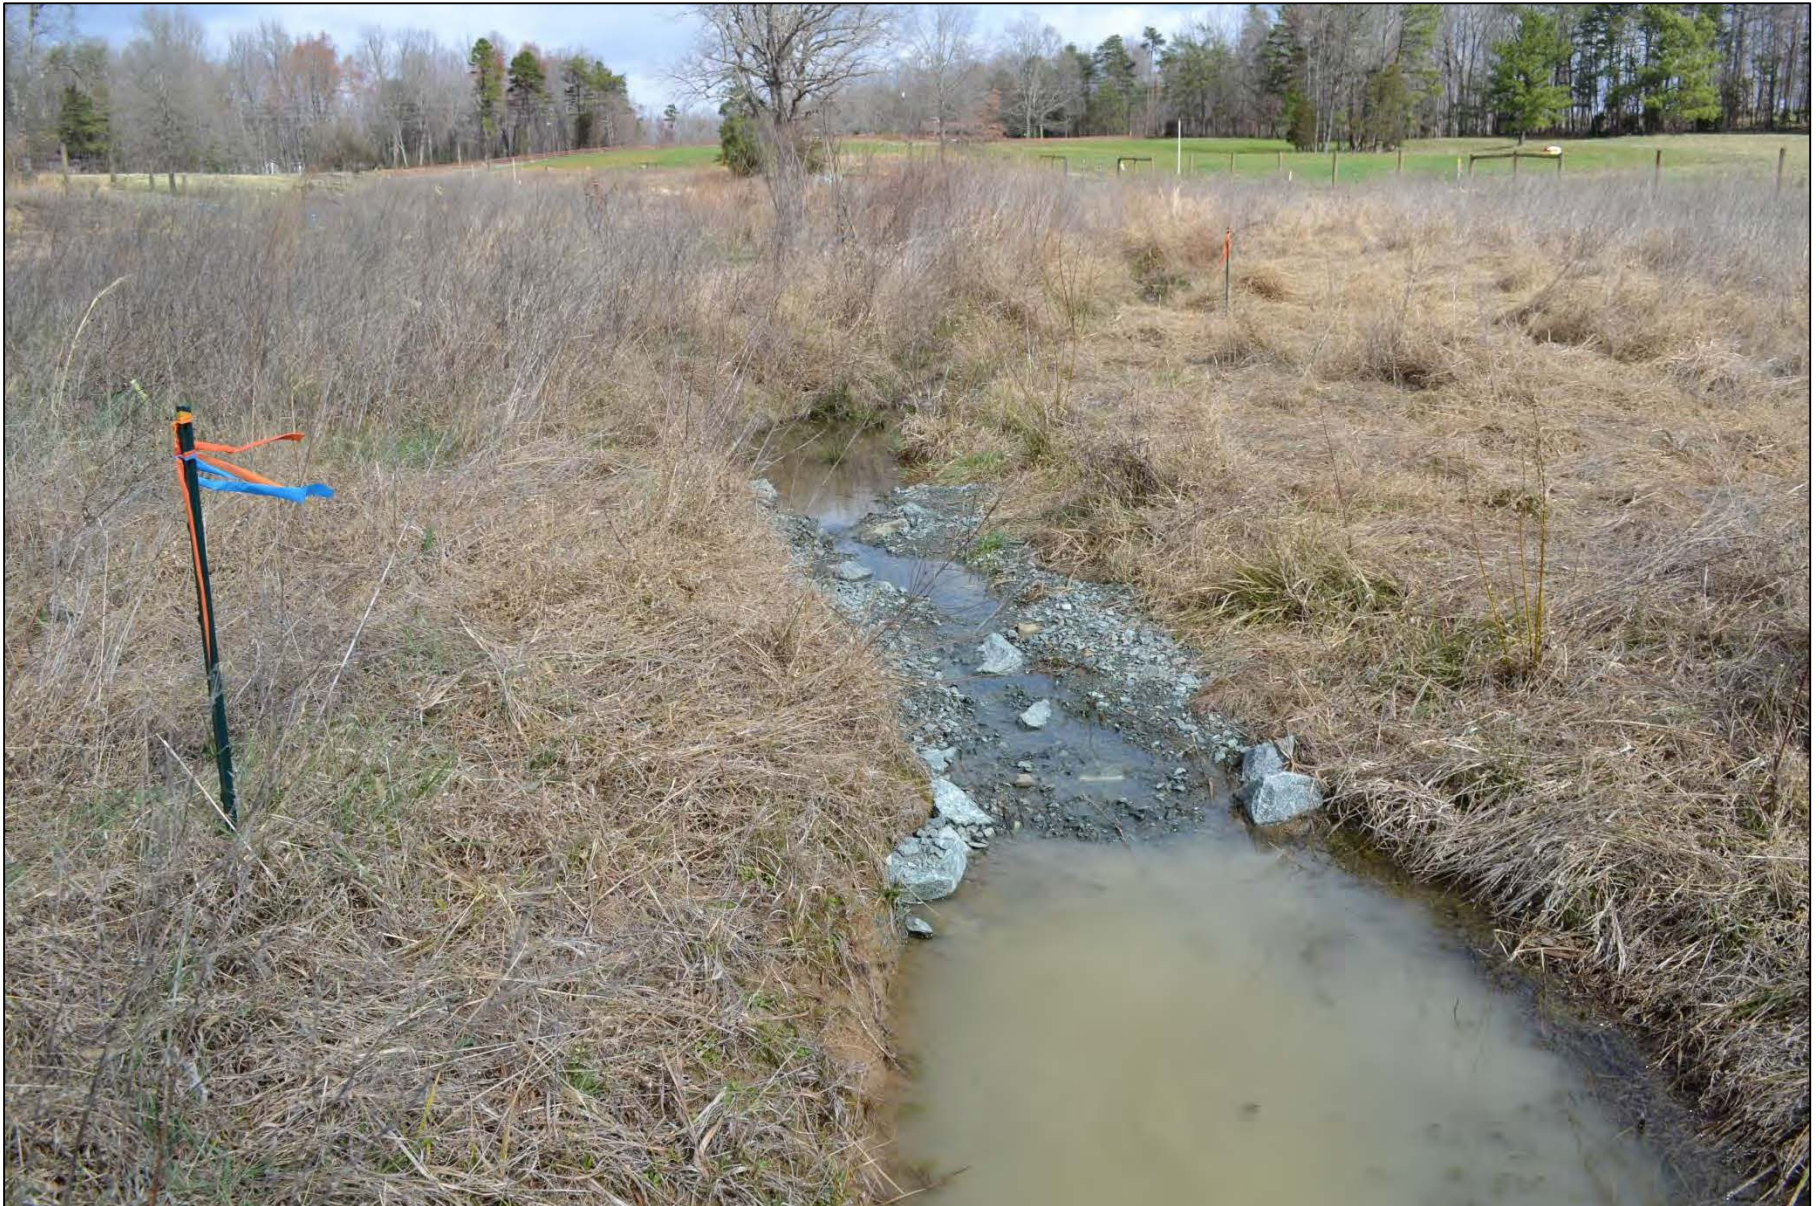
Photo 7: XC-10 – Post 3-1-2017 0.92 inch rain event (Per USGS Gauge at BUFFALO CREEK (SR2819 NR MCLEANSVILLE, NC) ~ 7 miles from Site

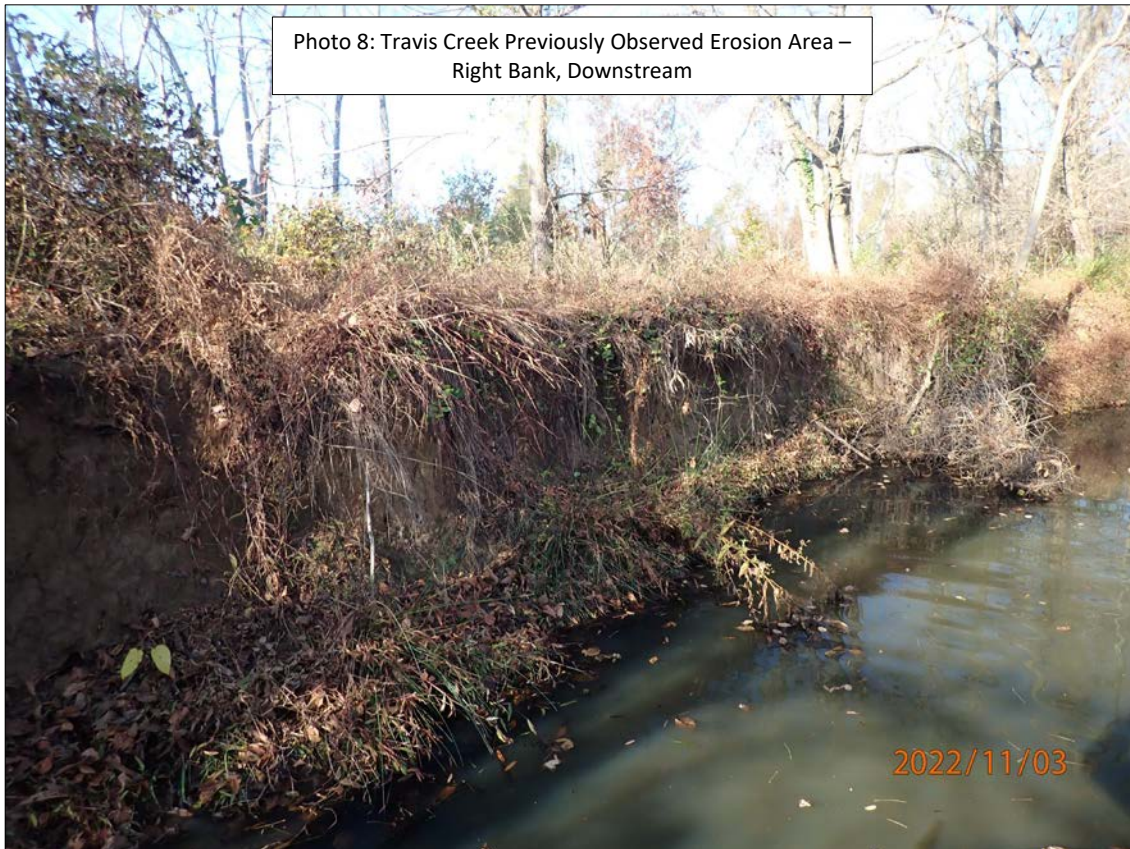
Across the Site, all in-stream structures are intact and functioning as designed. No stream areas of concern were identified during Year 7 (2022) monitoring; however, during previous monitoring years, three small areas of bank erosion were observed in the Enhancement (Level II) reach of Travis Creek. These areas remained during Year 7 (2022), however herbaceous vegetation has continued to establish along all three spans, rendering them smaller and more stable than past years. Since first identified in 2018, these areas have gradually stabilized, indicating that the Enhancement (level II) mitigation treatment is working as proposed; therefore, they are no longer considered areas of concern. Tables for annual quantitative assessments are included in Appendix C and photos are included in the site photo log (Appendix F).

Photo 8: Travis Creek Previously Observed Erosion Area –  
Right Bank, Downstream
