**YEAR 7 (2022) MONITORING REPORT**  
**AYCOCK SPRINGS**  
**STREAM AND WETLAND MITIGATION SITE**

ALAMANCE COUNTY, NORTH CAROLINA  
DMS PROJECT No. 96312  
FULL DELIVERY CONTRACT No. 5791  
NCDWR PROJECT No. 20140335  
USACE ACTION ID No. SAW-2014-01711

**Data Collection – January-October 2022**

**February 2023**

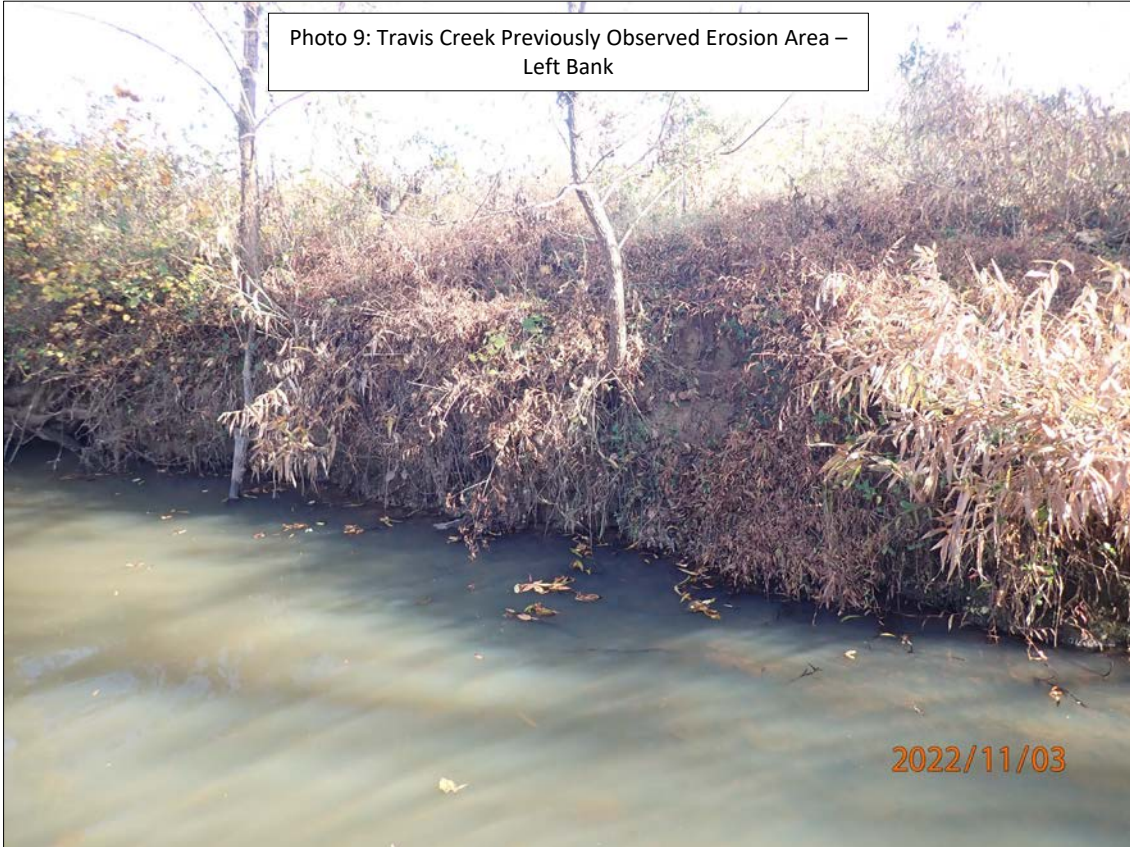
Across the Site, all in-stream structures are intact and functioning as designed. No stream areas of concern were identified during Year 7 (2022) monitoring; however, during previous monitoring years, three small areas of bank erosion were observed in the Enhancement (Level II) reach of Travis Creek. These areas remained during Year 7 (2022), however herbaceous vegetation has continued to establish along all three spans, rendering them smaller and more stable than past years. Since first identified in 2018, these areas have gradually stabilized, indicating that the Enhancement (level II) mitigation treatment is working as proposed; therefore, they are no longer considered areas of concern. Tables for annual quantitative assessments are included in Appendix C and photos are included in the site photo log (Appendix F).

Photo 9: Travis Creek Previously Observed Erosion Area –  
Left Bank

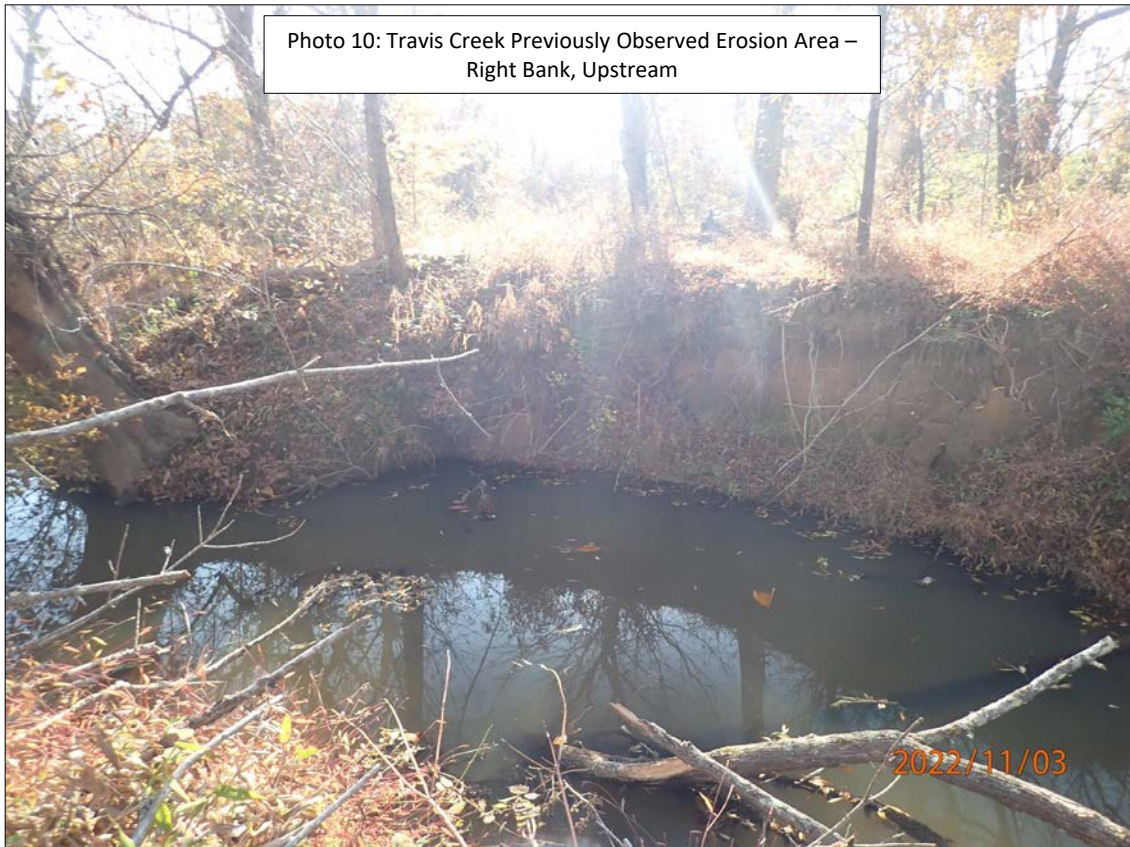
Photo 10: Travis Creek Previously Observed Erosion Area –  
Right Bank, Upstream
