Back Creek Stream and Wetland Restoration

Project No. 17

2006 Monitoring Report: Year 1 of 5

March 2007

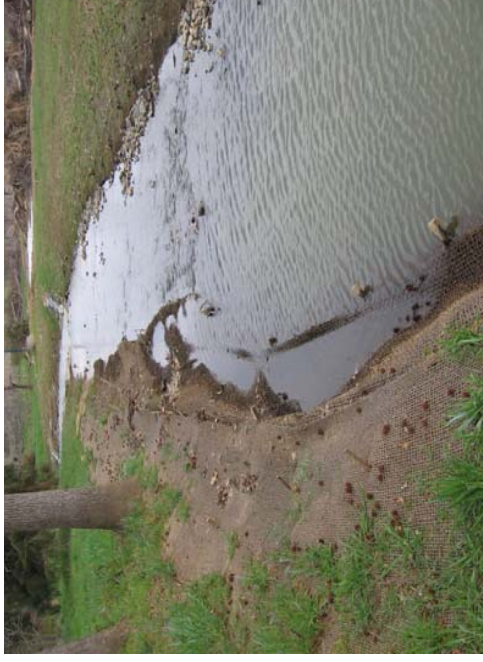
1. Bank Erosion: Moderate – Flood Event

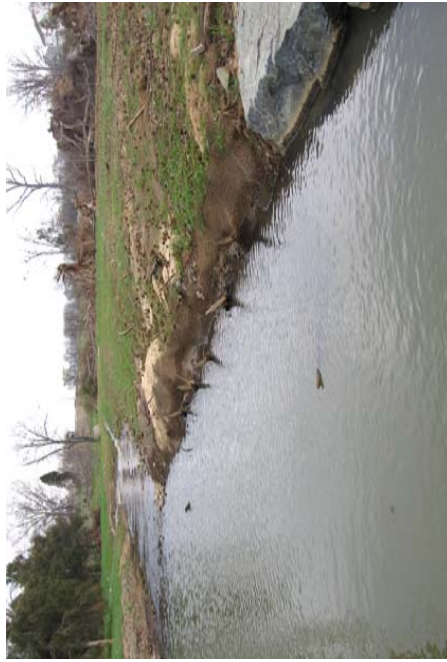
2. Loose matting – Flood Event

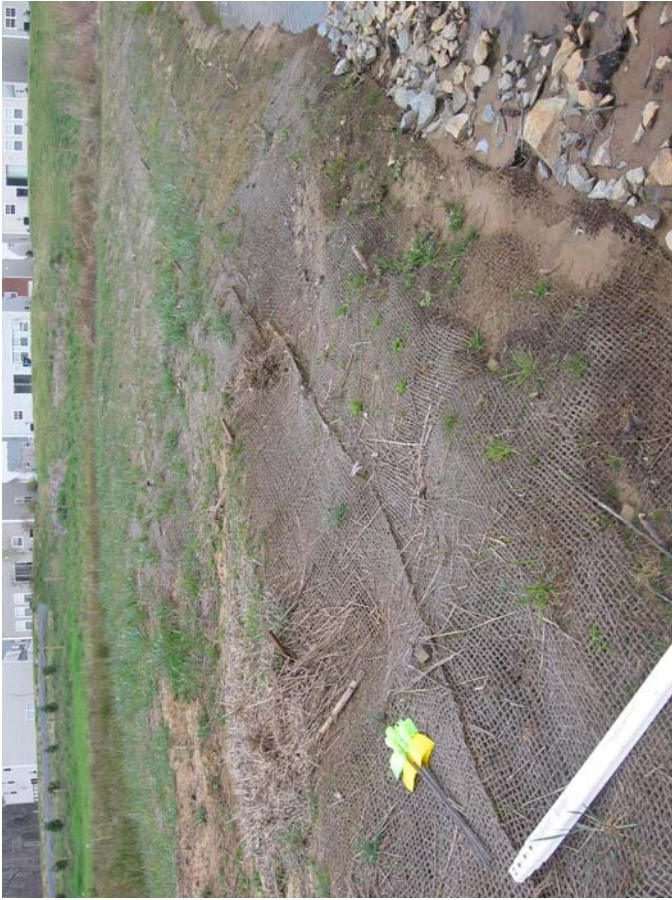
- There are a few areas of moderate erosion under the stream bank matting. However, once vegetation is established, these areas may be less noticeable and will likely not result in instability. If possible, these areas should be stabilized with riparian vegetation.
- Since completion of construction, one medium-sized cedar tree has fallen into the stream below the convergence of the tributary that was restored as a B-channel. Over time, this tree will likely catch debris.
- One area of bare bank was observed at the downstream end of the project. Access may have prevented completion of matting in this area.

1. Bank Erosion - Moderate

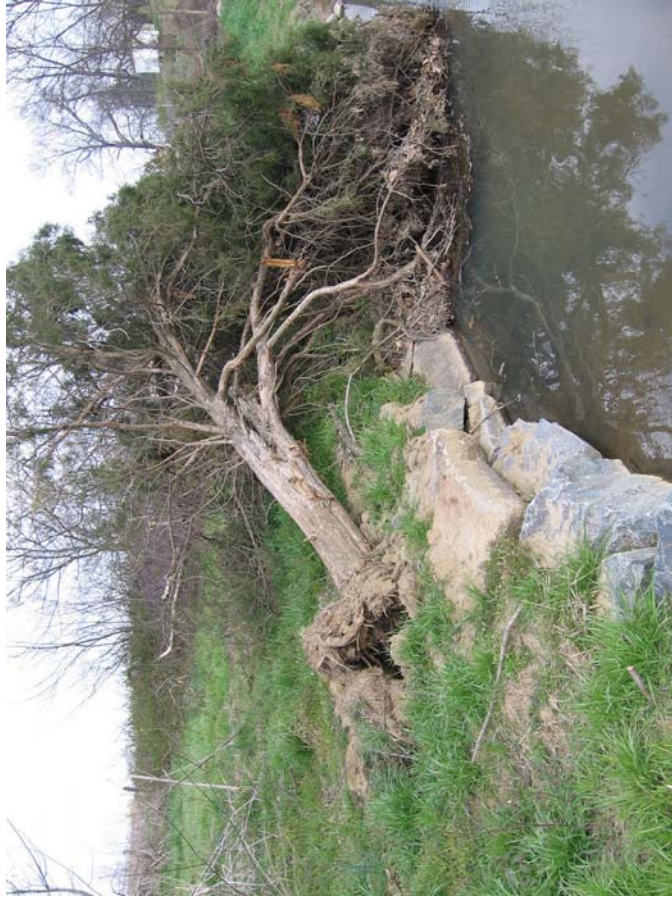
2. Down Tree

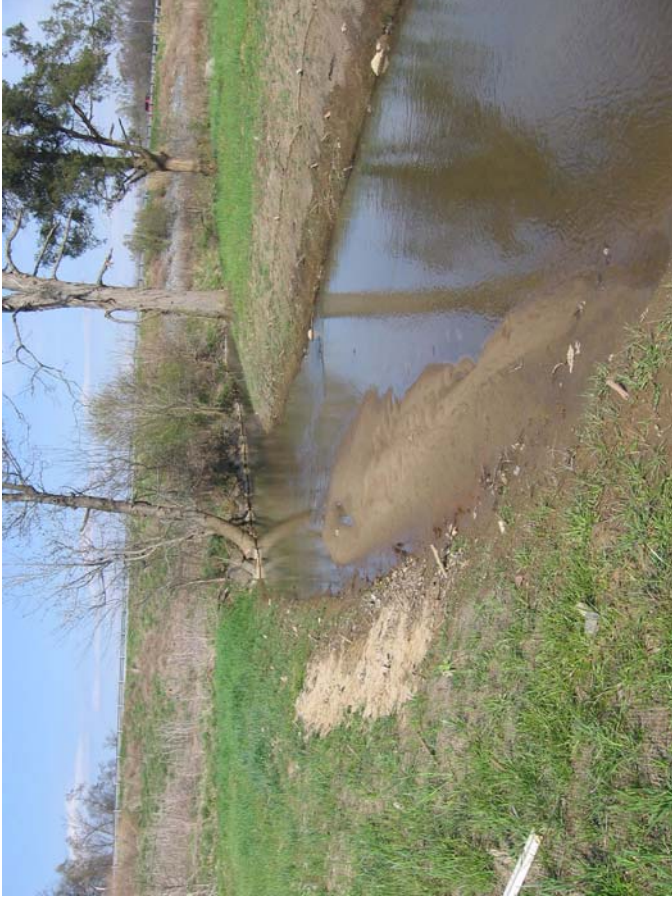
3. Lateral Bar

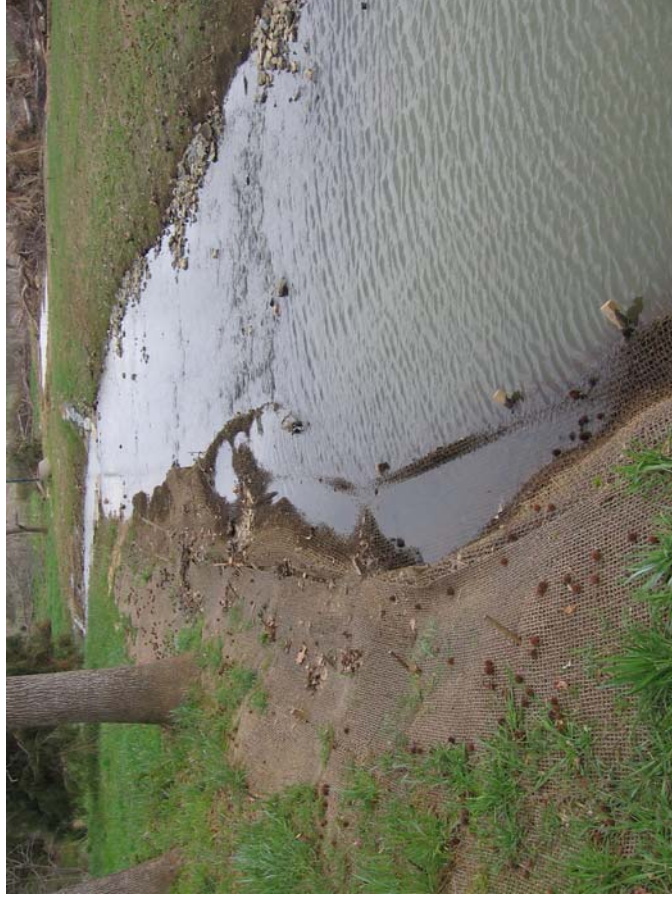
4. Loose Matting

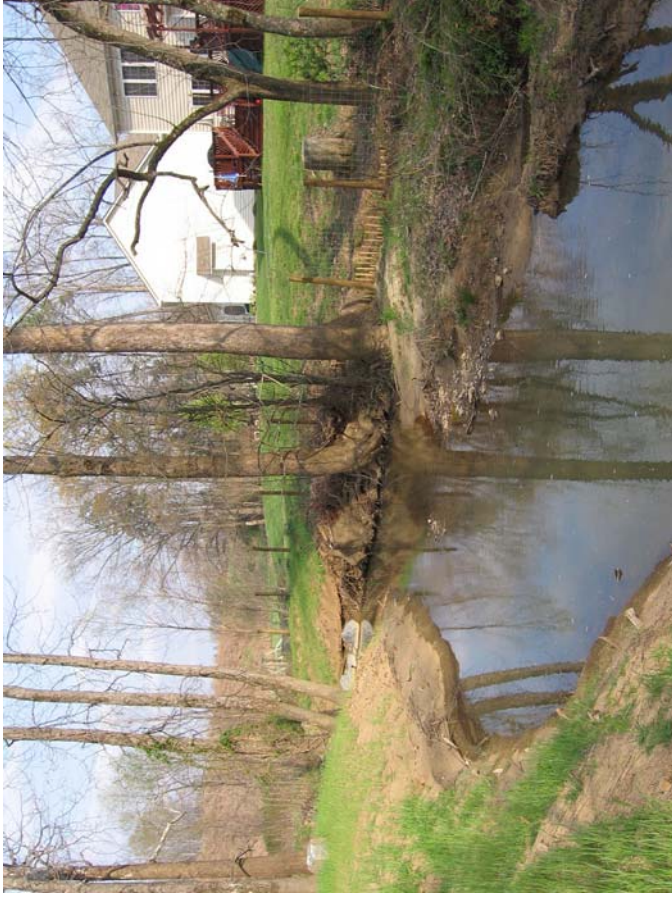
5. Stream Bank Cover – Moderate/Poor
