Back Creek Stream and Wetland Restoration

Project No. 17

2007 Monitoring Report (Final): Year 2 of 5

March 2008

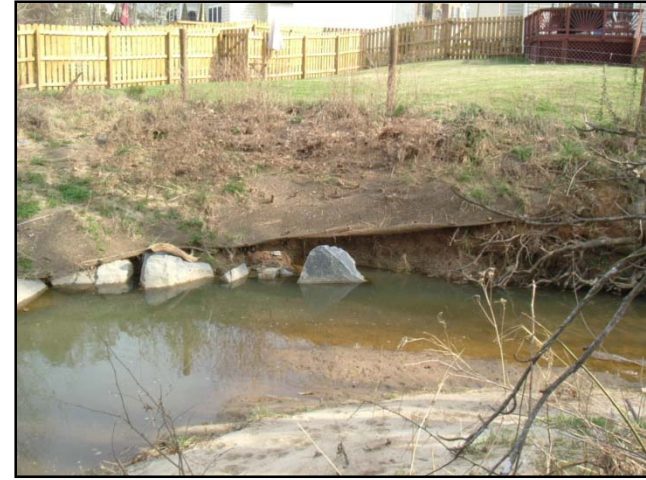
2. Bank Erosion: Severe
3/22/2007

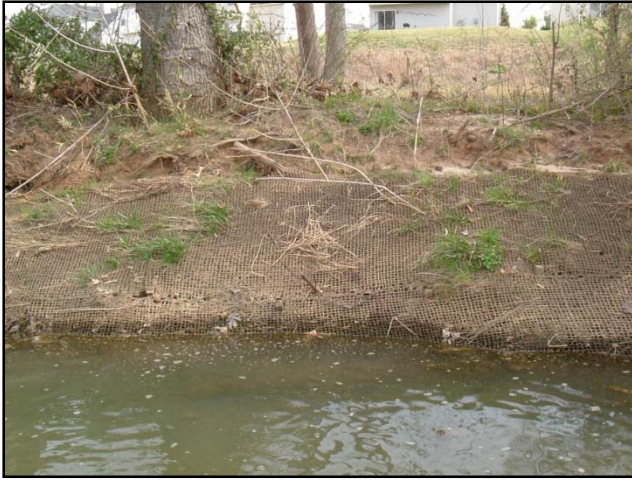
1. Bank Erosion: Moderate
3/22/2007

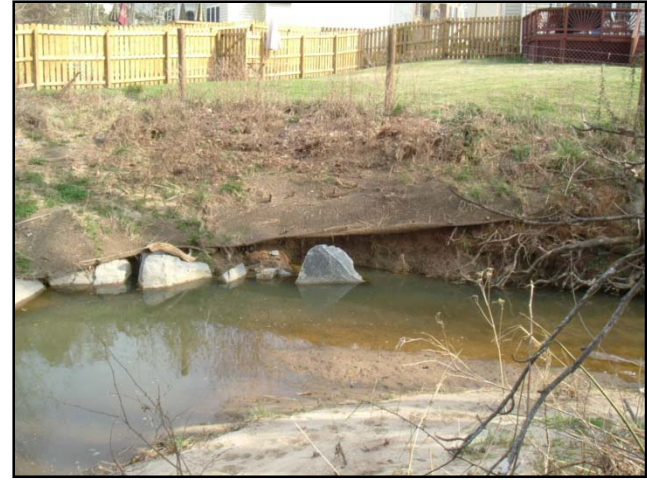
2. Bank Erosion: Severe
3/22/2007

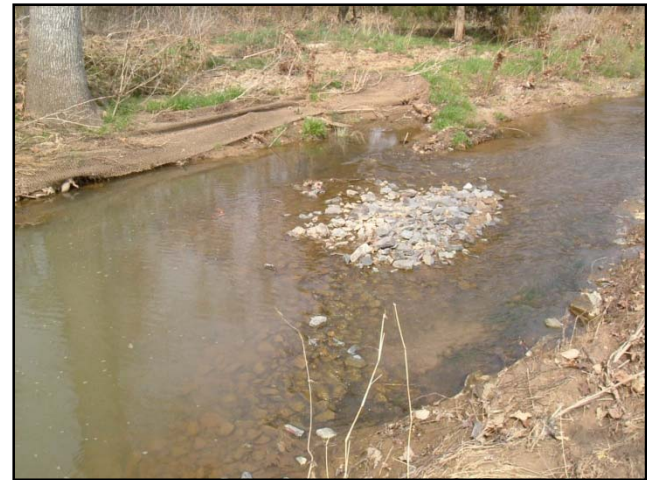
15+20	Overwidened channel - transverse/mid channel bar forming	4
	20+20 - 20+60	Overwidened channel - lateral bar forming - LB	9
	27+65-27+90	Overwidened channel - lateral bar forming, pushing TW to REW - LB	
Down Tree	17+85	Down tree from stream bank - potential for debris jam	3
Loose Matting	23+20-23+30	Loose matting, stakes failed to hold	5
Point Bar Eroding - Moderate	3+30-3+35	Channel dimension adjusting - RB	6
	3+70-3+80	Channel dimension adjusting - RB	
	4+50-4+53	Channel dimension adjusting - LB	
Structure- Stressed	7+25	Scour under arm at BKF - RB	10
	14+60	Scour under arm - LB	
Streambank Cover - Poor	6+60-6+68	Poor vegetative cover - RB	7
	8+65-8+80	Poor vegetative cover - LB	
	33+75-33+80	Bare bank needs coverage - RB	
	35+00 - 35+50	Bare bank needs coverage - RB

4. Aggradation: Transverse Bar
3/22/2007

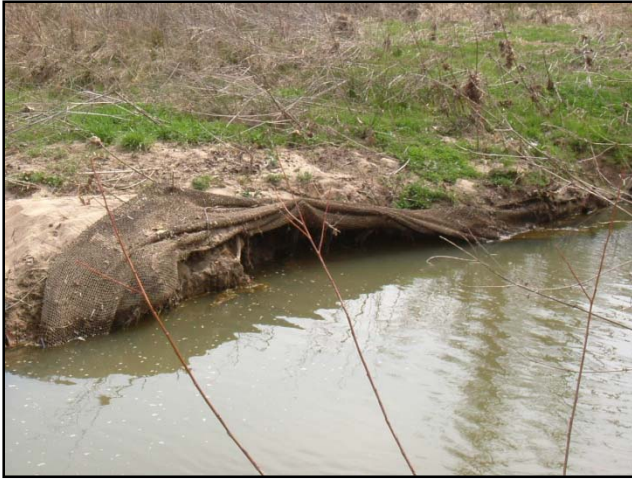
5. Loose Matting
3/22/2007

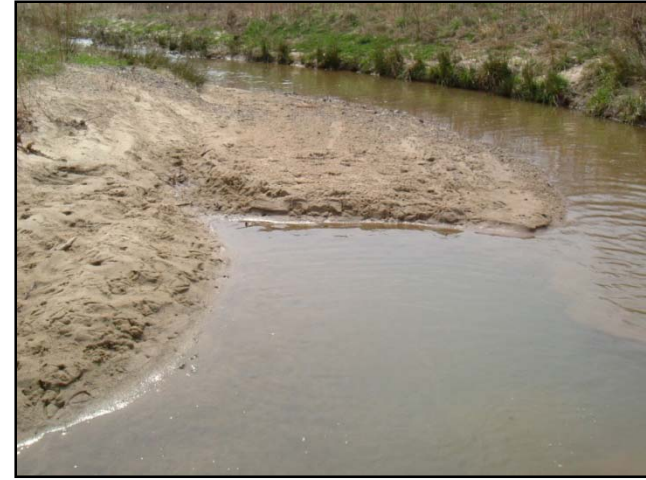
6. Point Bar Erosion
3/22/2007

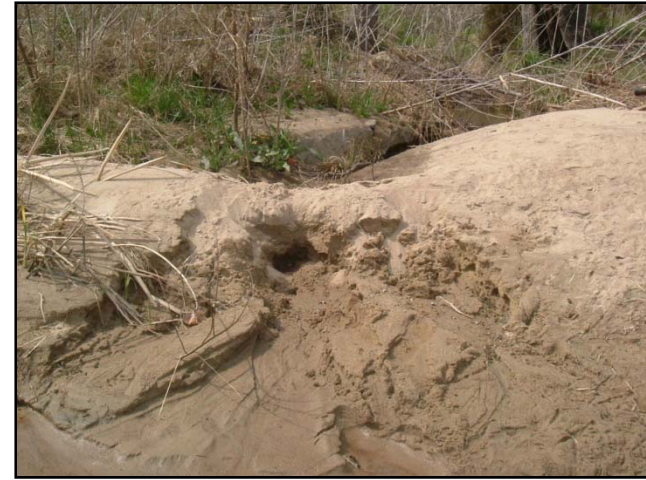
27+65-27+90	Change in near bank stress, eroding under matting - RB	
	29+00-29+50	Change in near bank stress - LB	
	31+75-31+78	Change in near bank stress, eroding under matting - LB	
33+42-33+52	Change in near bank stress, eroding under matting - RB		
34+00-34+20	Bare bank, lack of vegetative cover - RB		
34+55-34+70	Change in near bank stress, eroding under matting - LB		
Bank Erosion - Severe	8+80-9+15	Loose matting - LB	2
	14+60-14+85	Loose matting, bank erosion - RB	
	14+60 - 15+30	Loose matting, bank erosion under matting - LB	
	22+20-22+40	Bank erosion under matting - LB	
	22+55-22+65		
	22+81-22+91		
	26+70-26+75	Loose matting, bank erosion under matting - LB	
	27+40-27+60	Loose matting, bank erosion under matting - RB	
	27+49-27+51	Loose matting, bank erosion under matting - LB	
	30+75-31+00	Change in near bank stress, eroding under matting - RB	
35+00-35+50	Loose matting, vertical bank - RB		
Aggradation	13+20	Heavy sediment deposition in tributary	8

8. Heavy Sediment Deposition in Stormwater Swale
3/22/2007

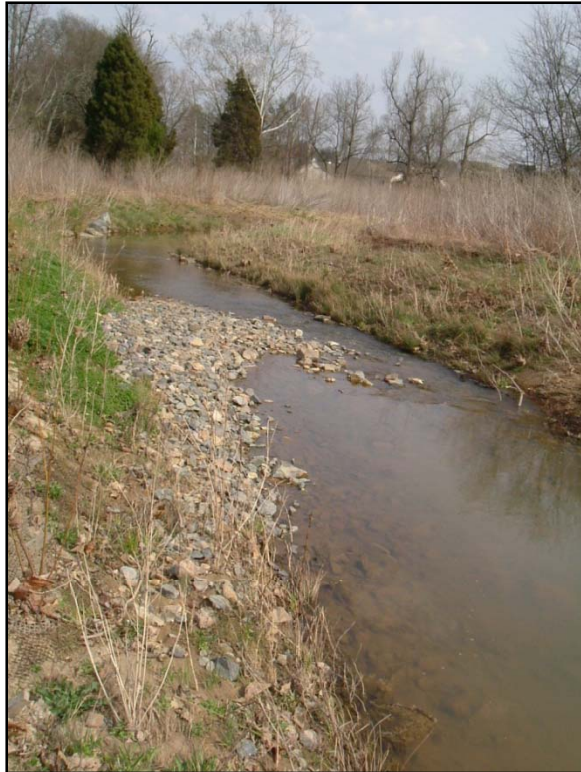
9. Aggradation: Lateral Bar
3/22/2007

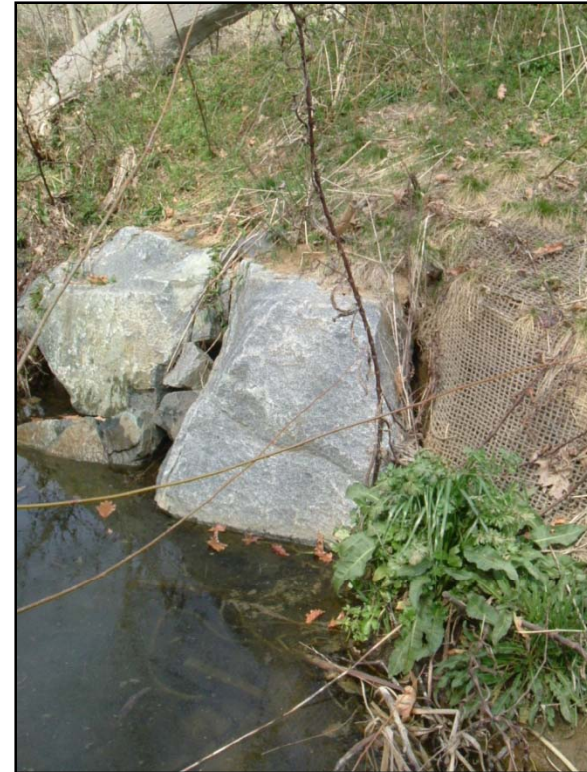
- The two side tributaries appear stable, but minor scouring is occurring within the central tributary.
- The majority of structures appear to be in good condition; however, a few structures have moderate erosion around the arms where they tie into the bankfull elevation.

10. Structure Stressed
3/22/2007
