Back Creek Stream and Wetland Restoration

Project No. 17

2008 Monitoring Report (Final): Year 3 of 5

March 2009

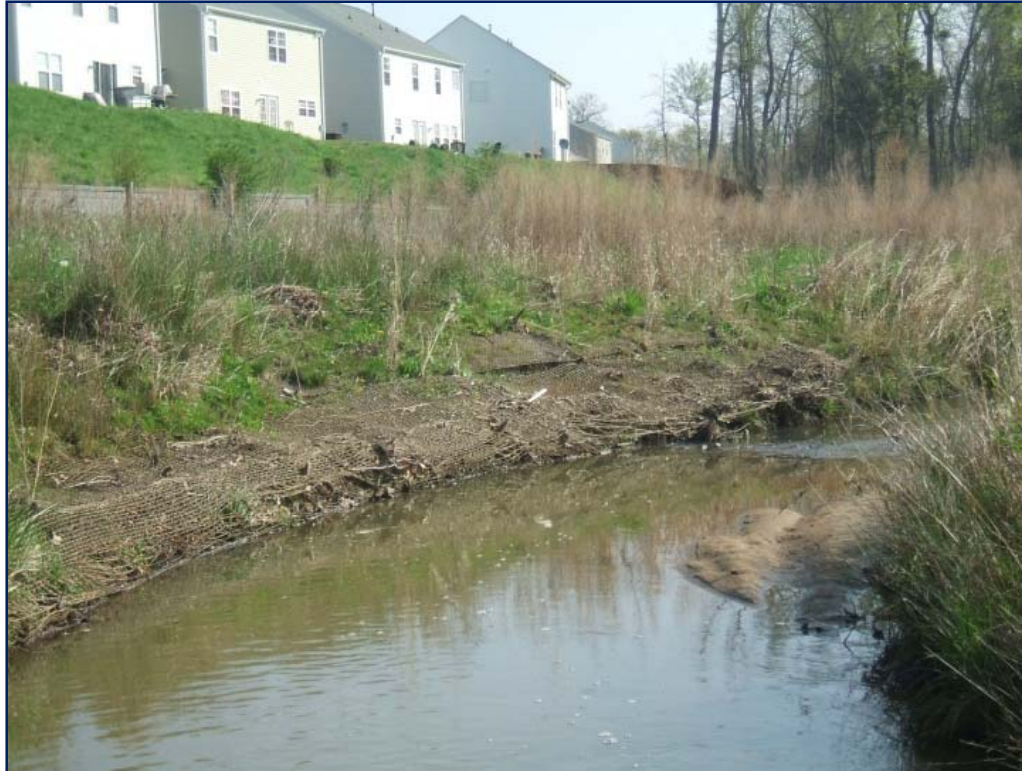
1. Streambank Cover Poor (4/2008)

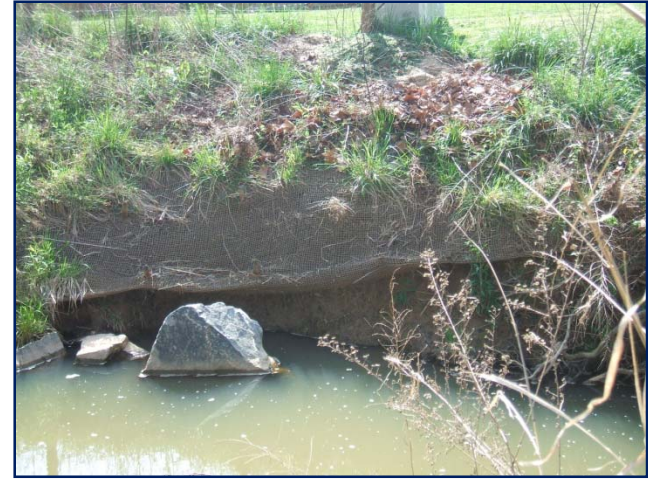
| Feature Issue | Station Numbers | Suspected Cause | Photo ID # |
|---|--|--|---|
| Bank Erosion - Severe | 8+81-9+07 | Loose matting - LB | 2 |

2. Bank Erosion: Severe (4/2008)

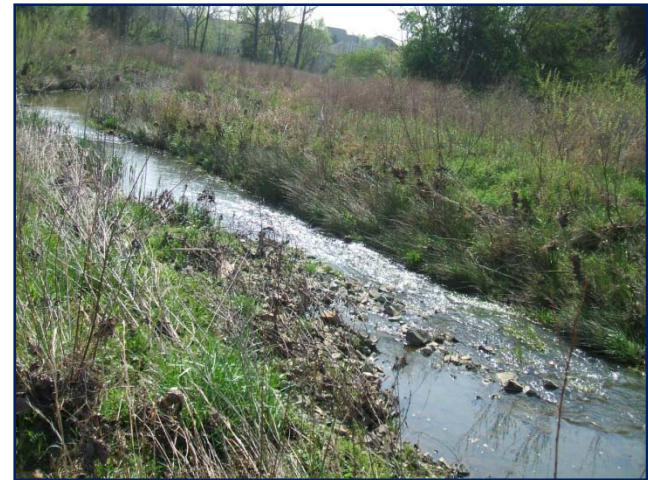
4. Aggradation: Lateral Bar (4/2008)

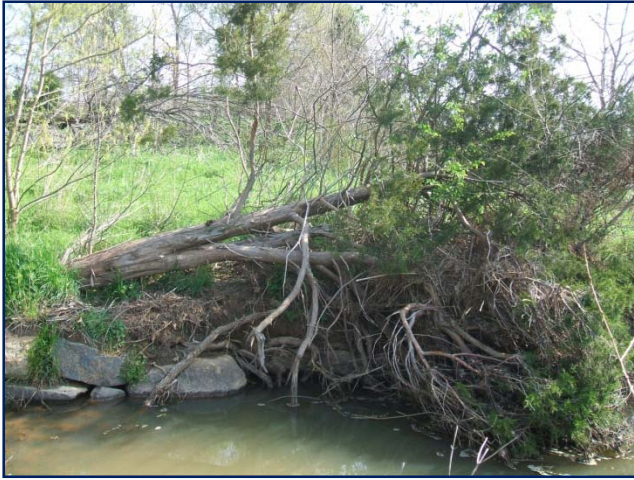
5. Tree Down (4/2008)

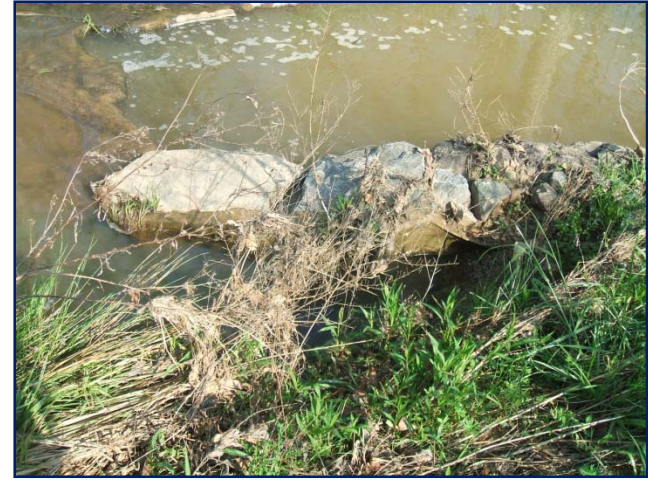
6. Structure Stressed (4/2008)
