# **Back Creek Stream and Wetland Restoration**

## **Project No. 17**

### **2009 Monitoring Report: Year 4 of 5**

**November 2009 (Revised May 2010)**

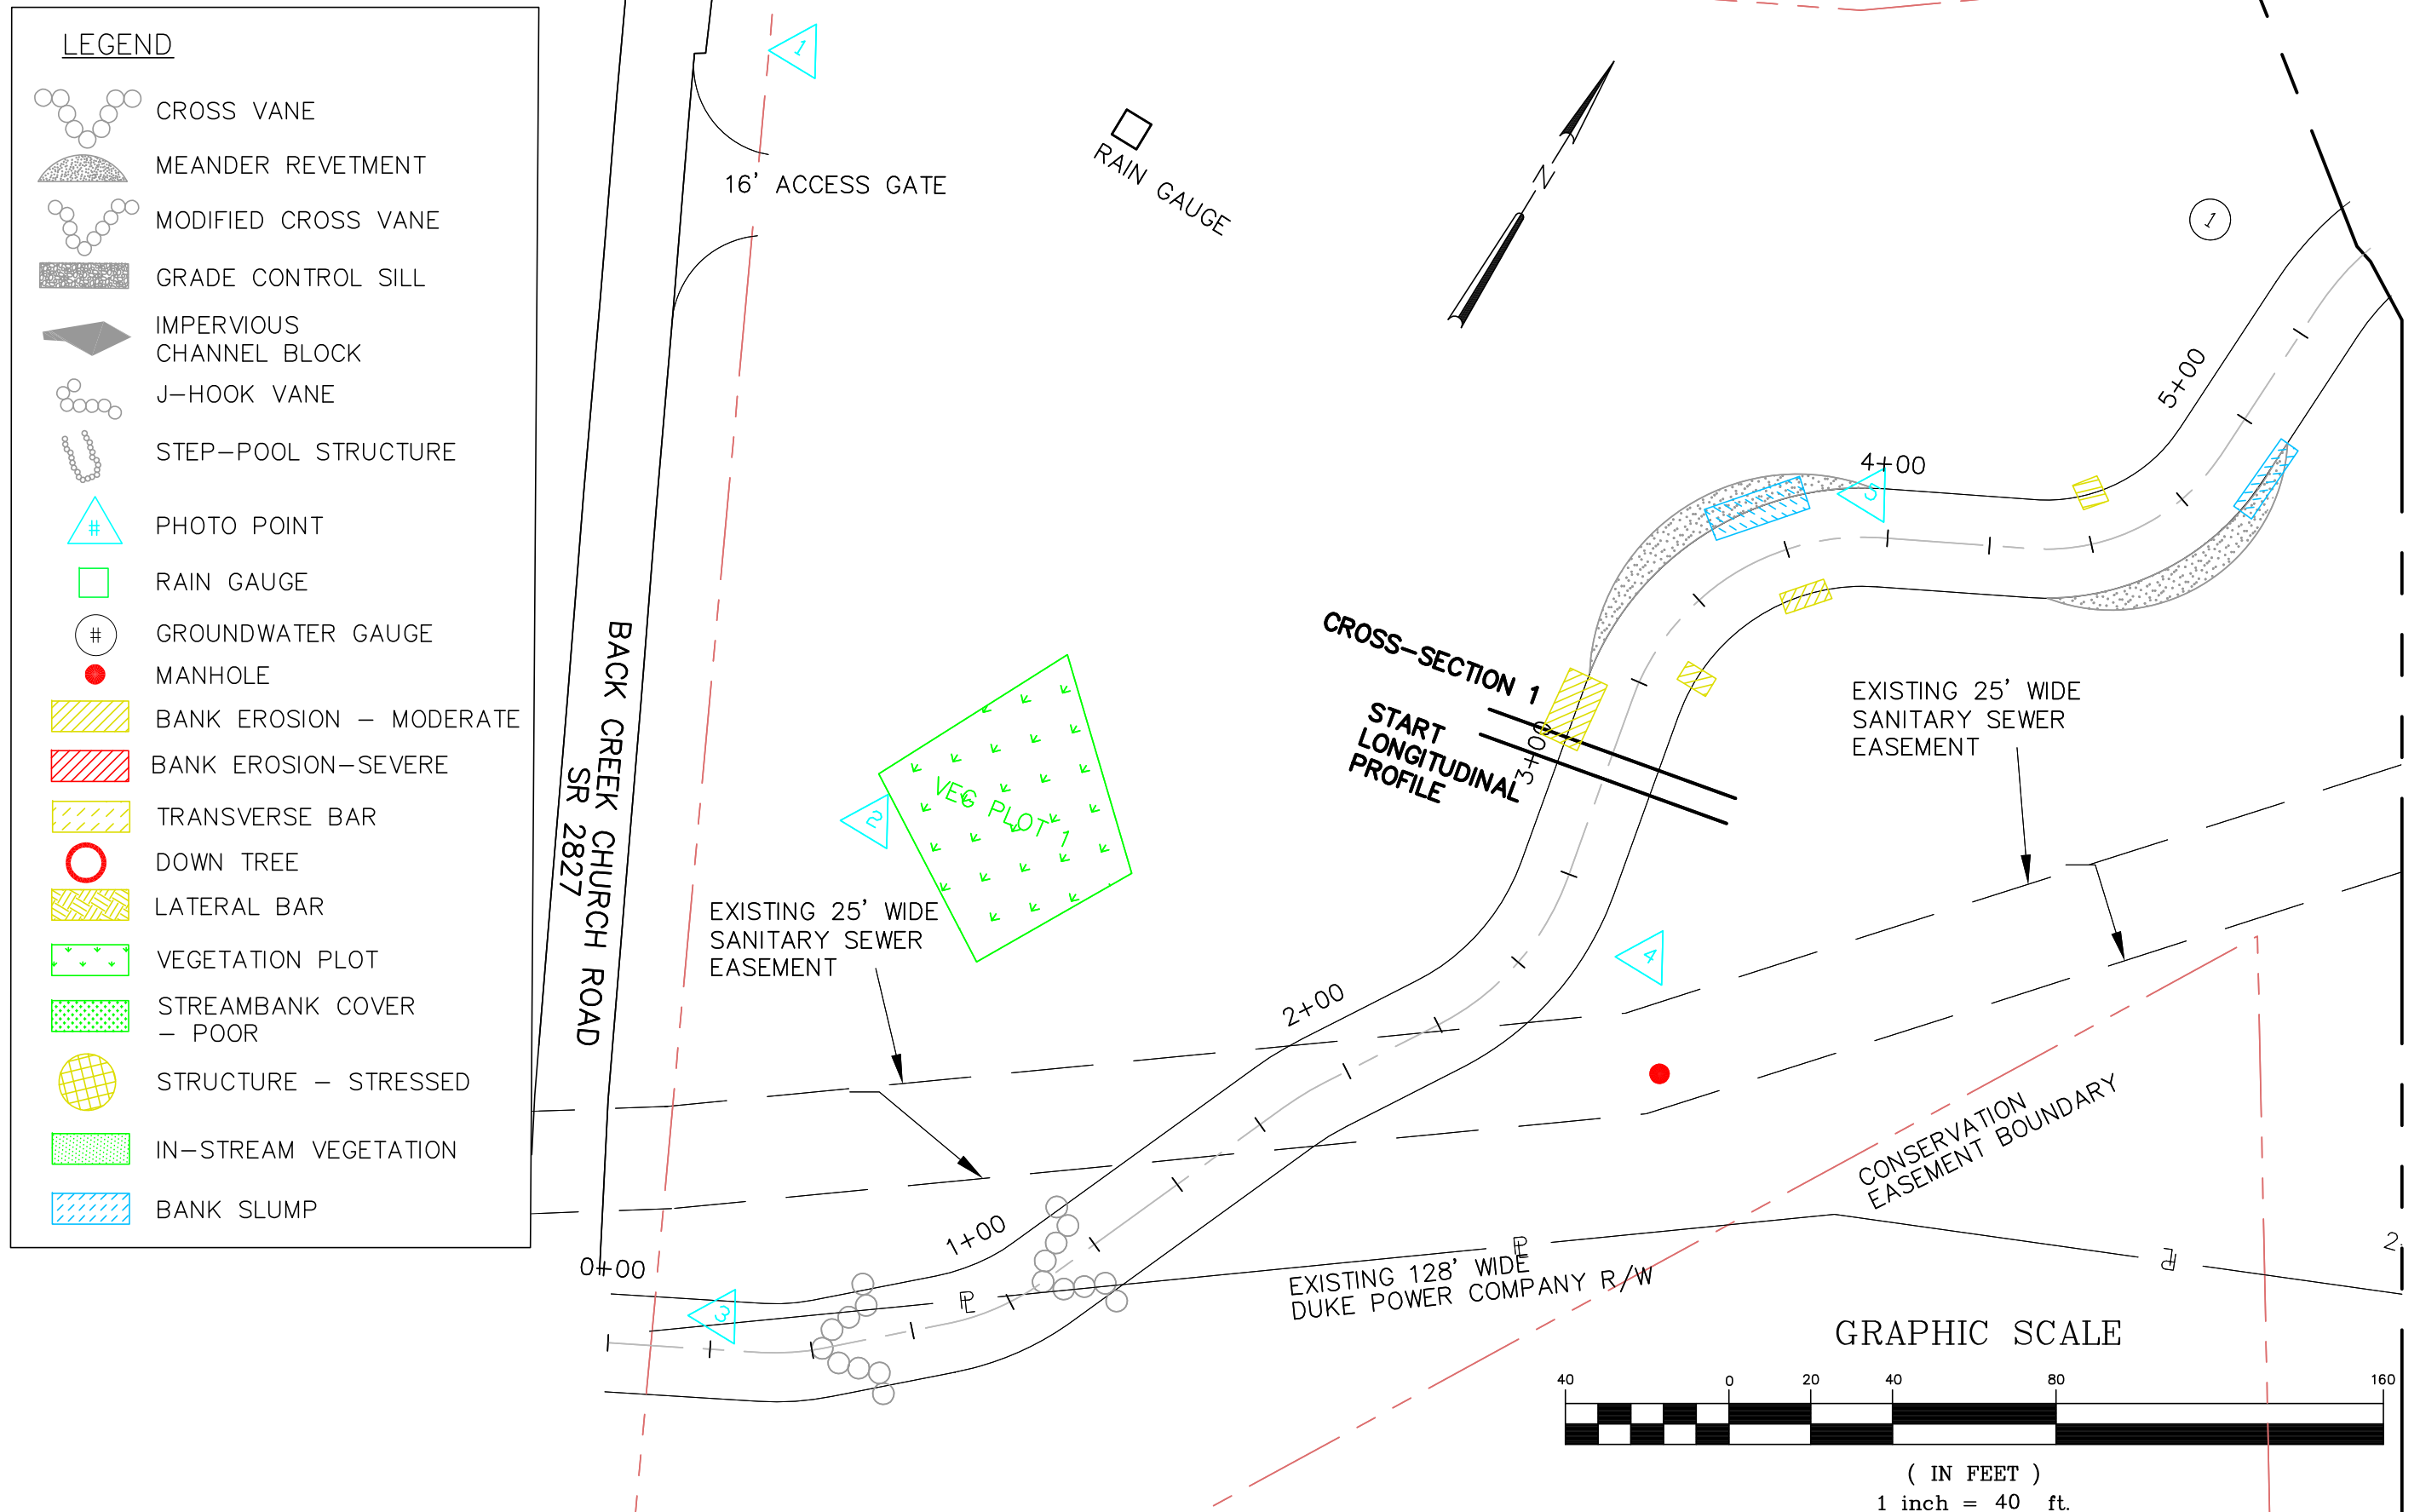
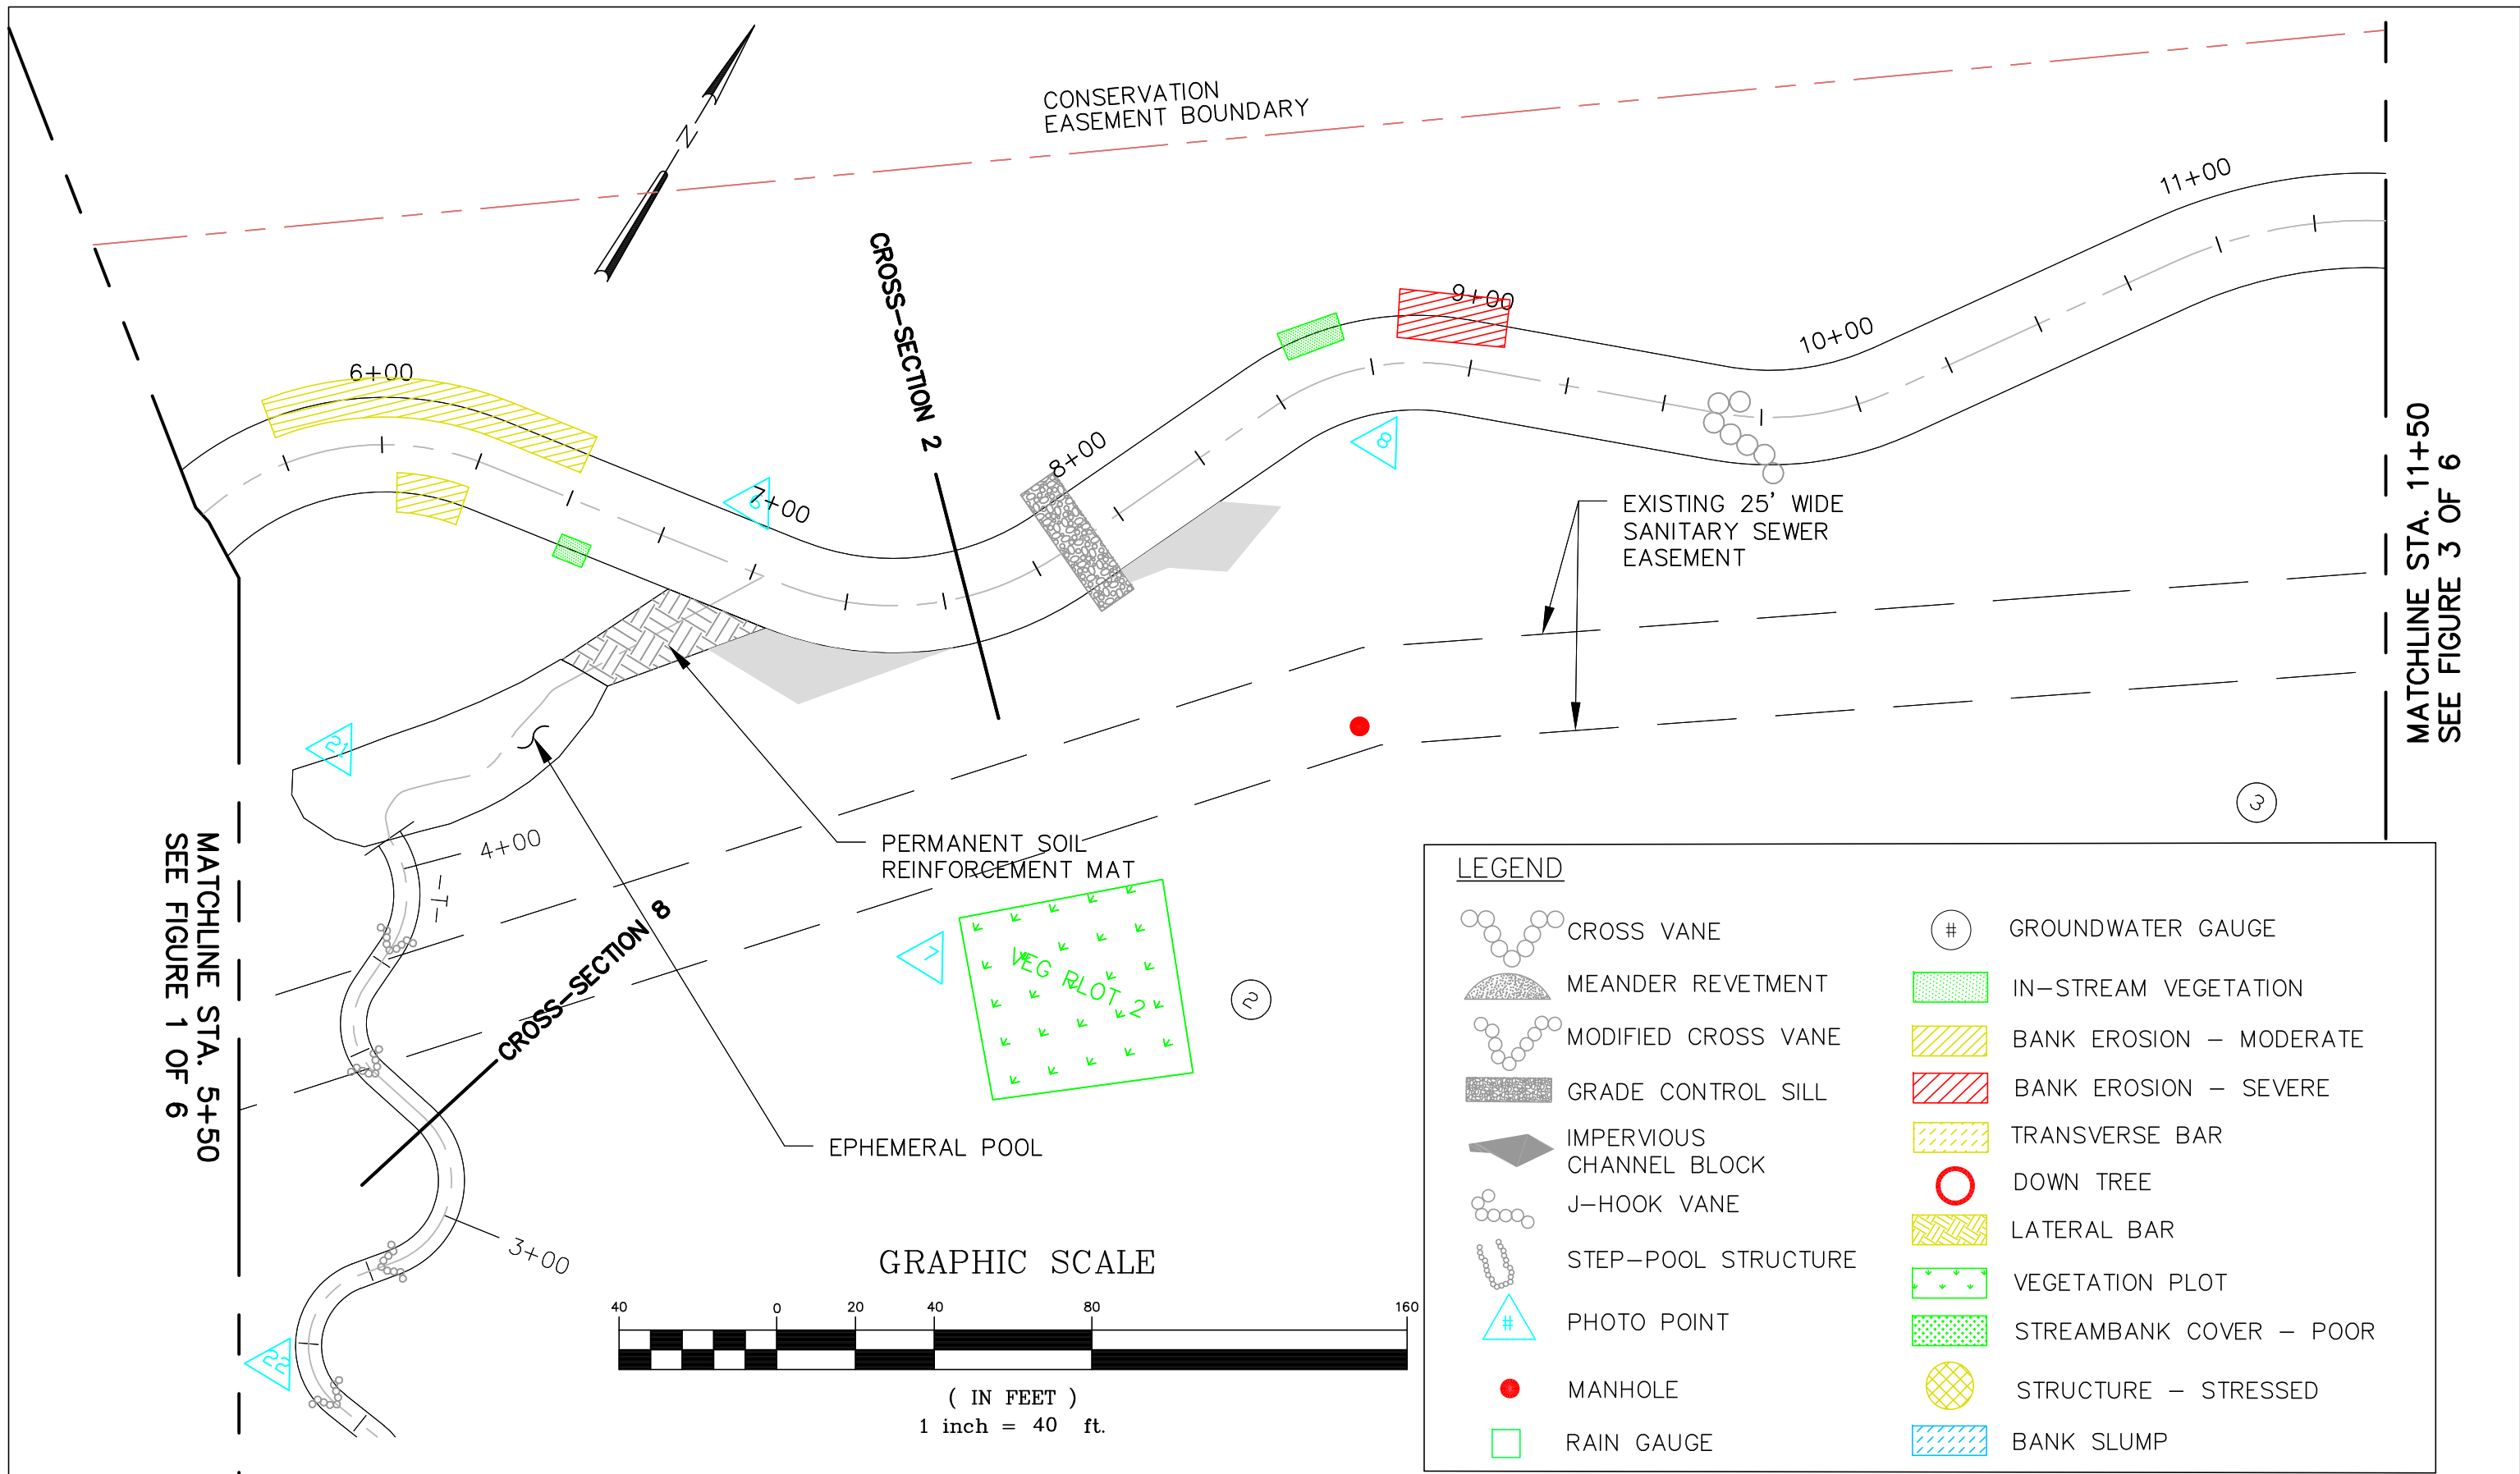
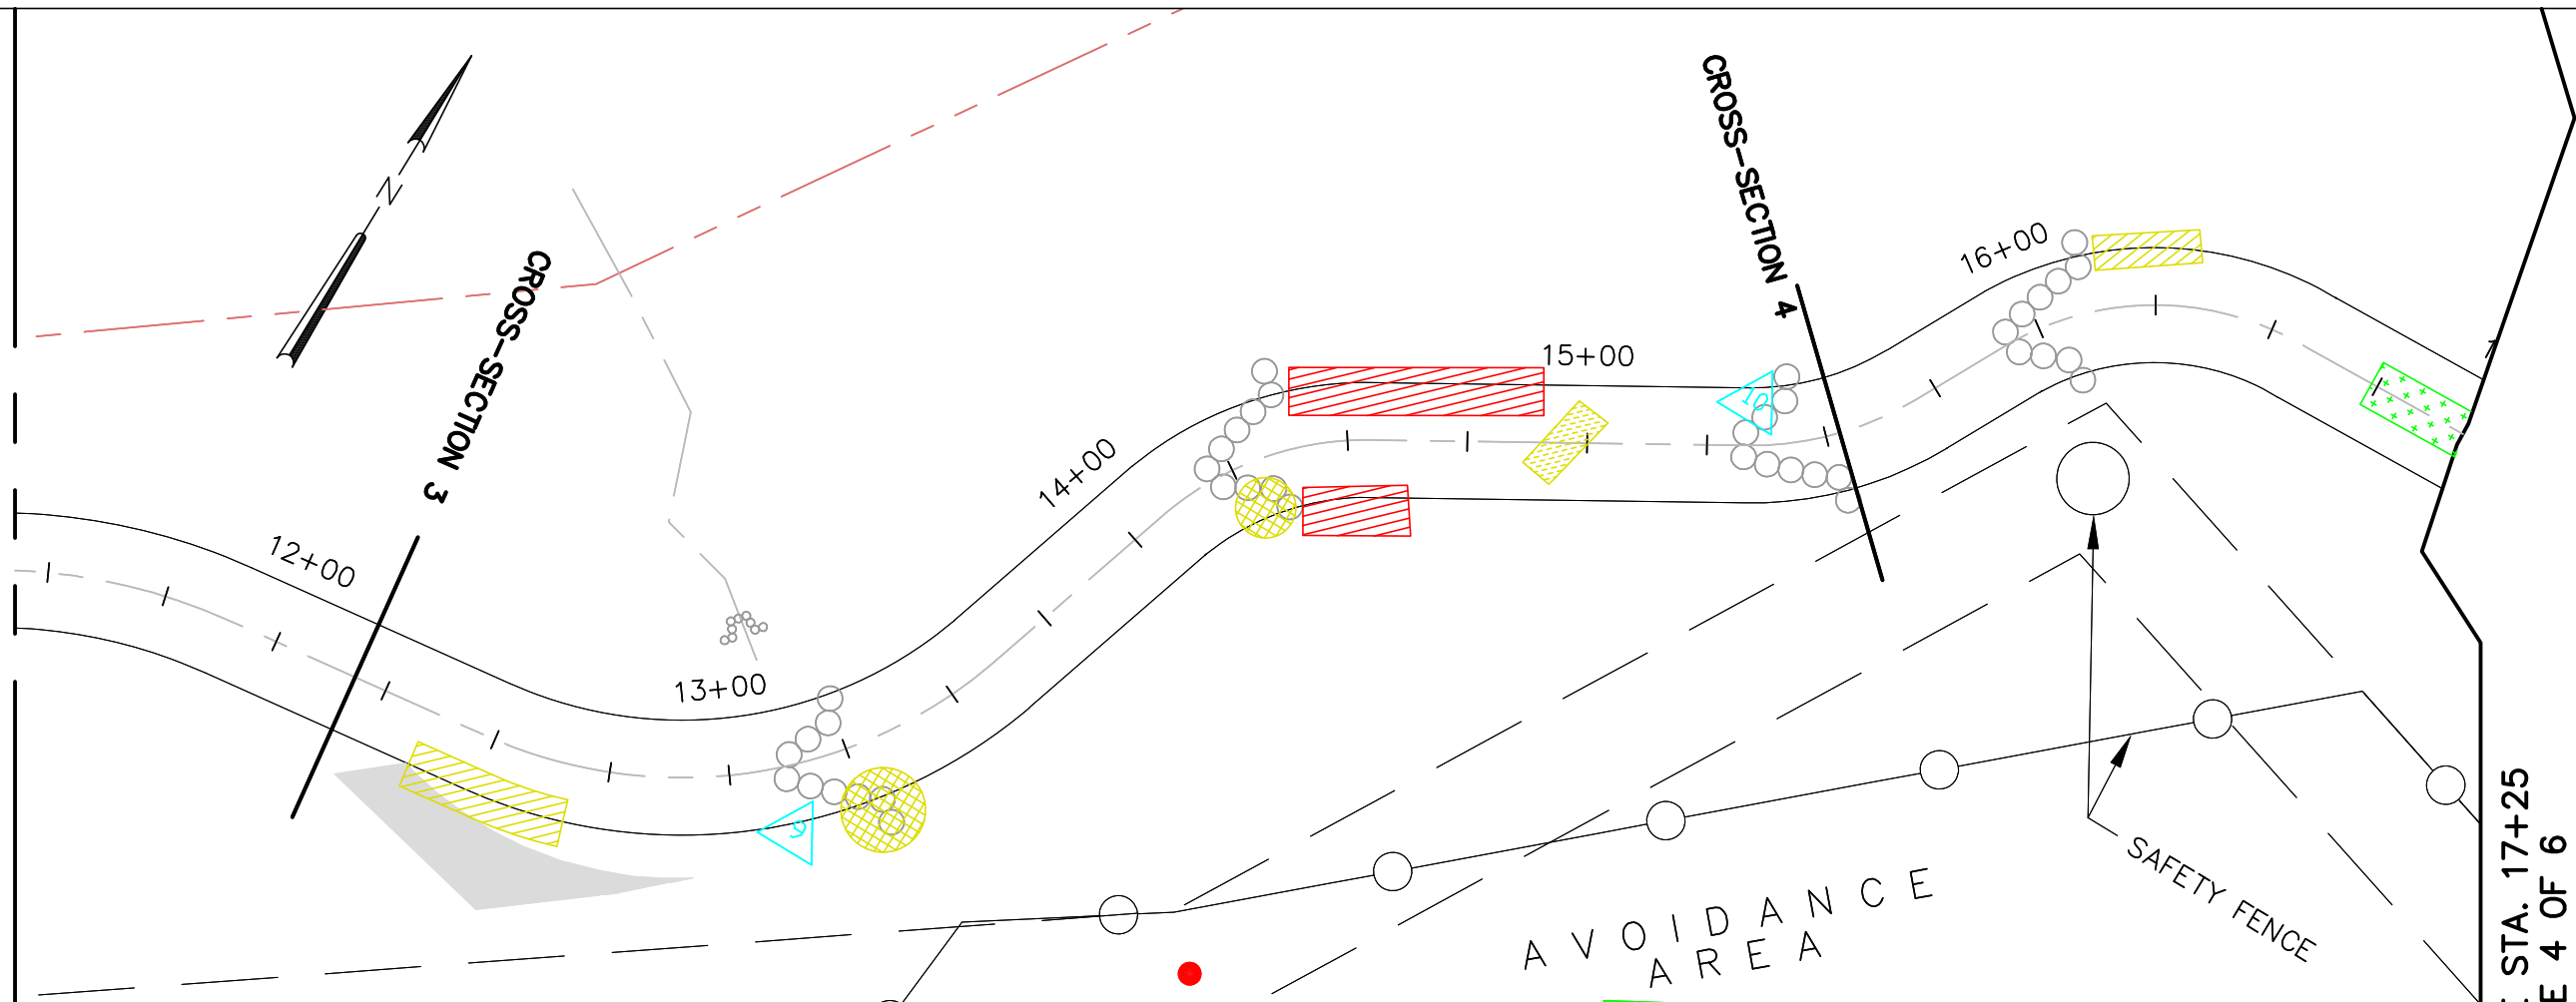
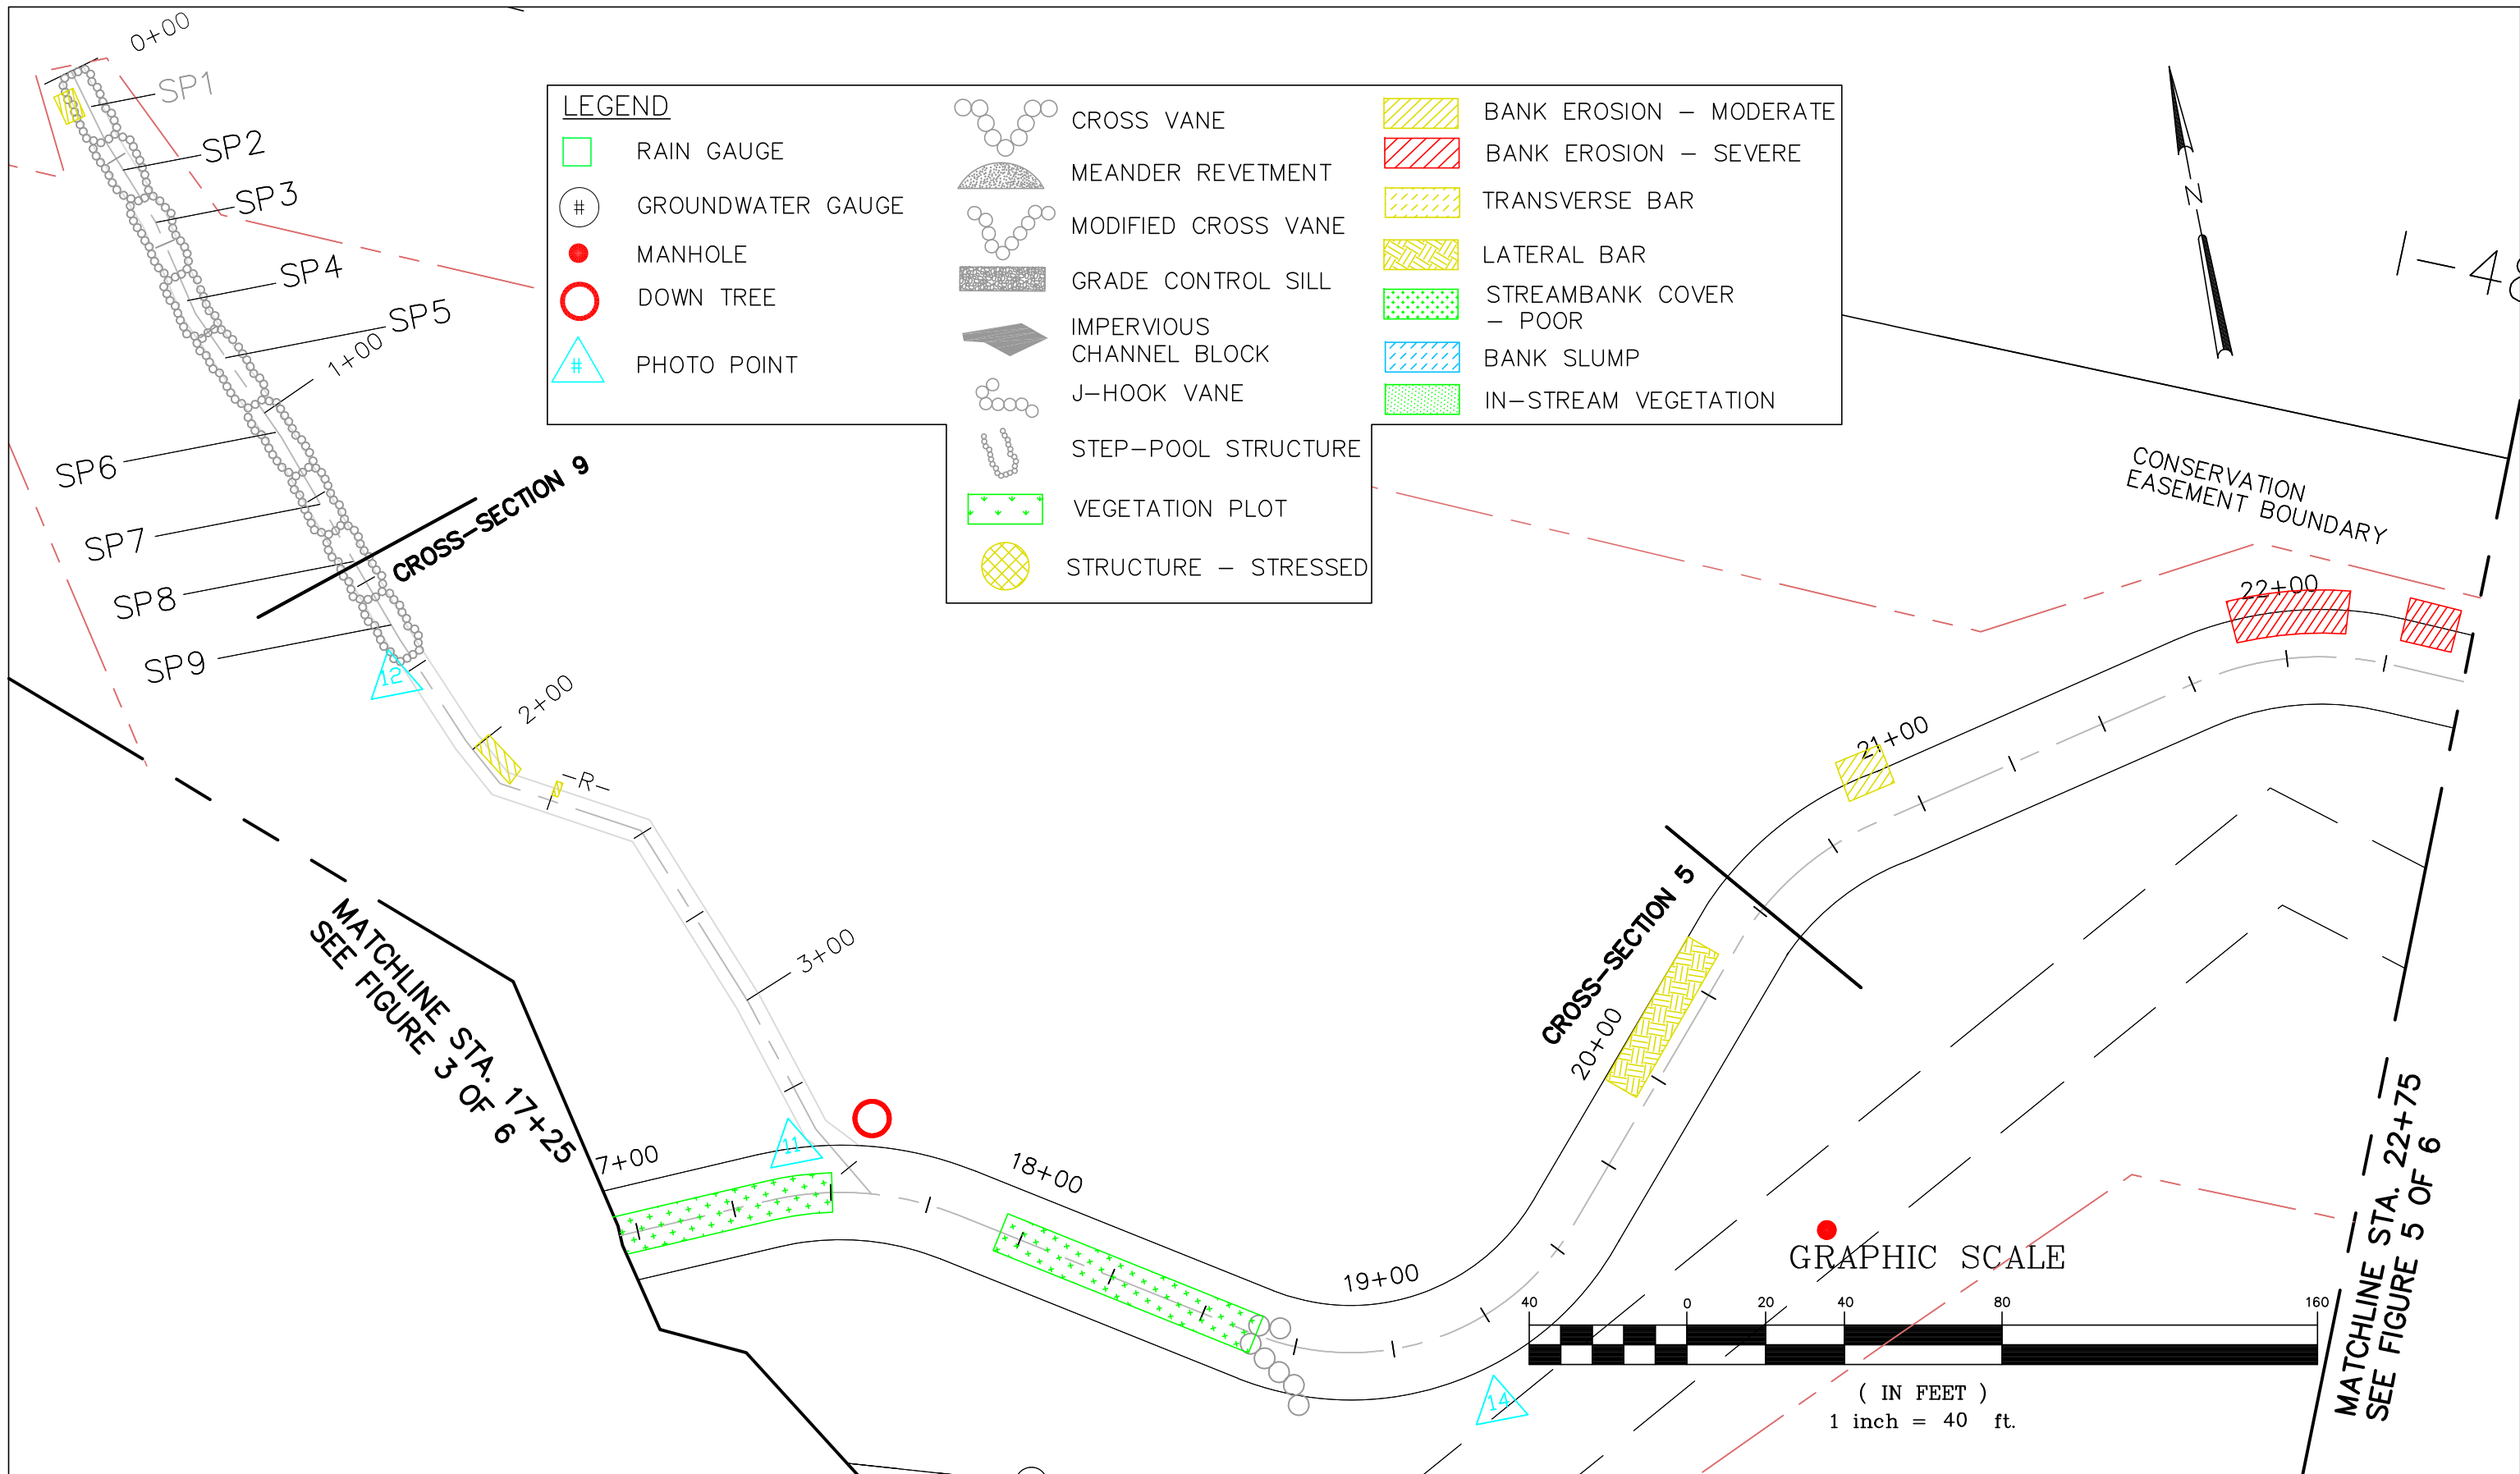
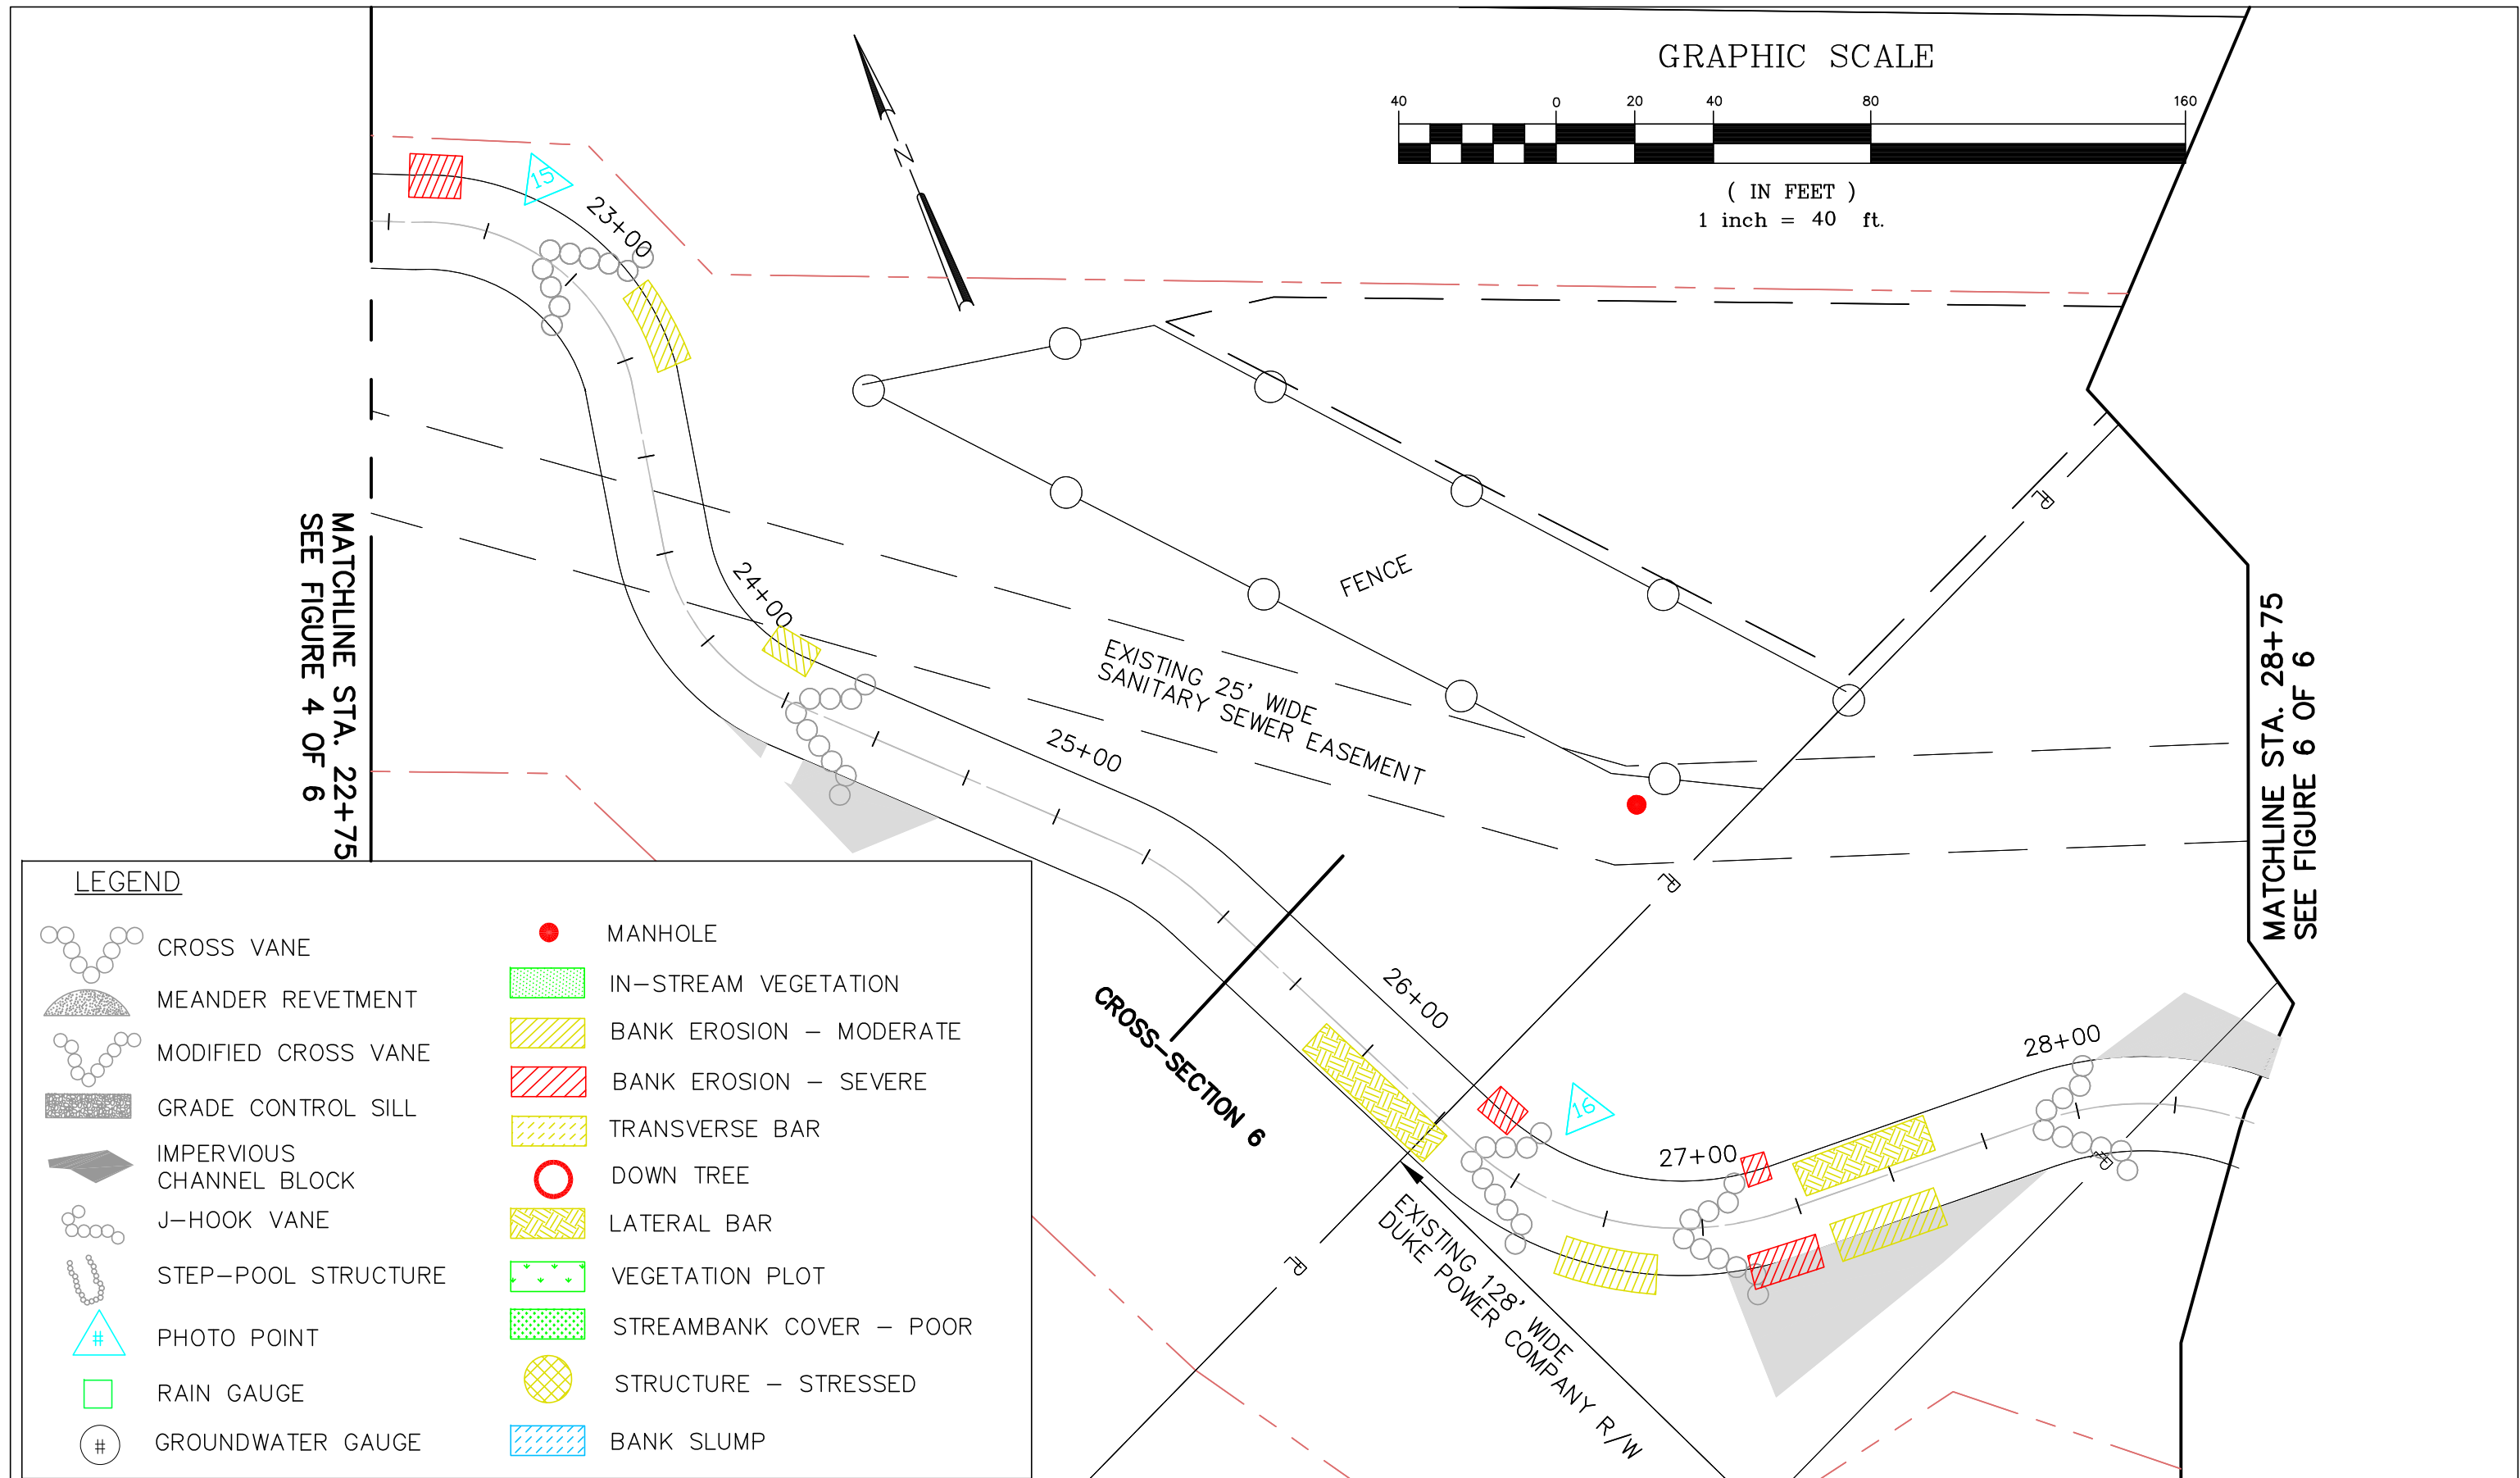
APPENDIX 1.2  
 CURRENT CONDITION PLAN VIEW

- The pattern, profile, and dimension of the restored channel appear stable for the majority of the Site.
- Five beaver dams were removed along the main channel (approximate stationing 0+50, 1+65, 7+05, 7+80, and 12+00) that were found during the Current Condition Plan View (CCPV) site visit.

- There are several areas with moderate bank erosion occurring under the matting, however the bank stability is 95% for the main channel and 100% for the tributaries.

- There are a few areas with eroding point bars on the upstream and downstream sides around stationing 3+30, 3+68, and 4+50.
- Five areas within the restored reach are illustrating signs of aggradation. Four areas have lateral bars forming (approximate stationing 19+93, 25+87, 27+27, and 30+06) and the fifth area has a transverse and mid channel bar forming (approximate stationing 14+90). All five areas show a shift in the thalweg.

- Bank erosion is occurring at different levels (from moderate to severe) throughout the channel, particularly where the lateral, transverse, and mid channel bars are forming and within the lower end of the Site.

- The medium-sized cedar tree, which had fallen into the stream during the 2006 monitoring year, has remained in place below the convergence of the B channel. The tree has continued to collect storm debris.

- The two side tributaries appear stable, but minor scouring has occurred.
- The majority of structures appear to be in good condition; however, a few structures have moderate erosion around the arms where they tie into the bankfull elevation (approximate stationing 13+27, 14+28, and 31+55).

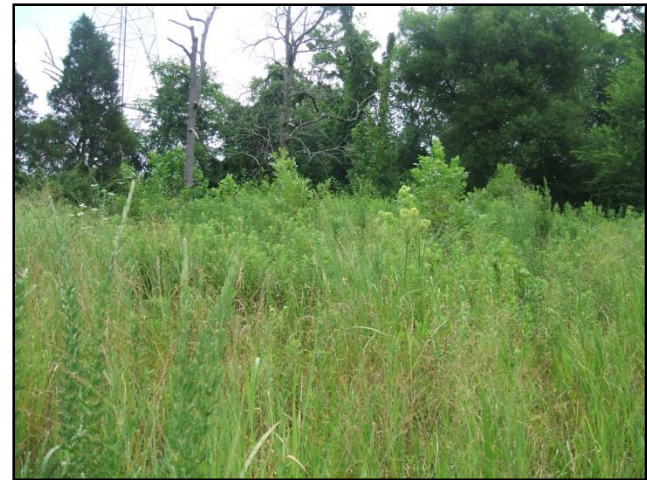
4. Monitoring Plot 4 (7/2009)

The 2009 vegetation monitoring results indicate that the Site appears to be meeting vegetation success criteria with the exception of plot 4. The Site density is approximately 364 planted stems per acre with a plot size of 0.057 ac, which exceeds the year 4 goal of 290 planted stems per acre. Only one of the four vegetation monitoring plots (Plot 4) continues to result in a low survival rate with sparse ground cover of emergent wetland plants in comparison to the previous (2006-2008) monitoring years. Planted stem mortality within Plot 4 was most likely due to the severe drought experienced during the 2007 growing season. However, volunteer species and resprouting of suspected dead saplings improve the stems per acre from 140 to 386 for monitoring year four.
