**Back Creek Stream and Wetland Restoration
EEP Project No. 17
2010 Monitoring Report: Year 5 of 5**

**Construction Completed: December 2005
Submission Date: February 2011**

Jordan, Jones and Goulding
309 East Morehead Street, Suite 110
Charlotte, NC 28202

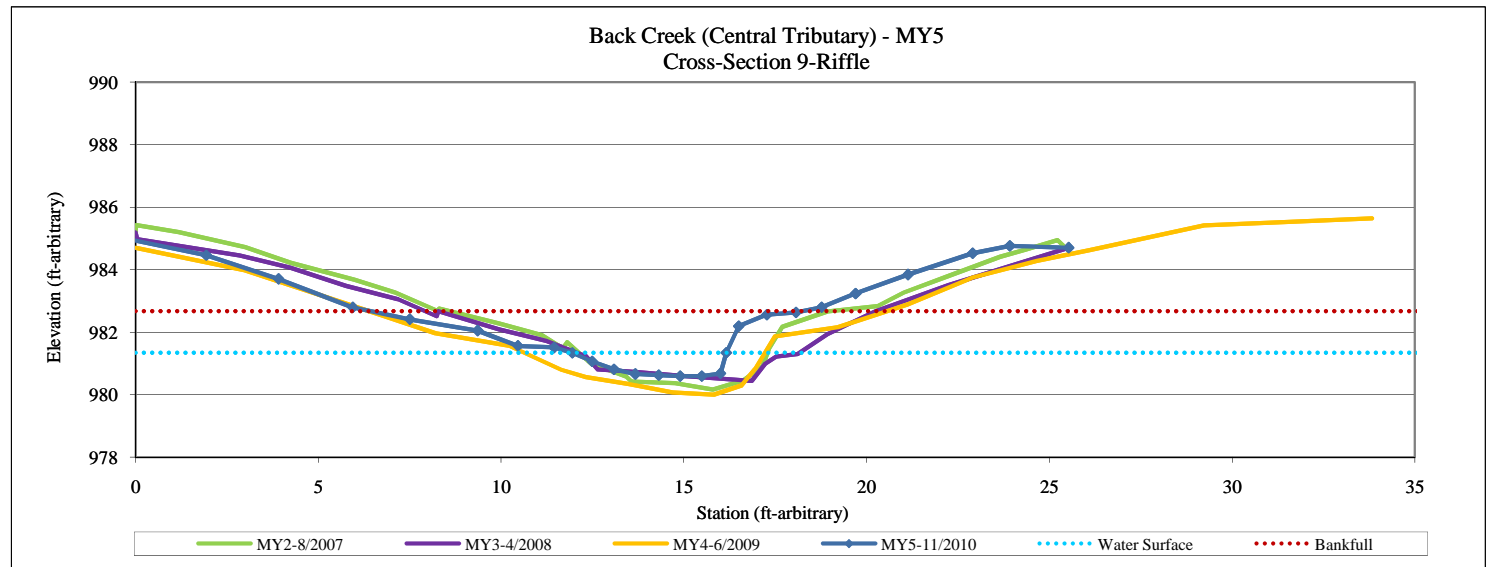
Project Name	Back Creek MY5
EEP Project Number	17
Cross-Section ID	XS-9, Riffle
Survey Date	11/2010

The tributary appears to be maintaining its proposed function as a B-type storm drain channel. There are some areas with minor bank erosion, but no structural failure is occurring along this reach. Cross-section 9, which is located midway along the tributary has remained vertically and laterally stable. Minor sediment deposition occurred in 2010, which resulted in a decrease in the cross-sections mean depth (1.04 ft) from previous monitoring year ranges (1.24-1.32 ft). The d50 and d84 particle size has decreased from 0.33 mm to 0.2 mm and 3.43 to 1.67, respectively. Most likely, these fine particles will be flushed with future rain events.
