**Badin Inn  
Stream Restoration  
Stanly County, North Carolina  
Year 1 Monitoring Report**

Monitoring Year: 2010  
Measurement Year 1  
As-Built Date 2009  
NCEEP Project Number 92666

**May 2010**

**BADIN INN STREAM RESTORATION  
YEAR 1 MONITORING REPORT**

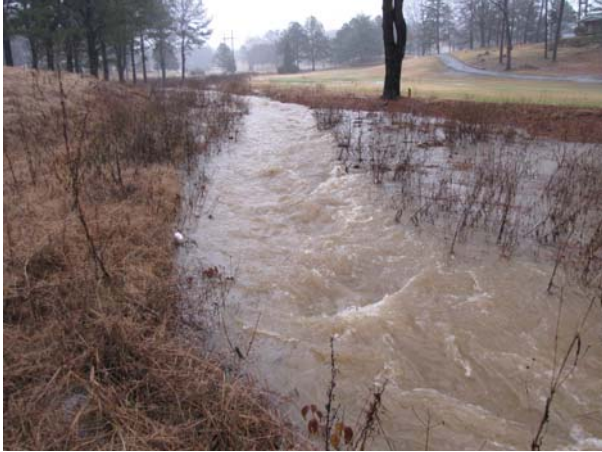
Photo 1. Photo of bankfull event on 12-25-09.

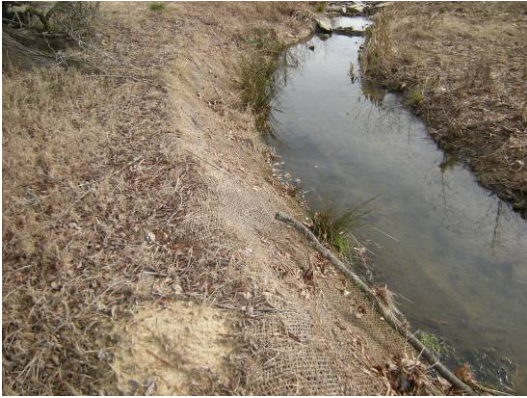
<b>Table 6. Vegetation Problem Areas  Badin Inn Stream Restoration/ EEP No. 92666  Appendix A</b>			
Feature/Issue	Station#/Range	Probable Cause	Photo #
Bare Bank	14+10	Vegetation having difficulty becoming established on coir matting	VPA 12
Bare Floodplain	23+20 to 23+90	Exposed soil and rocks from construction	VPA 2
	24+30	Exposed soil, Seed washed away by storm	
	27+50 to 28+00	Sparsely vegetated due to construction	
	29+70 to 30+10	Exposed soil, Seed washed away by storm	
	39+40 to 40+00	Exposed soil, Seed washed away by storm	
	40+70 to 41+40	Exposed soil, Seed washed away by storm	
	45+70 to 46+20	Exposed soil and rocks from construction	
46+60 to 46+80	Sparsely vegetated floodplain due to construction		
Invasive/Exotic Populations	48+30 to 49+80	<i>Ligustrum sinense</i> : encroachment from outside	VPA 1
Vehicular Disturbance of Easement	21+40	Vehicle travel across stream	VPA3
	42+50 to 46+00	Bridge construction

VPA 12. Sparsely vegetated coir matting along bank.

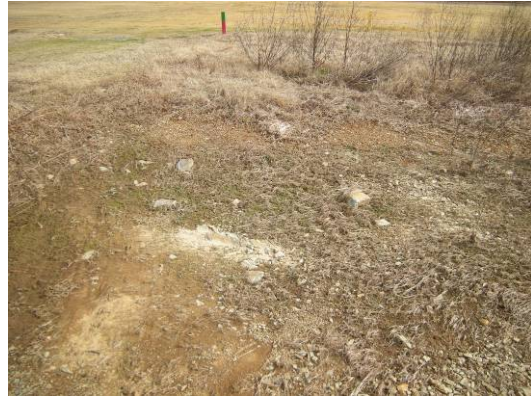
VPA 2. Sparsely vegetated floodplain from construction

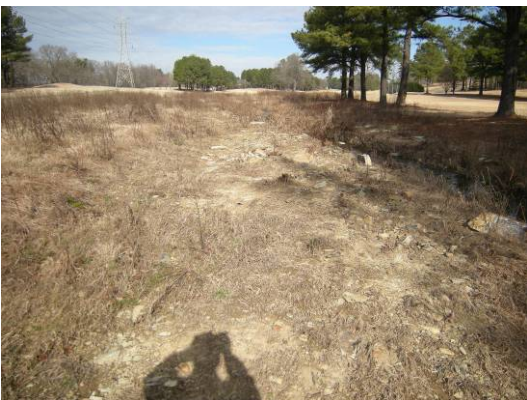
VPA 5. Scoured floodplain with sparse vegetation.

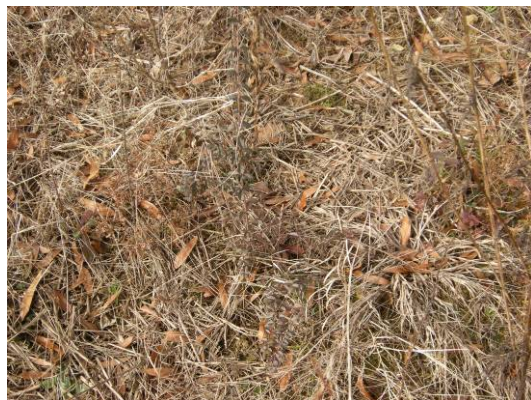
VPA 1. Exotic Chinese privette establishing foothold in floodplain near confluence with Little Mountain Creek.

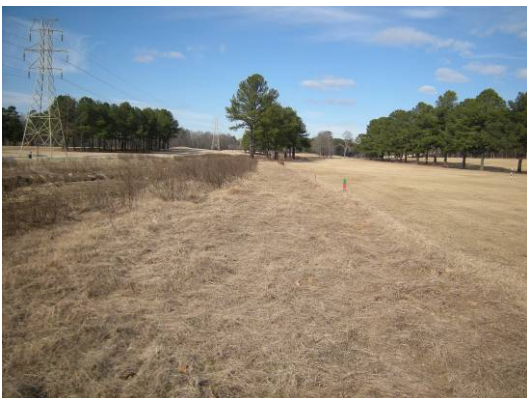
VPA 3. Mowed area in easement that receives vehicle traffic

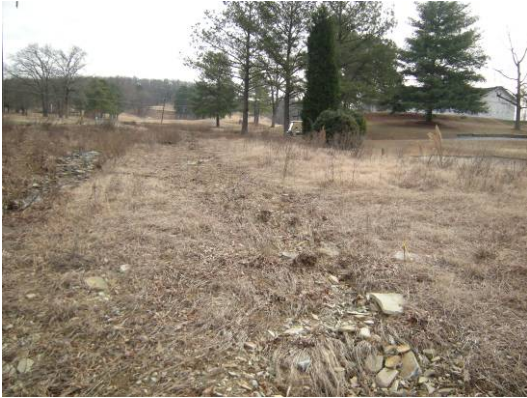
<b>Table B.1. Stream Problem Areas Badin Inn Stream Restoration/ EEP No. 92666 Appendix B</b>			
<b>Feature/Issue</b>	<b>Station#/Range</b>	<b>Probable Cause</b>	<b>Photo #</b>
Overflow channel forming	12+60 to 13+90	Frequent flooding and steeper grade	SPA 3
Overflow channel forming	22+10 to 22+60	Frequent flooding and steeper grade	SPA 1
Bank scour	18+90	Lack of protection from coir matting	SPA 2

SPA 1. Stream overflow channel beginning to form.

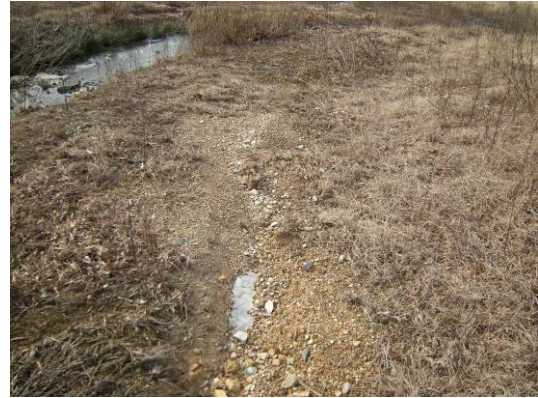
SPA3. Stream overflow channel beginning to form.
