**Badin Inn
Stream Restoration
Stanly County, North Carolina
Year 2 Monitoring Report**

Monitoring Year: 2011
Measurement Year 2
As-Built Date 2009
NCEEP Project Number 92666

March 2011

**BADIN INN STREAM RESTORATION
YEAR 2 MONITORING REPORT**

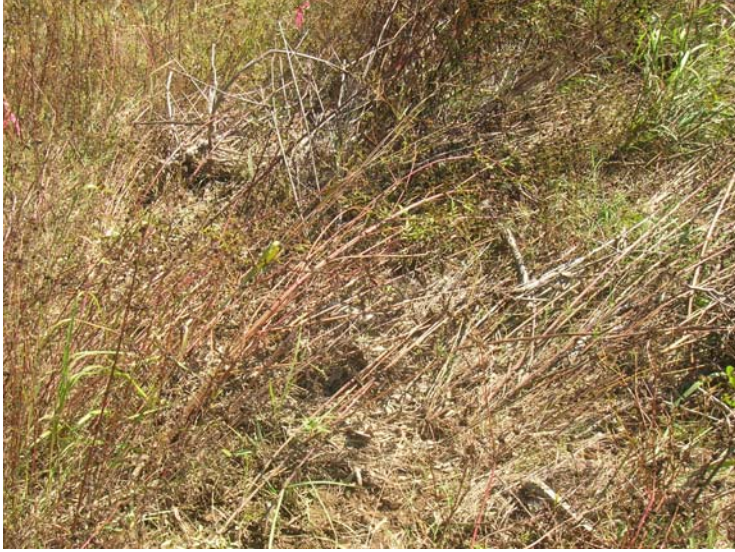
Photo 1. Photo evidence of bankfull event prior to 09-30-10.

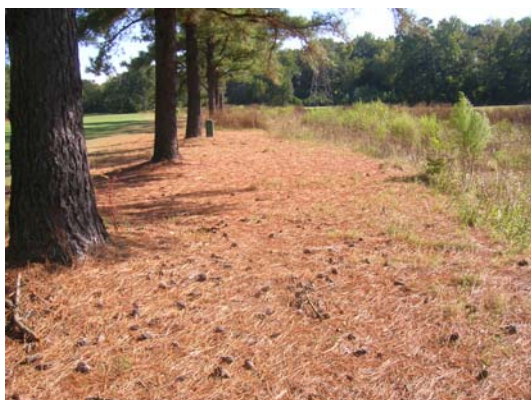
Table 6. Vegetation Problem Areas Badin Inn Stream Restoration/ EEP No. 92666 Appendix A			
Feature/Issue	Station#/Range	Probable Cause	Photo #
Sparse Vegetated Area	19+00 to 21+70	Gravel and shading causing sparse vegetation growth	VPA 4,8
	31+60 to 32+50	Sparse vegetative growth due to shading	
	39+00 to 42+00	Low tree survivability under mature trees	
Mowed Area	33+00 to 34+20	Mowing encroachment into easement	VPA 1,5,6
	36+00 to 39+00	Mowing encroachment into easement	
	39+00 to 41+50	Mowing encroachment into easement	
	42+70 to 45+50	Mowing encroachment into easement	
	45+80 to 48+00	Mowing encroachment into corners around bridge

VPA 4. Area of sparse vegetation under mature trees, 39+00 and 42+00.

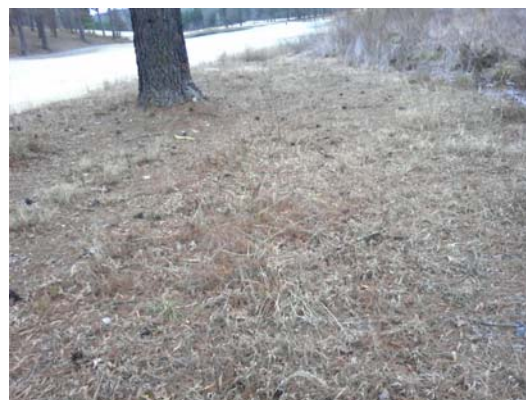
VPA 8. Area of sparse vegetation under mature trees, 19+00 to 21+70.

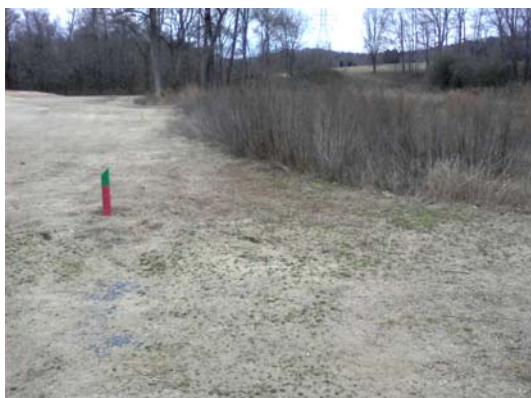
VPA 1. Mowing located around corners adjacent to bridge, 45+50 to 48+00.

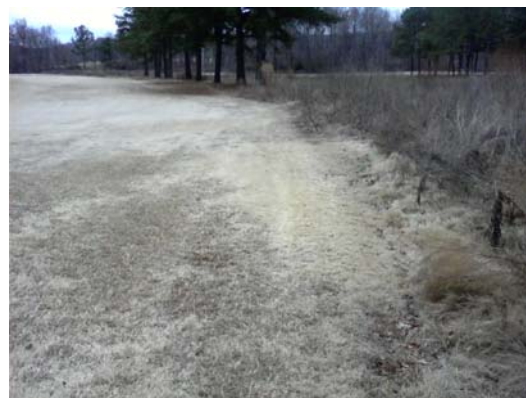
VPA 5. Mowed area in easement, 36+00 and 39+00.

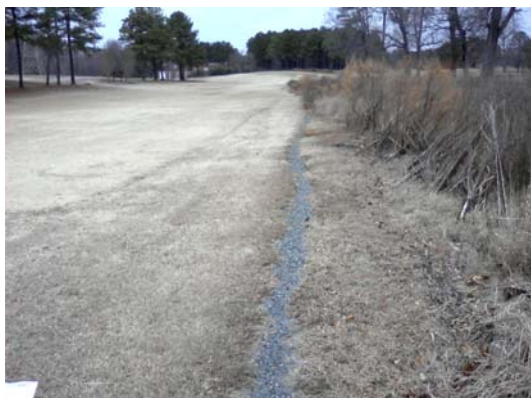
VPA 6. Mowing into easement, 33+00 and 34+20
