**Badin Inn
Stream Restoration
Stanly County, North Carolina
Year 3 Monitoring Report**

Monitoring Year: 2011
Measurement Year 3
As-Built Date 2009
NCEEP Project Number 92666

**BADIN INN STREAM RESTORATION
YEAR 3 MONITORING REPORT**

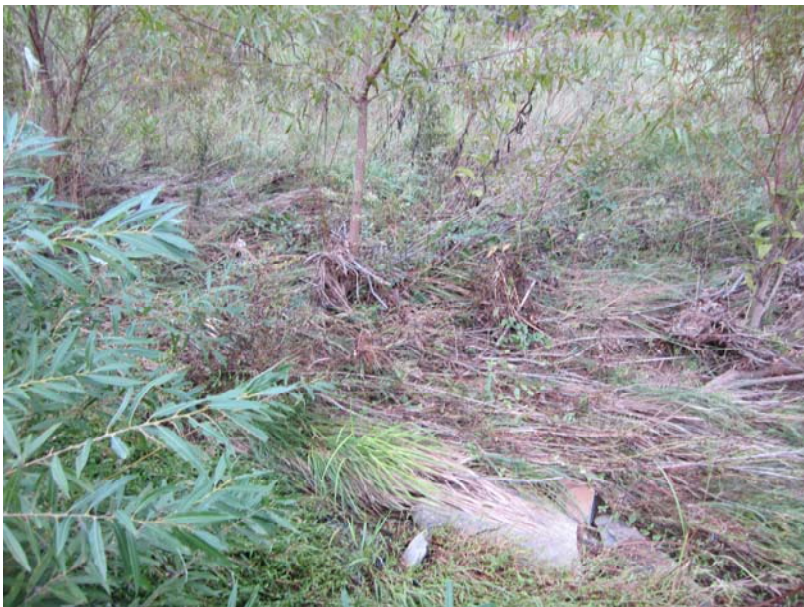
year offers evidence of a recent bankfull event prior to the November 22, 2011 monitoring event. Photo 1 shows a photo of vegetation laying flat as a result of flooding.

Photo 1. Photo evidence of bankfull event prior to 09-26-11.

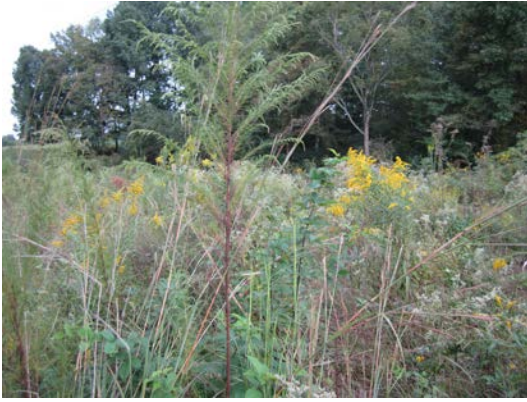
Vegetation Plot 1 facing 210°.

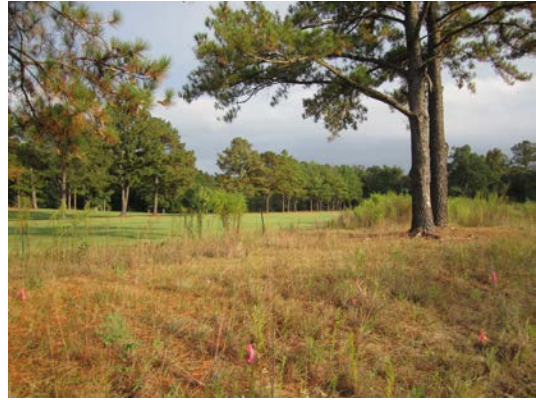
Vegetation Plot 2 facing 150°.

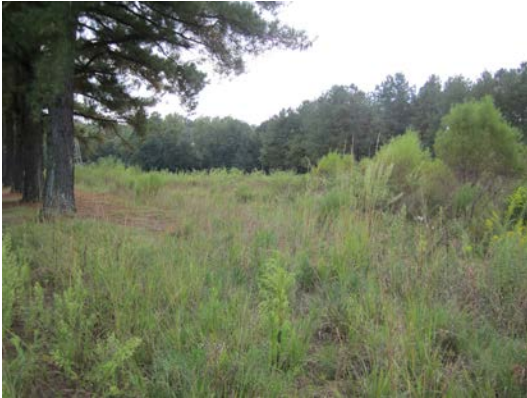
Vegetation Plot 3 facing 210°.

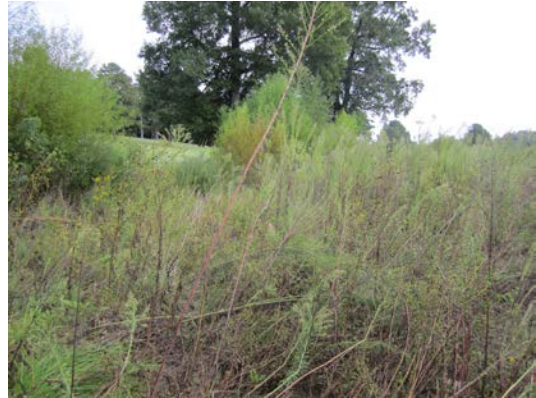
Vegetation Plot 4 facing 160°.

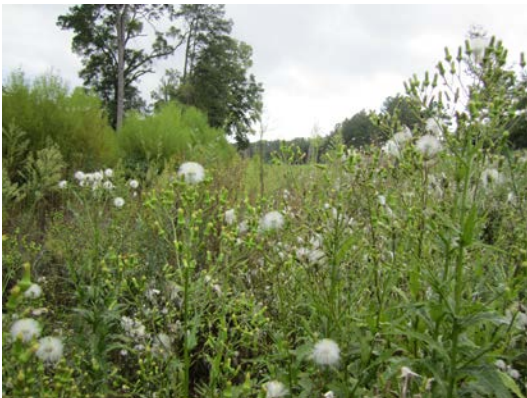
Vegetation Plot 5 facing 180°.

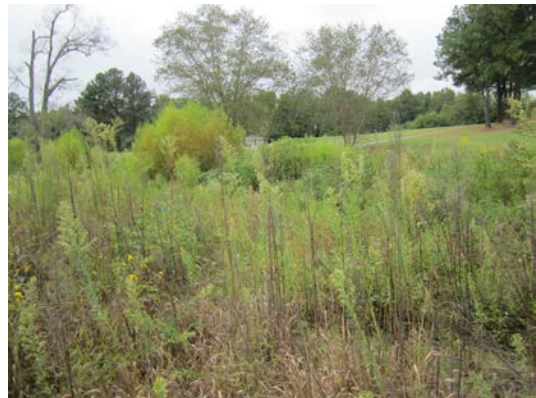
Vegetation Plot 6 facing 260°.

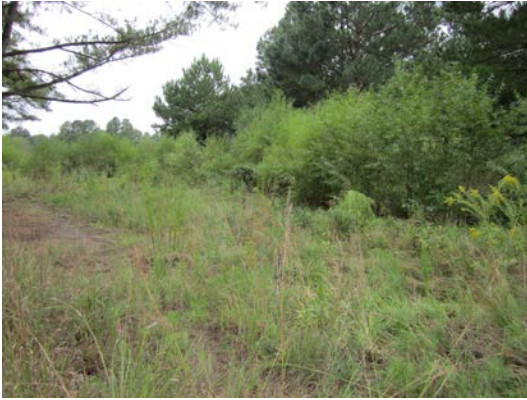
Vegetation Plot 7 facing 260°.

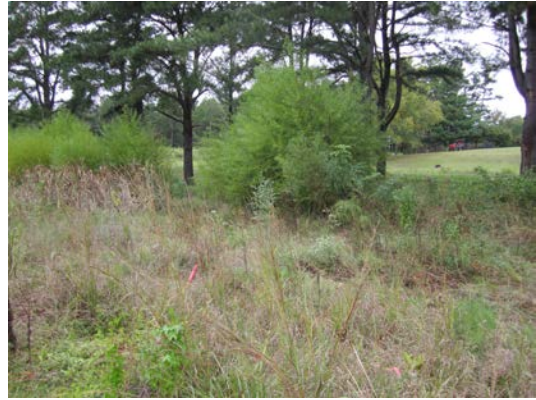
Vegetation Plot 8 facing 310°.

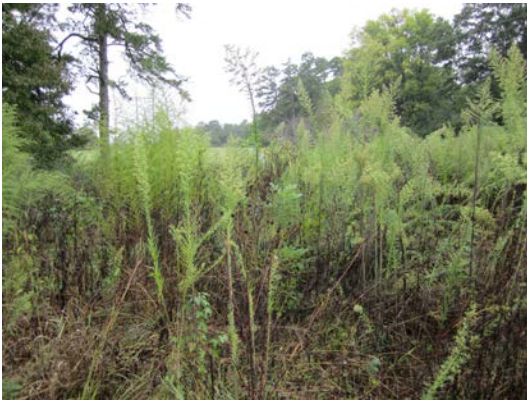
Vegetation Plot 9 facing 340°.
