**Badin Inn  
Stream Restoration  
Stanly County, North Carolina  
Year 4 Monitoring Report**

Monitoring Year: 2012  
Measurement Year 4  
As-Built Date 2009  
NCEEP Project Number 92666

**January 2013**

**BADIN INN STREAM RESTORATION  
YEAR 4 MONITORING REPORT**

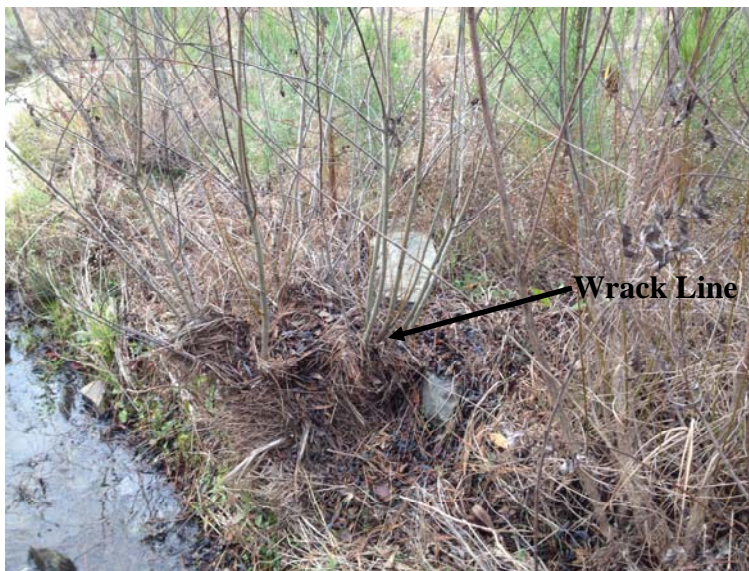
Monitoring requirements state that at least two bankfull events must be documented through the five-year monitoring period. To assist in documenting bankfull events a stream crest gauge was installed on UT Little Mountain Creek. One documented bankfull event occurred on December 25, 2009 following a heavy rainfall event. A second bankfull event occurred in the fall of 2010 and was documented by the observation of wrack deposits and vegetation lying flat as a result of flooding. A third observed bankfull event from the 2011 monitoring year was presumed due to the presence of wrack deposits prior to the 2011 monitoring effort. Evidence of a bankfull event was once again observed on the site during the 2012 monitoring period. Photo 1 shows a wrack deposits and vegetation laying flat as a result of flooding prior to December 13, 2012 during the 2012 monitoring period.

Photo 1. Photo evidence of bankfull event prior to 12-13-12.

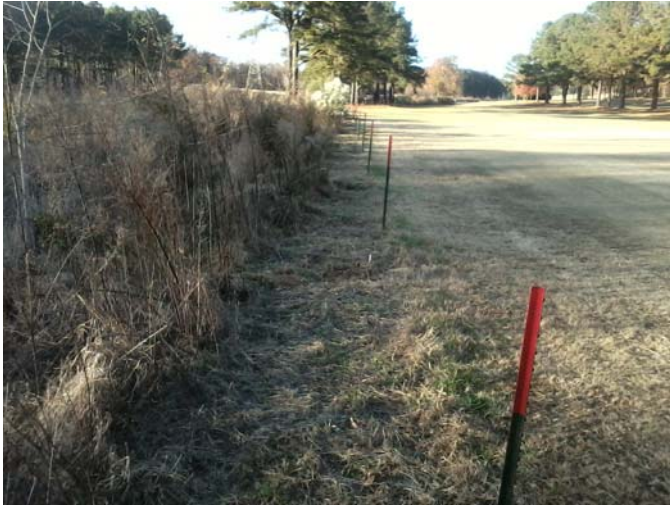
One moderate and a few minor vegetation problem areas were noted during Year 4 monitoring. As a whole the vegetation plantings have been very successful though a few areas of concern were noted where survival has been less than optimal, primarily due to golf course maintenance intrusions in the easement. Mowing once again is contributing to

vegetation mortality along the edges of the easement as in previous years, though the extent of the mowing is greater than previously experienced. A narrow strip was mowed in the fall along the outside of the easement boundary in the lower half of the easement. See Table 6 and Photo 1 in Appendix A-1. The mowed strip included an area approximately 3-4 feet wide and 1,900 (north side) and 900 feet (south side) long along the edge of the easement. It was noted that care had been taken to mow or use a weedeater to cut the vegetation cleanly around the metal easement boundary posts. Golf course management personnel have been contacted and informed that this is a violation of the easement and is to cease.

<b>Table 6. Vegetation Problem Areas Badin Inn Stream Restoration/ EEP No. 92666 Appendix A</b>			
Feature/Issue	Station#/Range	Probable Cause	Photo #
Mechanical cutting	N/A	Golf course maintenance crews cutting within posted boundary of easement	1

Photo 1. Mechanical encroachment along easement boundary
