**Badin Inn  
Stream Restoration  
Stanly County, North Carolina  
Year 5 Monitoring Report**

Monitoring Year: 2013  
Measurement Year 5  
As-Built Date 2009  
NCEEP Project Number 92666

**January 2014**

**BADIN INN STREAM RESTORATION  
YEAR 5 MONITORING REPORT**

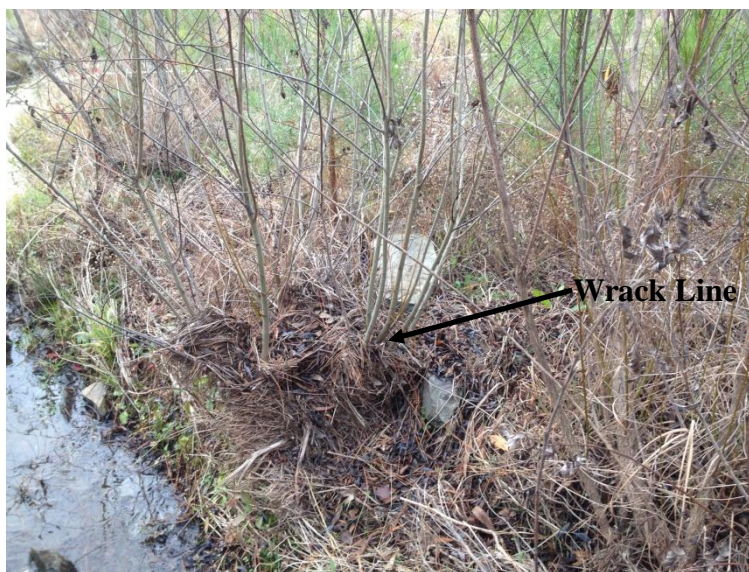
Monitoring requirements state that at least two bankfull events must be documented through the five-year monitoring period. To assist in documenting bankfull events a stream crest gauge was installed on UT Little Mountain Creek. One documented bankfull event occurred on December 25, 2009 following a heavy rainfall event. A second bankfull event occurred in the fall of 2010 and was documented by the observation of wrack deposits and vegetation lying flat as a result of flooding. A third observed bankfull event from the 2011 monitoring year was presumed due to the presence of wrack deposits prior to the 2011 monitoring effort. Evidence of a bankfull event was once again observed on the site during the 2012 monitoring period. Photo 1 shows wrack deposits and vegetation laying flat as a result of flooding prior to December 13, 2012.

**Photo 1. Photo evidence of bankfull event prior to 12-13-12.**

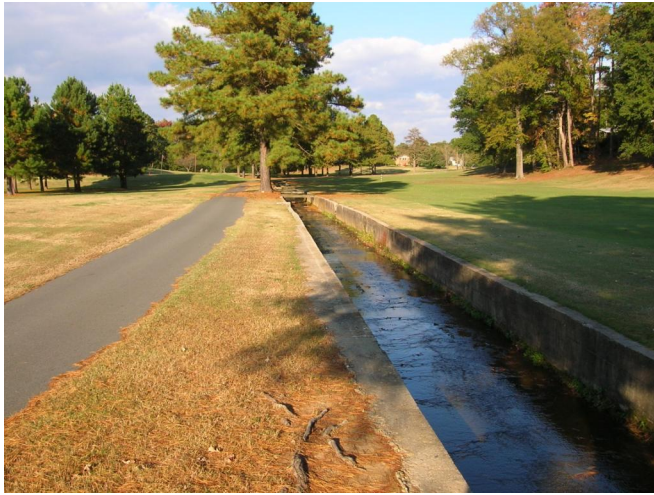
**Photo 2. UT Little Mountain Creek before restoration**

The UT Little Mountain Creek stream restoration project reintroduced natural stream characteristics to a reach that was previously confined by a cement-lined channel. The stream in this condition had no groundwater or floodplain interaction, lacked a functioning riparian zone, and provided little habitat variability for aquatic life. This stream restoration project reintroduced a riparian zone, created a variety of in-stream habitats and reconnected the stream with its floodplain. Because of these changes it was anticipated that there would be a significant uplift of the biotic functions of the stream. To assist

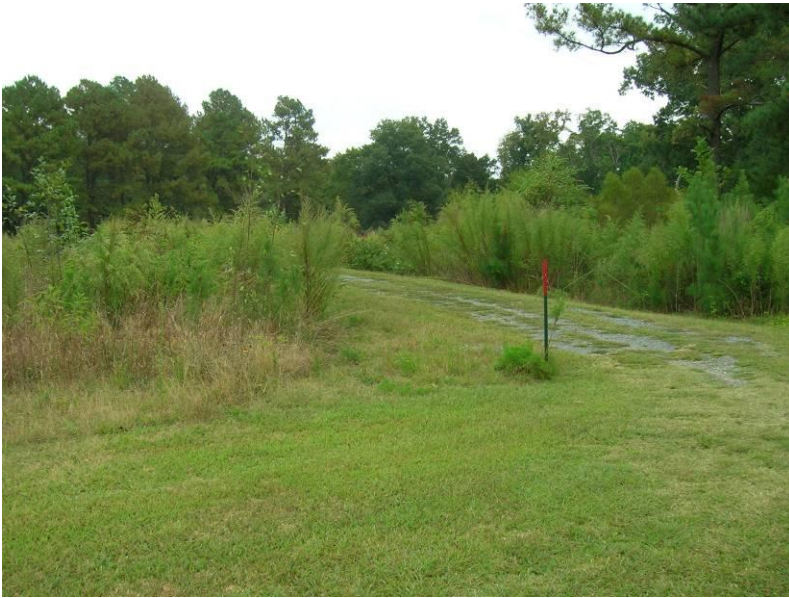
small area at a golf cart crossing no mowing of the easement by golf course personnel was observed this year. The mowed area included a corner area approximately 4-5 feet square at the northeastern corner of the easement. See Table 6 and Photo 1 in Appendix A-1. This violation is minor compared to ones in years past and it seems that the golf course personnel are adhering to the requirements of the easement overall. Supplemental plantings consisting of 75 3-gallon and 50 7-gallon container-grown river birch (*Betula nigra*) saplings were installed in March 2013, to address areas of concern identified during the Year 4 monitoring.

<b>Table 6. Vegetation Problem Areas Badin Inn Stream Restoration/ EEP No. 92666 Appendix A</b>			
Feature/Issue	Station#/Range	Probable Cause	Photo #
Mechanical cutting	N/A	Golf course maintenance crews cutting within posted boundary of easement	1

Photo 1. Small area of mowed vegetation at easement Corner.
