Bailey Fork Site Wetland and Stream Restoration Project

Mitigation Plan Report

Burke County, North Carolina

Date Submitted: July 2006

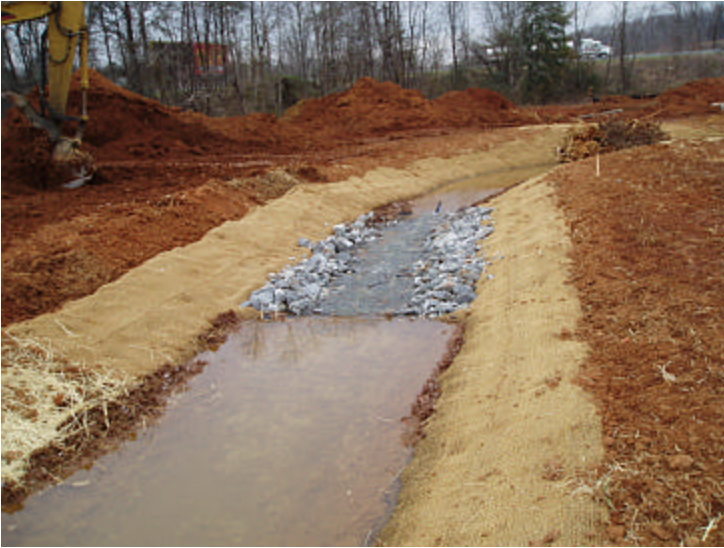
UT1 constructed riffle

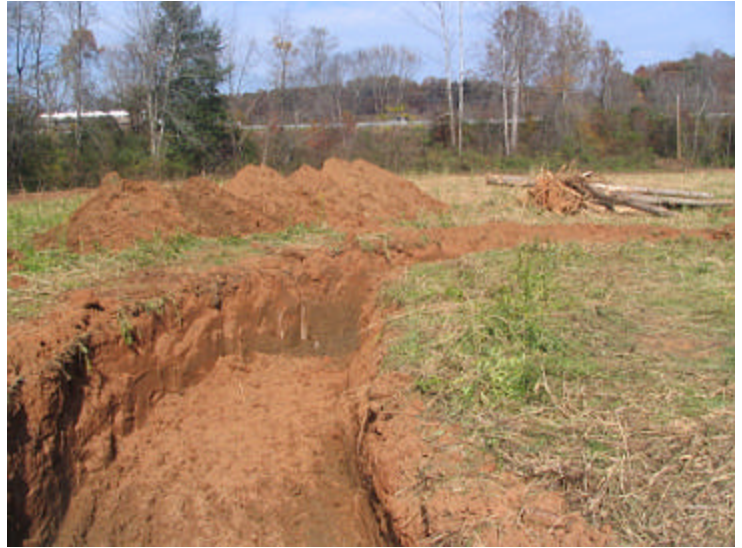
UT1 new channel construction_1

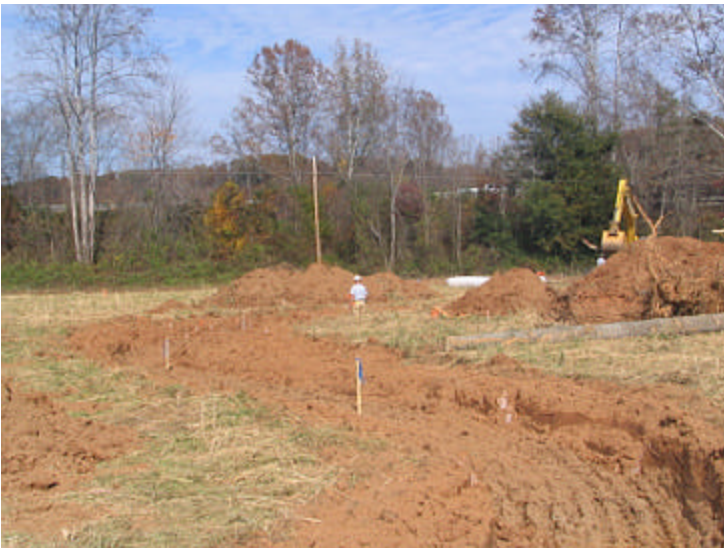
UT1 new channel construction_2

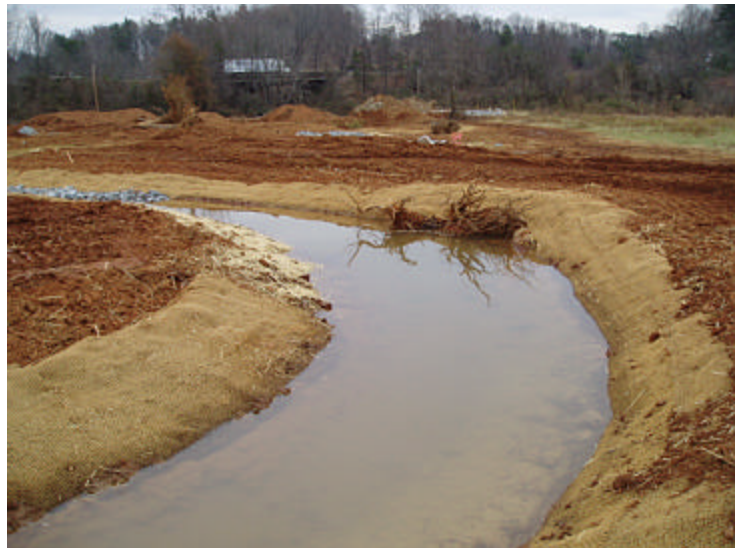
UT1 new channel construction_3

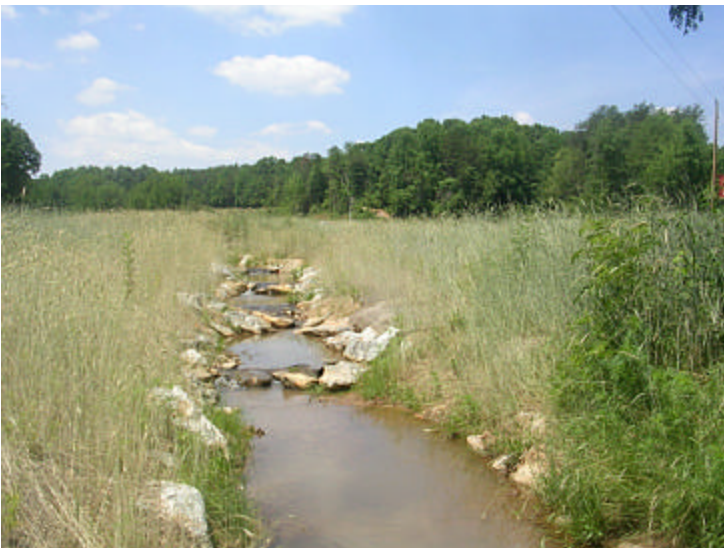
UT1 end of reach

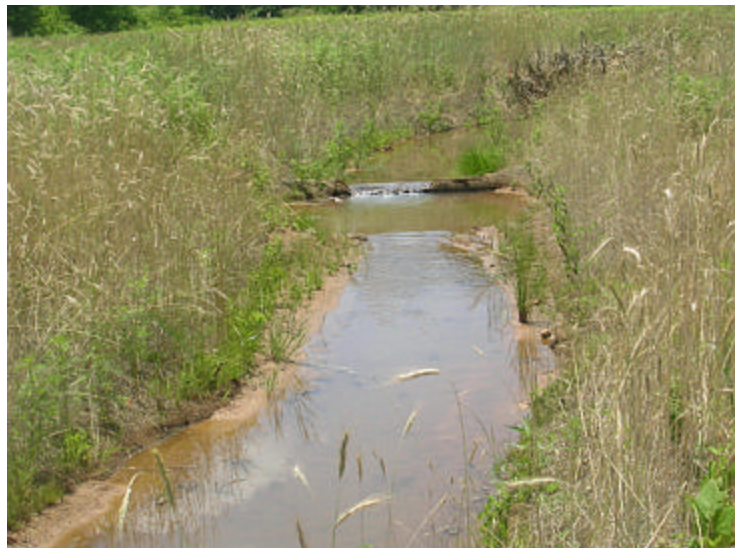
UT1 log weir

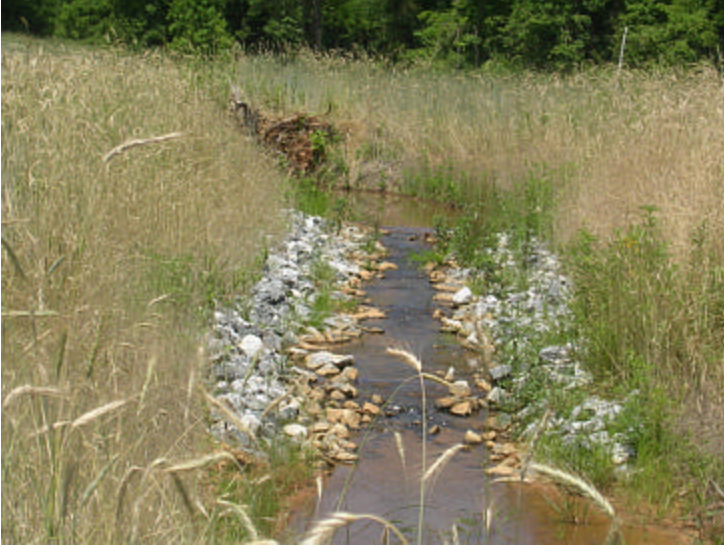
UT1 constructed riffle_1

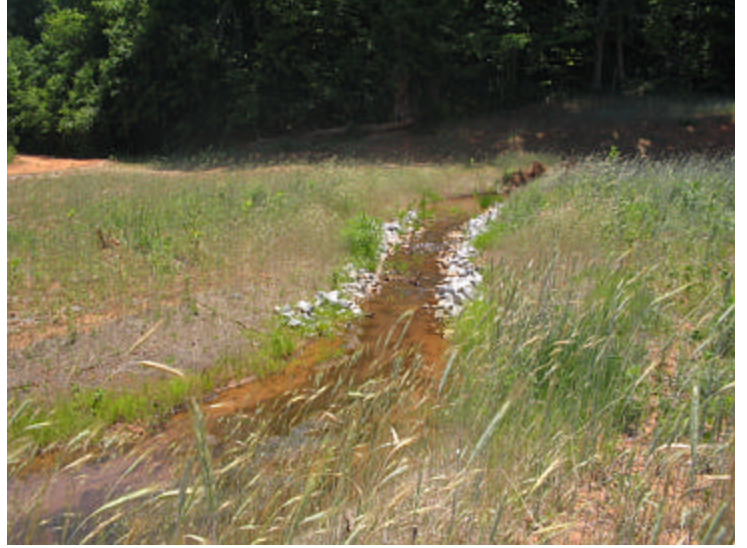
UT1 constructed riffle_2

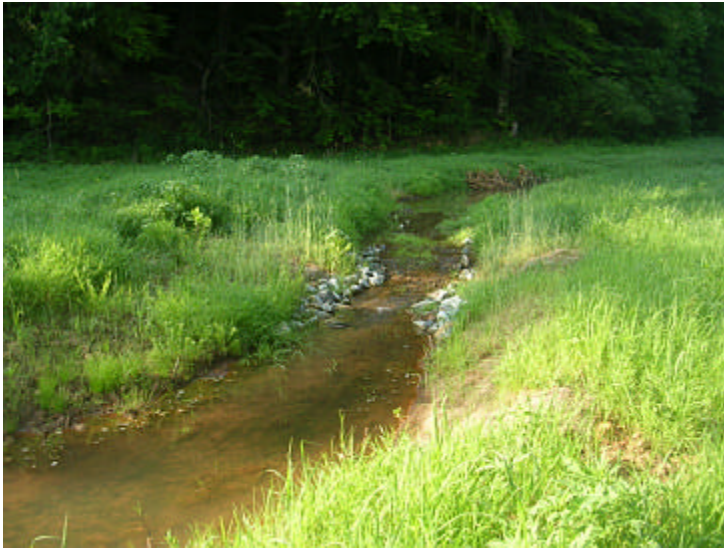
UT1 constructed riffle_3

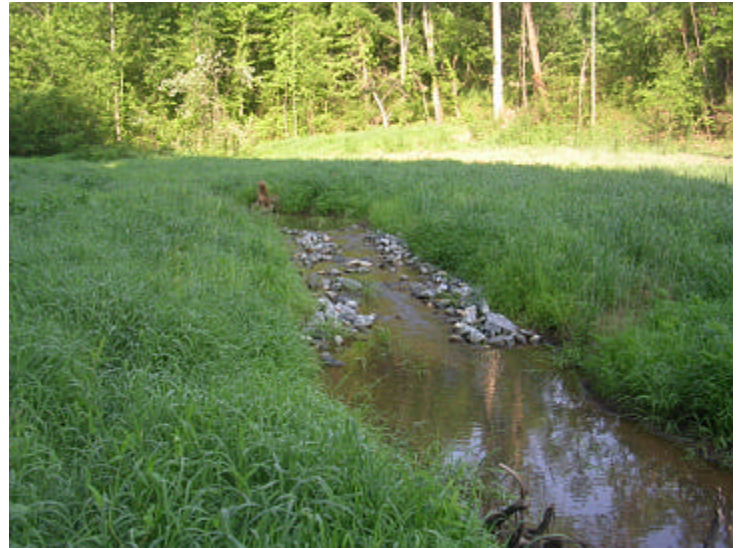
UT1 constructed riffle_4

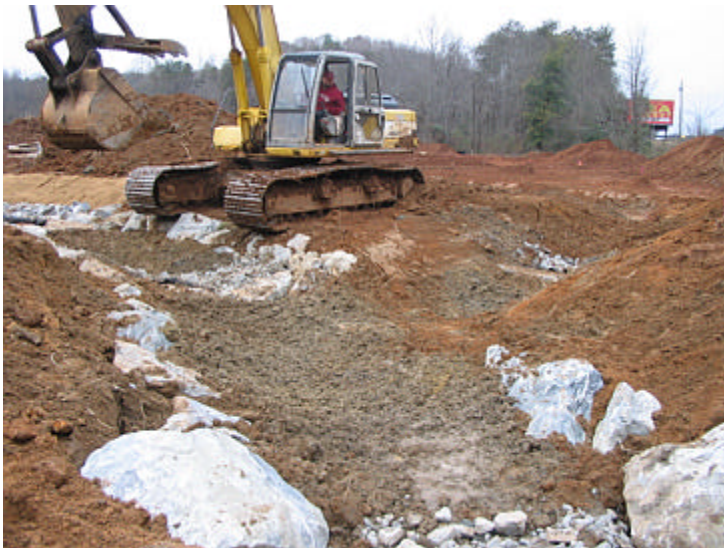
UT2 confluence with UT1

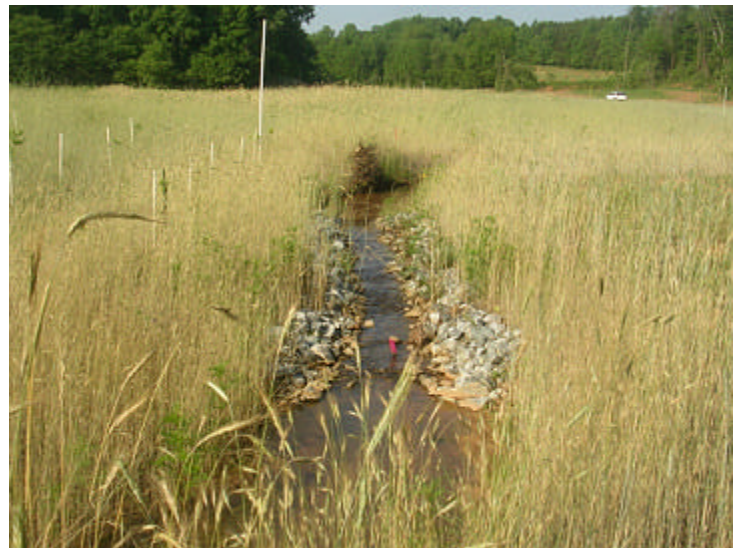
UT2 constructed riffle_1

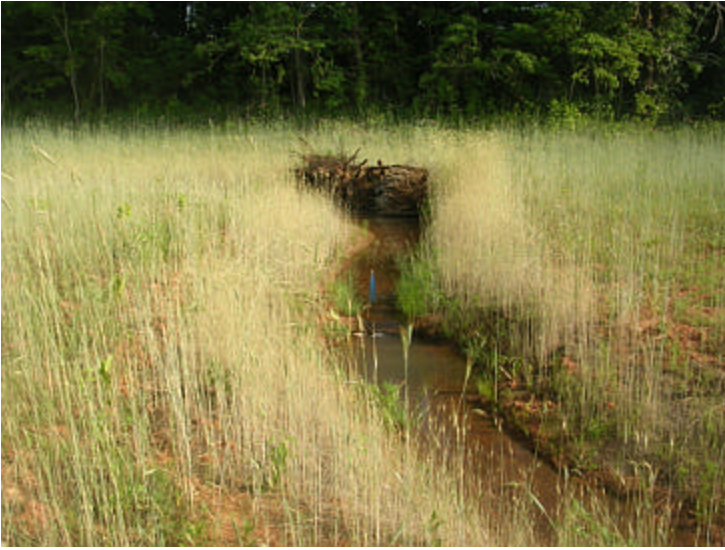
UT2 constructed riffle_2

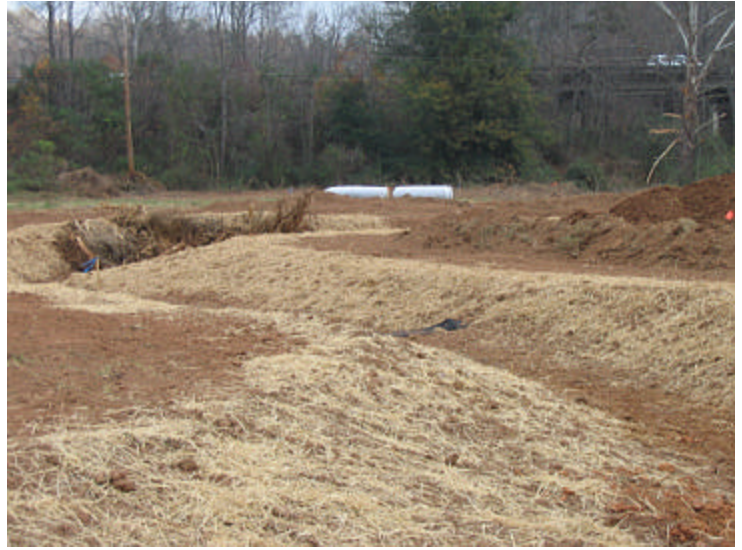
UT2 newly constructed channel_1

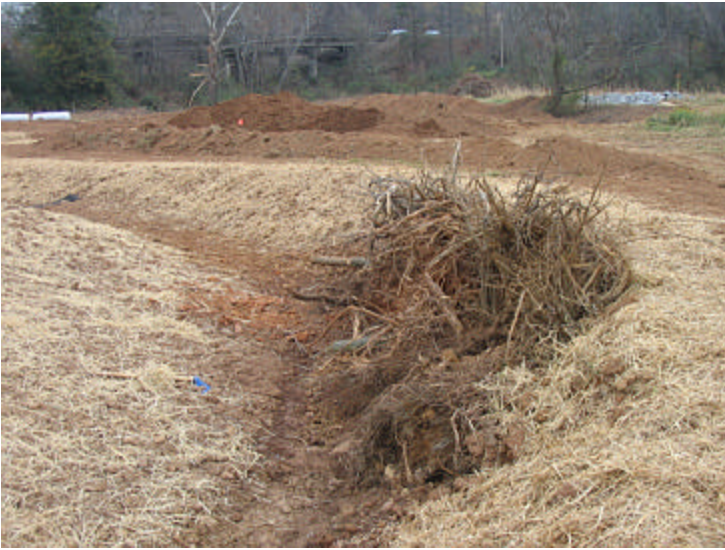
UT2 newly constructed channel_2

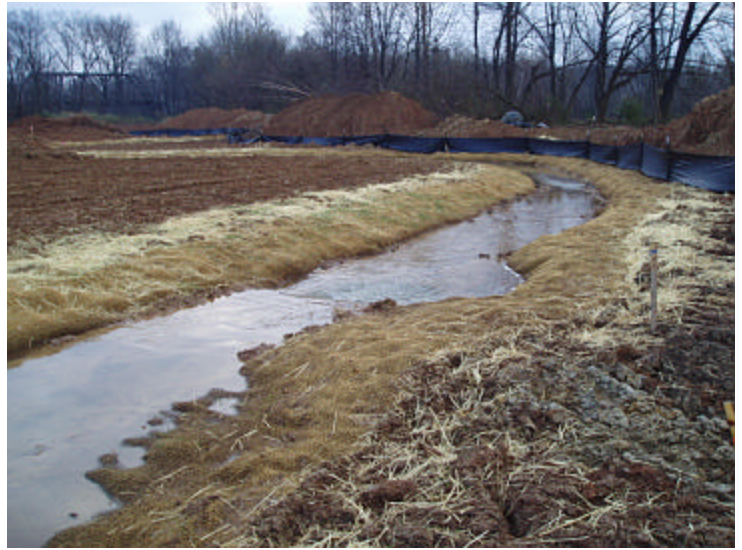
UT3 construction complete_1

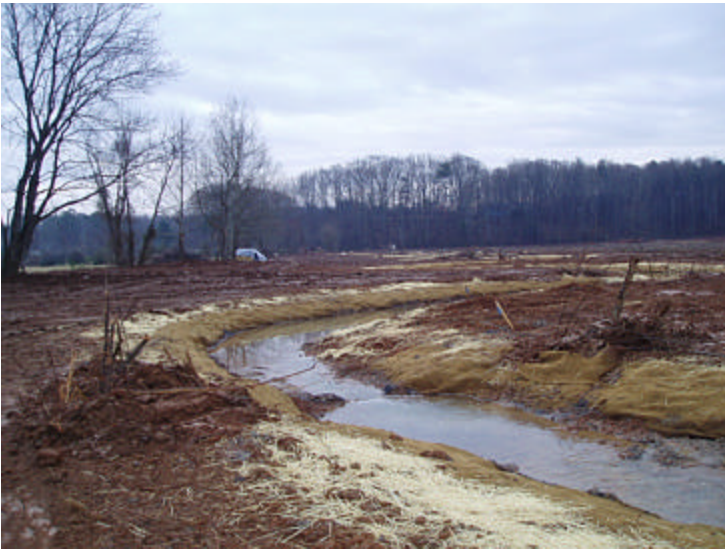
UT3 construction complete_2

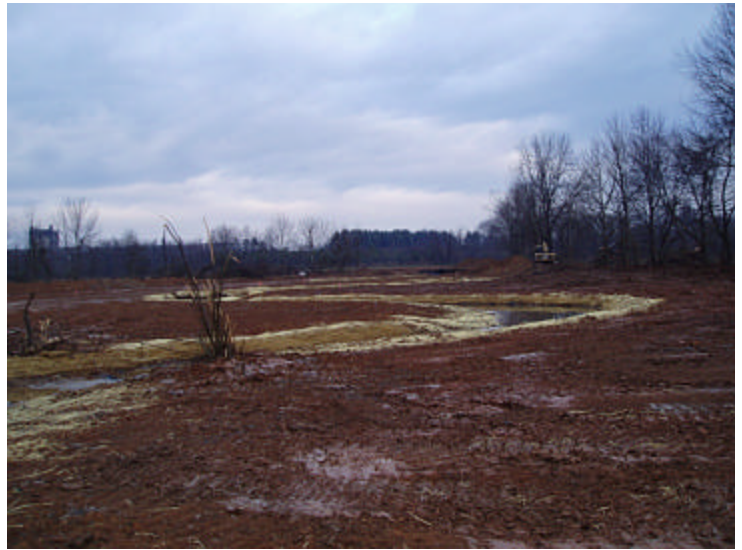
UT3 construction complete_3

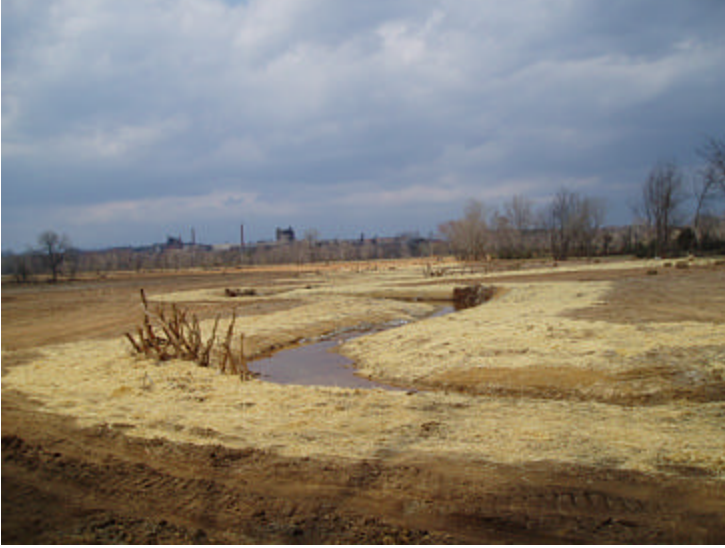
UT3 construction complete_4

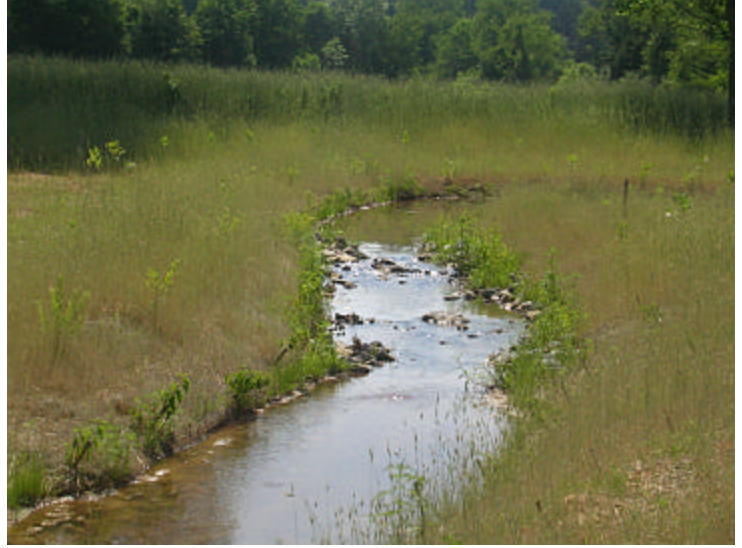
UT3 constructed riffle_1

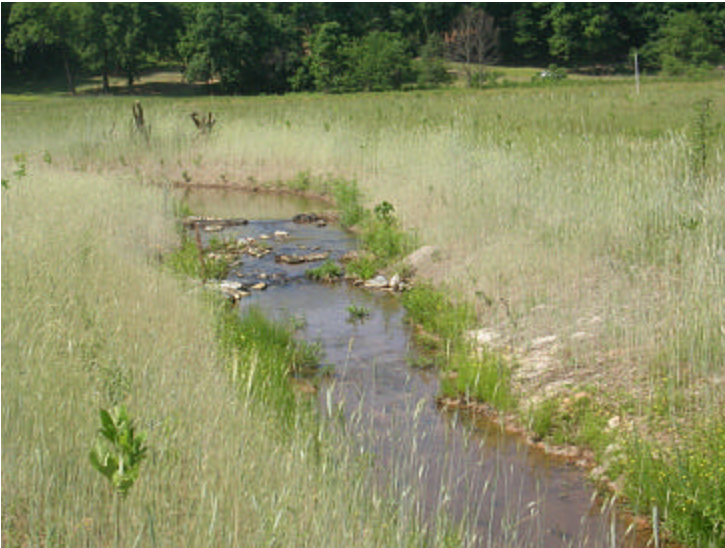
UT3 constructed riffle_2

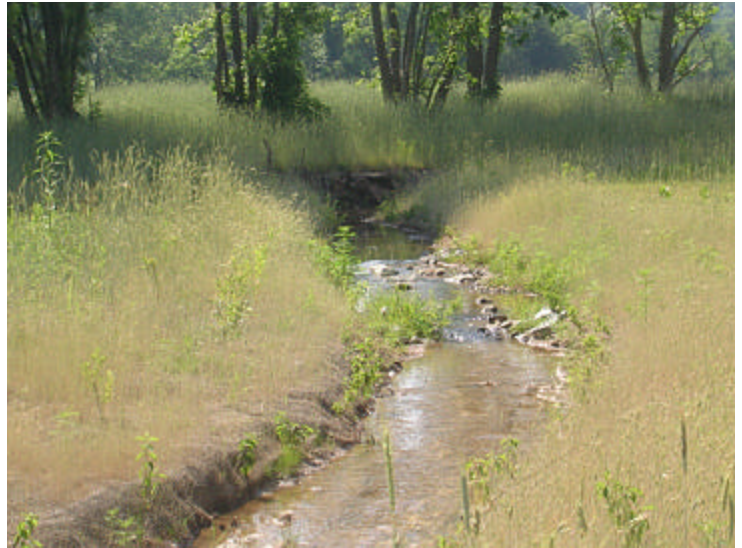
UT3 constructed riffle_3

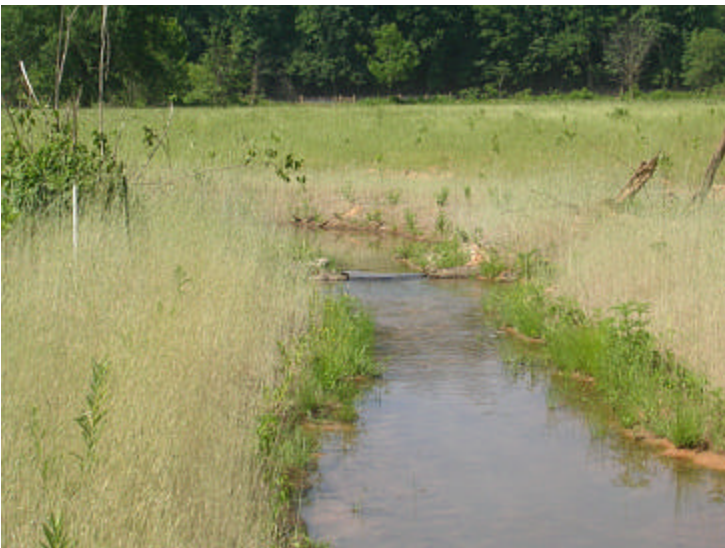
UT3 log weir_1

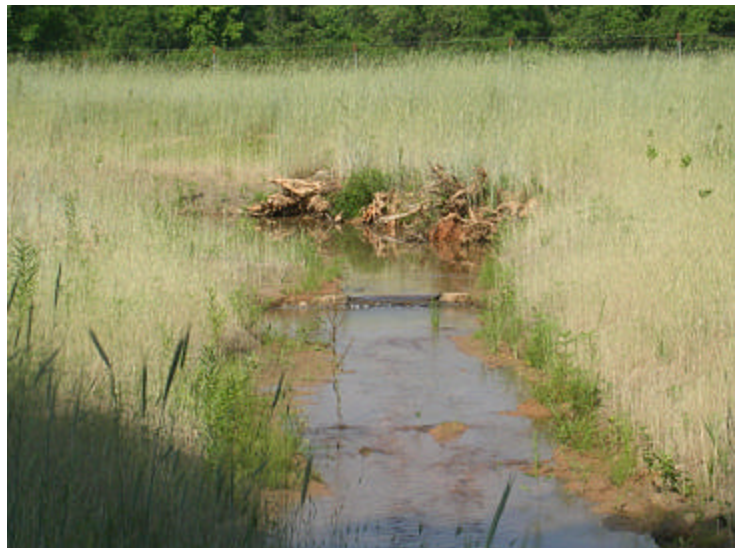
UT3 log weir_2
