# BAILEY FORK WETLAND AND STREAM RESTORATION PROJECT

## ANNUAL MONITORING REPORT FOR 2006 (YEAR 1)

Project Number D04006-3

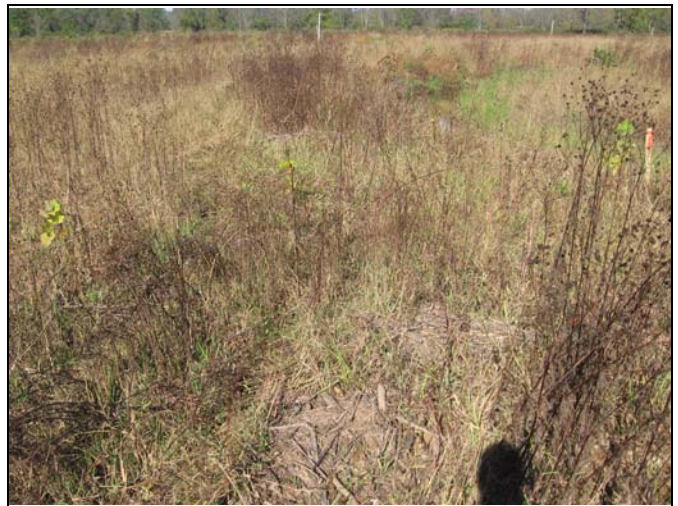
Photo 53 – Bankfull Evidence Near CR8

The onsite crest gauge documented the occurrence of at least two bankfull flow events during the first year (2006) of the post-construction monitoring period, as shown in Table 8. Inspection of conditions during a site visit revealed visual evidence of out-of-bank flow, confirming the crest gauge reading. The largest onsite stream flow documented by the crest gauge during Year 1 of monitoring was approximately 3.6 feet (43.2 inches) above the bankfull stage and was the result of overbank flooding of both Bailey Fork and Silver Creek.
