BAILEY FORK WETLAND AND STREAM RESTORATION PROJECT (DRAFT)

ANNUAL MONITORING REPORT FOR 2007 (YEAR 2)

Project Number D04006-3

December 2007

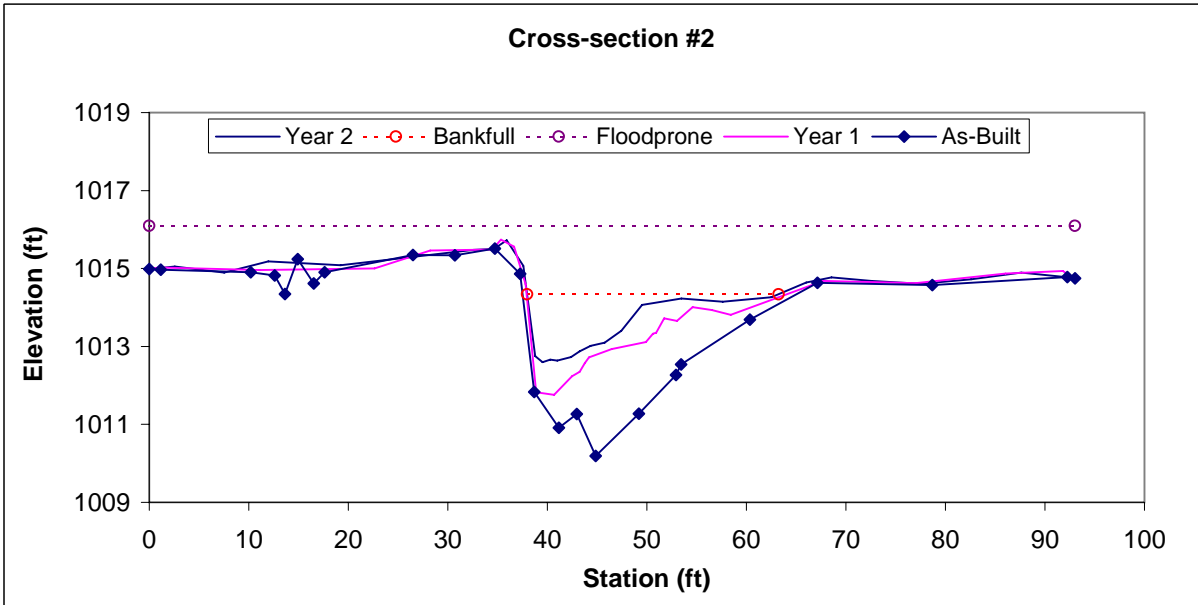
Permanent Cross-section #2

Cross-sections 2, 10, and 13 are located across pools found at the apex of a meander bend. Survey data from these cross-sections indicate that these pools have aggraded substantially during Year 2. Cross-sections 4, 6 and 8 which are also located in pools aggraded slightly during Year 2. Cross-section 12 which is riffle also aggraded slightly during Year 2 monitoring. The observed collection of finer sediments in these locations is believed to primarily the result of low rainfall and flow conditions for much of the summer of 2007.

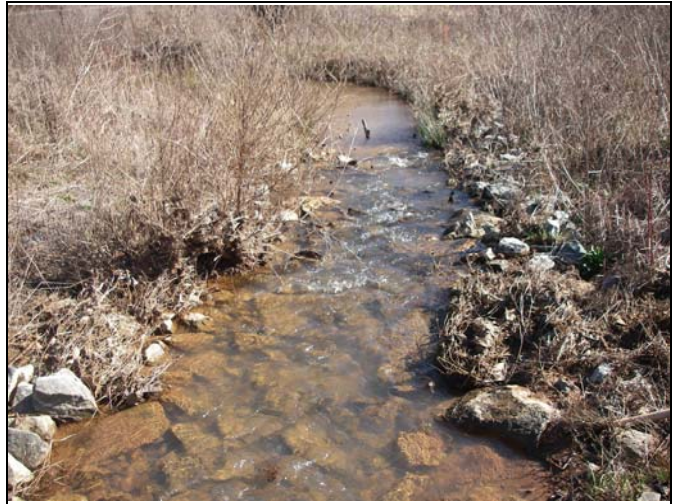
P-1

Site 1 received an 82 on the Habitat Assessment Field Data Sheet. The site exhibited excellent riffle pool sequencing, pattern, and habitat diversity. Riffles were mostly gravel and cobbles, moderately embedded with sand, and the pool bottoms were sandy. The Site 1 riparian buffer could be classified as fallow field with immature hardwood seedlings scattered throughout. Because there was no woody vegetation directly adjacent to the channel, organic habitats such as sticks and leaf packs were rare throughout Site 1. The lack of organic habitats is likely the cause for the decreased shredder communities from pre-construction monitoring to post-construction monitoring. It is anticipated that as the riparian buffer matures, the shredders from the upstream reference site (Site 2) will begin to colonize the restoration reach.

Site 1 – looking upstream

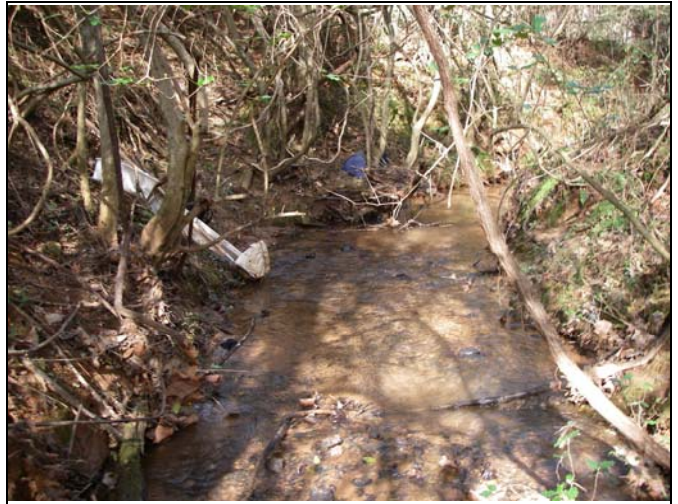
P-3

Site 2, the reference reach for Site 1, received a habitat assessment score of 70. The reach exhibited riffle pool sequencing with moderate bank erosion on alternating banks. The riparian buffer was mature and intact along most of the reach. Rocks, sticks, leaf packs, snags and undercut banks were all present along this reach; however large substrate in riffles was often embedded by sand. Bottoms of pools were sandy and filling in. As stated above, the ecological habitat observed during this monitoring cycle appears to be very similar to the pre-construction conditions.

Site 2 – looking upstream
