BAILEY FORK WETLAND AND STREAM RESTORATION PROJECT (DRAFT)

ANNUAL MONITORING REPORT FOR 2008 (YEAR 3)

Project Number D04006-3

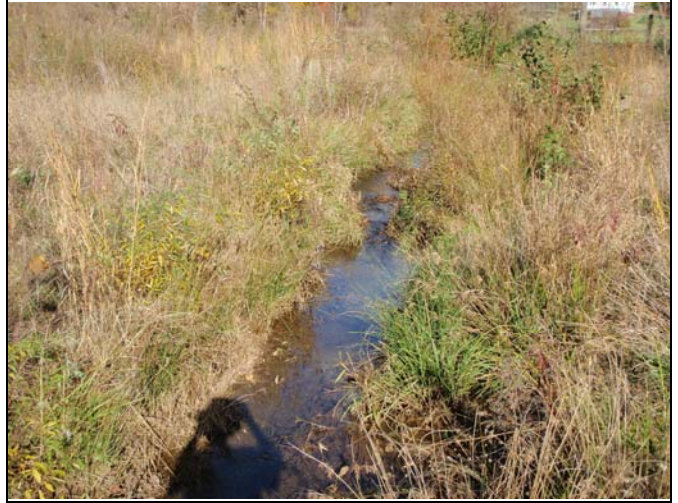
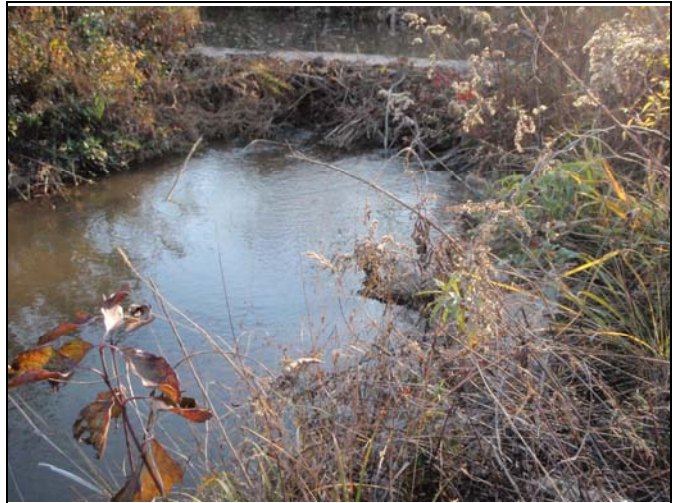
It was also noted that two rock cross vanes on Bailey Fork Creek at approximate stations 17+00 and 28+50 have been impacted by beaver activity. During a site visit in early November 2008, two beaver dams were observed across the rock inverts on top of the cross vanes. The observer noted that water was flowing around the sides of both dams and over the arms of the structures. The dams will require removal during the winter of 2008/2009 and the area will be monitored for further beaver activity going forward.

Bailey Fork Cross Vane 1, beaver dam across invert

Bailey Fork Cross Vane 2, beaver dam across invert

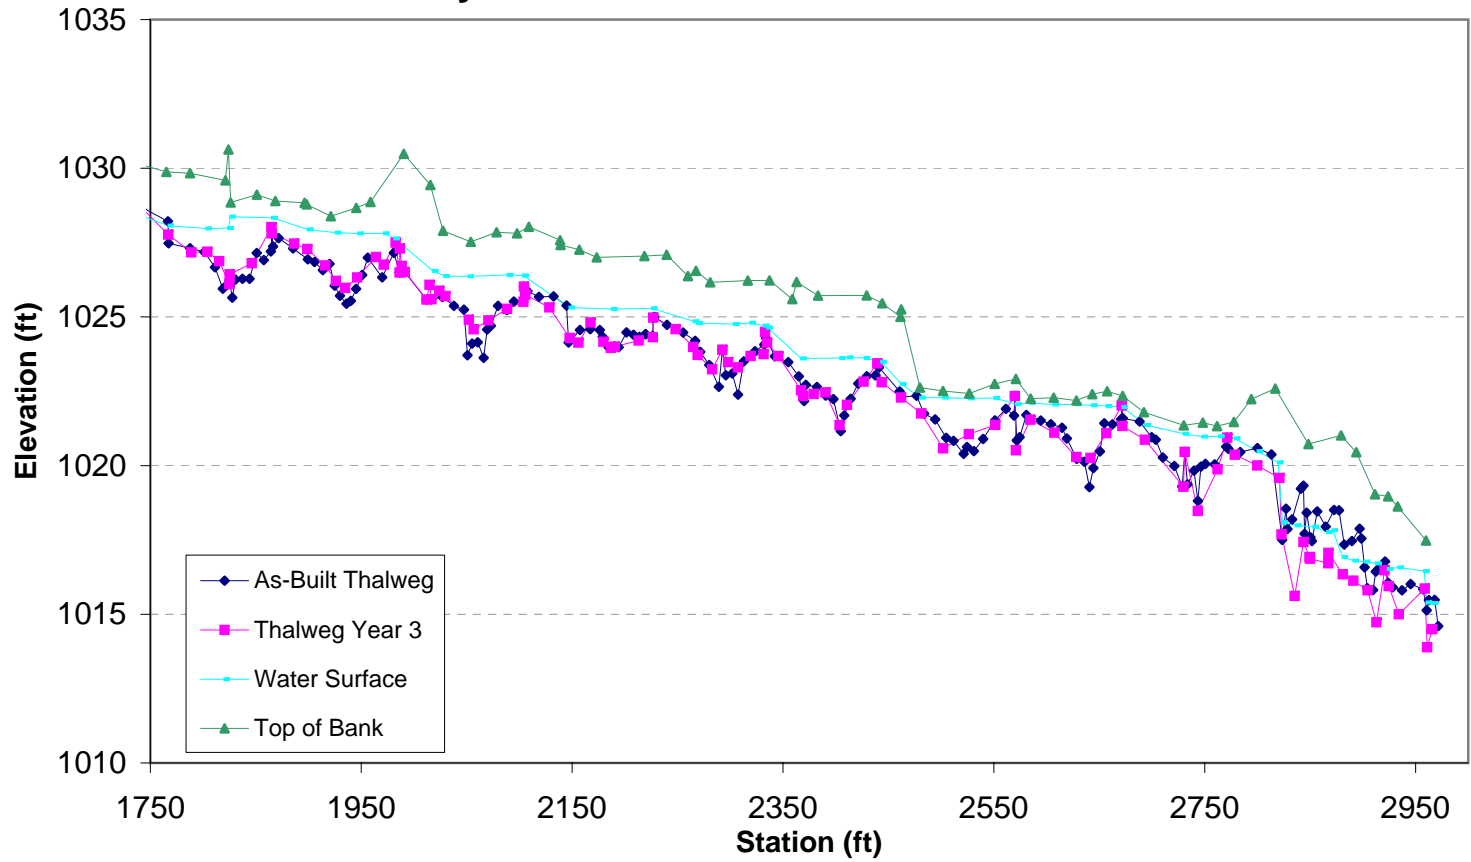
Baily Fork UT 1 Profile Station 17+50 to 29+65

According to the Year 3 longitudinal profile of UT1, all pools and riffles from stations 17+50 to 29+65 are at relatively the same elevations as the as-built conditions. However, during Year 2 of monitoring, the pools in this section of UT1 had accumulated sediment. The accumulation of sediment did not result in instability of UT1 and was attributed to below normal rainfall conditions during 2007.

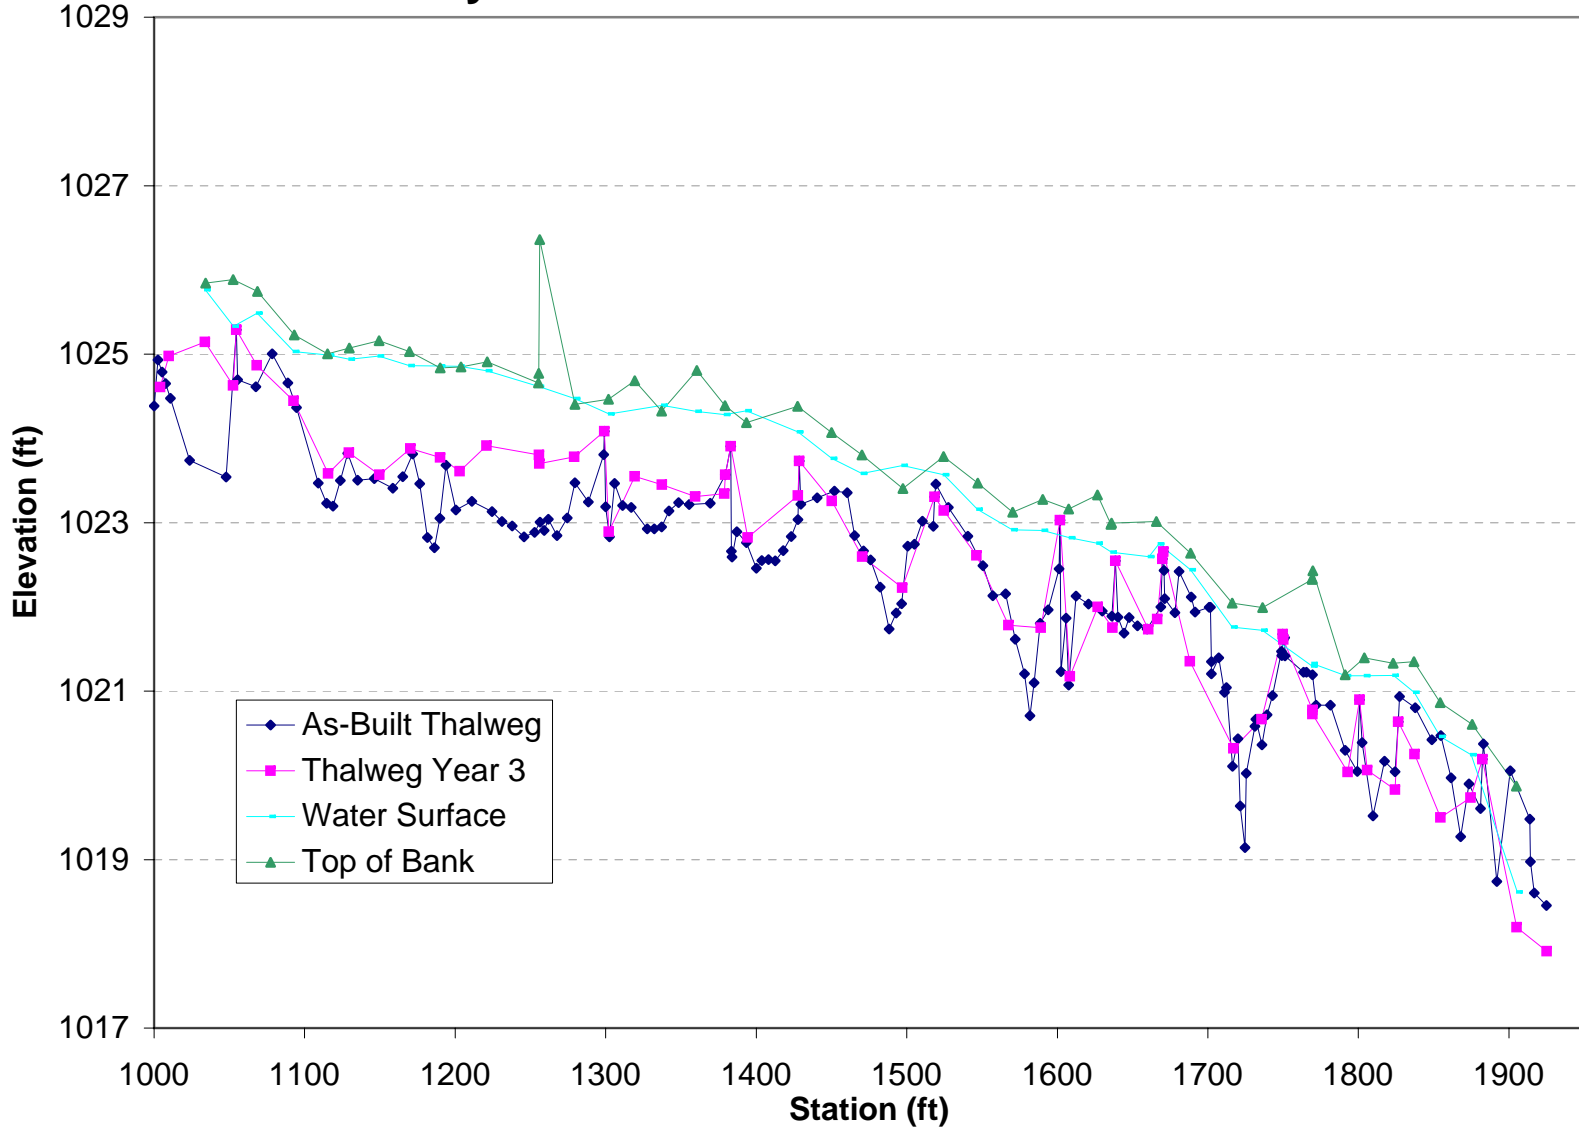
Baily Fork UT 2 Profile Station 10+00 to 19+30

The Year 3 longitudinal profile of UT2 shows that most pools and riffles from stations 10+50 to 19+30 have changed slightly since as-built conditions. It was determined that during Year 3 of monitoring, stations 10+00 to 10+50 and 12+00 to 13+00 have filled in with sediment that has apparently originated off site. This sediment has not caused stream instability, but has decreased the depths of some pools. Also on UT2, stations 13+00 to 14+50 have filled in with less sediment than the aforementioned upstream stations. All stations downstream of 14+50 are relatively similar to the as-built conditions.

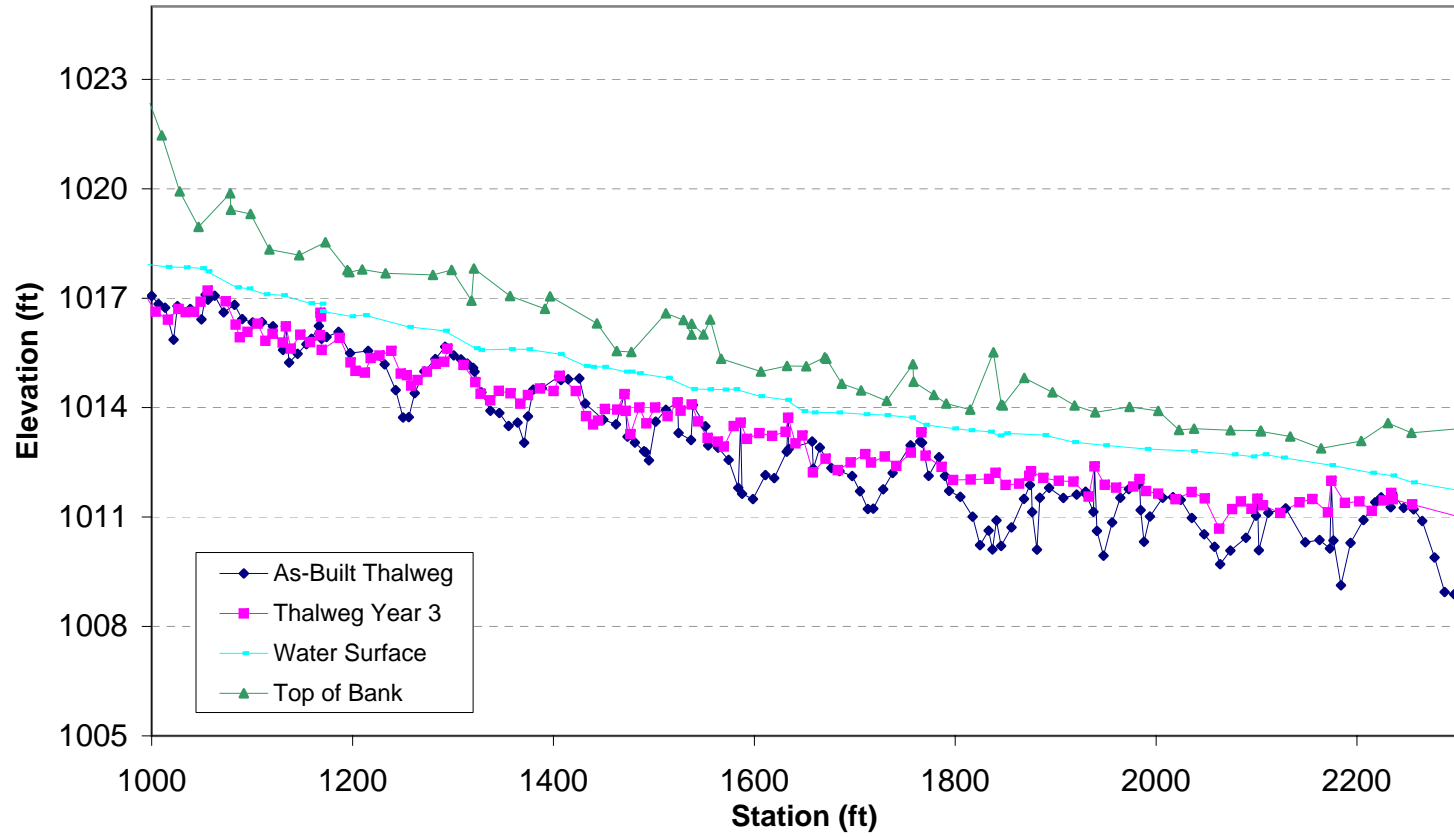
Baily Fork UT 3 Profile Station 10+00 to 22+50

The Year 3 longitudinal profile of UT3 also shows that some pools have filled slightly since as-built conditions. Stations 10+00 to 15+00 have remained unchanged or have filled slightly. However, stations 15+50 to 22+00 have filled in significantly with sediment. The Year 3 longitudinal profile of UT3 is similar to the Year 2 longitudinal profile. While pool depths have decreased, pools are still prevalent through the reach and channel stability has not been affected by the accumulated sediment.
