BAILEY FORK WETLAND AND STREAM RESTORATION PROJECT (DRAFT)

ANNUAL MONITORING REPORT FOR 2009 (YEAR 4)

Project Number D04006-3

December 2009

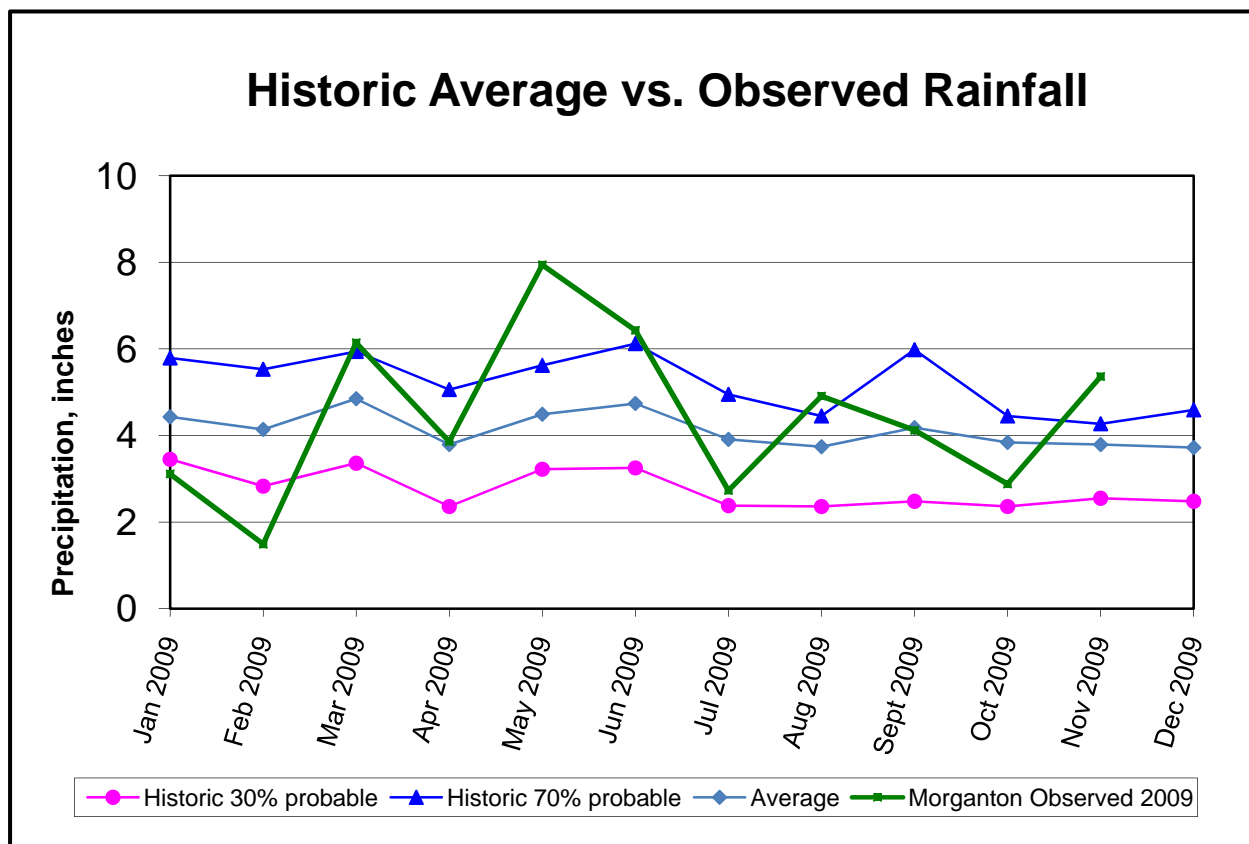
Figure 3. Historic Average vs. Observed Rainfall

Table 10. Comparison of Historic Rainfall to Observed Rainfall (inches)				
Bailey Fork Mitigation Site: EEP Contract No. D04006-3				
Month	Average	30%	70%	Observed 2009 Precipitation
January	4.43	3.45	5.79	3.11
February	4.14	2.83	5.53	1.49
March	4.85	3.36	5.94	6.14
April	3.79	2.36	5.06	3.86
May	4.49	3.22	5.62	7.94
June	4.74	3.25	6.12	6.43
July	3.91	2.38	4.95	2.73
August	3.74	2.36	4.45	4.91
September	4.18	2.48	5.98	4.12
October	3.84	2.03	4.76	2.88
November	3.79	2.55	4.27	5.36
December	3.72	2.48	4.59	NA
Total:	49.62	--	--	48.97 (through November 2009)

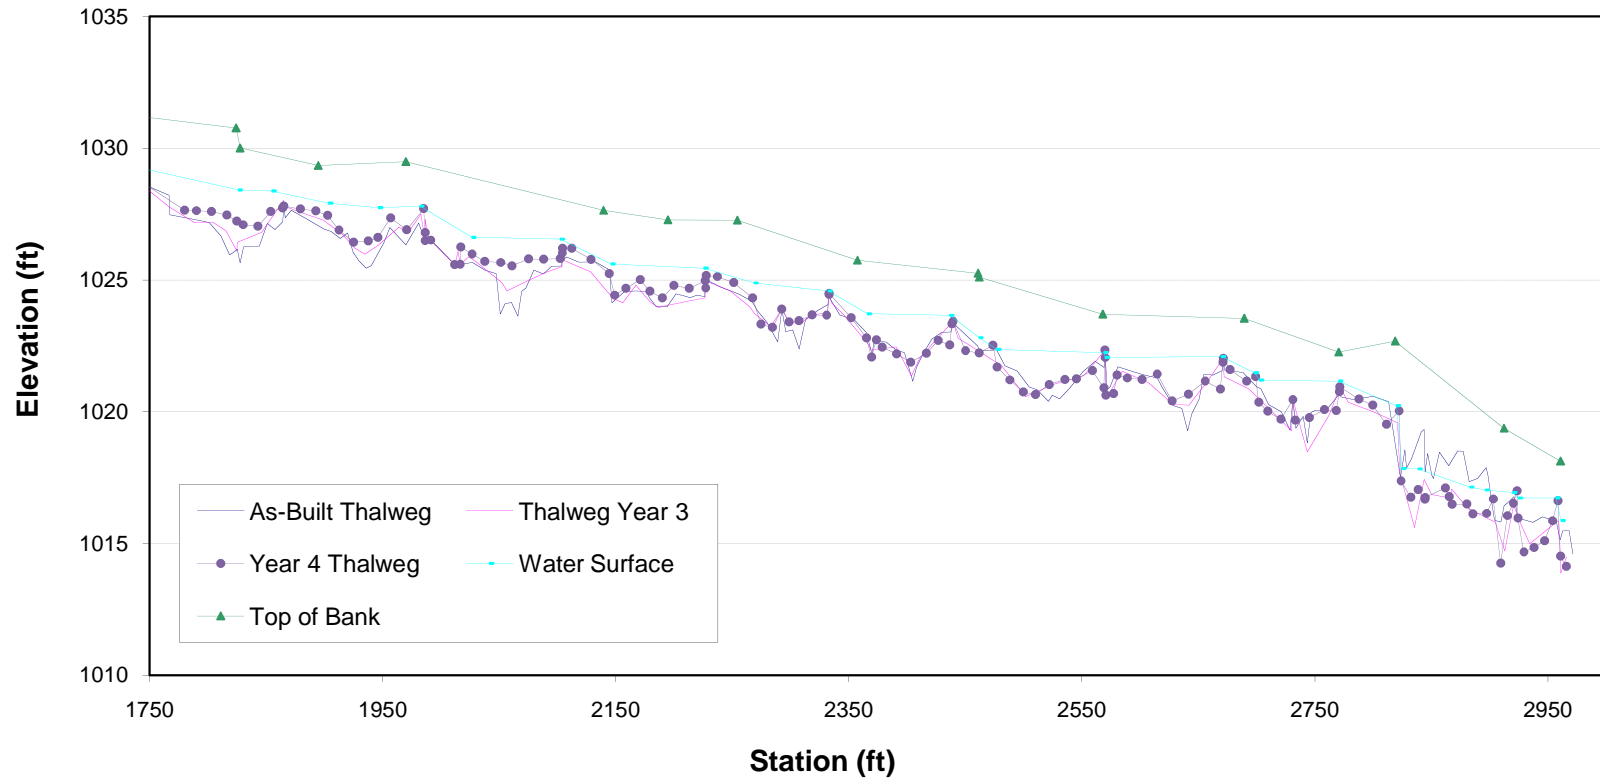
Baily Fork - UT 1 Profile Station 17+50 to 29+65

During Year 4 of monitoring 1,215 feet of UT1 were surveyed. According to the Year 4 longitudinal profile of UT1, pools from stations 17+50 to 26+55 have accumulated some sediment since as-built conditions and Year 3 monitoring; however, the pools remain significantly deeper than the riffles and are functioning as designed. The longitudinal profile in this same section shows that the riffles and structures have maintained the same elevations as as-built conditions. Riffles located in UT1 from stations 26+55 through 28+24 have also remained stable during Year 4 monitoring.

monitoring, the thalweg in this section of UT1 has shifted below the as-built elevation; however, the thalweg has remained relatively stable since Year 3. Minor piping has been noted above a rock step within the rock step-pool sequence on UT1. In this same localized area one stream bank has experienced some slight erosion. At this time, repair of the area does not appear necessary, but observation of the area will continue into 2010. During Year 4 of monitoring, 930 feet of UT2 were surveyed. The longitudinal profile of UT2 shows that from stations 10+00 to 13+00, the streambed has become elevated due to deposition of bed material from upstream. This material has not resulted in stream instability, but has rather acted to increase the average slope from stations 10+00 to 13+00 to approximately the same average slope as the remainder of the channel. This is seen as a positive evolution of the channel, as a section of essentially backwatered channel from 11+00 to 13+00 has now evolved to a section of free-flowing channel with a steeper slope. Also within UT2, stations 13+00 to 15+00 have accumulated some sediment, but the bed elevations are similar to those documented in Year 3. All stations downstream of 15+00 are relatively similar to the as-built conditions.

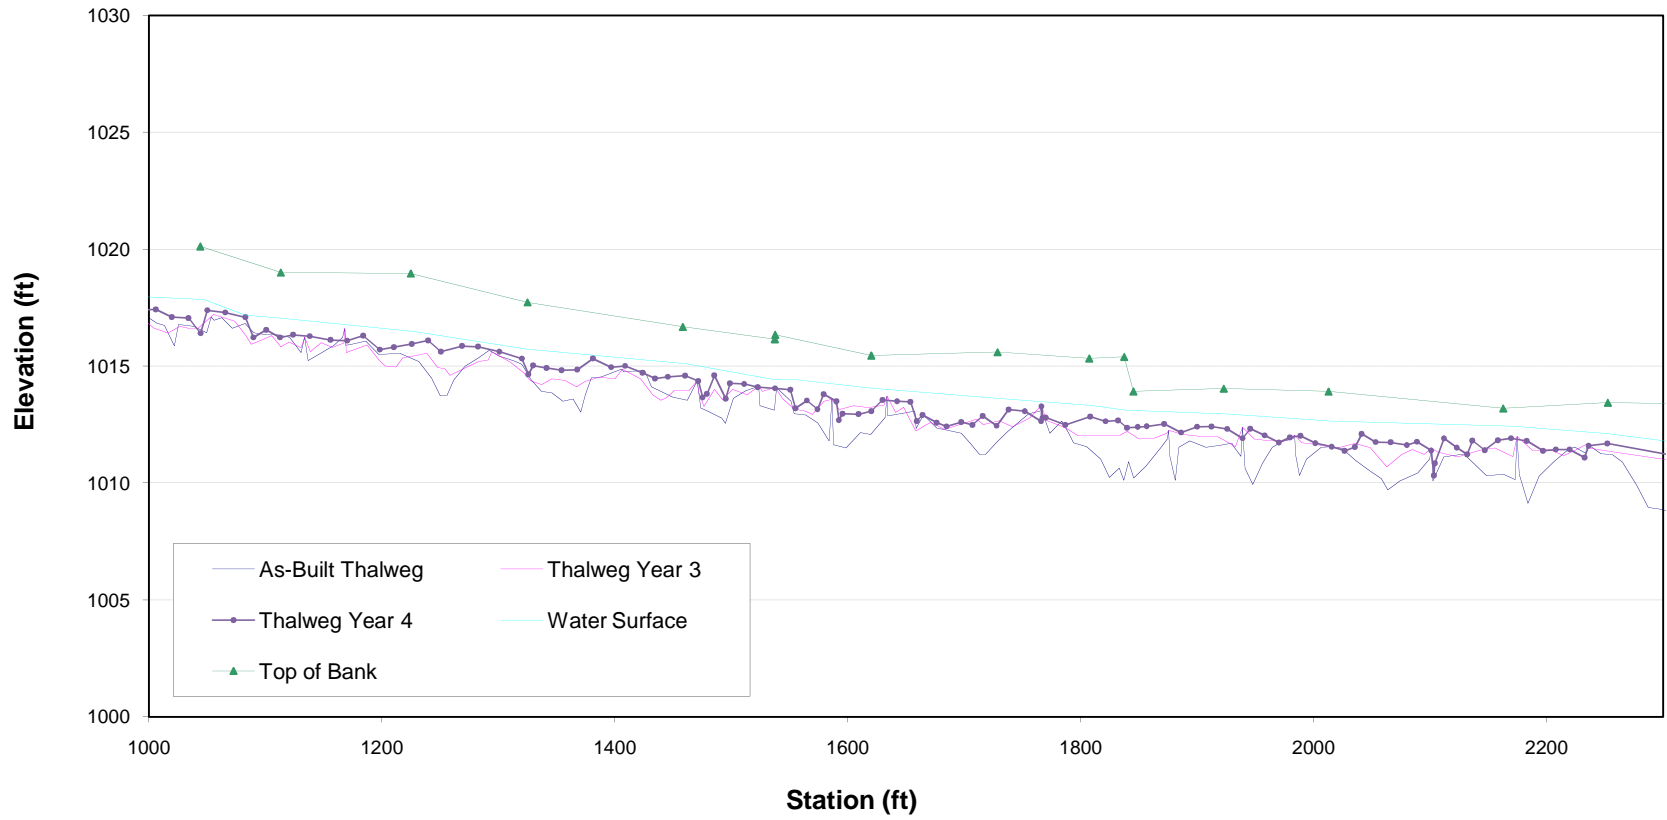
Baily Fork UT 3 Profile Station 10+00 to 22+50

During Year 4 of monitoring 1,250 feet of UT3 was surveyed. The Year 4 longitudinal profile of UT3 shows that many pools have accumulated some sediment since as-built conditions; however, riffles and the in-channel structures are holding grade and have not accumulated sediment. Due to the above average rainfall amounts observed during 2009, it is concluded that large storm events have caused higher amounts of sediment from upstream to be deposited in the pools. This deposition of sediment in UT3 during 2009 has likely exceeded the scouring potential normally seen during past monitoring years. While pool depths have decreased, pools are still prevalent throughout the reach and channel stability has not been affected by the accumulated sediment.
