BAILEY FORK WETLAND AND STREAM RESTORATION PROJECT (FINAL)

ANNUAL MONITORING REPORT FOR 2010 (YEAR 5)

Project Number D04006-3

January 2011
FINAL

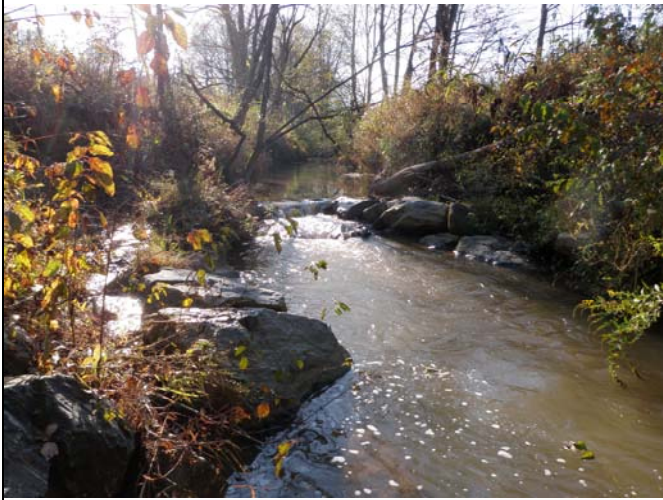
It was also noted that two rock cross vanes on Bailey Fork Creek at approximate stations 17+00 and 28+50 have been impacted by past beaver activity. During a site visit in early November 2008 (Year 3), two beaver dams were observed across the rock inverts on top of the cross vanes. At that time, water was flowing around the sides of both dams and over the arms of the structures. These beaver dams were not present in October 2009 (Year 4).

During a site visit in the summer of 2010 it was determined that cross-vane 2 and the adjacent banks should be repaired due instability from the Year 3 beaver dam impact. The arms of the cross vane

Bailey Fork Cross Vane 1 October (2010)
Before repairs

had worsened and the banks needed to be re-stabilized. In December of 2010, cross vane 2 and the adjacent banks were repaired. Repairs to the cross vane and concerned areas included stabilizing the right and left arms of the cross vane. The cross vane arm boulders were stabilized and adjusted using a track hoe and then backfilled with Class I and Class B stone. The right and left banks were stabilized with three geo-lifts that consisted of a brush layer at the toe, a soil lift, a brush layer, a soil lift, a brush layer, a soil lift and then matting at the top of terrace. After repairs, the areas affected were seeded and mulched.

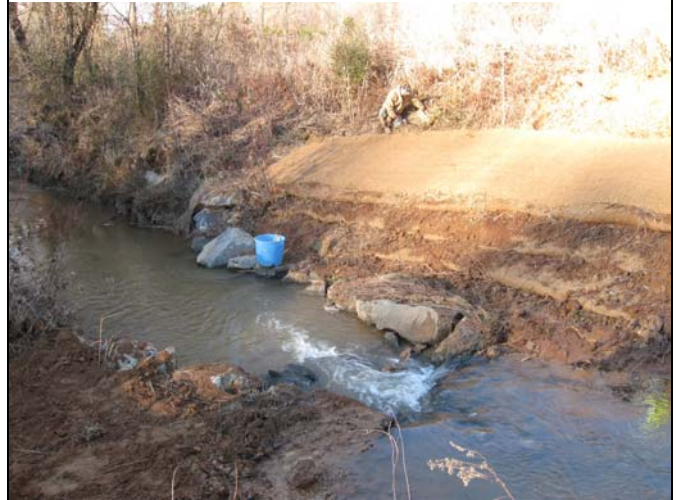
Bailey Fork Cross Vane 1 (December 2010)
After repairs

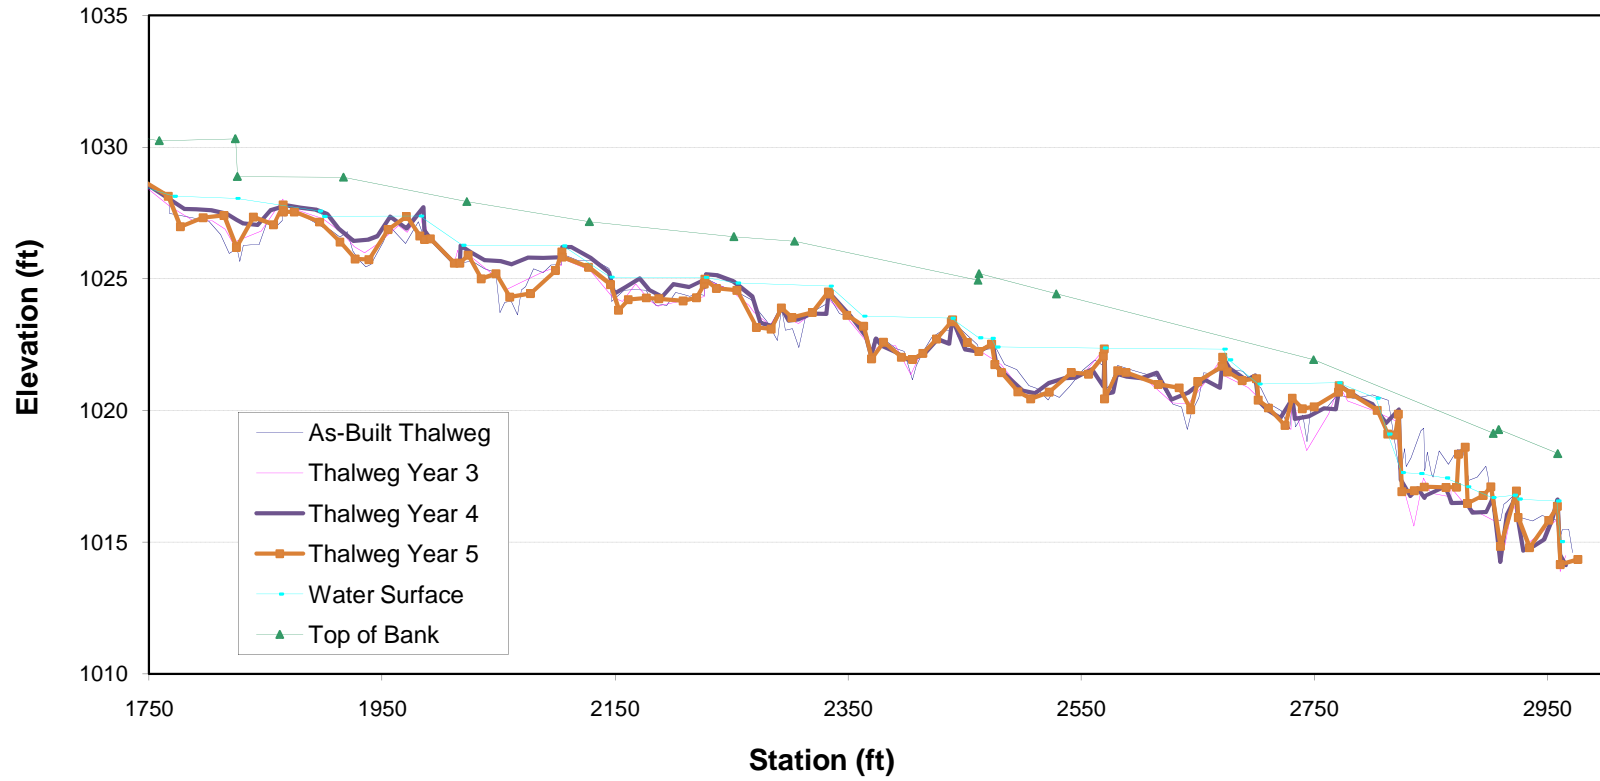
Baily Fork Year 5 - UT 1 Profile Station 17+50 to 29+65

During Year 5 of monitoring 1,215 feet of UT1 was surveyed. According to the longitudinal profiles of the as-built, Year 3, Year 4 and Year 5 surveys of UT1; pools from stations 17+50 to 26+55 have fluctuated with sediment accumulation since as-built conditions. The Year 5 survey shows that most

of the pools are remaining significantly deeper than the riffles and are functioning as designed. The longitudinal profile in this same section shows that the riffles and structures have maintained similar elevations as as-built conditions. The constructed riffle and rock step-pool sequence located at stations 28+25 through 29+65 is installed on the lower end of UT1. This section of UT1 was installed to step down the elevation of the UT1 thalweg to match the existing channel at the confluence with Bailey Fork. The thalweg in this section of has deepened below the as-built elevation, however, the thalweg has remained relatively stable since Year 3. In this localized area one stream bank has experienced some slight erosion. Repair of the area does not appear necessary.

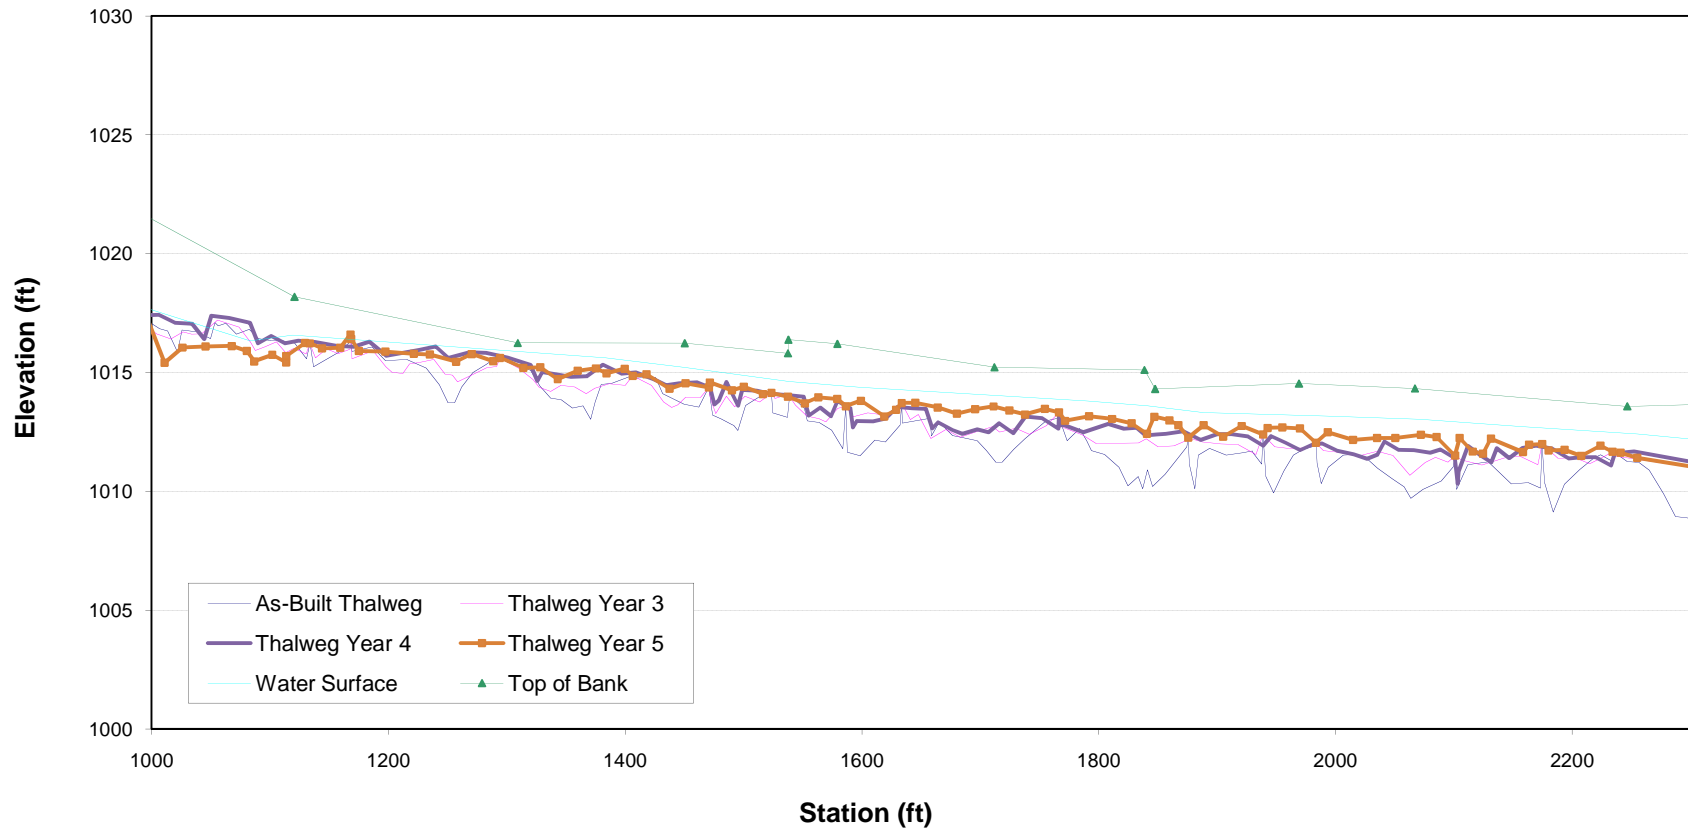
Baily Fork Year 5 UT 3 Profile Station 10+00 to 22+50

During Year 4 of monitoring 1,250 feet of UT3 was surveyed. The Year 4 and 5 longitudinal profiles show that UT3 pools have accumulated some sediment since as-built conditions; however, riffles and the in-channel structures are holding grade and have not accumulated sediment. Due to the below average rainfall amounts observed during 2010, it is concluded that a lack of large storm events have caused higher amounts of sand to be deposited in the pools. This observation has been made in other stream systems, where pools fill and are scoured back out during higher flow periods. While pool depths have decreased, it should be noted that pools are still prevalent throughout the reach, riffle areas have continued to maintain their grades through the five-year monitoring period, and channel stability has not been affected by the accumulated sediment.

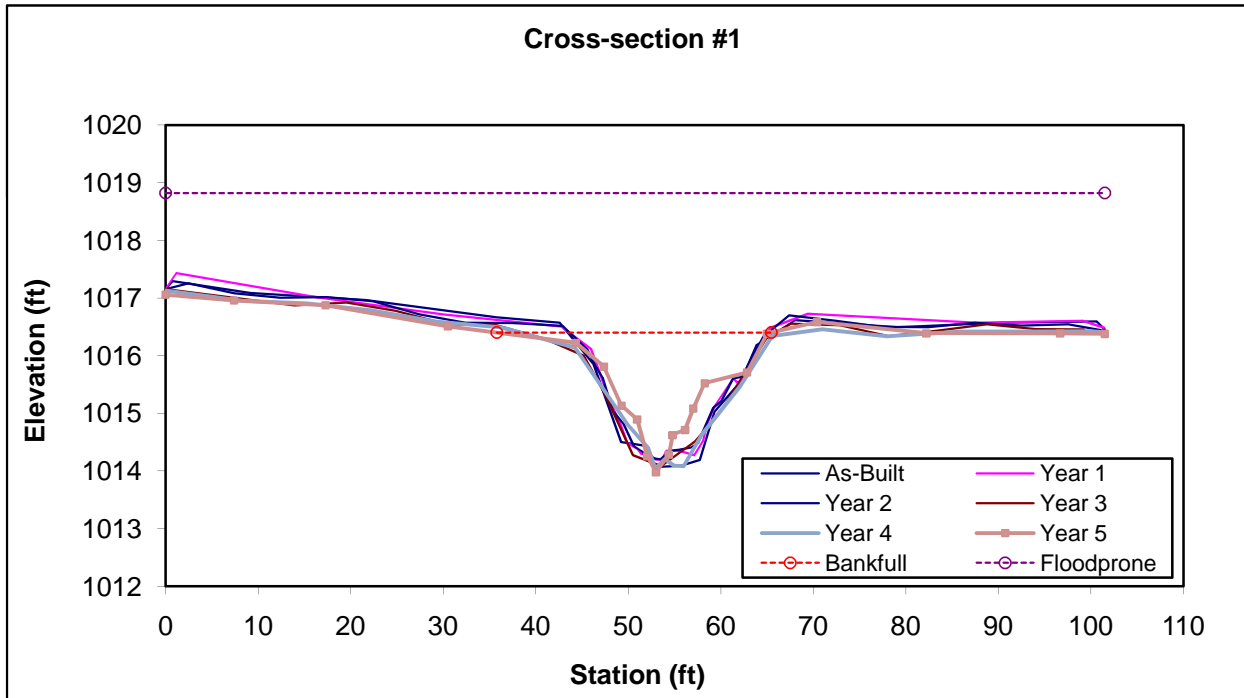
Permanent Cross-section #1 UT3
 (Year 5 Data - Collected October 2010)

Riffle cross-sectional survey data for cross-sections 1, 3, 5 and 7 indicate that all riffles on UT3 have remained stable since as-built conditions. However, during Year 5 monitoring, cross-section 1 indicated a narrower channel with a stable thalweg elevation. Visual observations did not indicate that cross-section 1 is experiencing unstable conditions. Survey data from UT2 riffle cross-section 11, indicate that the riffle has remained relatively stable since as-built conditions. Survey data from UT1 indicate that riffle cross-section 12 has experienced moderate dimensional changes since as-built conditions. It is likely that cross-section 12 is continuing a natural shift towards more stable conditions within UT1. It is noted that the channel dimensions of cross-section 12 have fluctuated each monitoring year since construction, but has never scoured deeper than the as-built condition, and such fluctuations are common for streams with a sandy bed material. UT1 riffle cross-section 9 has remained stable since as-built conditions.

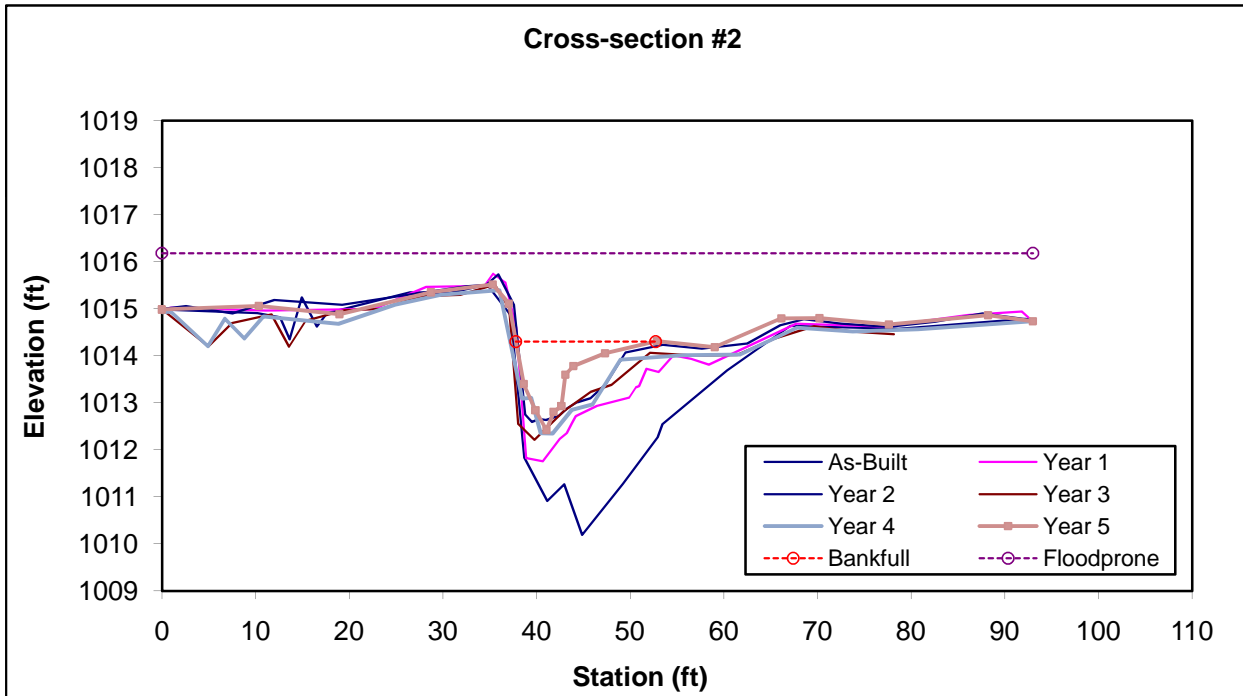
Permanent Cross-section #2 UT3
 (Year 5 Data - Collected October 2010)

UT3 pool cross-sections 2, 4 and 6 indicate that all pools have experienced some dimensional changes since as-built conditions. Cross-section 2 has seen a decreased area since as-built conditions; however, it has remained relatively stable since Year 3 monitoring. Cross-section 4 has remained very stable since as-built conditions. Cross-section 6 has remained relatively stable since as-built conditions. Survey data from UT2 pool cross-section 10, indicate that the pool has experienced a decrease in cross-sectional area since as-built conditions, but this accumulation of material is considered a positive evolutionary step and dimension has changed little since Year 2. Survey data from UT1 pool cross-sections 8 and 13 indicate that the channel is evolving to a stable dimension with the same general trends as seen for UT2.
