Year 1 Monitoring Report for Stream Restoration of Bailey Fork

Burke County, NC
SCO # D04006-02

Submitted: January 2008

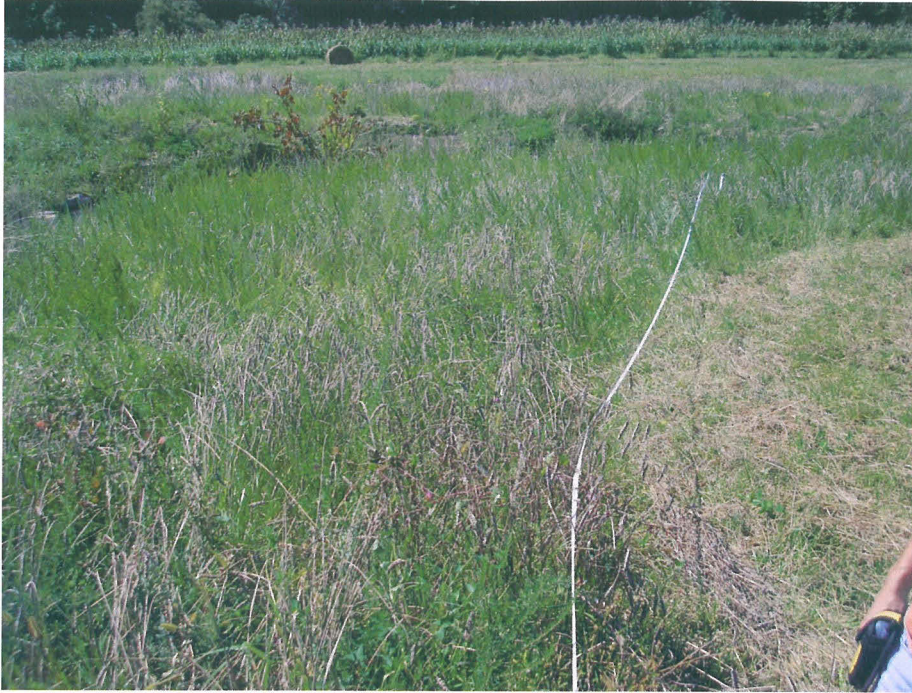
Table VII. Vegetative Problem Areas Bailey Fork Stream Restoration / EEP Project No. D04006-02			
Feature/Issue	Station # / Range	Probable Cause	Photo #
Other	Vegetation Plot 5	Pasture mowing infringed upon riparian buffer	VPA 1

The only vegetation problem area was a section near Vegetation Plot #5 where mowing of the adjacent pasture land for hay had infringed upon the riparian buffer. This mowing appeared to have damaged and killed some of the woody vegetation planted in this area.

View of mowed pasture infringing upon the riparian area near Vegetation Plot 5.
(EMH&T, Inc. 9/20/06)

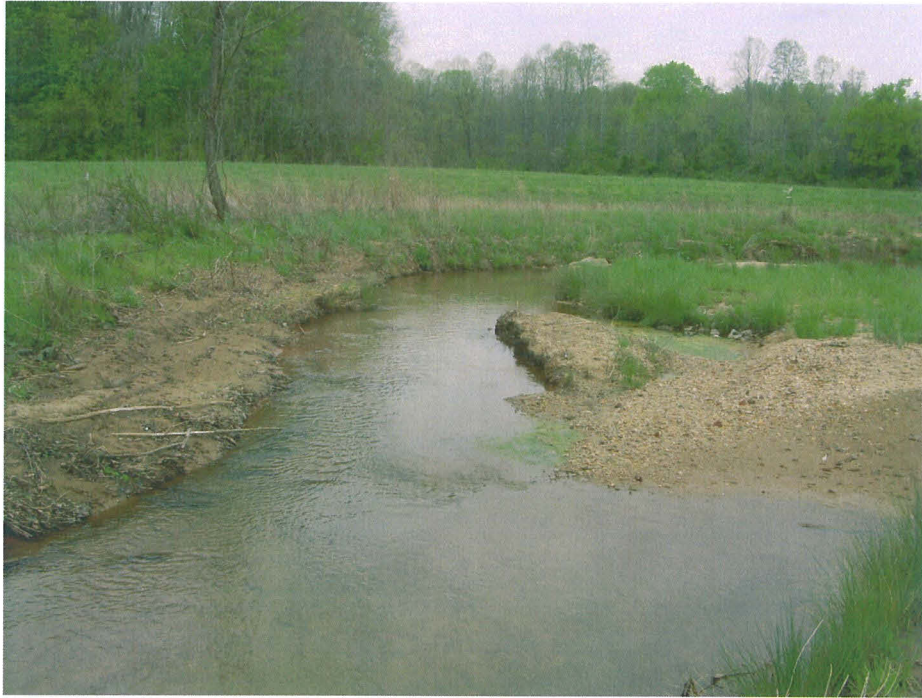
SPA 1
Area of aggradation along Upper Bailey Fork between stations 1+50 and 2+00.
(EMH&T, Inc. 4/13/07)

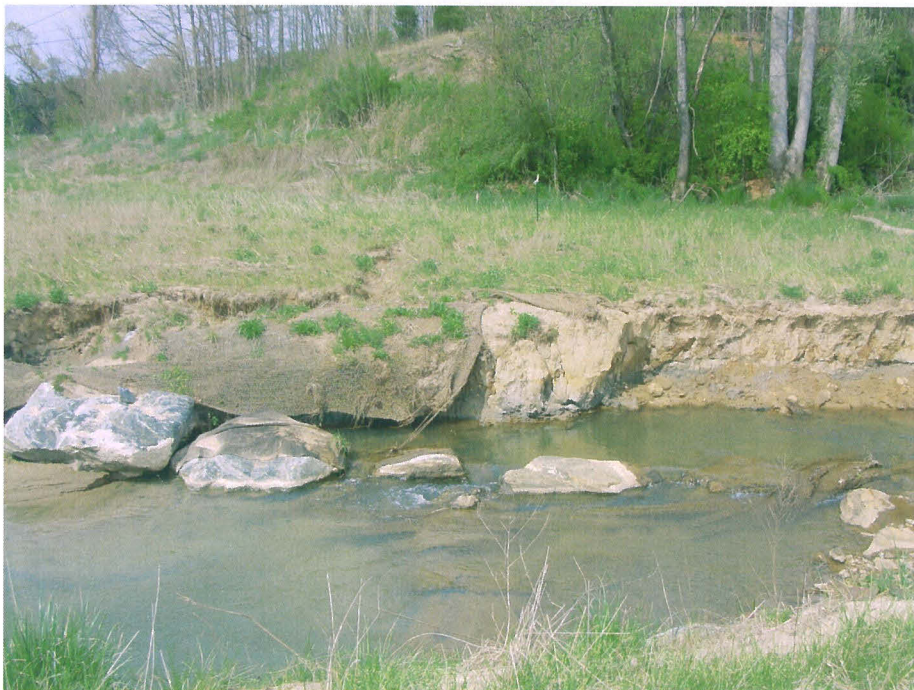
SPA 2
Bank failure along Upper Bailey Fork between stations 11+25 and 11+75.
(EMH&T, Inc. 4/13/07)

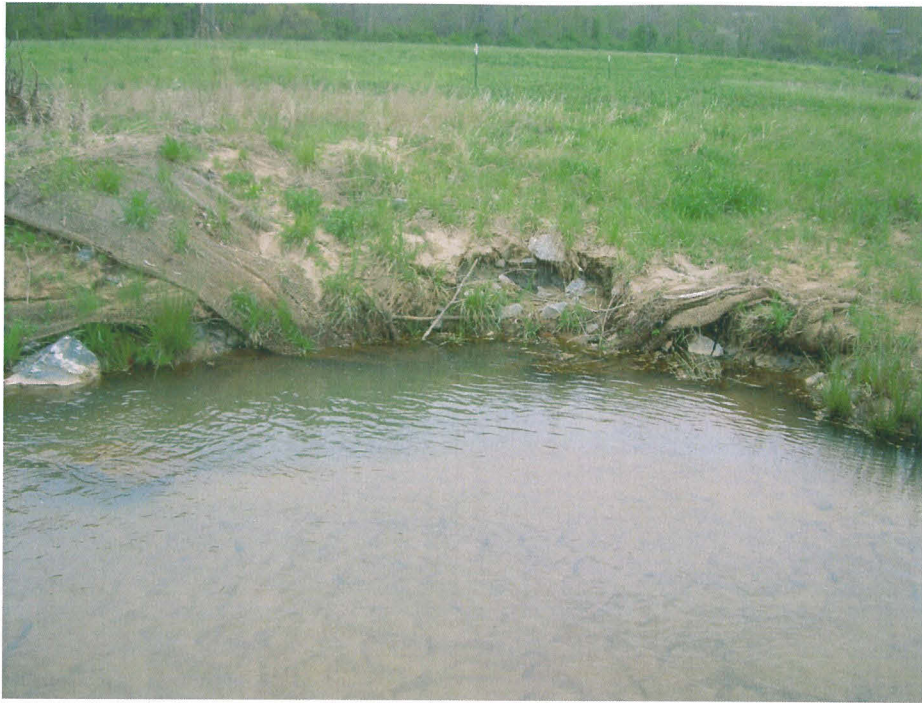
SPA 3
Bank scour along Upper Bailey Fork at station 3+50.
(EMH&T, Inc. 4/13/07)

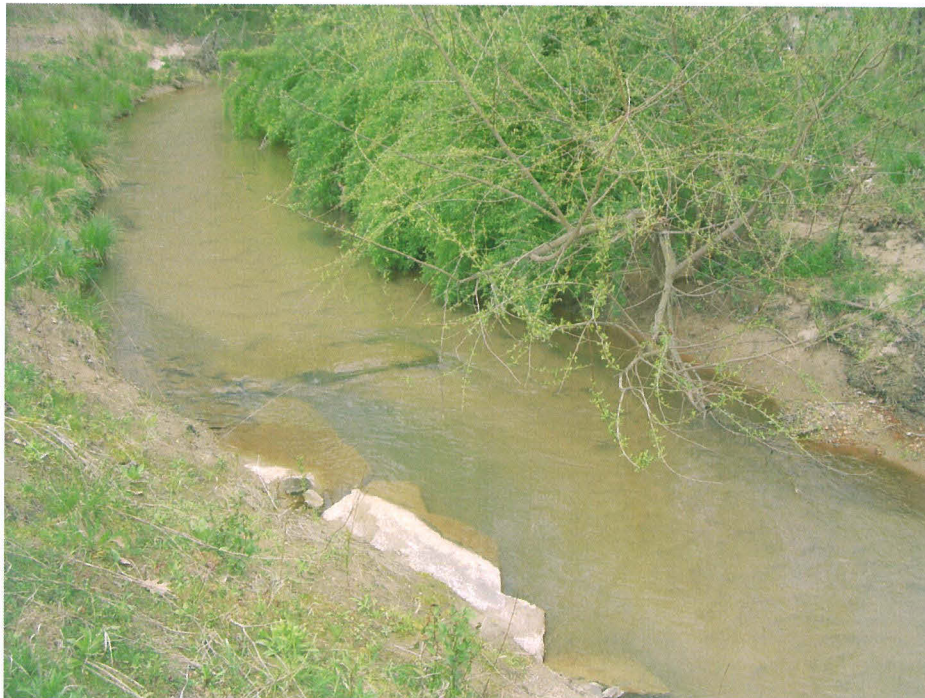
SPA 4
Stressed or failing structure along Upper Bailey Fork at station 1+25.
Buried J-hook.
(EMH&T, Inc. 4/13/07)

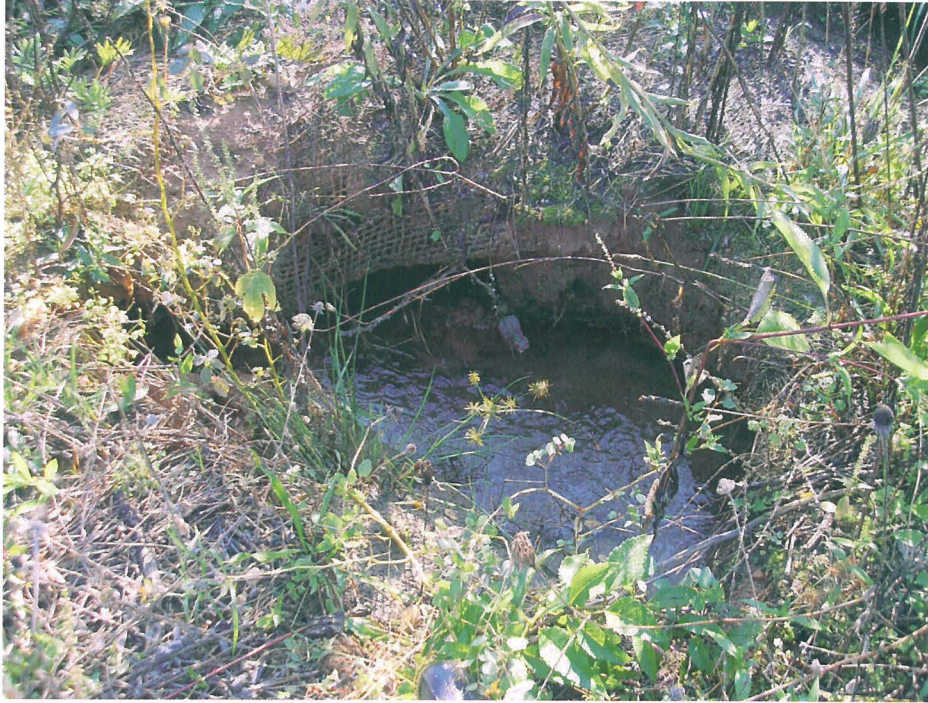
SPA 5

**Sinkhole along right bank of UT1 near station 7+00.
(EMH&T, Inc. 9/21/06)**
