Year 2 Monitoring Report for Stream Restoration of Bailey Fork

Burke County, NC
SCO # D04006-02

Submitted: January 2008

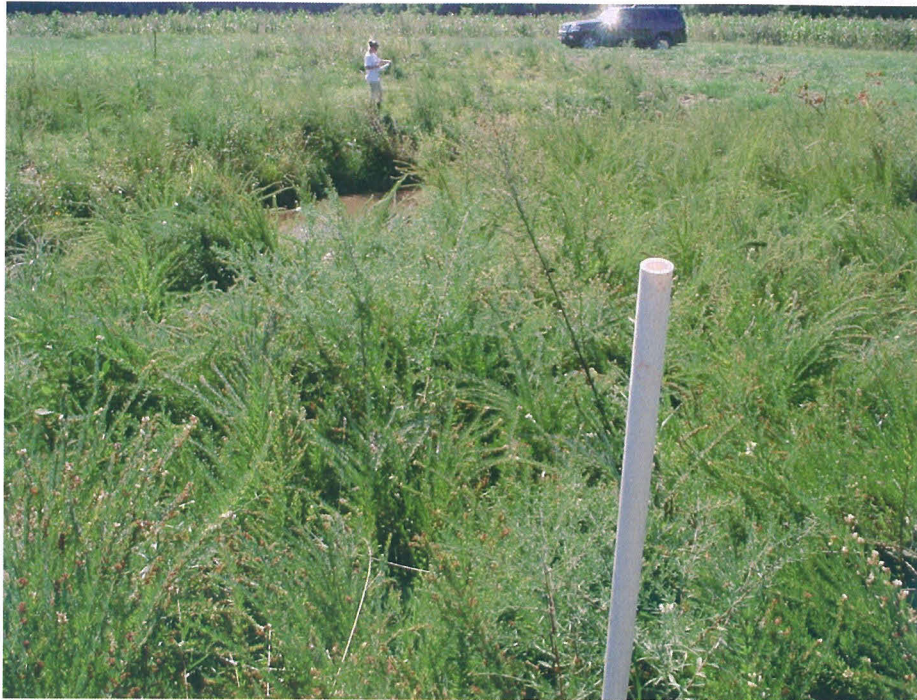
It is likely that the spread of *Sericea lespedeza* throughout much of the project corridor has hindered the growth and survival of woody vegetation. Where present, this species is dominant, providing a thick coverage of growth approximately three feet high through which any species must break in order to receive sunlight or rainfall. After management of this species is conducted in the spring of 2008, as discussed previously, a round of remedial tree plantings will be conducted. These plantings are intended to bring deficient areas of the site back into compliance with the 320 stems per acre minimum, and to replace trees inadvertently impacted by the herbicide treatments. The plantings will be spread throughout the project corridor, with an emphasis placed on those plots below the minimum stem count threshold.

VPA 1
View of the dominance of *Sericea lespedeza* in Vegetation Plot 5.
(EMH&T, Inc. 9/18/07)

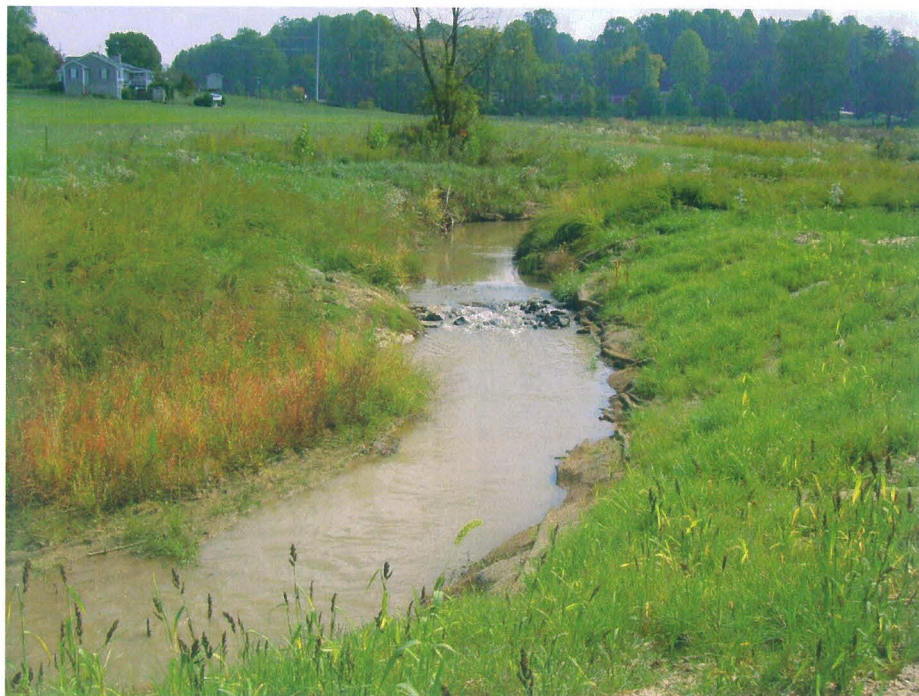
VPA 2
Overview of the spread of *Sericea lespedeza* along Upper Bailey Fork, looking upstream near station 10+00.
(EMH&T, Inc. 9/18/07)

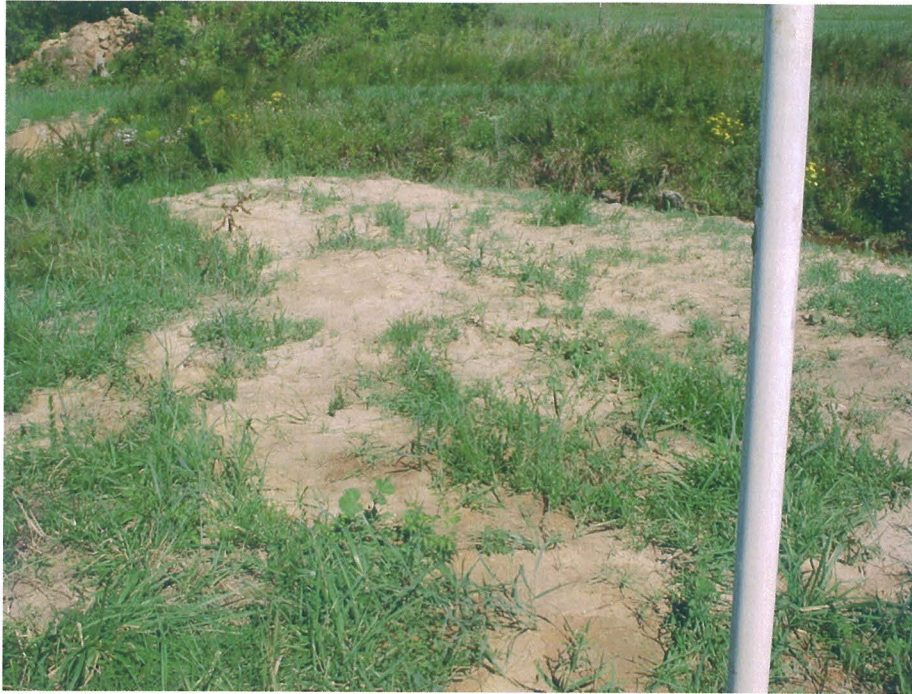
VPA 3

The remaining vegetation problem area was a section along Upper Bailey Fork where remedial maintenance activities along the stream banks impacted Vegetation Plot #6. These activities were represented by a plan sent by email to EEP on August 3, 2007 and subsequently discussed in the field with the EEP following completion. The focus of the efforts to repair the degraded reaches of the channel was to improve channel bank stability by creating a more stable bank slope that also provided a more stable width to depth relationship within the bankfull channel. In order to accomplish this, the existing banks were cut back to decrease the slope, which disturbed half of Vegetation Plot #6. The vegetation in the remainder of the plot, along with much of the buffer vegetation along the top of the slope at this location was damaged or destroyed by the construction activities. The streambanks were reseeded upon completion of maintenance activities, and new trees will be planted in the spring of 2008.

View of Vegetation Plot 6, where remedial maintenance on the stream impacted the vegetation plot. Half of the plot is missing due to the reshaping of the stream bank and planted woody vegetation has been lost.

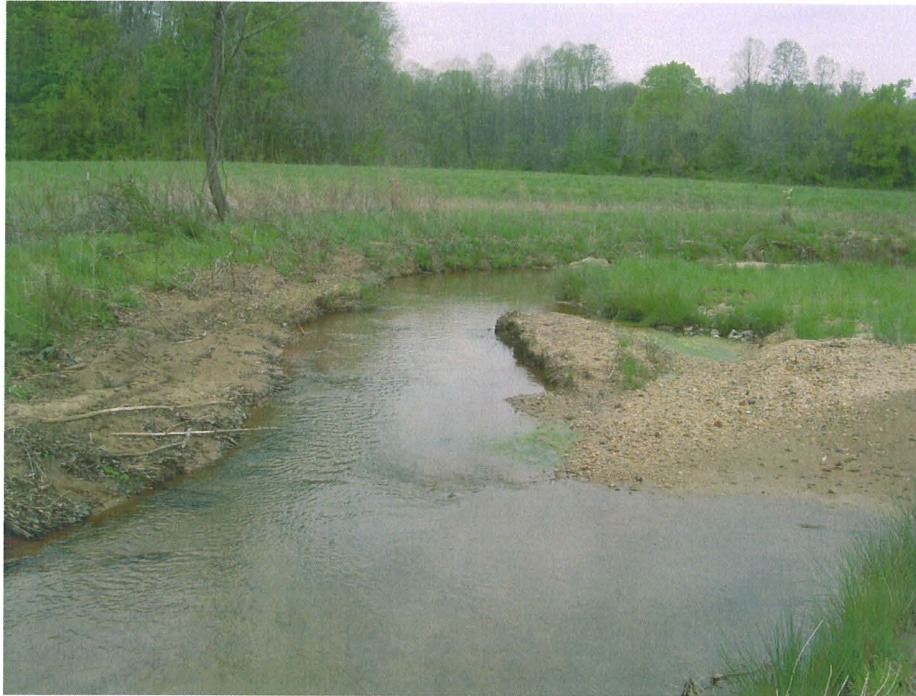
SPA 1

**Area of aggradation in Year 1 along Upper Bailey Fork between stations 1+50 and 2+00.
(EMH&T, Inc. 4/13/07)**

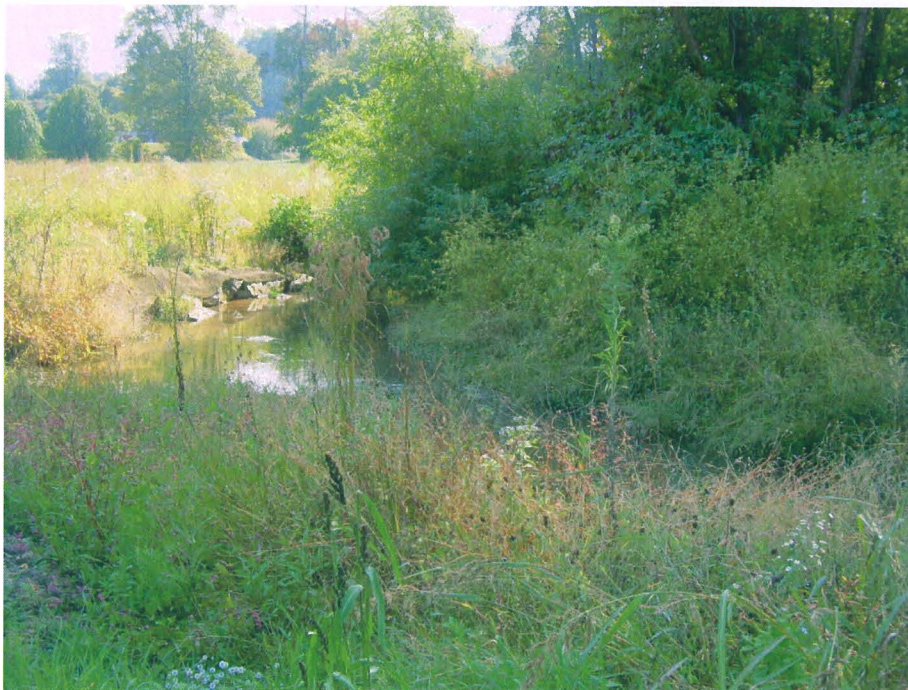
SPA 2

**Area of aggradation in Year 2 along Upper Bailey Fork between stations 1+50 and 2+00.
Lateral bar has become vegetated and is stable.
(EMH&T, Inc. 10/22/07)**

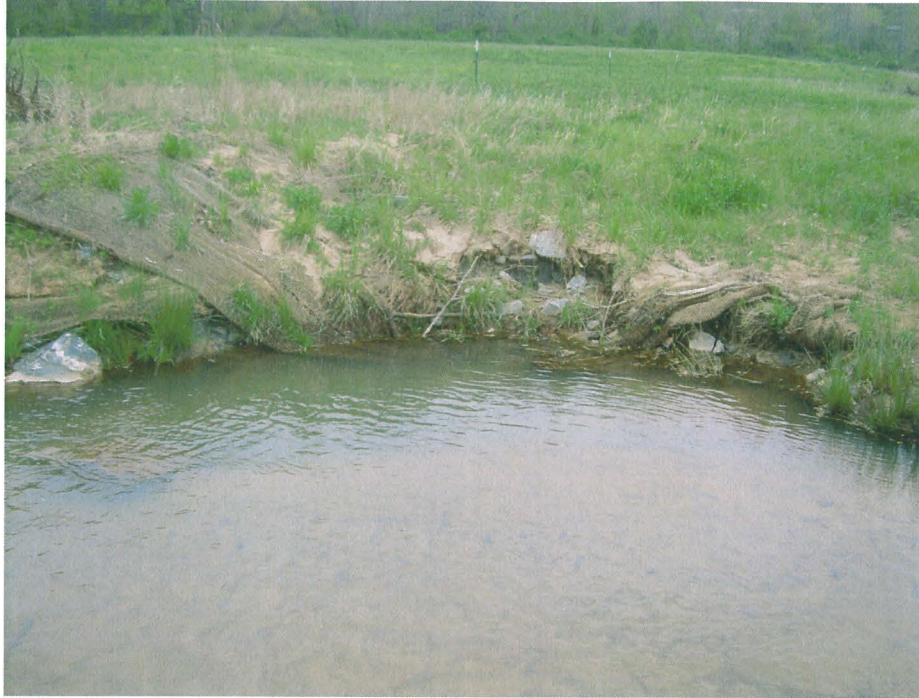
SPA 3
Bank scour in Year 1 along Upper Bailey Fork at station 3+50.
(EMH&T, Inc. 4/13/07)

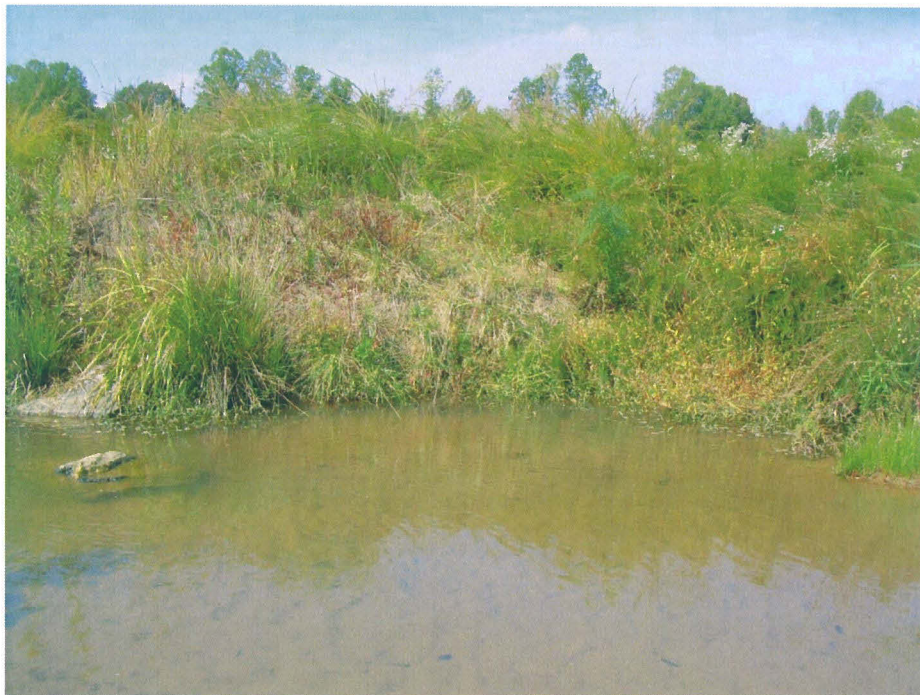
A few unstable areas were found along the upper and lower reaches on Bailey Fork mainstem in Year 2, including areas of aggradation and bank scour. Bank scour at station 3+50 widened the channel increasing its width/depth ratio resulting in aggradation. The area of aggradation at station 4+00 on Upper Bailey Fork was no longer present in Year 2. In addition, most of the areas of bank scour at each of the areas of bank failure were repaired during the remedial stream maintenance conducted in August 2007. These repairs have been effective, with no anticipated need for further work. The remaining areas of aggradation and bank scour have become heavily vegetated in Year 2, which is providing greater streambank stability than was present during the previous year.

SPA 4
Bank scour in Year 2 along Upper Bailey Fork at station 3+50.
Bank is now vegetated. W/D ratio is too high resulting in aggradation.
(EMH&T, Inc. 10/22/07)

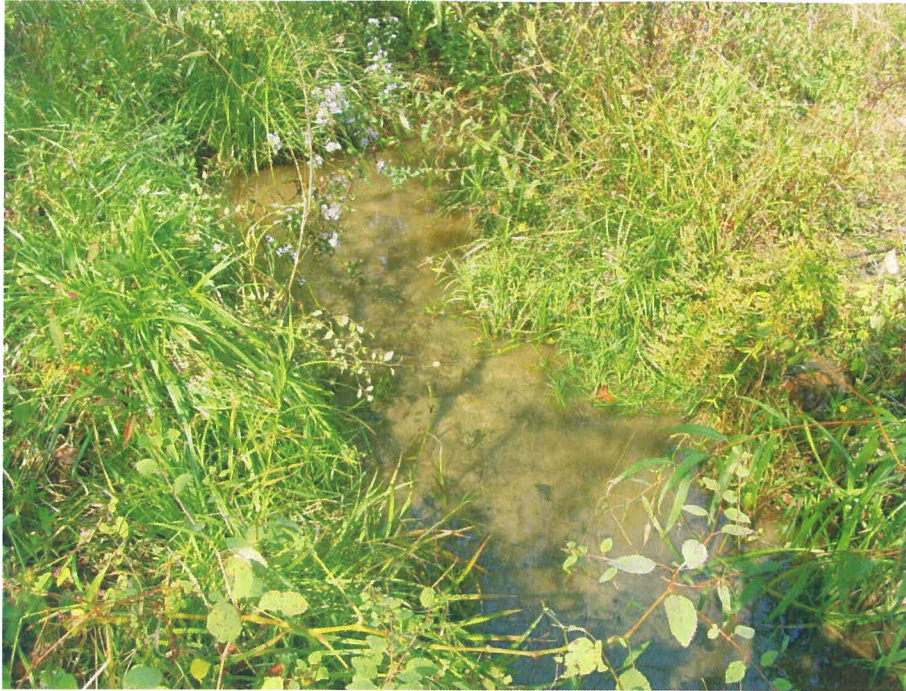
SPA 5

**J-hook and root wad in UT1 that have eroded out of channel near station 0+50.
(EMH&T, Inc. 10/22/07)**

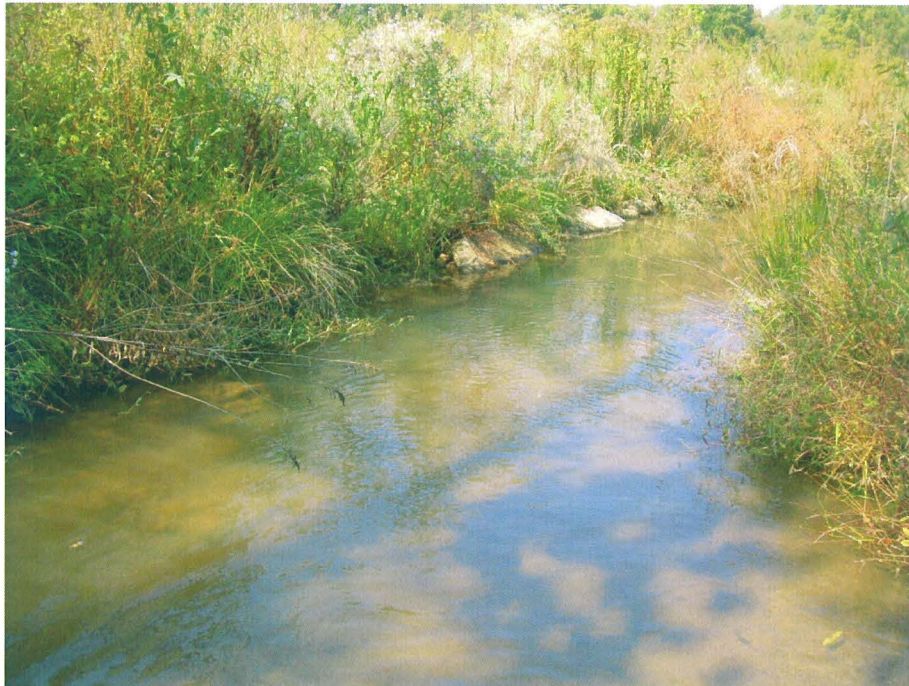
SPA 6

Several structures along Upper Bailey Fork and Tributaries UT1 and UT2 have become impacted by channel aggradation at these structures. Three additional structures were found to be at least partially embedded in sediment during the Year 2 visual assessment, including one J-hook on Upper Bailey Fork (station 2+50), one J-hook (station 0+50) and one rock sill (station 12+00) on UT1. Sand is the dominant streambed substrate in the project reaches. Sediment aggradation over the noted structures is attributed to high sediment supply upstream in the watershed; however, in each area where a structure is embedded, the channel is stable, with no bank failure or bar formation. One structure was also removed from the problem area list in Year 2, as the rock sill at the upstream end of UT1 (station 0+25) has become cleared of sand and is providing grade control.

**Embedded J-hook in Upper Bailey Fork near station 2+50.
(EMH&T, Inc. 10/22/07)**

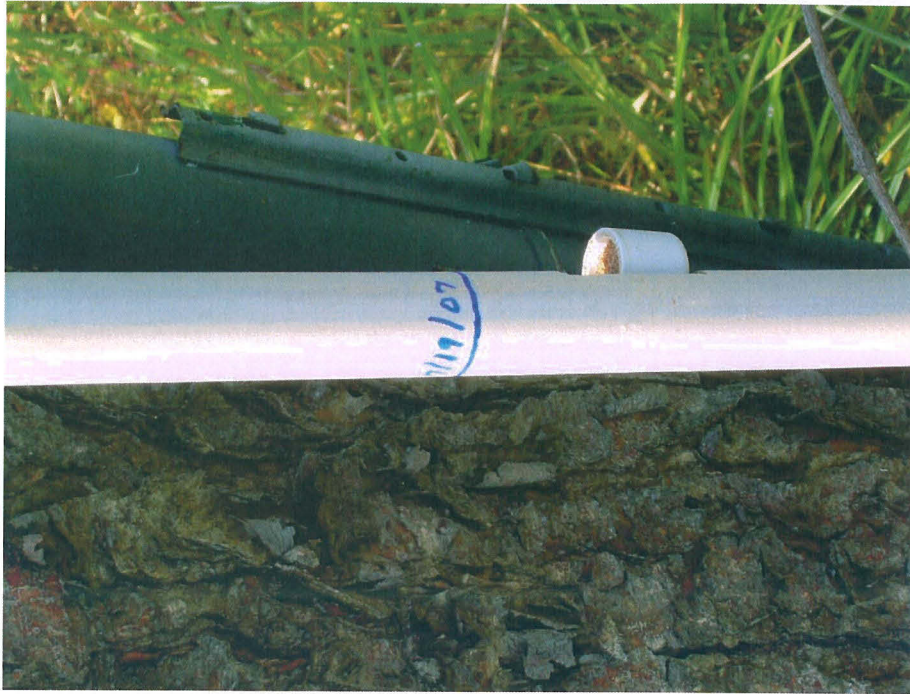
The crest gage on UT1 had registered a bankfull event when examined in July of 2007. In October 2007, the crest gage on Lower Bailey Fork registered a bankfull event. The height of the bankfull events were not measured for either crest gage. Photographs of the crest gages are shown in Appendix B.

BF 1
Crest Gage 1 on UT1.
(EMH&T, Inc. 7/19/07)

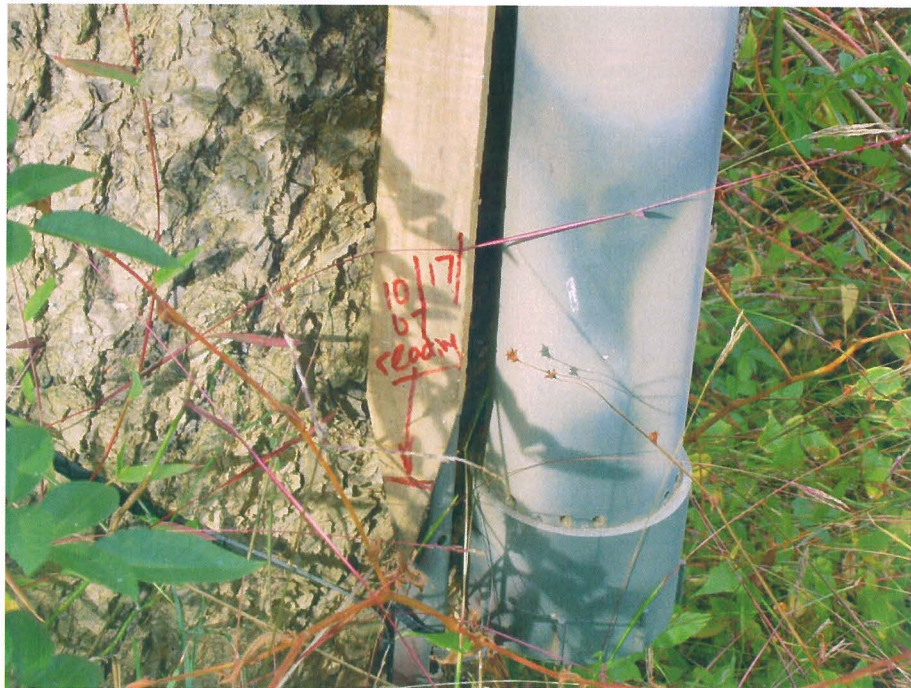
BF 2
Crest Gage 4 on Lower Bailey.
(EMH&T, Inc. 10/17/07)
