Year 3 Monitoring Report for Stream Restoration of Bailey Fork

Burke County, NC
SCO # D04006-02

Submitted: November 2008

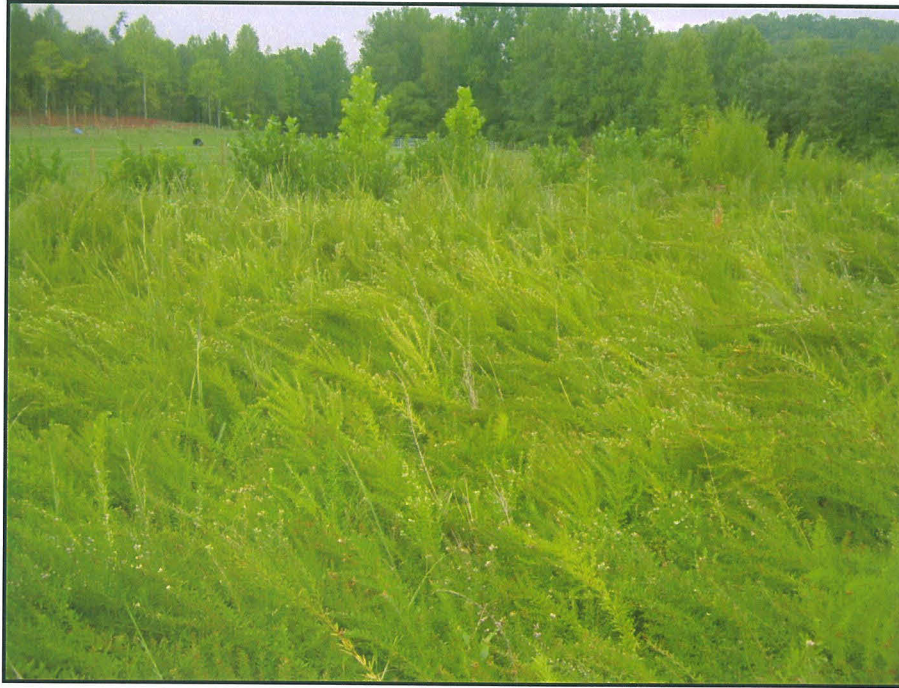
VPA 1

Table VII. Vegetative Problem Areas Bailey Fork Stream Restoration / EEP Project No. D04006-02			
Feature/Issue	Station # / Range	Probable Cause	Photo #
Invasive Population	Throughout: See VPA Plan View	<i>Sericea lespedeza</i> : encroachment from pasture	VPA 1, VPA 2

It is likely that the spread of *Sericea lespedeza* throughout much of the project corridor has hindered the growth and survival of woody vegetation. Where present, this species is dominant, providing a thick coverage of growth approximately three feet high through which any species must break in order to receive sunlight or rainfall. A round of remedial tree plantings were conducted in 2008, which were intended to bring deficient areas of the site back into compliance with the 320 stems per acre minimum. Due to continued mortality of planted stems which is speculated to be due to the coverage of *Sericea lespedeza*, these plantings did not bring all areas of the site back to the minimum stem count. The remedial plantings did, however, result in a net

View of the dominance of *Sericea lespedeza* in Vegetation Plot 8, considered a problem area of high concern.

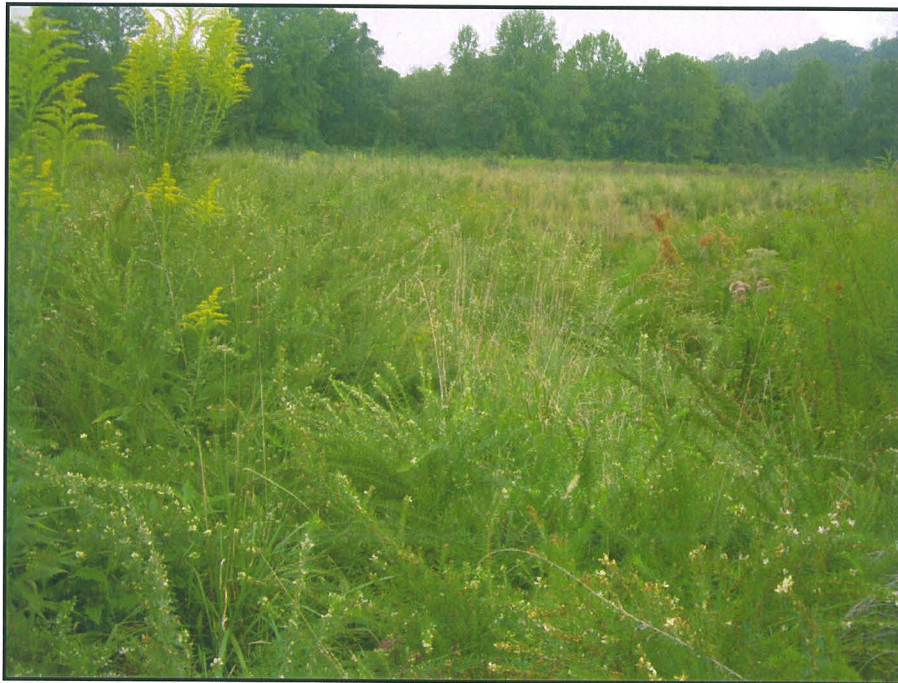
VPA 2

Overview of the spread of *Sericea lespedeza* along Upper Bailey Fork, looking upstream along the left bank near station 7+00, considered a problem area of low concern.

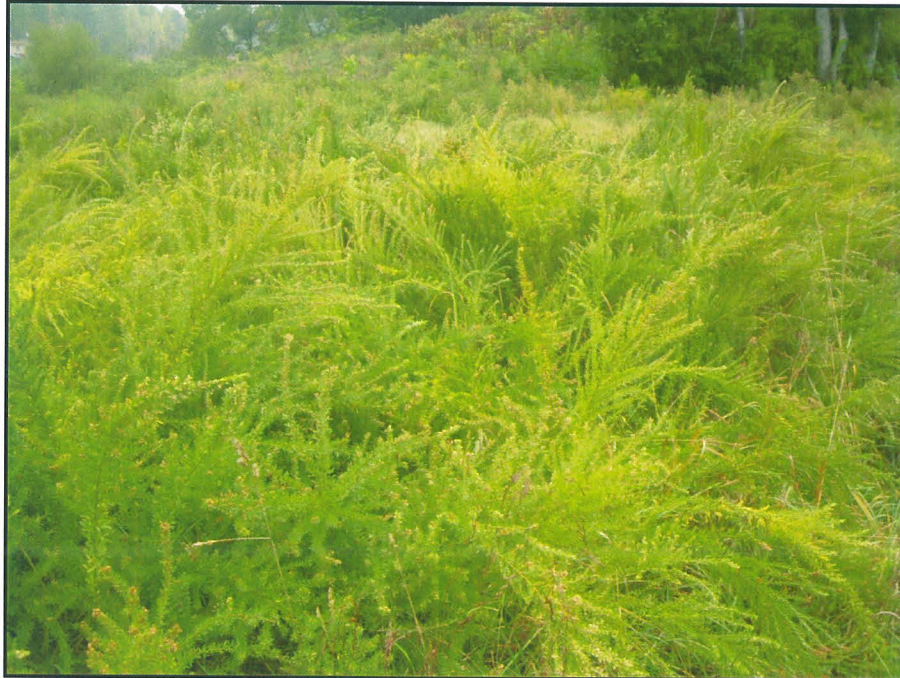
Vegetation Plot 6
Monitoring Year 3
(EMH&T, Inc. 9/9/08)

An additional problem area noted in Year 2 included a section along Upper Bailey Fork where remedial maintenance activities along the stream banks impacted Vegetation Plot #6. The vegetation of the plot, along with much of the buffer vegetation along the top of the slope at this location, was damaged or destroyed by the construction activities. The streambanks were reseeded upon completion of maintenance activities, and new trees were planted in the spring of 2008. As this plot has become fully vegetated, it has been removed from consideration as a problem area for bare banks.

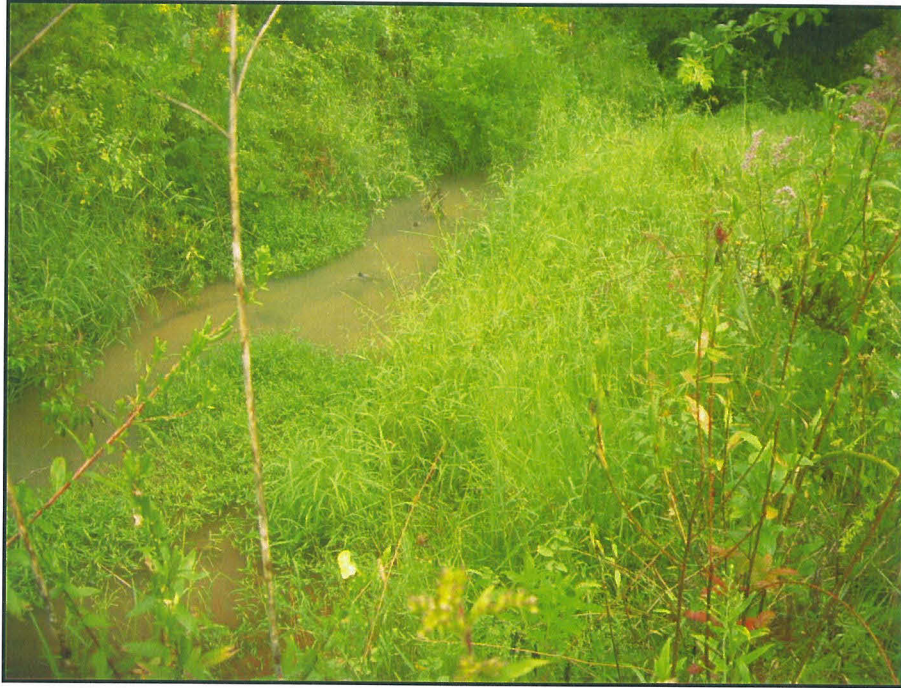
Feature Issue	Station Numbers	Suspected Cause	Photo Number
Aggradation	1+50 - 2+00 Upper	Point bar; vegetated and stable	SPA 1, 2
	1+75 Lower	Mid-channel bar; vegetated and stable	
	6+30 UT1	Embedded rock sill; channel is stable	
	8+00 UT1	Embedded J-hook; channel is stable	
Bank scour	3+50 Upper	Slumping on left bank; heavily vegetated, channel is stable	SPA 3, 4, 5

SPA 1
Area of aggradation along Lower Bailey Fork near station 1+75. Bar is heavily vegetated and stable.
(EMH&T, Inc. 9/9/08)

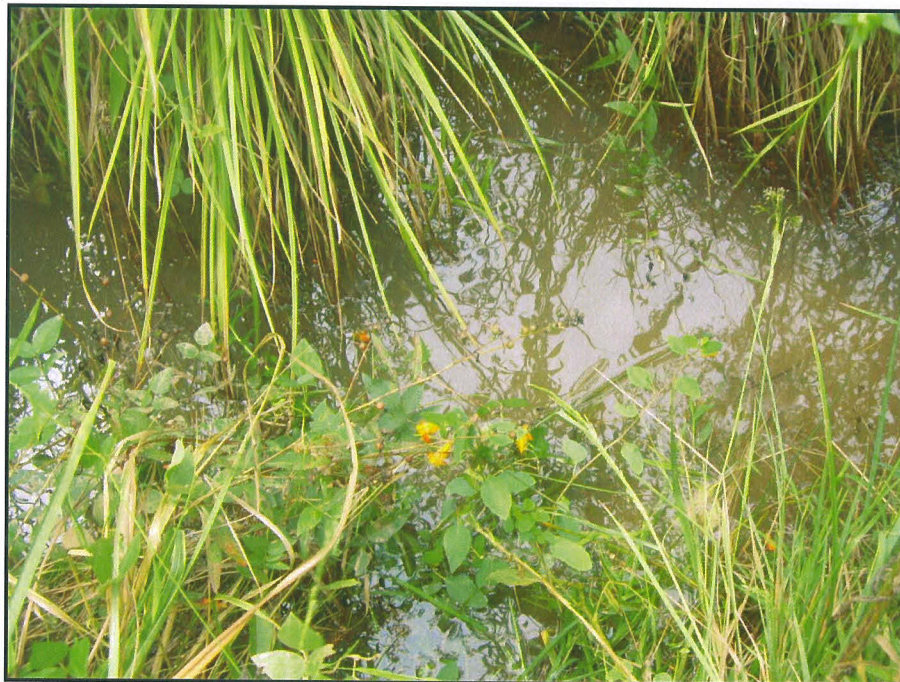
Two structures along UT1 were affected by aggradation in Year 3. Sand is the dominant streambed substrate in the project reaches, and as such, sediment deposition over the noted structures is attributed to high sediment supply readily available to UT1 upstream in the contribution watershed. Because the issue for these structures arises from depositional trends, rather than a concern with the physical structure, these areas are listed in the table as aggradation issues, not failed structures. It is noted that at both locations on UT1 (profile stations 6+30 and 8+00) where the two structures are embedded, the channel and streambanks are stable, with no bar formation.

SPA 2
Close-up view of aggradation over a rock sill in UT1 near station 6+30.
(EMH&T, Inc. 9/9/08)

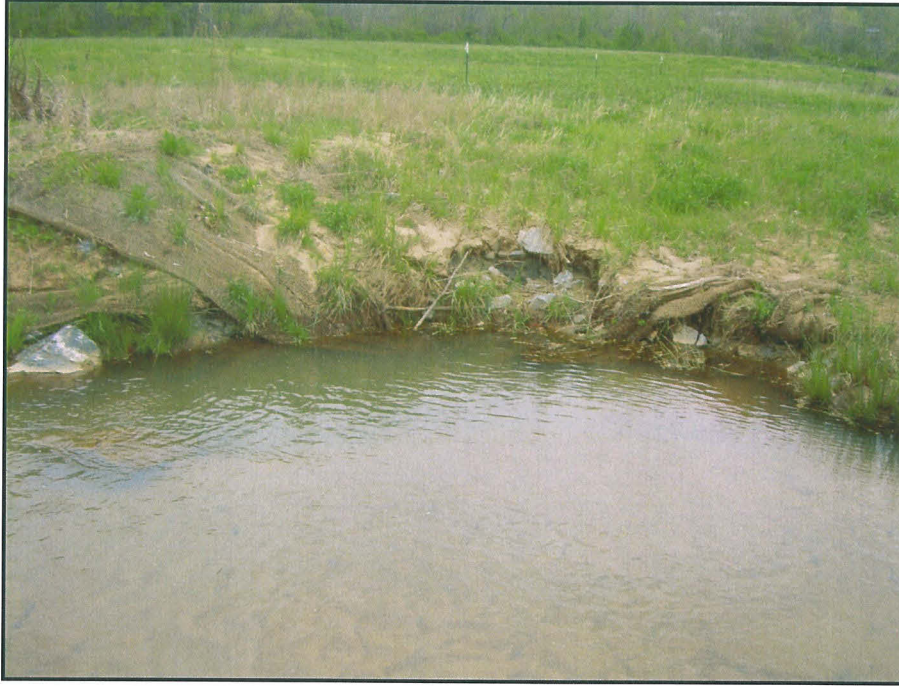
SPA 3
Bank scour in Year 1 along Upper Bailey Fork at station 3+50.
(EMH&T, Inc. 4/13/07)

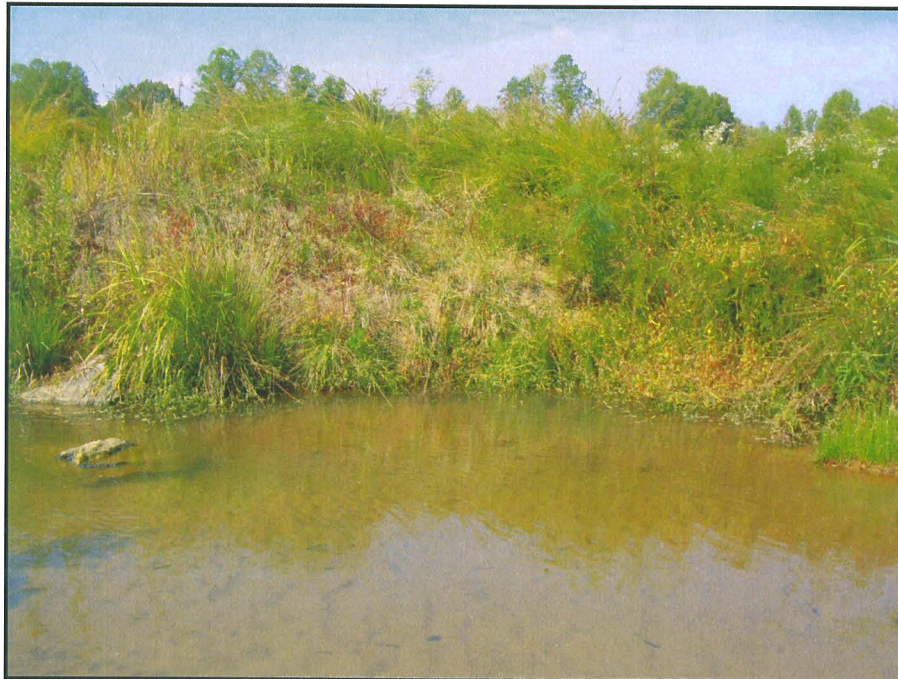
SPA 4
Bank scour in Year 2 along Upper Bailey Fork at station 3+50.
Bank is now vegetated. W/D ratio is too high resulting in aggradation.
(EMH&T, Inc. 10/22/07)

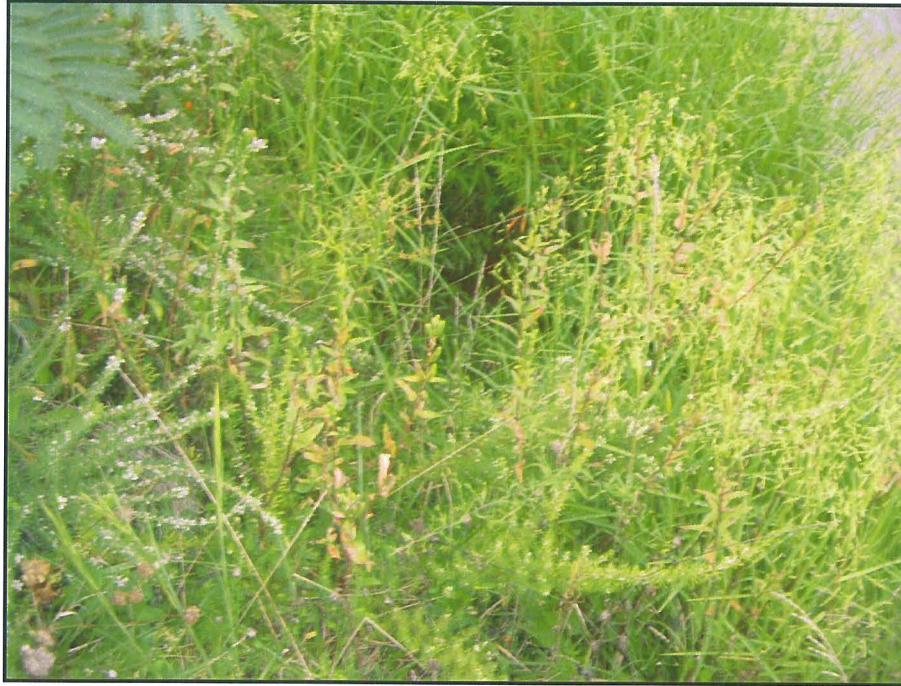
SPA 5

Five potential problem areas remain in Year 3, and are limited to isolated areas of aggradation and minimal bank scour. The bank scour noted near station 3+50 along Upper Bailey Fork in Years 1 and 2 has become heavily vegetated in Year 3, providing increases in root mass densities and streambank stability. The area noted as aggrading between profile stations 1+50 and 2+00 on Upper Bailey Fork is a point bar, an area of natural deposition in a sand and gravel dominated, C4 stream type. The mid-channel bar at profile station 1+75 on Lower Bailey Fork is of greater concern due to increases in near-bank shear stress associated with these types of mid-channel depositional features. Although the streambanks and channels are presently stable at the locations noted, these areas will remain on the problem area table to ensure each is monitored through Year 4.

**Bank scour in Year 3 along Upper Bailey Fork at station 3+50.
Close-up of bank shows the heavy vegetation; scour is no longer visible and bank is stable
(EMH&T, Inc. 9/9/08)**
