Year 4 Monitoring Report for Stream Restoration of Bailey Fork

Burke County, NC
SCO # D04006-02

Submitted: December 2009

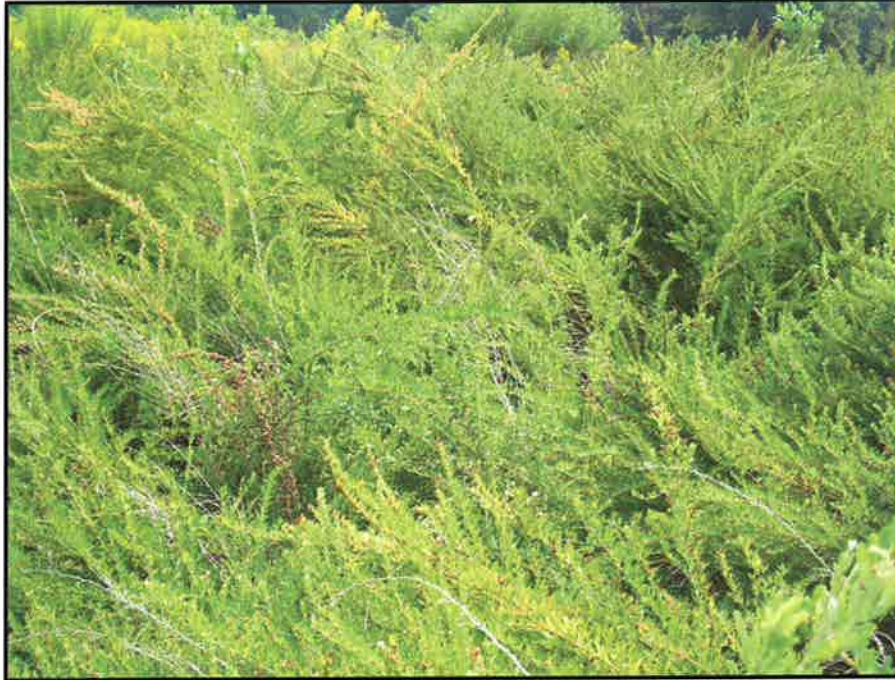
Table VII. Vegetative Problem Areas Bailey Fork Stream Restoration / EEP Project No. D04006-02			
Feature/Issue	Station # / Range	Probable Cause	Photo #
Invasive Population	Throughout: See VPA Plan View	Sericea lespedeza: encroachment from pasture	VPA 1
	7+25 Upper	Kudzu; encroachment from roadside ditches	
Bare Bank	12+50 – 12+70 UT2	Sparse vegetation along left bank due to unknown disturbance	VPA 2
Other	7+00 – 10+50 UT2	Adjacent landowner mowing within easement on left bank	VPA 3

**View of the dominance of *Sericea lespedeza* near Vegetation Plot 5.
(EMH&T, Inc. 9/15/09)**

A few vegetative problem areas of low concern were noted in the project area, included scattered populations of problematic species. The problematic species have been and will continue to be proactively managed by herbicide treatment. An additional problem area included a section along UT2 with sparse vegetation along the stream banks damaged by an unknown source. It is expected that the vegetation will recover on its own. The final problem area along UT2 concerns mowing inside the easement by an adjacent landowner. The landowner has been informed of the easement boundary, which has been demarcated by fencing to prevent further encroachment.

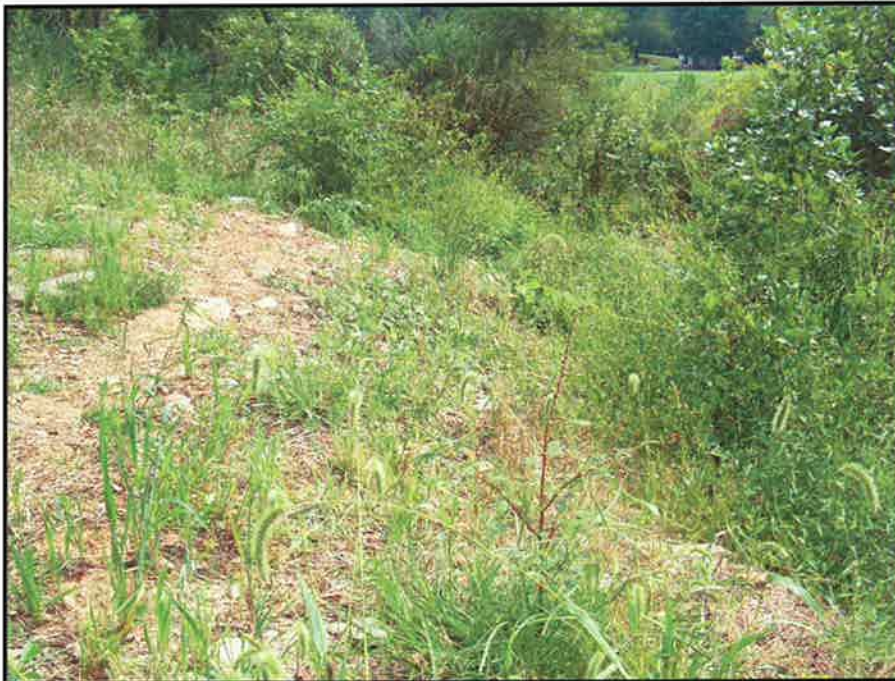
VPA 2

An additional problem area noted in Year 4 included a section along UT2 with sparse vegetation along the stream banks. The vegetation along the left bank was damaged or destroyed by an unknown source. Since this area has previously had adequate vegetation, and because the banks are not denuded, it is expected that the vegetation will recover on its own. This is therefore an area of low concern with no anticipated management necessary.

**Example of sparse vegetation along the stream bank near station 13+00 on UT2.
(EMH&T, Inc. 9/15/09)**

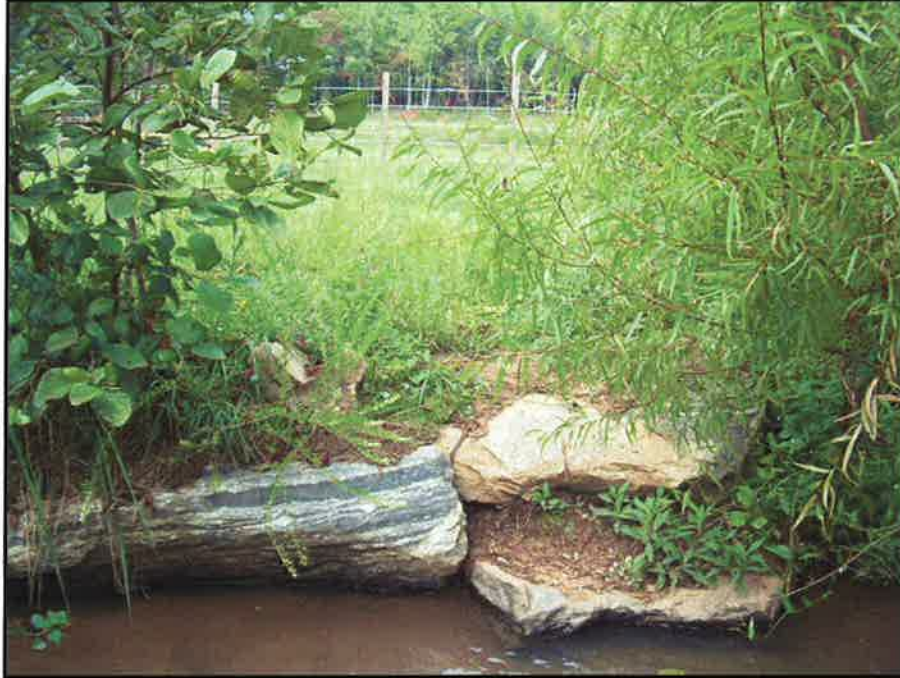
VPA 3

**Example of an area where mowing within the easement has infringed upon the riparian corridor, near station 10+25 on UT2.
(EMH&T, Inc. 9/15/09)**

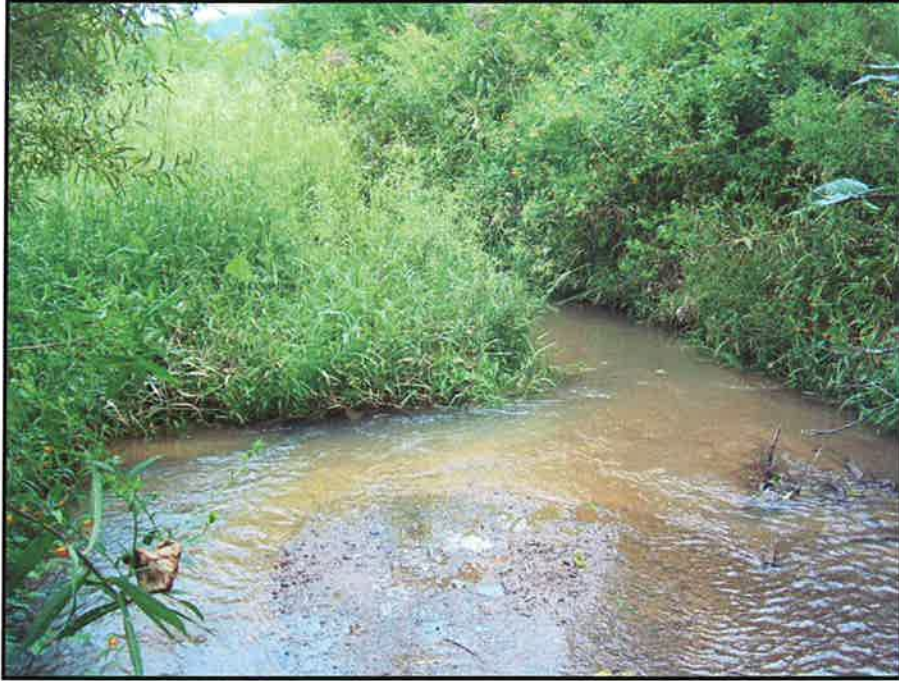
SPA 1

Table Xd. Stream Problem Areas – Year 4 Bailey Fork Stream Restoration / EEP Project No. D04006-02			
Feature Issue	Station Numbers	Suspected Cause	Photo Number
Aggradation	2+00 Lower	Bar forming along left bank; likely the remnants of the mid-channel bar formerly at station 1+75; vegetated and stable	SPA 1, 2, 3
	1+80 UT1	Embedded rock sill; channel is stable	
	2+95 UT1	Embedded rock sill; channel is stable	
	4+15 UT1	Embedded rock sill; channel is stable	
	8+00 UT1	Embedded J-hook; channel is stable	
	13+80 UT1	Bar forming along right bank; vegetated and stable	
Bank scour	5+50 Upper	Scour on right bank upstream of J-hook on left bank	SPA 4, 5
	8+80 – 9+00 Lower	Slumping on right bank underneath erosion matting

Five additional areas of aggradation were noted in Year 4. Three structures along UT1 were noted to have been affected by aggradation for the first time in 2009. Sand is the dominant streambed substrate in the project reaches, and as such, sediment deposition over the noted structures is attributed to high sediment supply readily available to UT1 upstream in the contribution watershed. Because the issue for these structures arises from depositional trends, rather than a concern with the physical structure, these areas are listed in the table as aggradation issues, not failed structures. It is noted that at all locations on UT1 where the structures are embedded, the channel and stream banks are stable. The other two areas of noted aggradation involved sand bars that are forming along the edge of the stream channel, one each on UT1 and the Lower Bailey Fork mainstem. The bar on Lower Bailey Fork is assumed to be the remnant of

Area of aggradation along Lower Bailey Fork near station 2+00. Bar is heavily vegetated and stable.

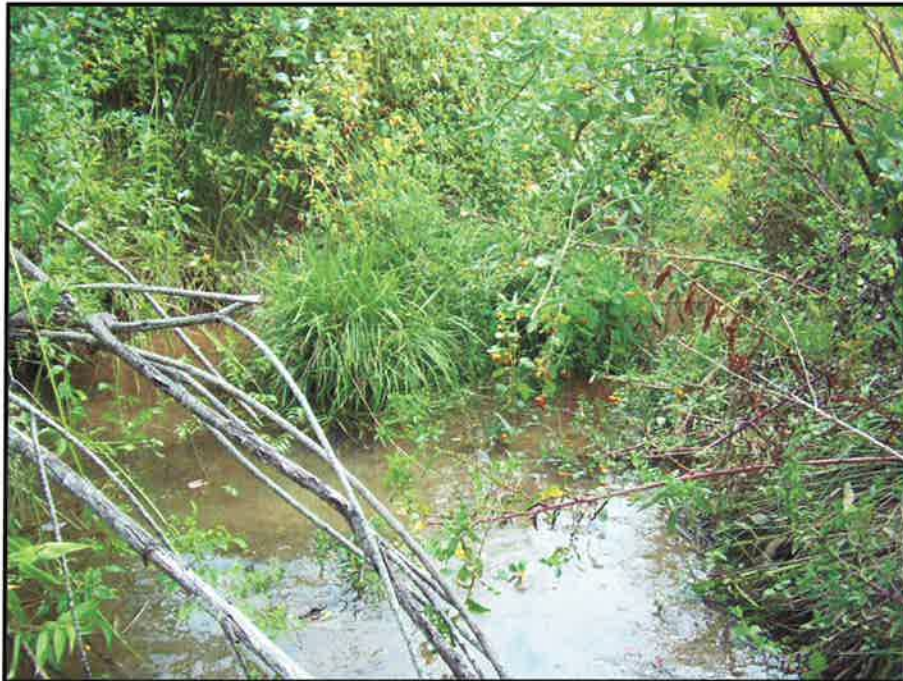
SPA 2

Area of aggradation along UT1 near station 13+80, facing downstream. Bar is heavily vegetated and stable.

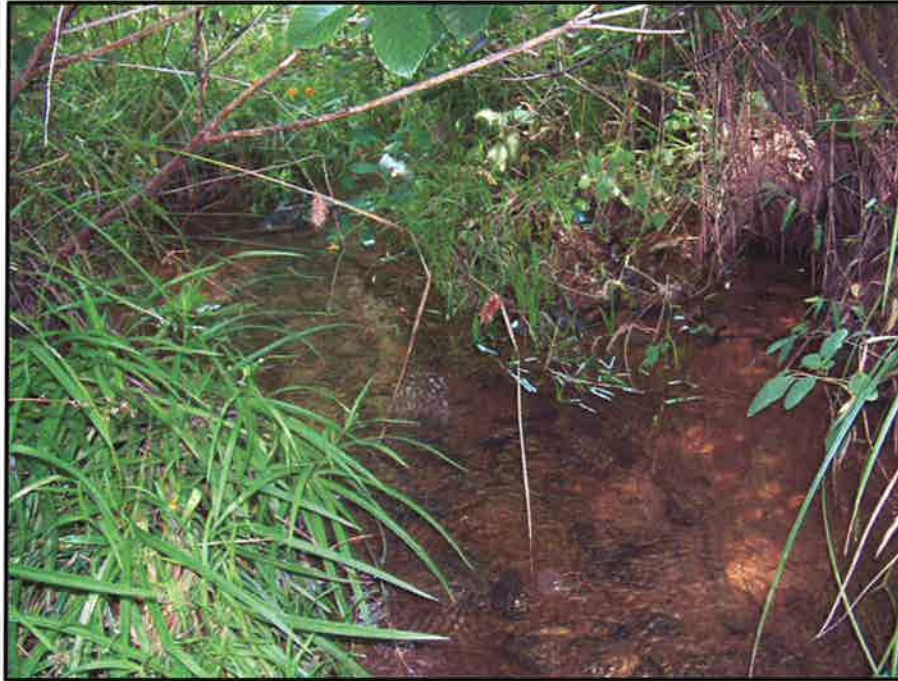
SPA 3

Area of aggradation along UT1 at station 4+15. A point bar has formed over a constructed rock sill.

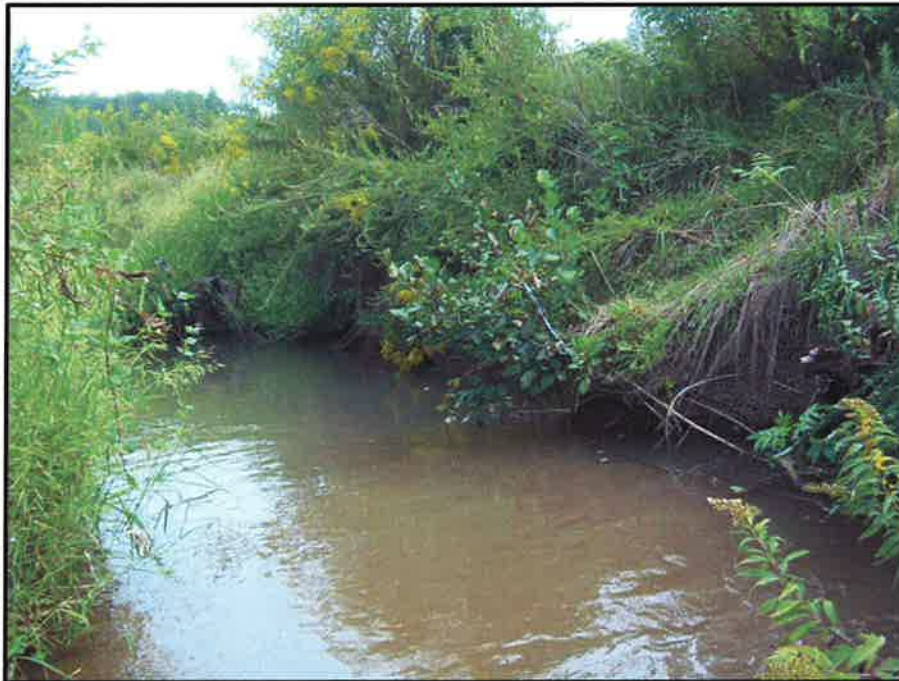
SPA 4

Bank slumping on the right bank of Lower Bailey Fork near station 9+00.

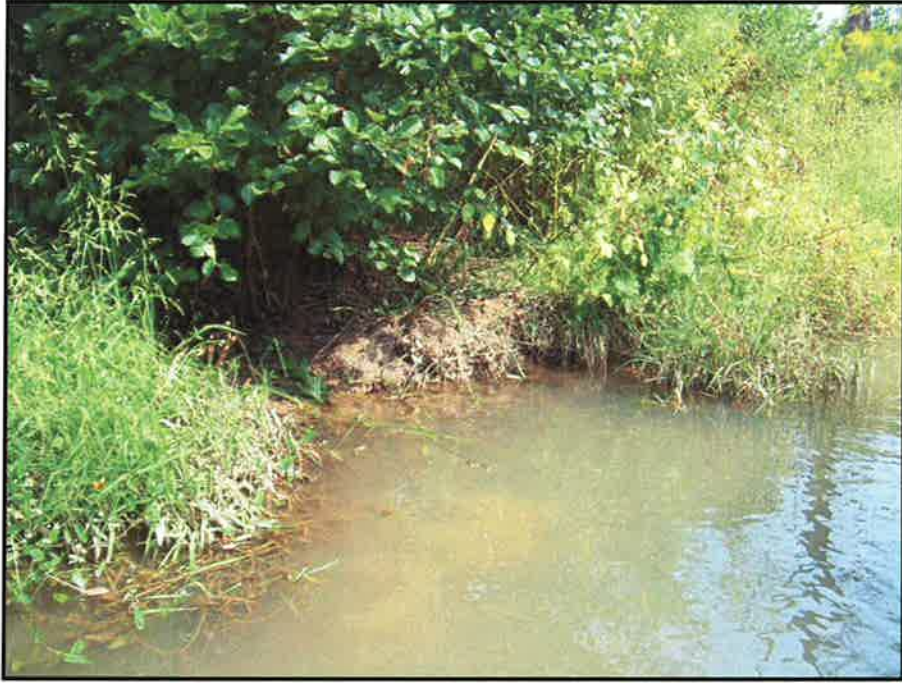
SPA 5

**Scour hole on the right bank of Upper Bailey Fork near station 5+50.
(EMH&T, Inc. 9/15/09)**
