Year 5 Monitoring Report for Stream Restoration of Bailey Fork

Burke County, NC
SCO # D04006-02

Submitted: February 2011

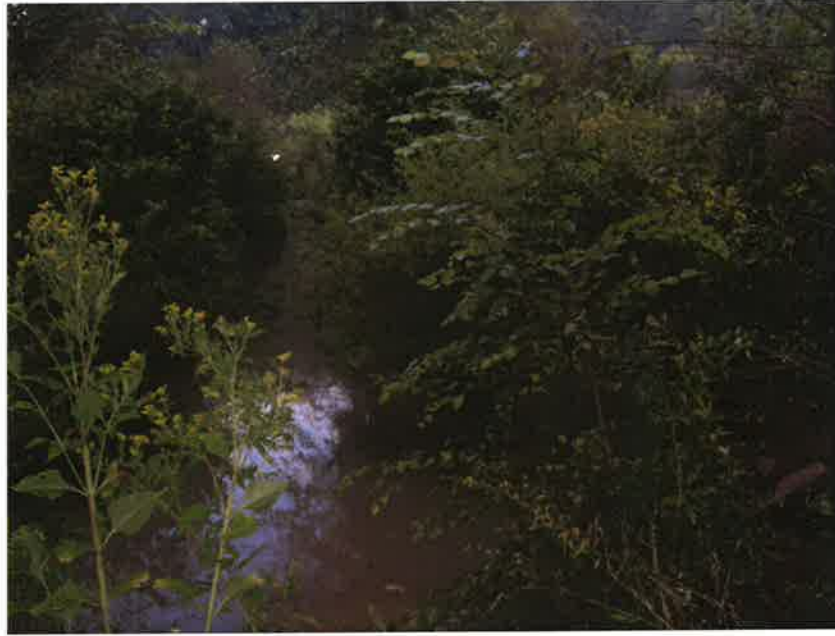
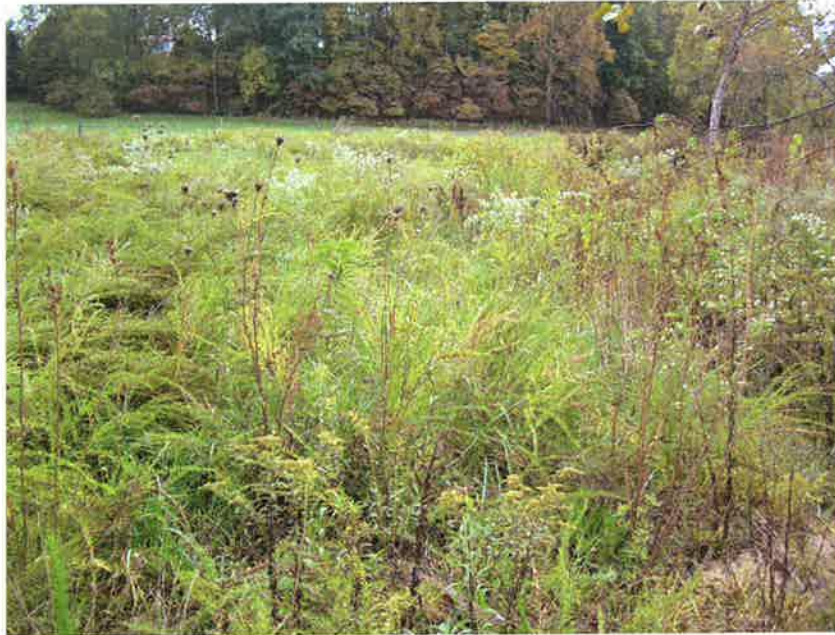
Fixed Station 1 (Photo Point 13)

Overview of the valley at the confluence of Lower Bailey Fork and UT2, near the downstream terminus of the project, facing upstream along the mainstem.

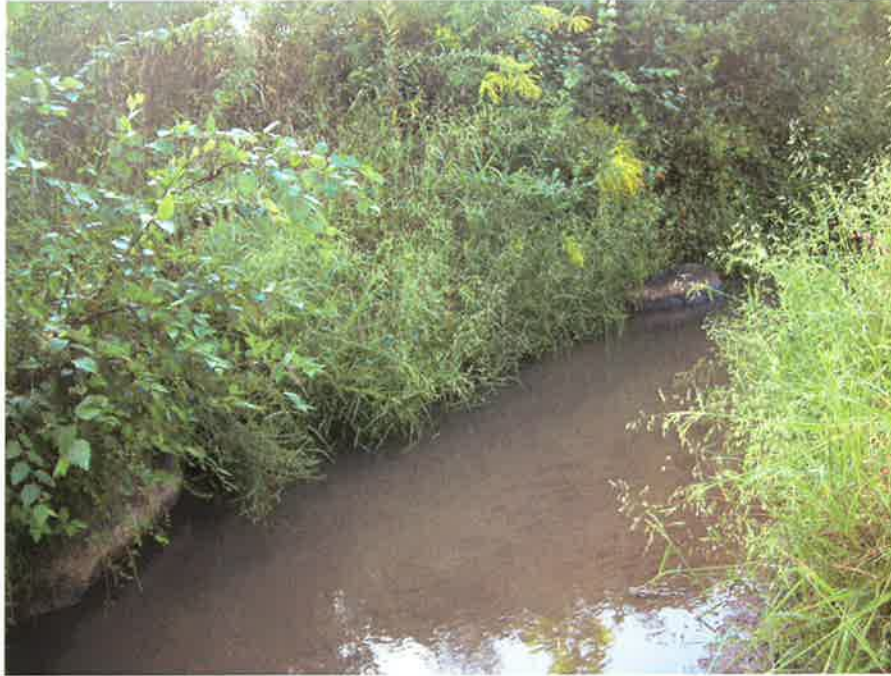
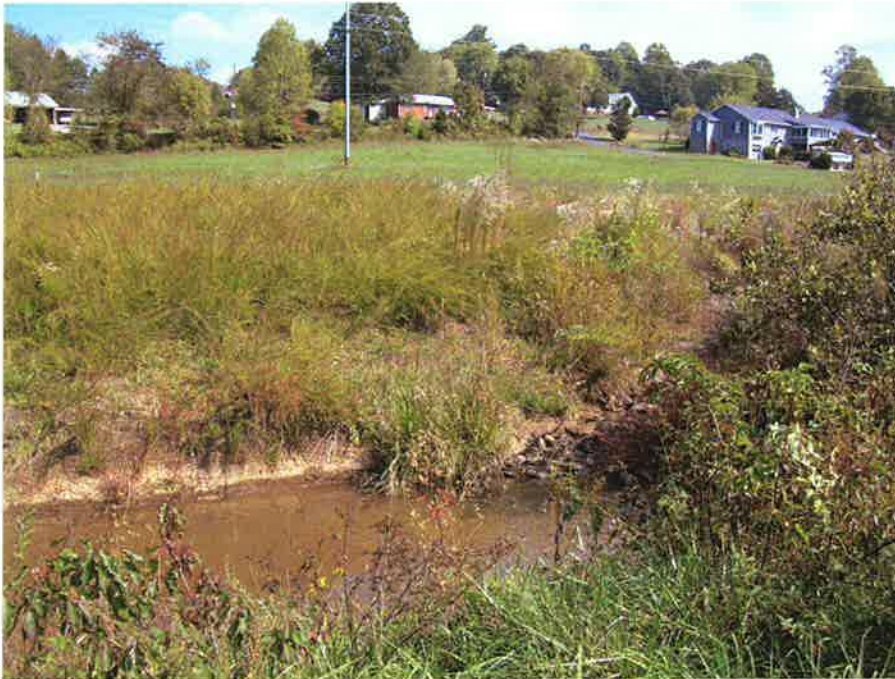
Fixed Station 2 (Photo Point 14)

Overview of valley at confluence of Upper Bailey Fork and UT1, facing upstream.

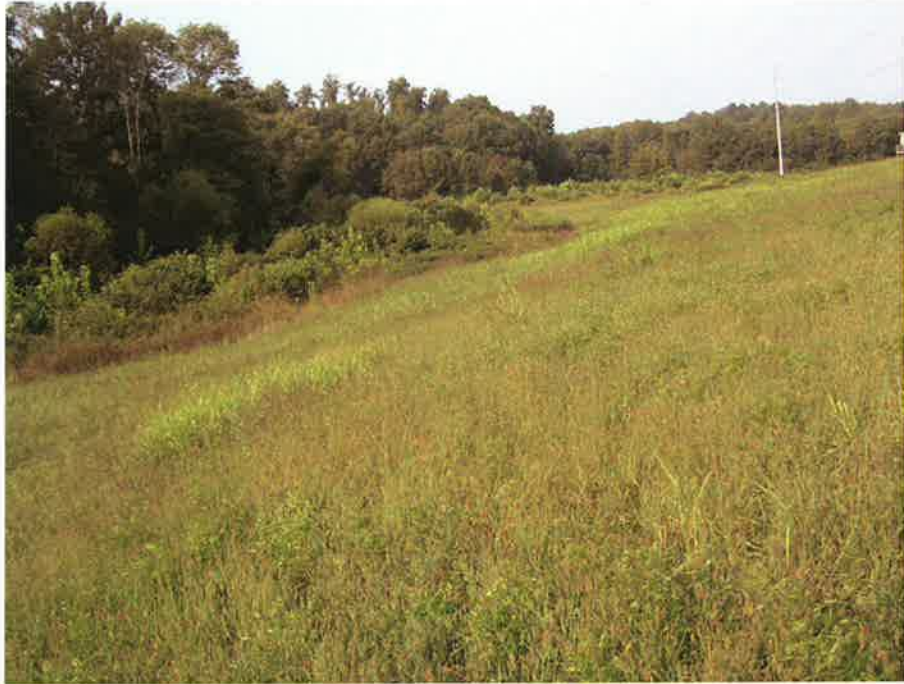
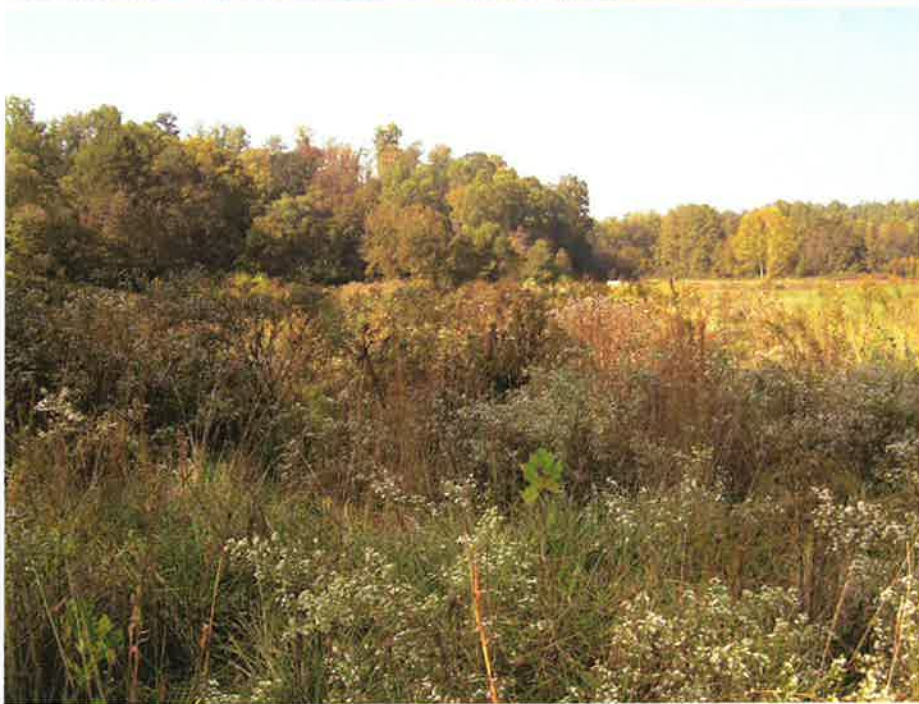
Fixed Station 3 (Photo Point 15)

Overview of valley along UT1 near the upstream terminus of the project, facing downstream.

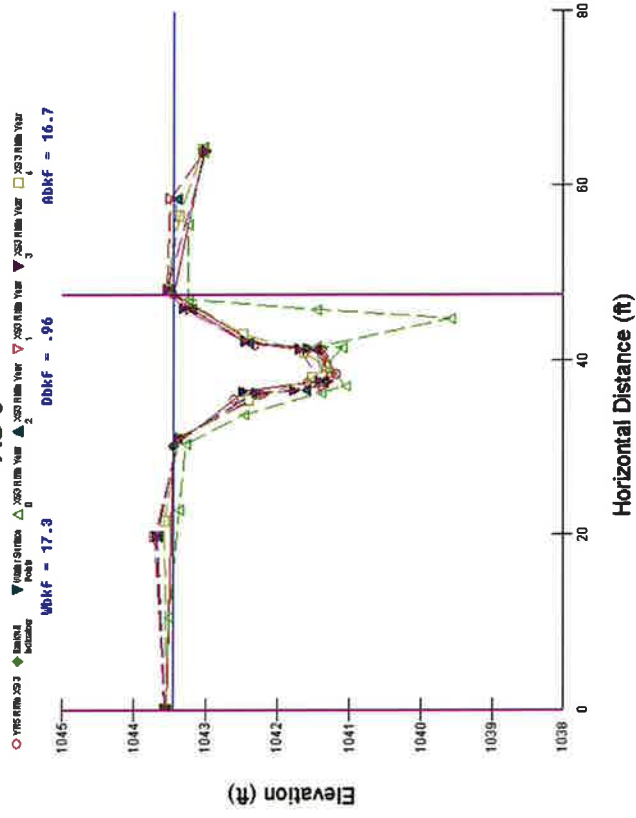
XS 3

Cross-section photo – looking downstream
 Channel is obscured by vegetation.

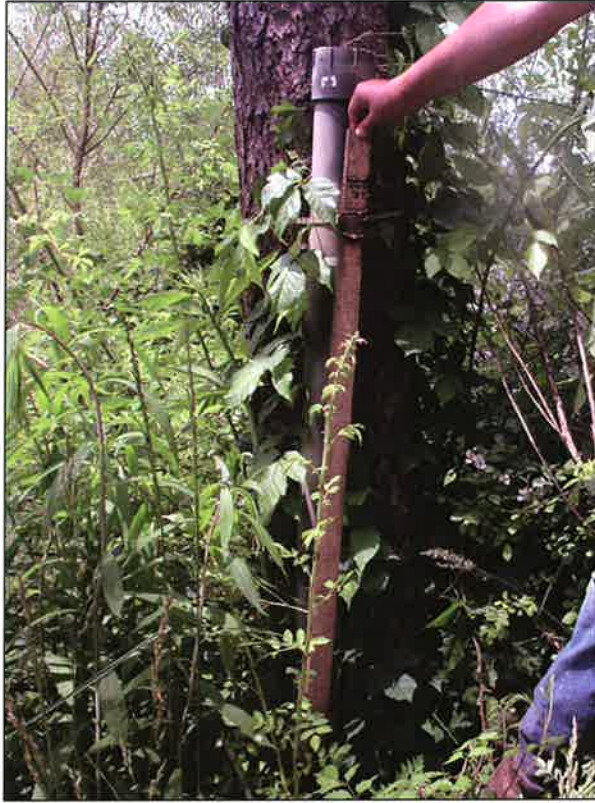
BF 7
Crest Gage 4 on Lower Bailey.
(EMH&T, Inc. 09/28/10)

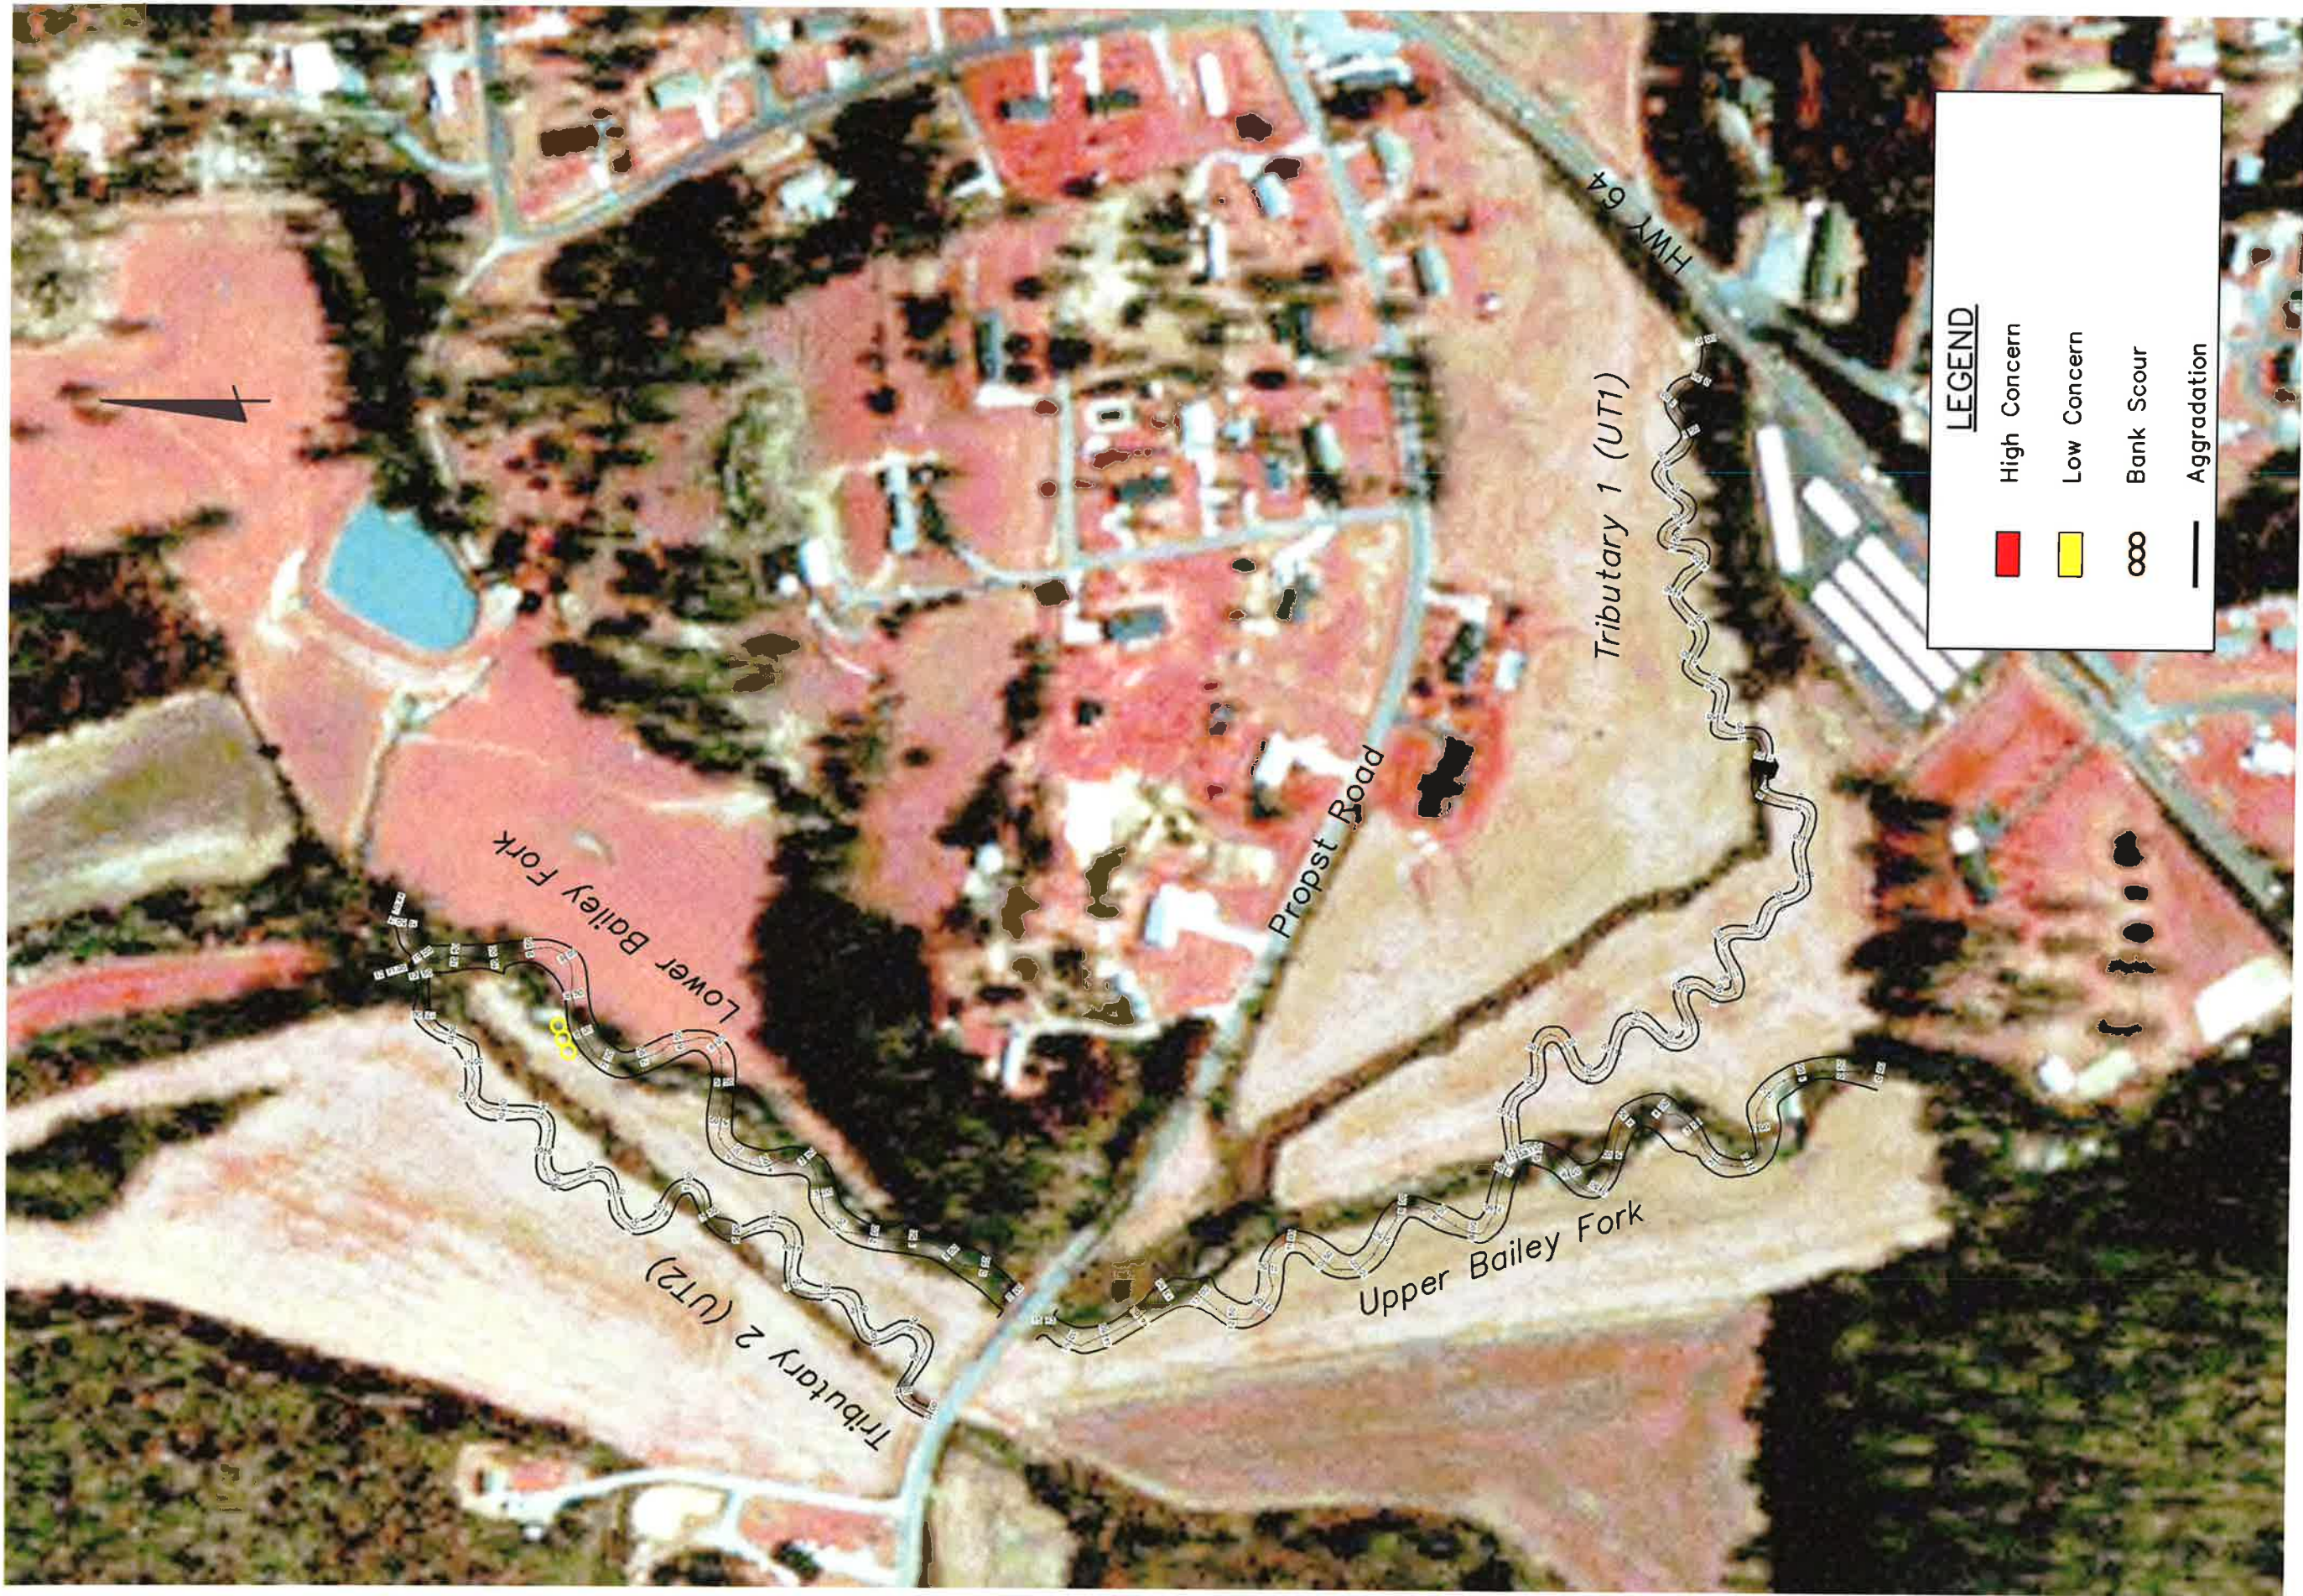
The other category of potential problem areas that remained in Year 4 was limited to two isolated areas of minimal bank scour (one scour area on Lower Bailey Fork and the other on Upper Bailey Fork). These scour areas were removed from Table Xd. in Year 5 because they have since been repaired, are densely vegetated and remain stable. Only one new scour area was observed on Lower Bailey Fork in 2010. The scour hole is located at station 8+00 on Lower Bailey Fork. The scour hole although tall, remains localized to a small area along the left bank of Lower Bailey Fork. The left bank near this station is heavily vegetated and appears stable and is located immediately upstream of a grade control feature. It is therefore predicted that this minimal scour area will not become more than a localized issue and will re-stabilize, over time. Accordingly, maintenance work is not warranted and the scour area is mapped in Appendix B as a stream problem area of low concern.

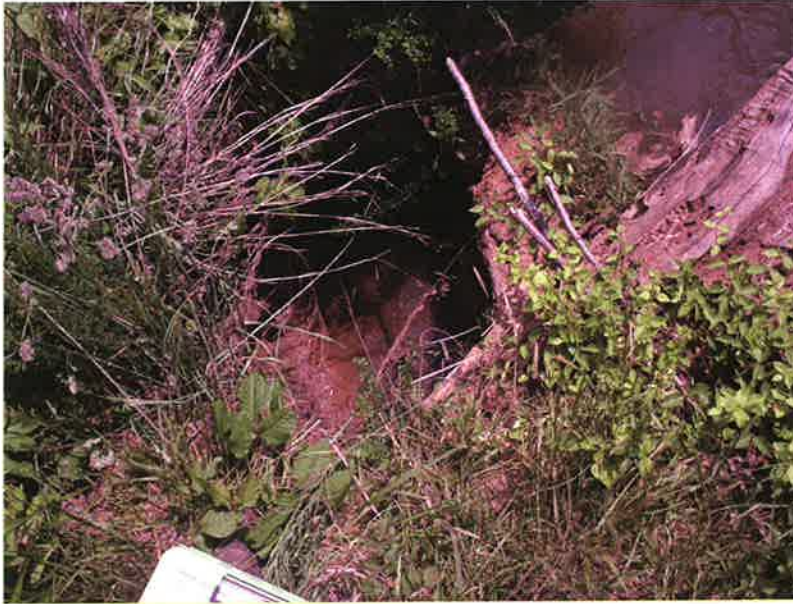
SPA 1

**Scour hole on the right bank of Upper Bailey Fork near station 5+00.
(EMH&T, Inc. 9/18/10)**
