# **Ballance Site Riparian Buffer Restoration Project Monitoring Report (Year 2)**

**Wayne County, North Carolina**

This report is being submitted to document completion of the Year 2 monitoring.

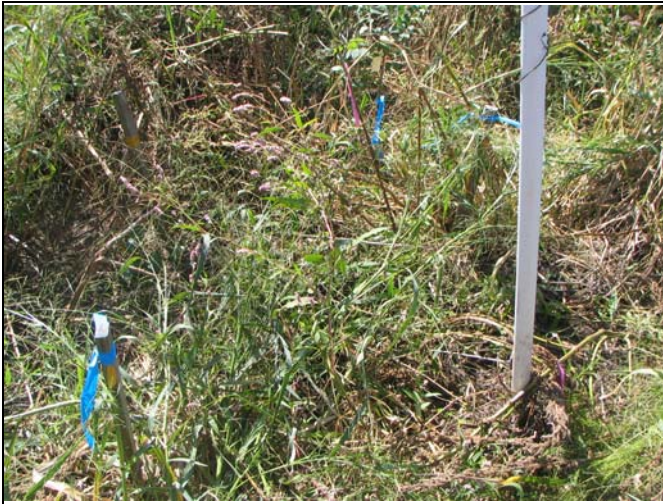
7. Veg Plot 4 Herbaceous Plot.

One monitoring plot had a lower than expected survivability rate for Year 2. The density for Plot 4 was 283 stems per acre. This plot will be monitored closely during the 2008 growing season to determine if some trees which were recorded as dead were actually green at the base and will re-sprout. The prevalence of volunteer species will also be assessed to determine if natural recolonization is compensating for lower planted stem densities.
