MY2 FINAL MONITORING REPORT Banner Branch Mitigation Project Stokes County Roanoke River Basin CU 03010103

DMS Project # 100080

Monitoring Year 2 (MY2) activities occurred during September 2022. This report presents the data for MY2. The Project meets the MY2 success criteria for stream hydrology, stream horizontal and vertical stability, and streambed condition and stability. One of the six flow gauges is not meeting the 30-day flow criteria. Eight of the nine wetlands are meeting success criteria for hydrology. One of the 23 (21 fixed and 2 random transects) vegetation plots is not meeting interim success criteria. Based on these results, the Project is on trajectory to meet interim and final success criteria. For more information on the chronology of the project history and activity, refer to Appendix E. Relevant project contact information is presented in Appendix E and project background information is presented in Table 3.

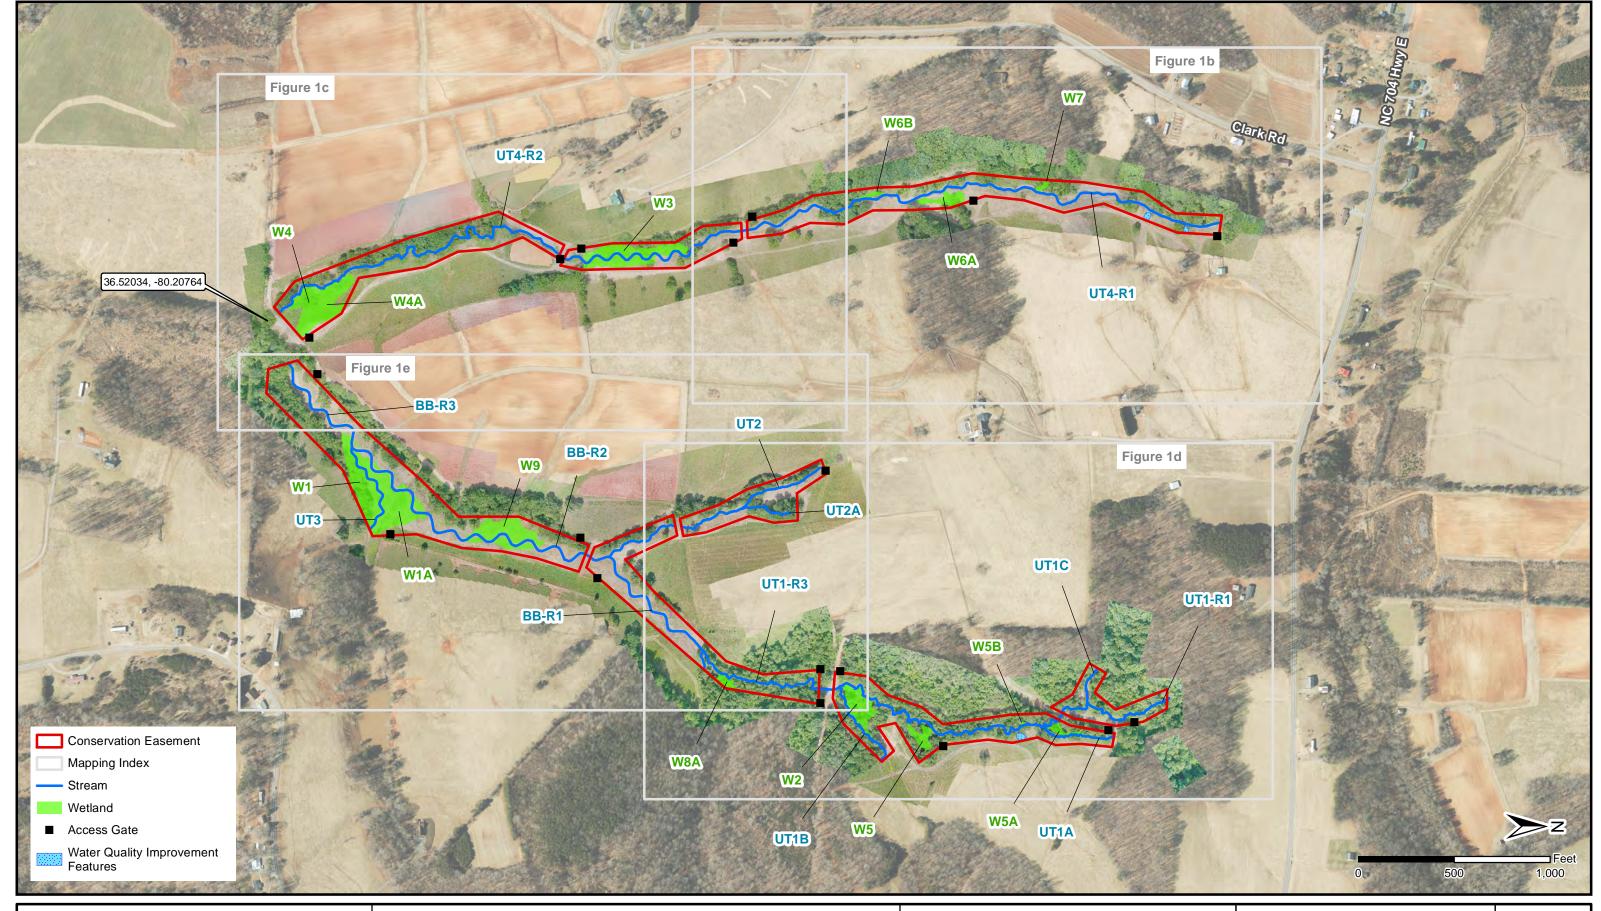
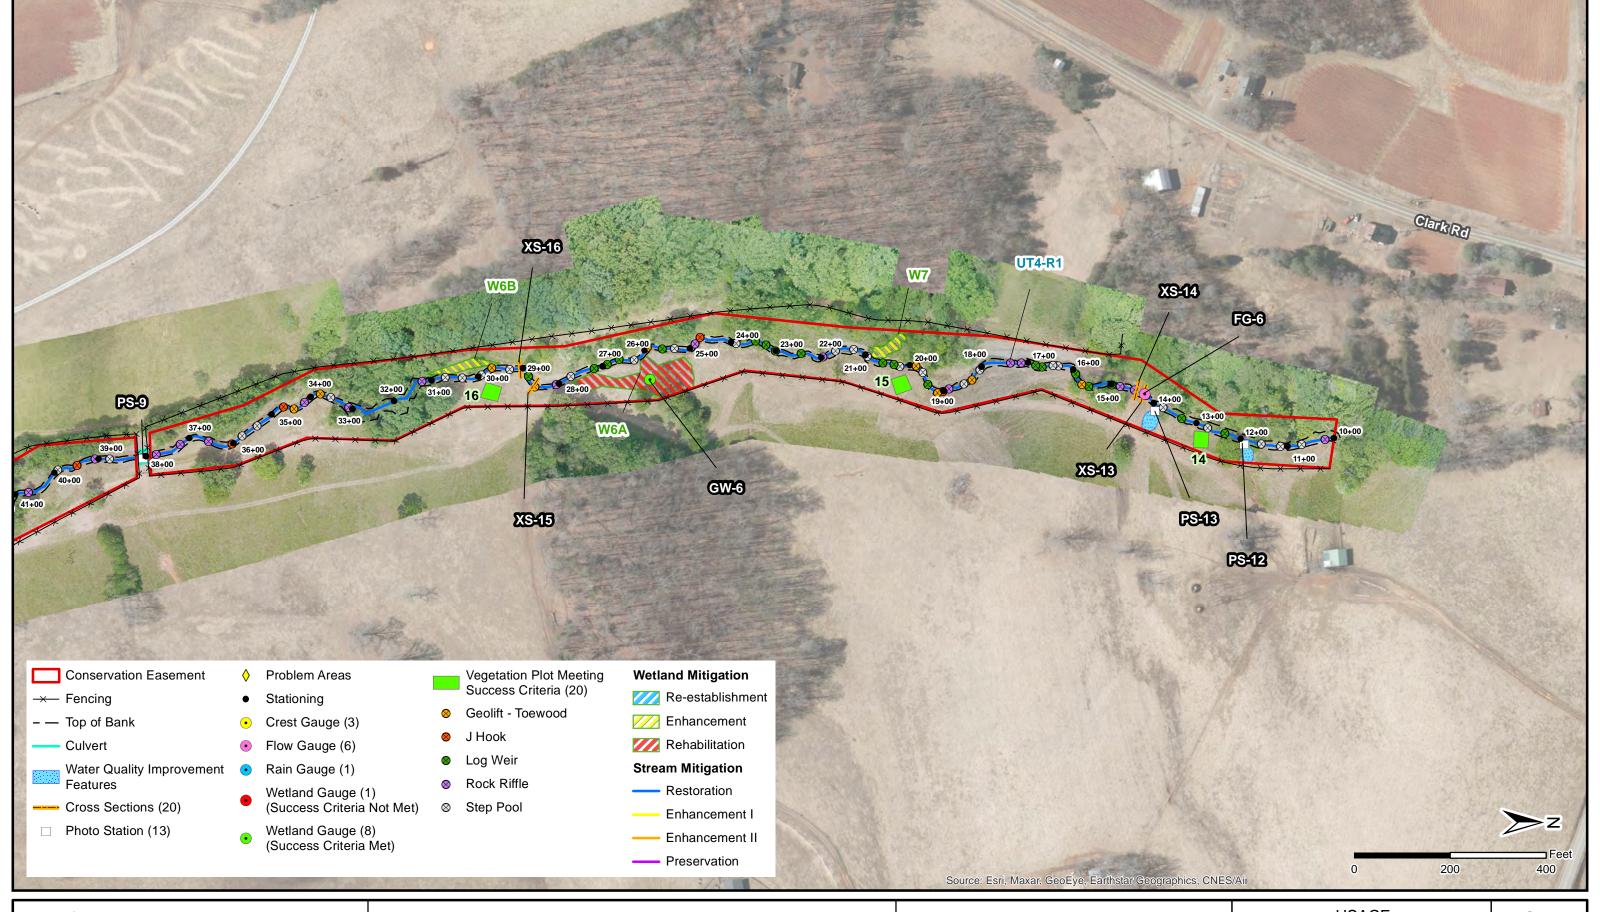
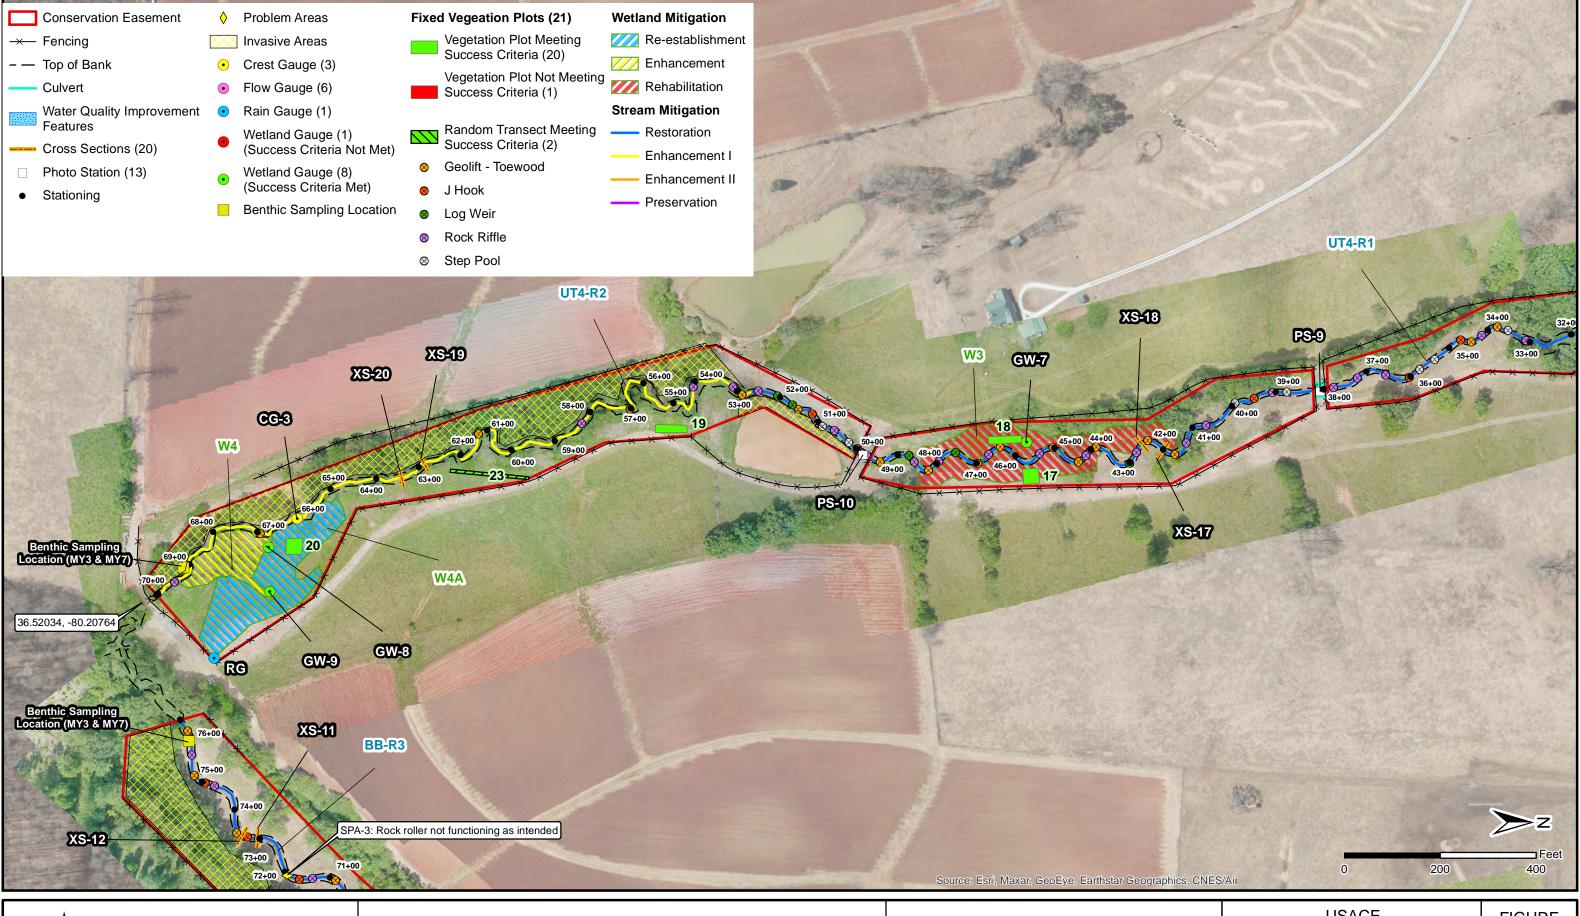
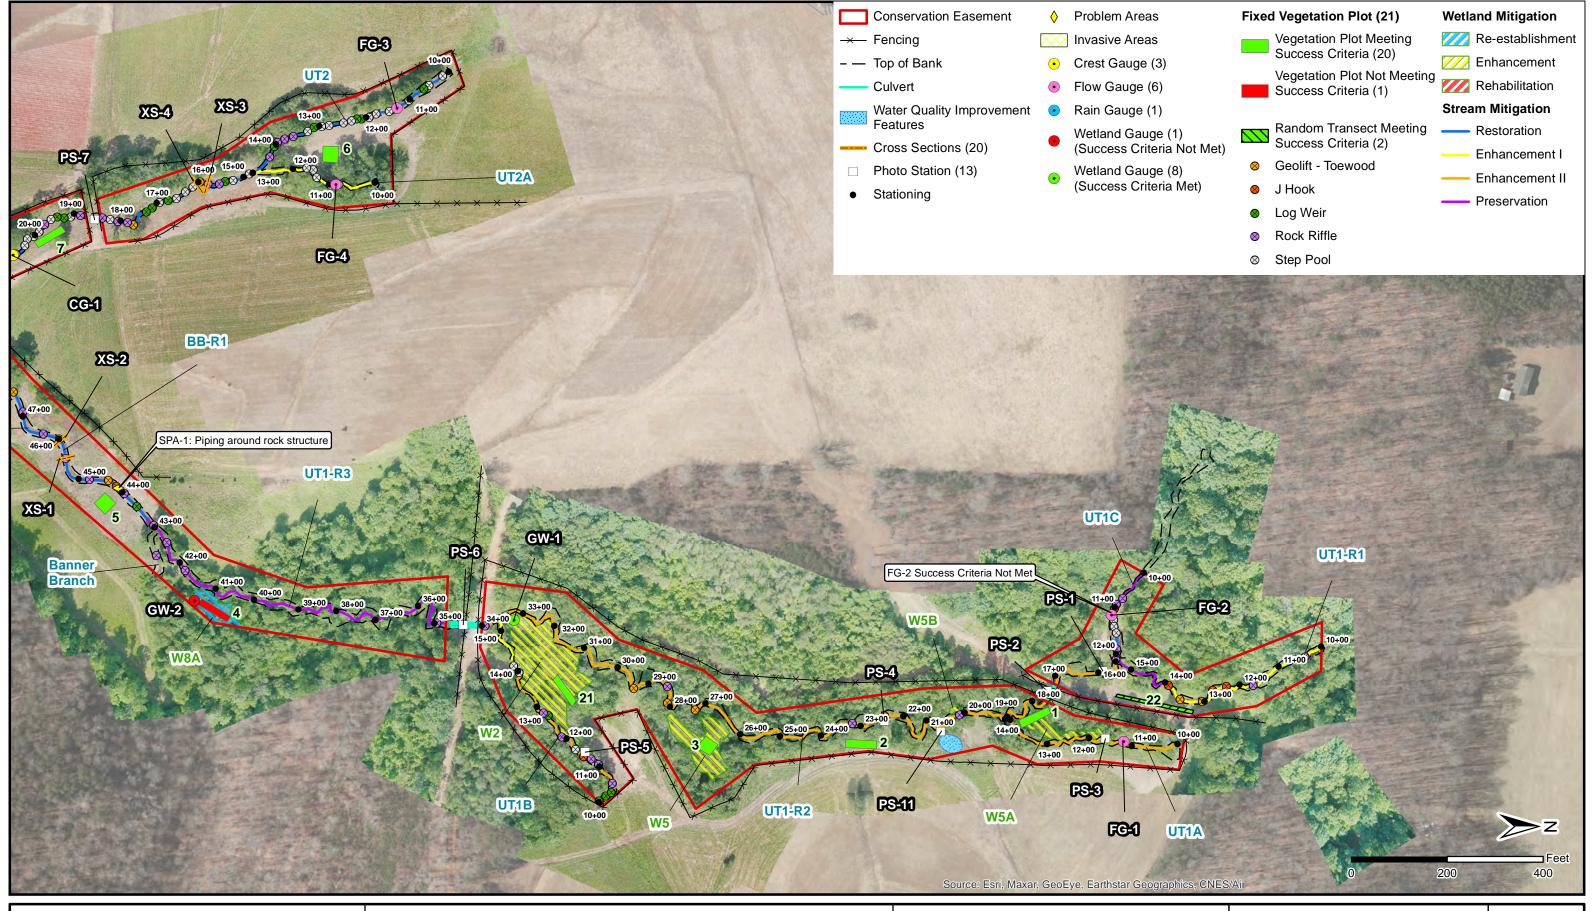
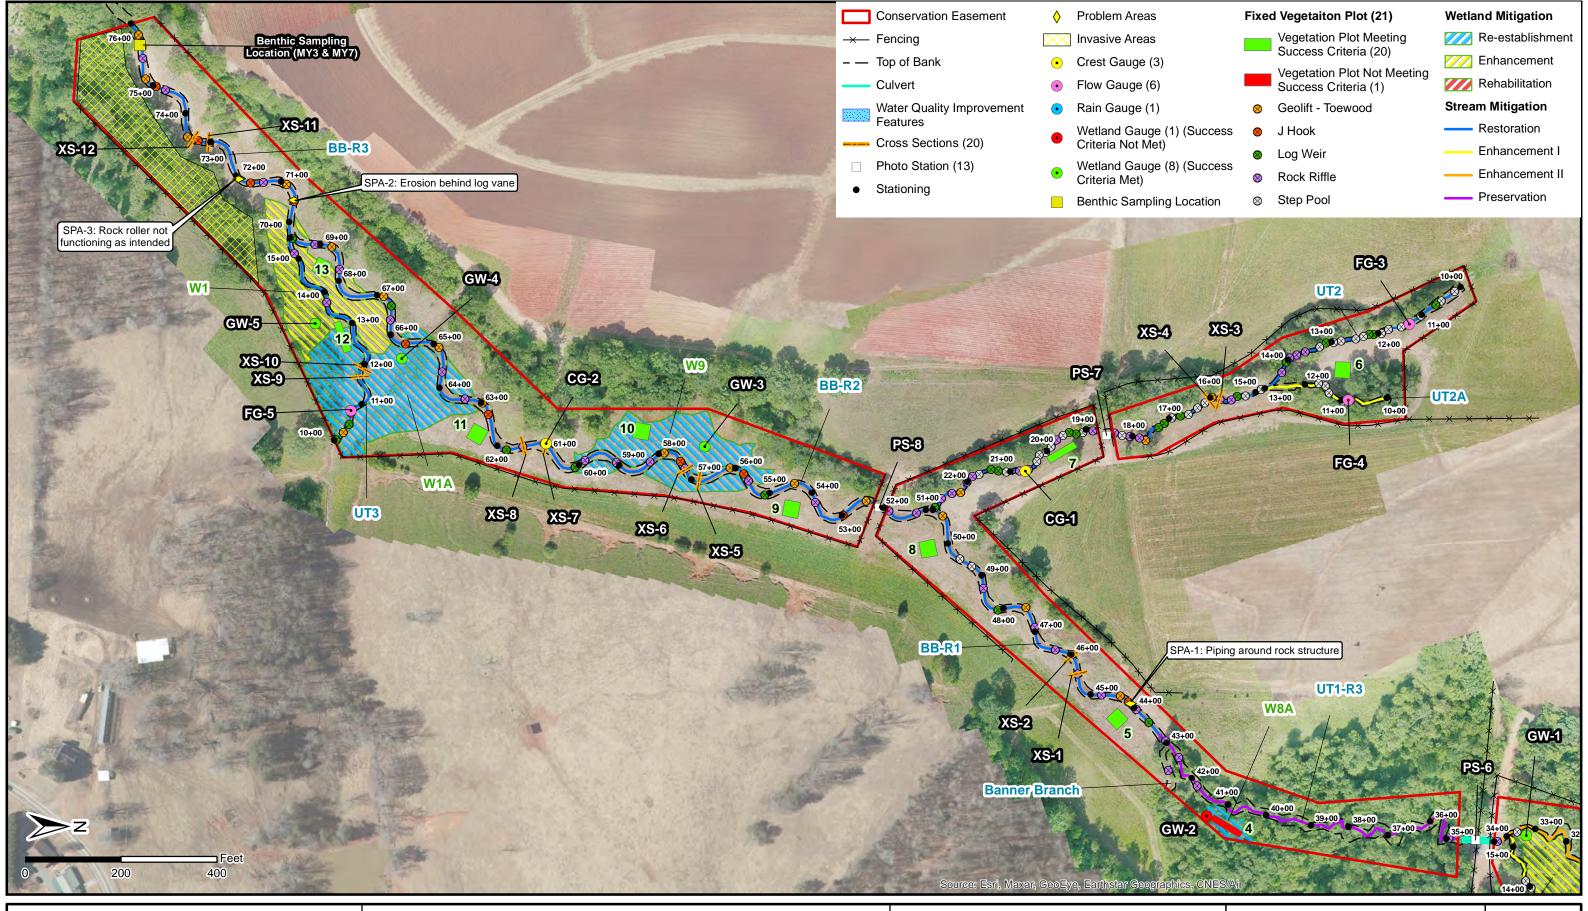
Three potential stream problem areas were noted during MY1 (see CCPV). During MY2, these problem areas were monitored and no new problem areas were documented.

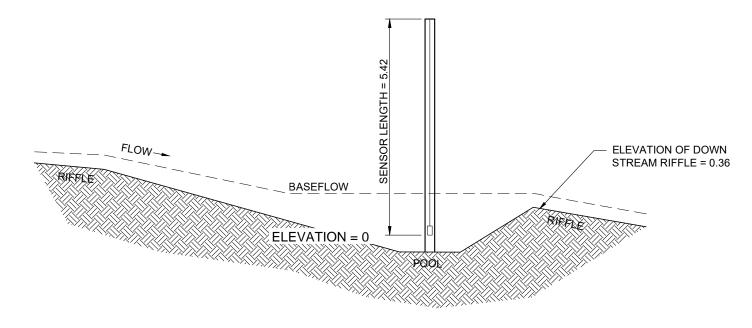
FLOW GAUGE FG-2 (UT1C)

Flow Depth = 0.36 feet

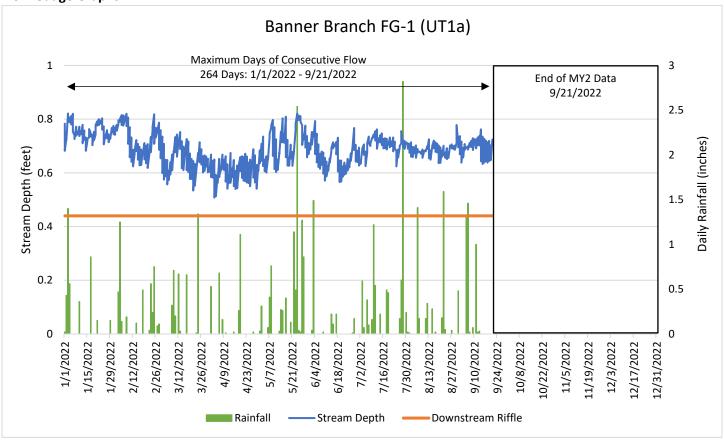
*FG-1: 264 days of cumulative flow, 0 days of no flow

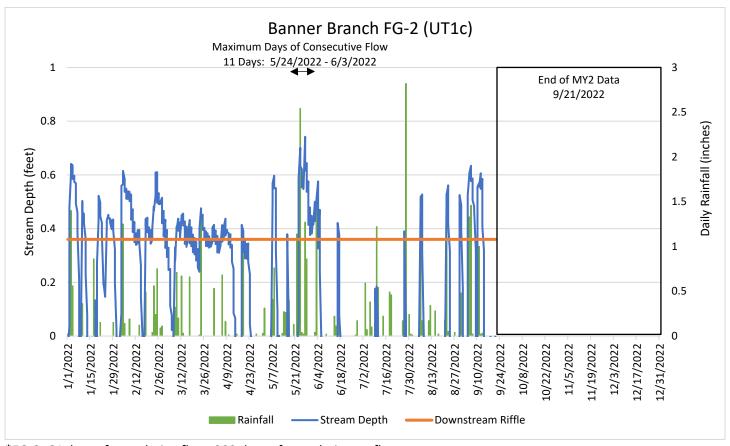
- 3. Flow Gauge 2 should be shown on the CCPV (Figure 1d) as not meeting success criteria. A simple callout with the FG-2 label would suffice or use an alternative color. Response: A callout was added stating FG-2 did not meet success criteria.

*FG-2: 64 days of cumulative flow, 200 days of cumulative no flow

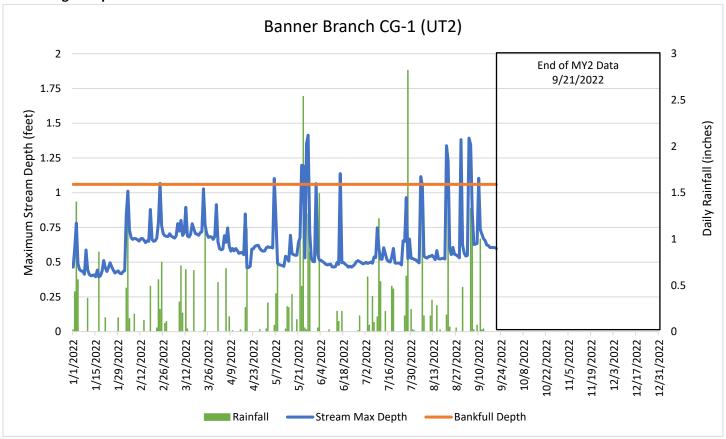
*CG-1: 5 overbank events with a maximum of 0.354' above bankfull

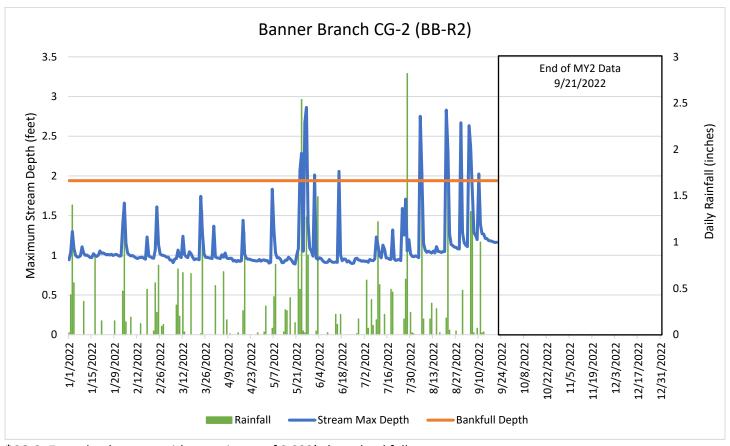
*CG-2: 7 overbank events with a maximum of 0.923' above bankfull

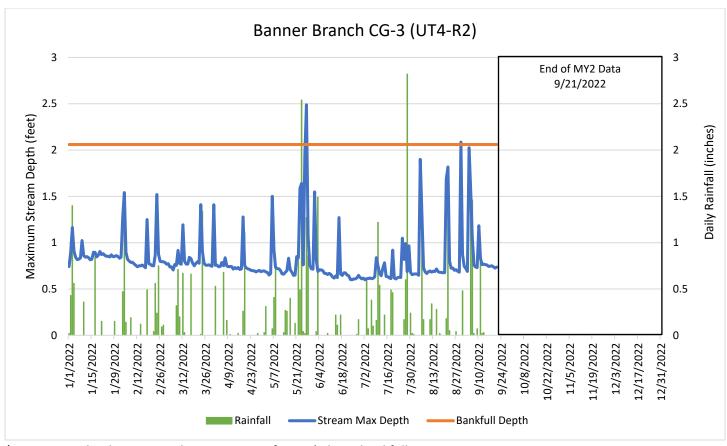
*CG-3: 2 overbank events with a maximum of 0.429' above bankfull
