MY3 FINAL MONITORING REPORT
Banner Branch Mitigation Project
Stokes County
Roanoke River Basin
CU 03010103

DMS Project # 100080
DMS Contract # 7610 and 7701
DMS RFP # 16-007405
USACE Action ID Number SAW-2018-01760
DWR Project # 18-1154
Calendar Year of Data Collection: 2023

USACE
Current Conditions Plan View
Monitoring Year 3

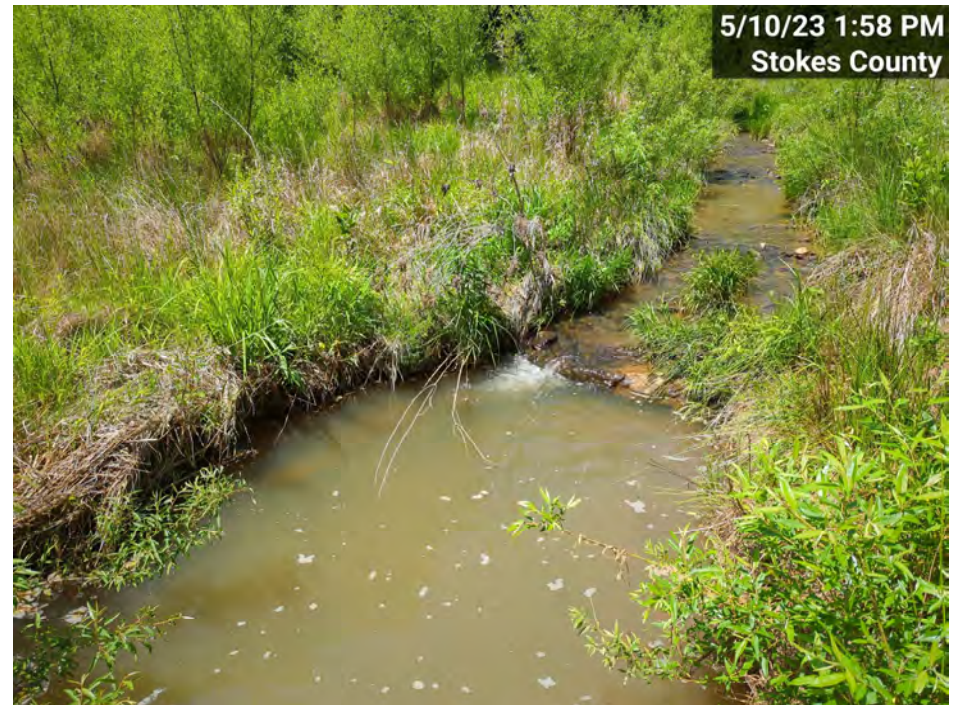
SPA-3 – BB-R3, Rock roller not functioning as intended @ STA 72+00 (MY-01)

SPA-3 – BB-R3, Rock roller not functioning as intended @ STA 72+00 (MY-03)

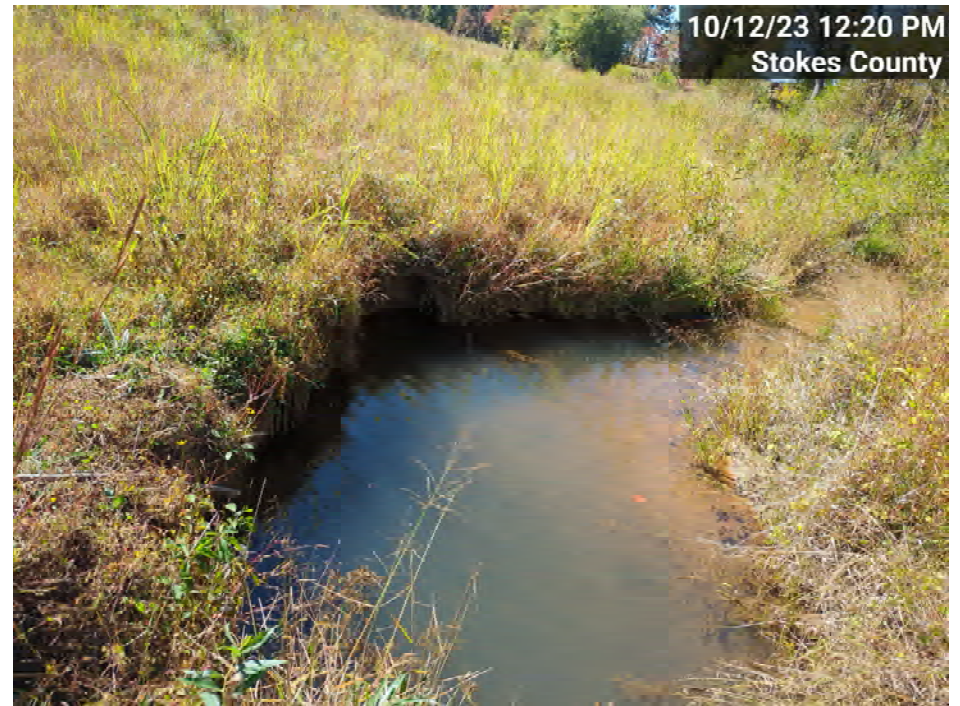
SPA-4 – BB-R1, Bank scour & erosion @ STA 47+25 (MY-03)

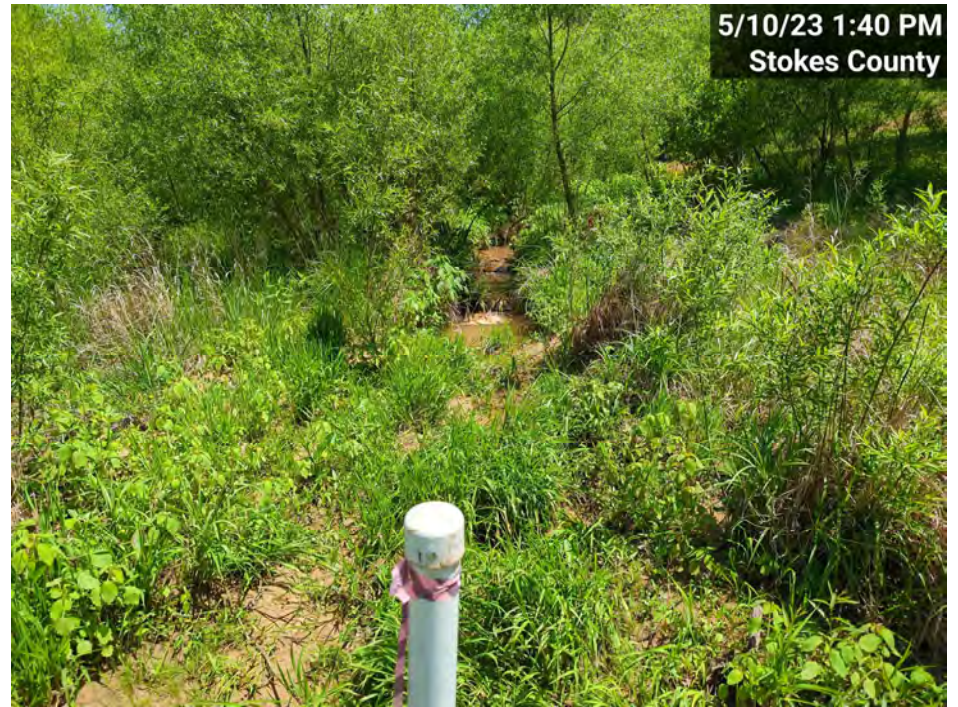
- **SPA-7:** Cattle access and erosion is occurring upstream of the project on Reach UT3. Sedimentation is present along the reach and was noted in MY2 for aggradation on cross-sections 9 and 10. This reach is being monitored by WLS closely. No remedial action is planned to occur. UT3 was noted as flowing through the restored channel and no side channels or diverging flows were noted in MY3. WLS will continue to watch this stream closely for issues in MY4.

SPA-7 - UT3 Additional Photos - Downstream from flow gauge 5 (MY-03)

SPA-7 - UT3 Additional Photos - Upstream from flow gauge 5 (MY-03)
