# **MONITORING YEAR 1 ANNUAL REPORT**

## **BANNER FARM MITIGATION SITE**

Henderson County, NC  
French Broad River Basin  
HUC 06010105

DMS Project No. 100062  
DEQ Contract No. 7530  
DMS RFP No. 16-007334  
Date of Issue: September 8, 2017  
USACE Action ID No. SAW-2018-01153  
DWR Project No. 20181032

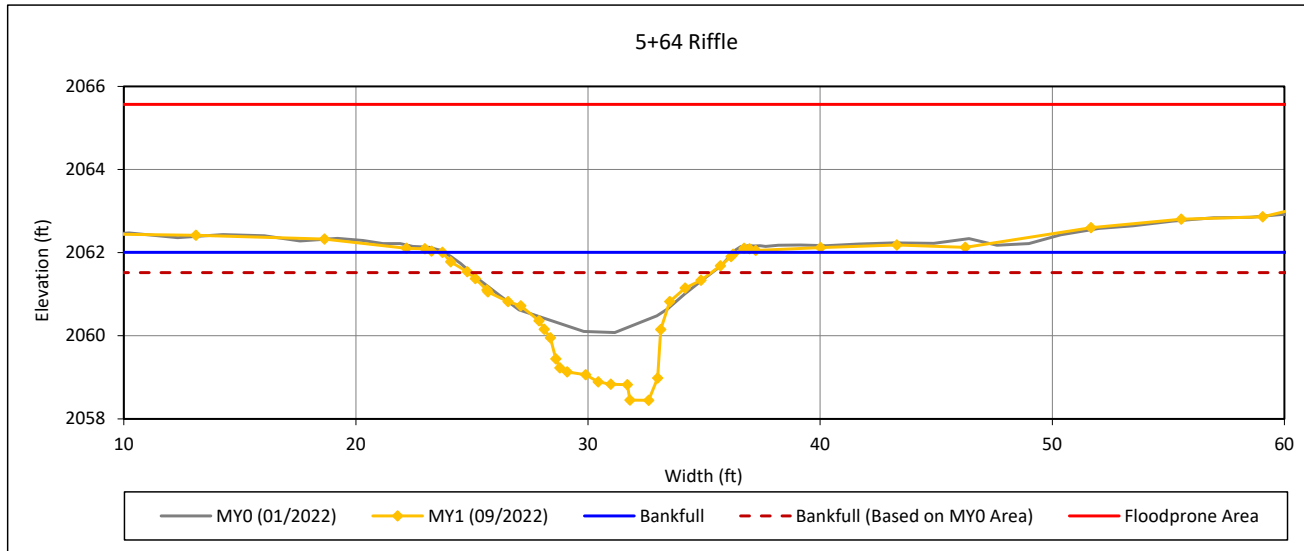
#### Cross-Section 4-Banner Creek Reach 1

In MY1, one riffle experienced some bed scour along Banner Creek Reach 1 at station 5+60, as indicated by the increase in max depth at cross-section 4. Assessments revealed that the log structure located at the end of this riffle is maintaining grade and should inhibit additional degradation. This area of concern is considered minor but will continue to be monitored for signs of instability.

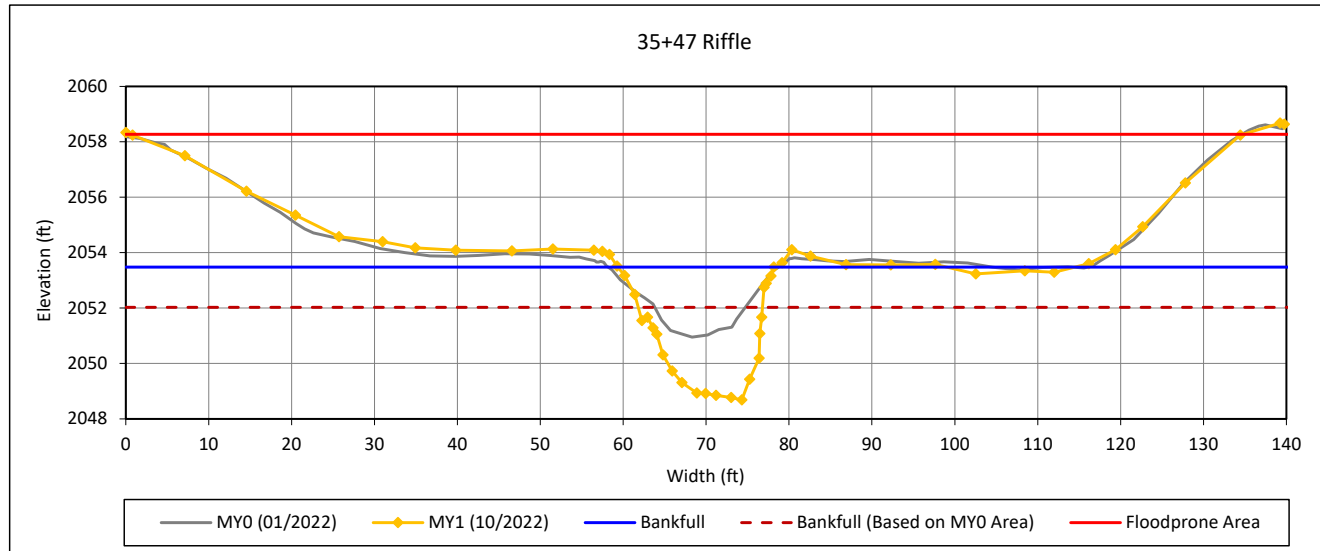
#### Cross-Section 12-Banner Creek Reach 4b

<sup>3</sup>Cross-section 12 is located in the MY1 repair area and was not rebuilt to the original design or as-built condition.

Note: XS12 is in the MY1 repair area and not rebuilt to the original design or as-built condition

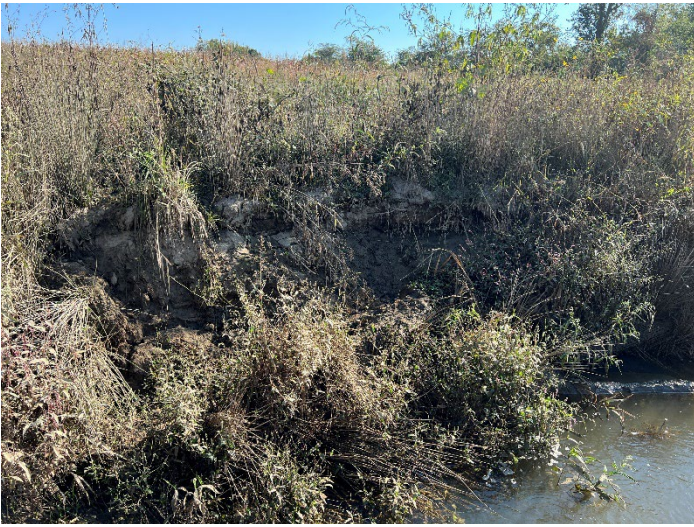
**Pre-repair:** BC R4b, STA 34+55, left bank erosion (09/22/2022)

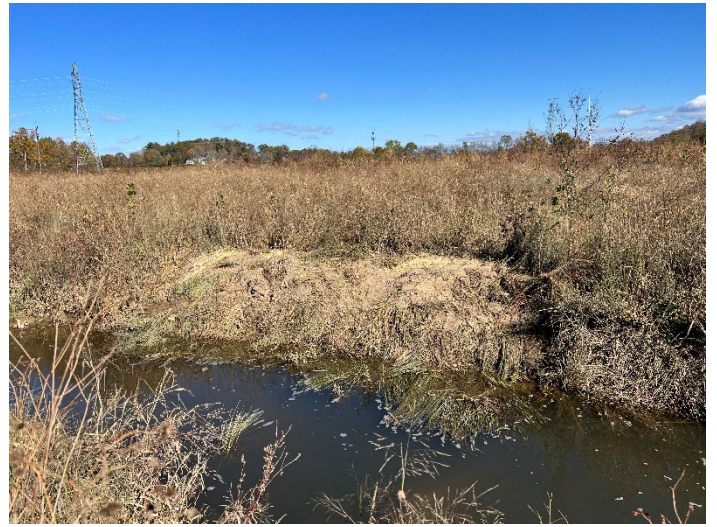
**Post-repair:** BC R4b, STA 34+55, left bank repair (10/19/2022)

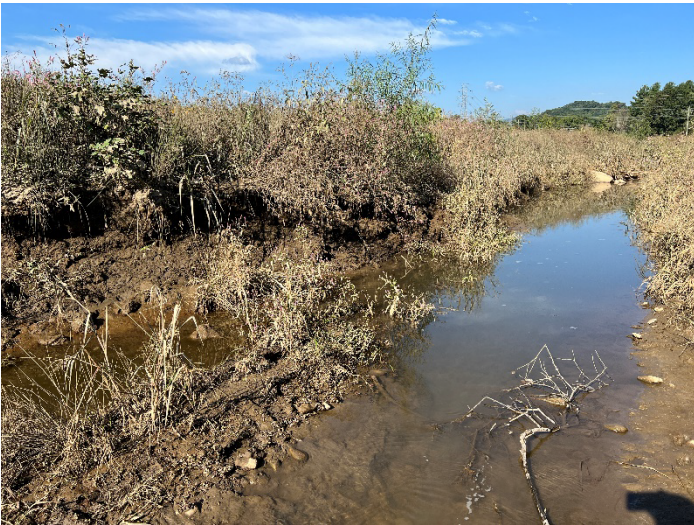
**Pre-repair:** BC R4b, STA 35+25, bank erosion and bed scour (09/22/2022)

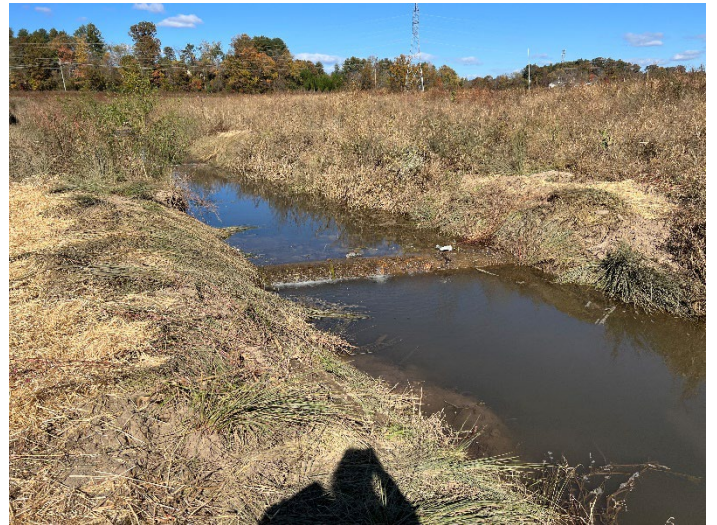
**Post-repair:** BC R4b, STA 35+25, structure & bank repair (10/19/2022)

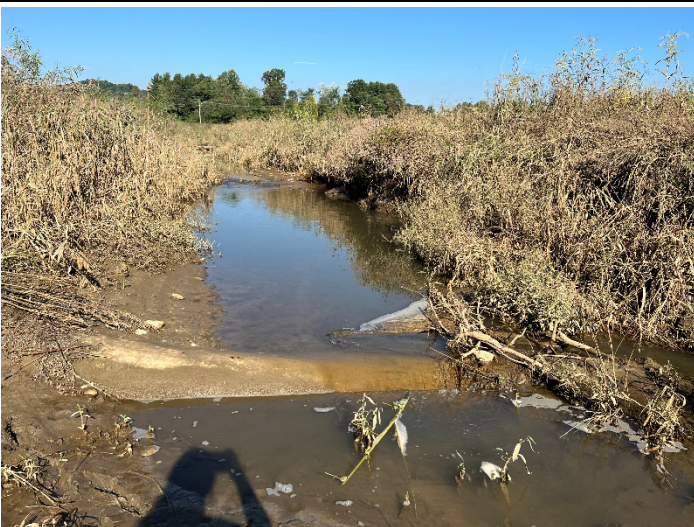
**Pre-repair:** BC R4b, STA 35+85, bank scour & structure issue (09/22/2022)

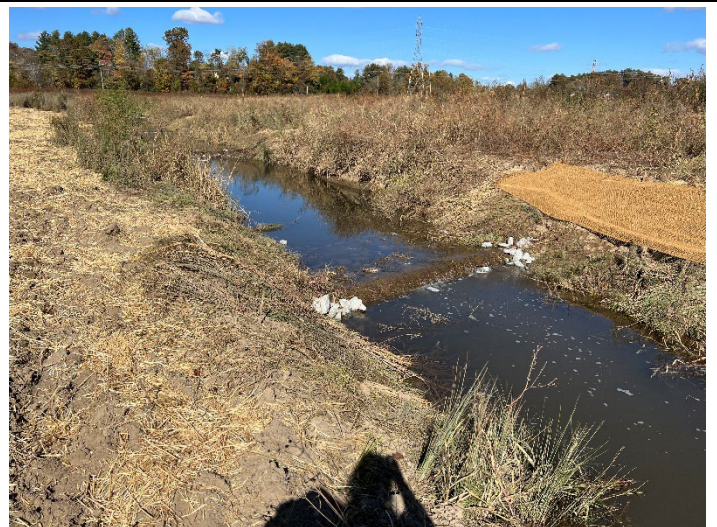
**Post-repair:** BC R4b, STA 35+85, structure & bank repair (10/19/2022)

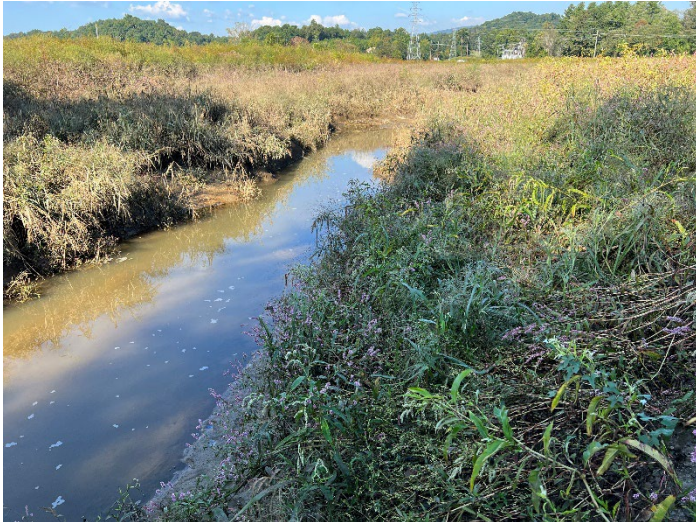
**Pre-repair:** BC R4b, STA 37+00, riffle & bank scour (09/22/2022)

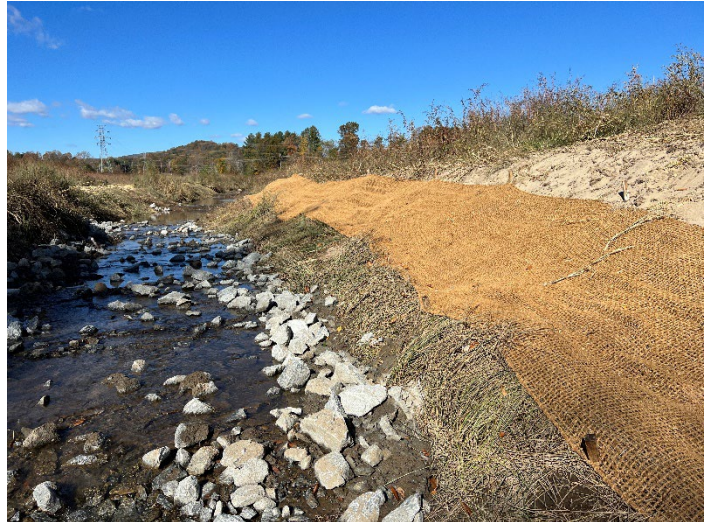
**Post-repair:** BC R4b, STA 37+00, riffle & bank repair (10/19/2022)
