MONITORING YEAR 2 ANNUAL REPORT

BANNER FARM MITIGATION SITE

Henderson County, NC
French Broad River Basin
HUC 06010105

DMS Project No. 100062
DEQ Contract No. 7530
DMS RFP No. 16-007334
Date of Issue: September 8, 2017
USACE Action ID No. SAW-2018-01153
DWR Project No. 20181032

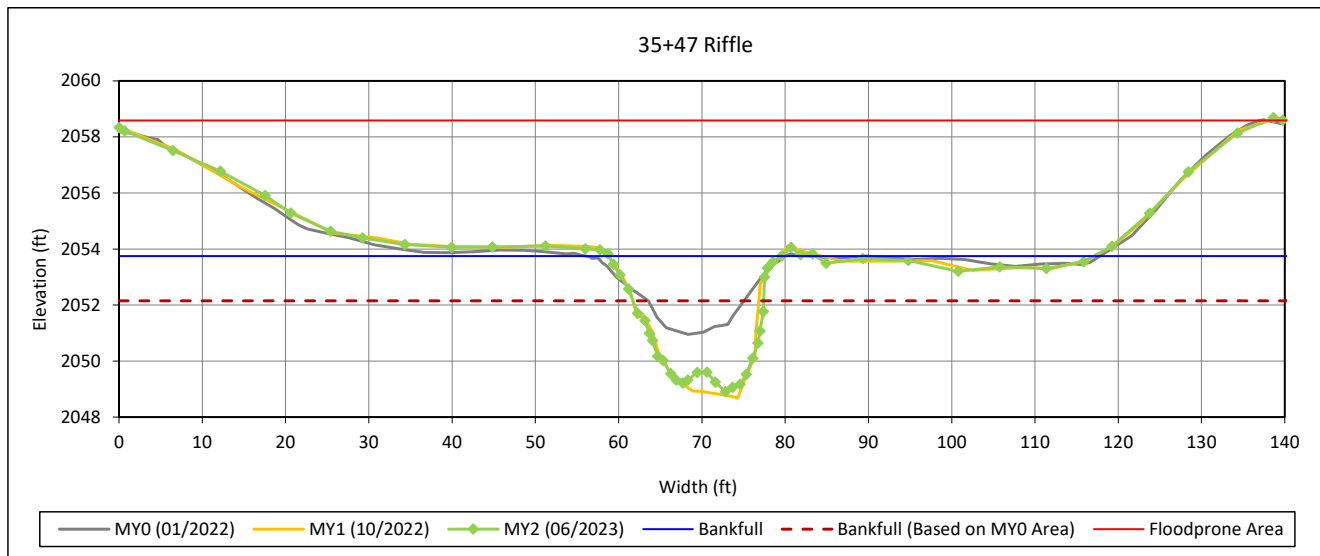
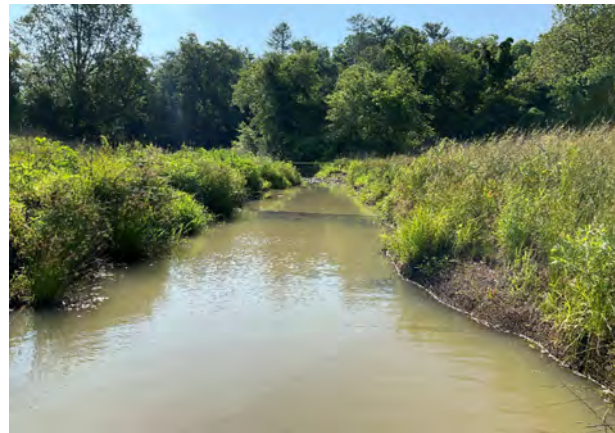
Cross-Section 12-Banner Creek Reach 4b

³Cross-section 12 is located in the MY1 repair area and was not rebuilt to the original design or as-built condition.

XS12 located in area of MY1 repair and not rebuilt to the original design or as-built condition
