ANNUAL REPORT FOR 2003

**Little Ivy Creek Stream Mitigation Site (Barnhill Site)
Madison County
WBS Element 32573.4.1
TIP No. A-10WM**

Prepared By:
Office of Natural Environment & Roadside Environmental Unit
North Carolina Department of Transportation
December 2003

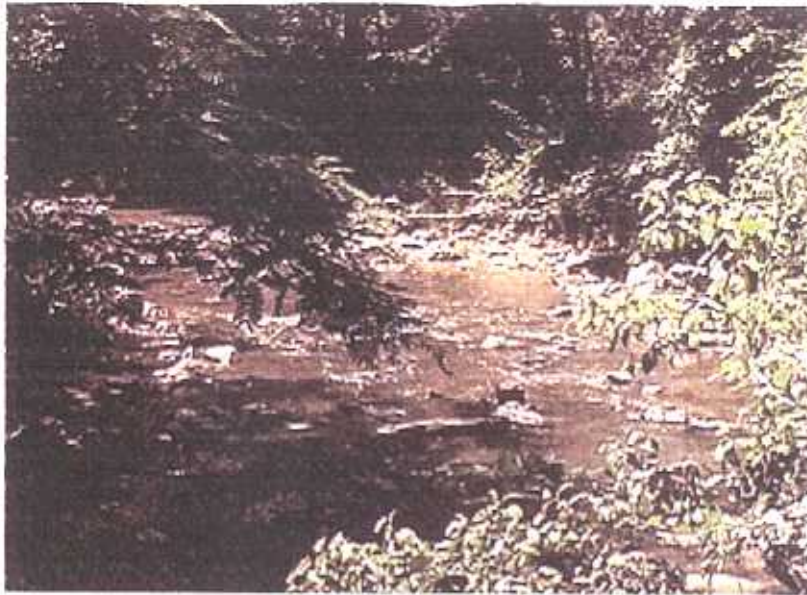
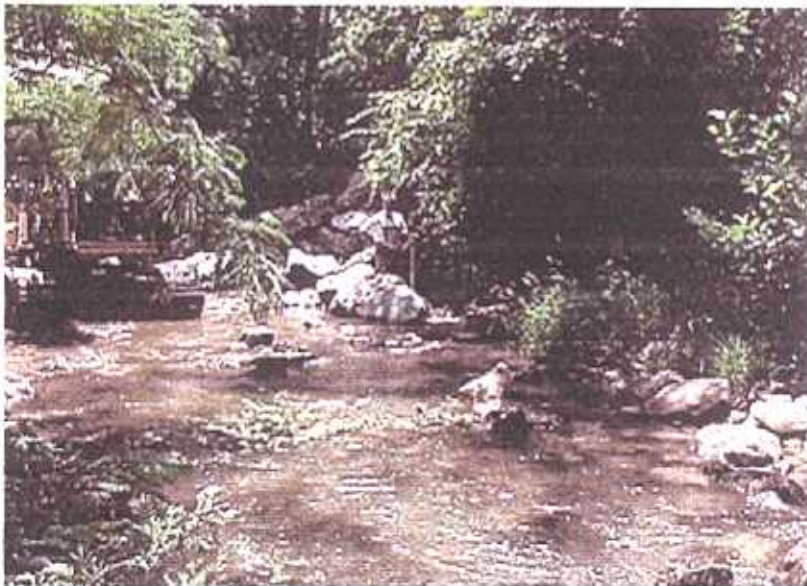
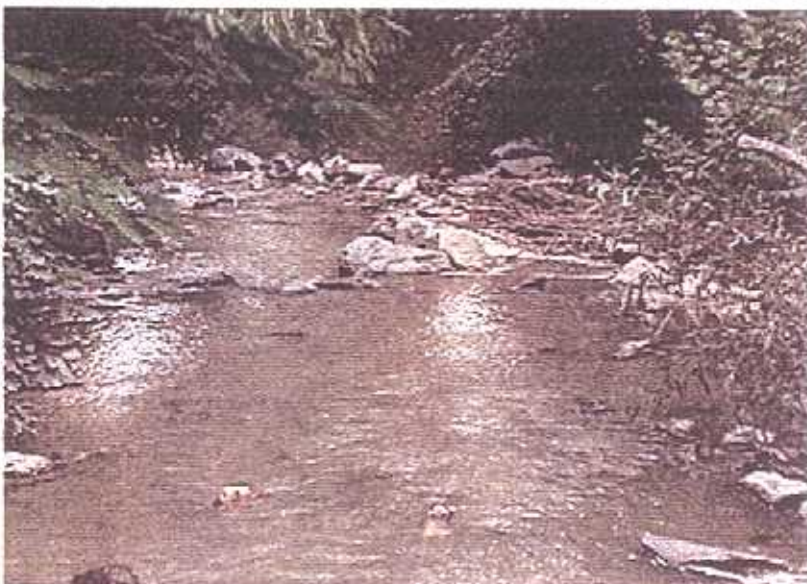
Site of the second vane, taken from the first vane downstream. Top photo shows site before construction, middle photo is the site during construction and bottom photo is three months after construction.

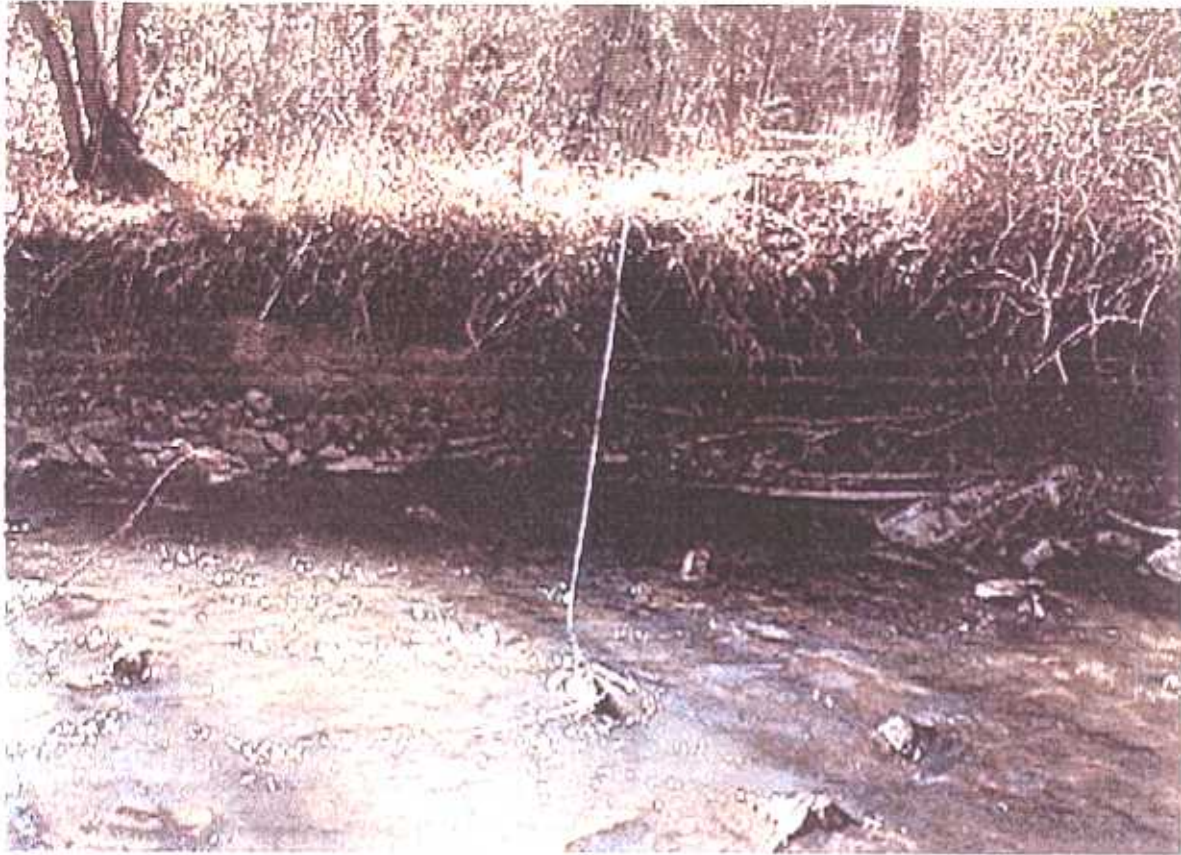
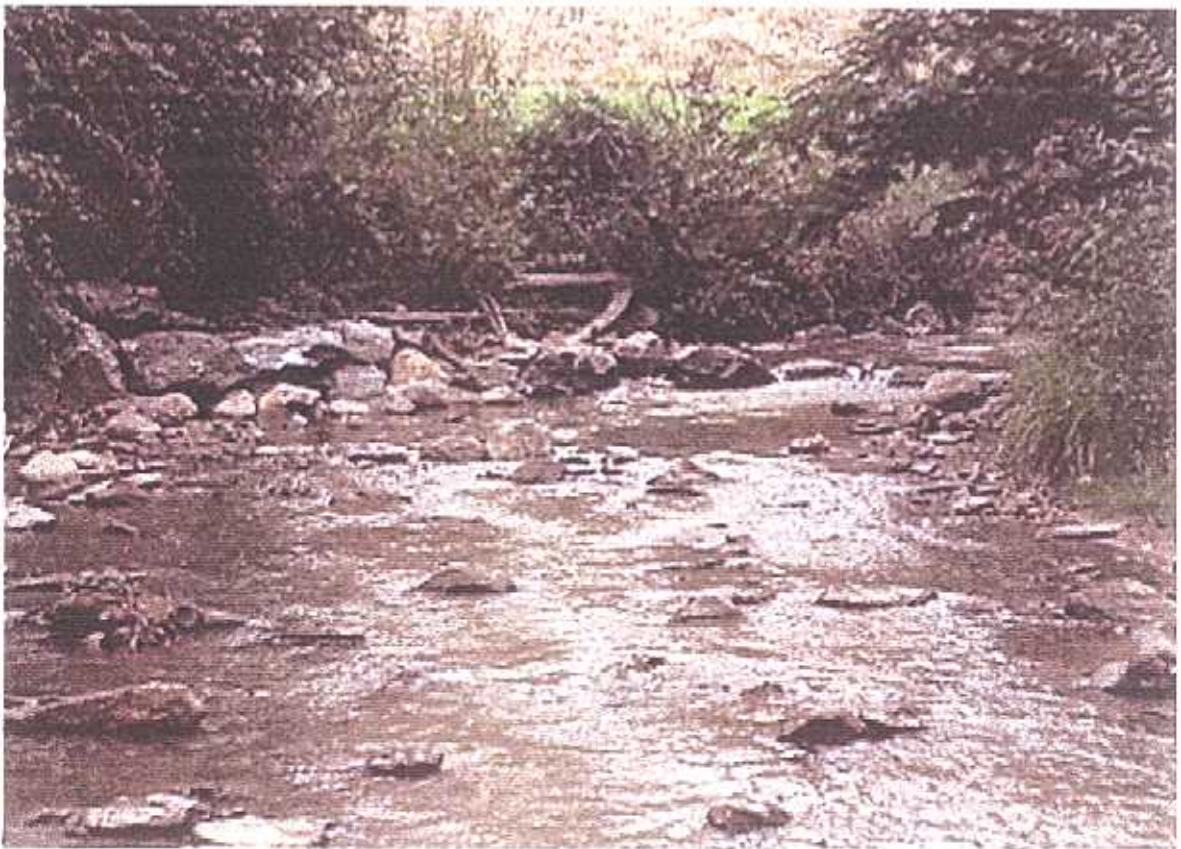
Site of second vane, taken from the third vane upstream. Top photo shows the area before construction and bottom photo shows the same area after construction, with scour hole developed.

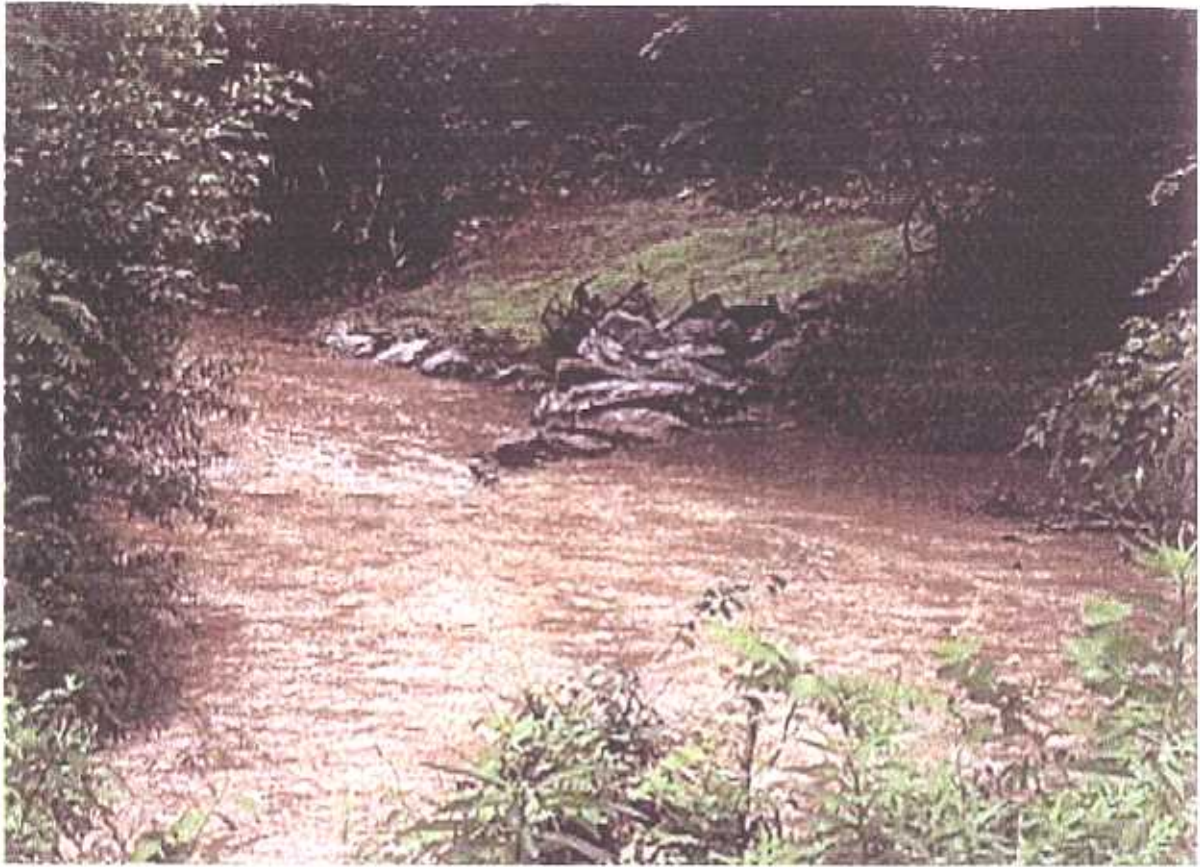
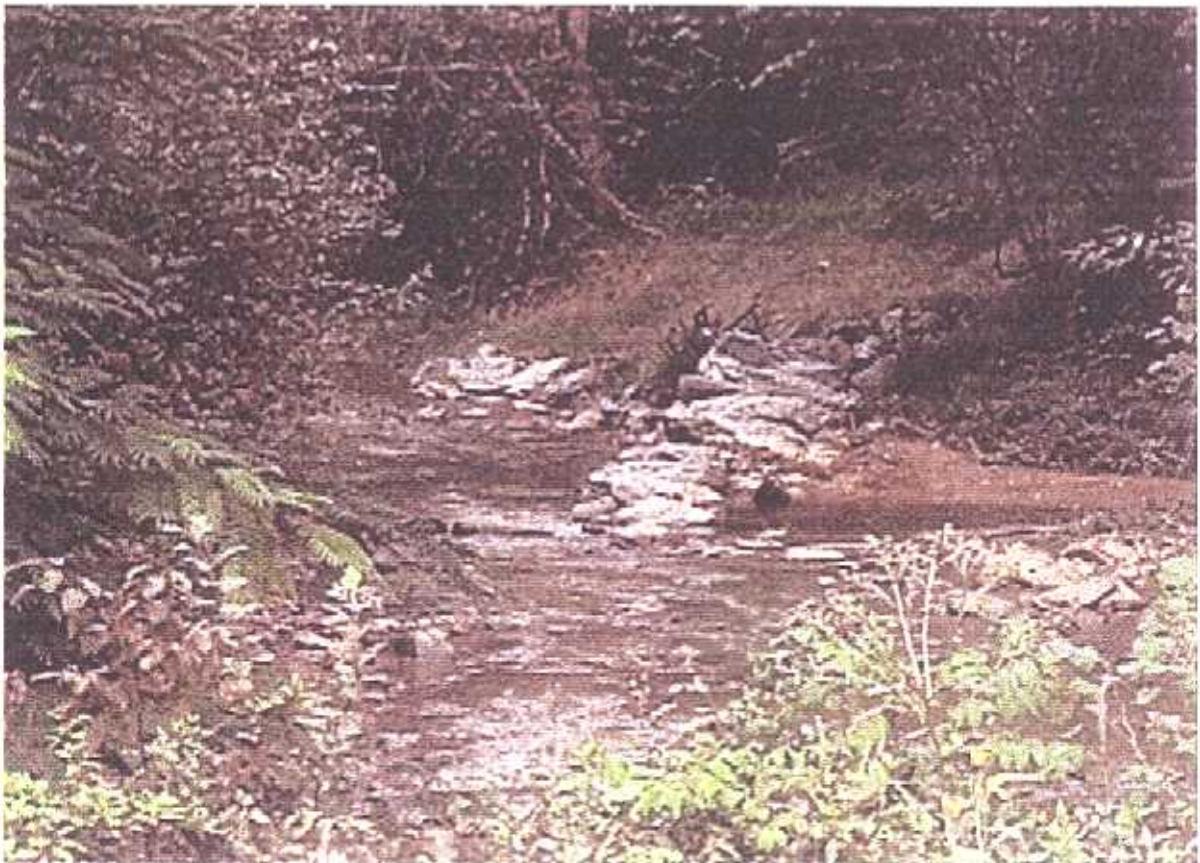
Upper photo - the third vane after construction showing high water pooling upstream of the vane and falling toward mid-channel. Bottom photo - shows the same vane with sediment deposited above the vane as water slows and the sloped, vegetated bank.

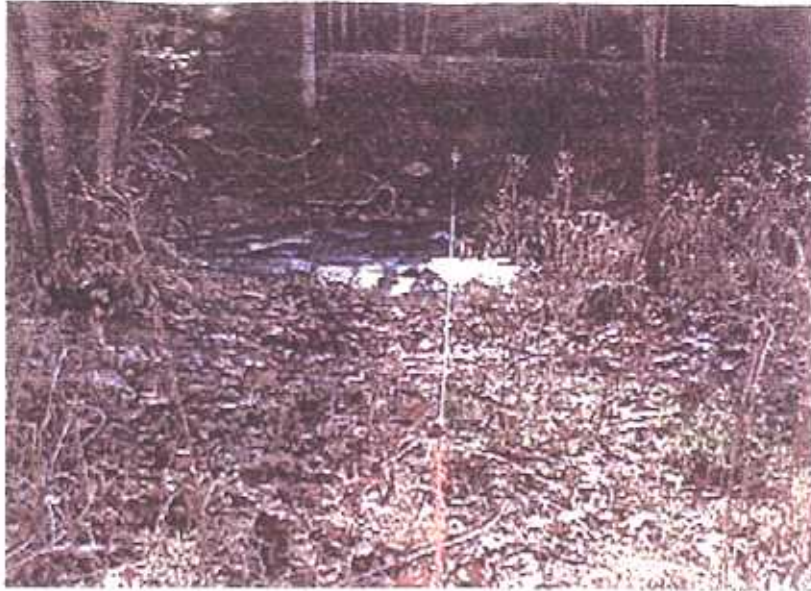
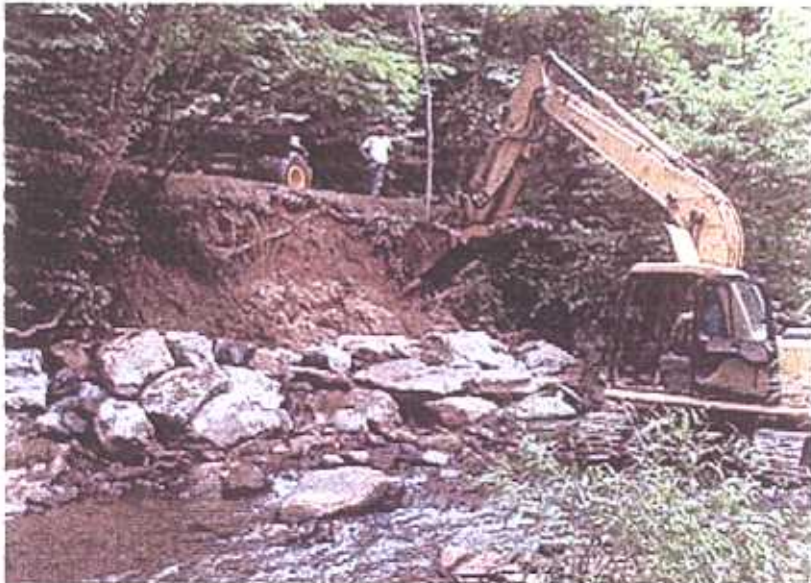
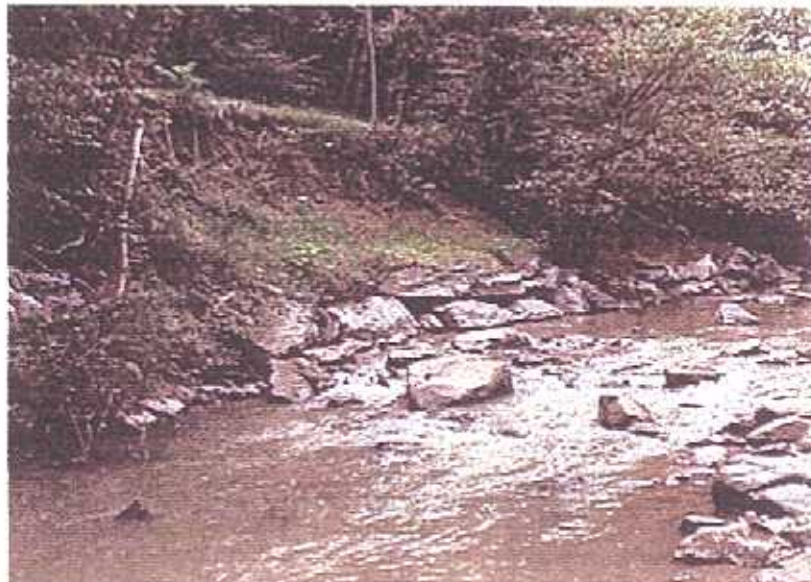
Bench construction at the lower end of the reach. Top photo shows the condition of the high vertical bank before construction. Middle photo shows construction and bottom photo shows site three months after construction.
